SRNL-ESB-2008-00017

Re: Video Survey of Saltstone Vault 4, Cell G

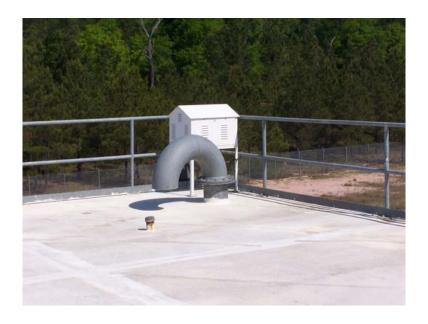
Figure 2. Twelve inch diameter pipe vent located near the north corner of Saltstone Vault #4 Cell G. The pipe elbow was removed to provide an access point for lowering the remote controlled camera.
