PVP2009-77790

## Severe Transportation Accidents: Impacts of Severe Fires on Radioactive Material Transportation

Christopher S. Bajwa, PE  
U.S. Nuclear Regulatory Commission  
301-492-3333  
[Chris.Bajwa@nrc.gov](mailto:Chris.Bajwa@nrc.gov)

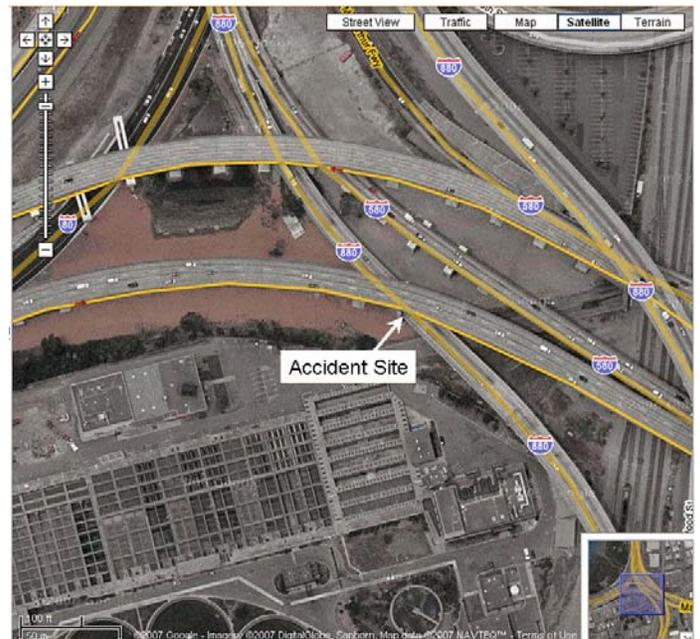
The accident occurred on Sunday morning, April 29, 2007, in an area commonly known as the "MacArthur Maze", a network of connector ramps that merge highways I-80, I-580, and I-880 in Oakland, California. An aerial photograph of the area, with the accident site identified, is shown in Figure 1 [1]. The fire that eventually led to the overpass collapse started about 3:38 a.m. when a gasoline tanker truck carrying 32,500 liters [8,600 gallons] of gasoline crashed and caught fire. The tanker truck was heading south along I-880 at the time of the accident. While nearing the I-580 overpass, the vehicle rolled onto its side and slid to a stop on the 50-foot-high ramp connecting westbound I-80 to southbound I-880. The fire, fueled by the gasoline from the tanker, heated the

Fig. 1. Aerial photograph of I-880 and I-580 Interchange

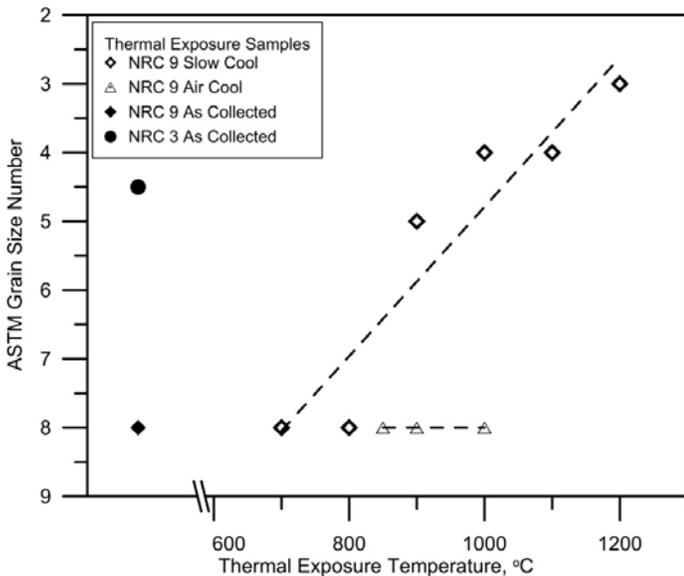
Specific tests on the effect of cooling rate on microstructure were not conducted; however, the effect of a fast cooling rate is apparent when comparing the microstructures of the samples. Specimen sections from both NRC 3 and NRC 9 that were thermally exposed at temperatures of 900 and 1,000 °C [1,652 and 1,832 °F] and cooled in ambient laboratory air. This rapid cooling rate does not allow sufficient time for grain growth after phase transformation. As a result, the final microstructure of the laboratory-air-cooled specimens and the as-received condition of Sample NRC 9 is similar and has a much smaller grain size compared to the slow-cooled specimens. A plot of the grain size as a function of thermal exposure conditions is shown in Figure 9.

**Fig. 9. ASTM grain size as a function of thermal exposure conditions**

Although the cooling rate for the actual structure is not known, it is expected that the cooling rate was slow due to the nature of the fire and the overpass collapse. The large size of the girders, limited use of water on the fire, and the insulating effects of the concrete around the girders likely prevented rapid cooling. Based on the grain size of the thermally exposed and slow-cooled specimens from NRC 9, a grain size between 4 and 5 is expected at temperatures of approximately 980 to 1,020 °C [1,796 to 1,868 °F].

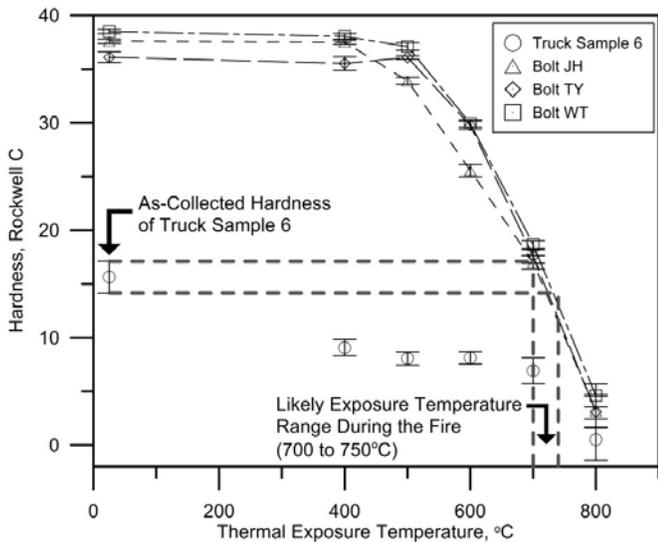
**Fig. 15. Effect of exposure temperature on the hardness of Truck Sample 6 and standard Grade 8 bolts**

The effect of temperature on hardness is apparent for the new Grade 8 bolts. Although the new bolts had slight compositional differences, the hardness as a function of temperature was similar. At temperatures below 500°C [932°F], the hardness of the Grade 8

bolts is not significantly altered. At higher temperatures, the hardness is a function of exposure temperature. The as-collected hardness of Truck Sample 6 was Rockwell B93.8 ± 1.1 or equivalently Rockwell C16. Data from the bolts JH, TY, and WT suggest an exposure of approximately 720°C [1,328°F] for 2 hours would result in a similar reduction in hardness comparable to the as-collected condition of Truck Sample 6. At 800°C [1,472°F], the hardness of the bolts was less than Rockwell B82 or equivalently Rockwell C5. Figure 15 also shows the effect of thermal exposure on sections of the Truck Sample 6. Most significant is the substantial decrease in hardness observed after the exposure at 800°C [1,472°F]. Based on the data shown in Figure 15, it is estimated that Truck Sample 6 was exposed to a temperature in the range of 700 to 750 °C [1,292 to 1,382 °F] in the MacArthur Maze fire.
