PVP2009-77790

Severe Transportation Accidents: Impacts of Severe Fires on Radioactive Material Transportation

Christopher S. Bajwa, PE
U.S. Nuclear Regulatory Commission
301-492-3333
Chris.Bajwa@nrc.gov

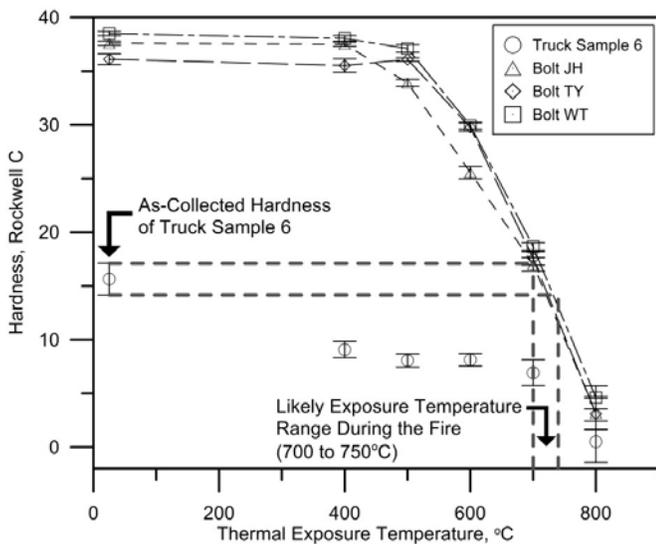
Fig. 15. Effect of exposure temperature on the hardness of Truck Sample 6 and standard Grade 8 bolts

The effect of temperature on hardness is apparent for the new Grade 8 bolts. Although the new bolts had slight compositional differences, the hardness as a function of temperature was similar. At temperatures below 500°C [932°F], the hardness of the Grade 8

bolts is not significantly altered. At higher temperatures, the hardness is a function of exposure temperature. The as-collected hardness of Truck Sample 6 was Rockwell B93.8 ± 1.1 or equivalently Rockwell C16. Data from the bolts JH, TY, and WT suggest an exposure of approximately 720°C [1,328°F] for 2 hours would result in a similar reduction in hardness comparable to the as-collected condition of Truck Sample 6. At 800°C [1,472°F], the hardness of the bolts was less than Rockwell B82 or equivalently Rockwell C5. Figure 15 also shows the effect of thermal exposure on sections of the Truck Sample 6. Most significant is the substantial decrease in hardness observed after the exposure at 800°C [1,472°F]. Based on the data shown in Figure 15, it is estimated that Truck Sample 6 was exposed to a temperature in the range of 700 to 750 °C [1,292 to 1,382 °F] in the MacArthur Maze fire.
