Oyster Creek Generating Station
Facility Operating License No. DPR-16
NRC Docket No. 50-219

Subject: Submittal of Information to ACRS Plant License Renewal Subcommittee Related to AmerGen's Application for Renewed Operating License for Oyster Creek Generating Station (TAC No. MC7624)

**Oyster Creek
License Renewal Project
Drywell Monitoring Program**

Information for ACRS Subcommittee

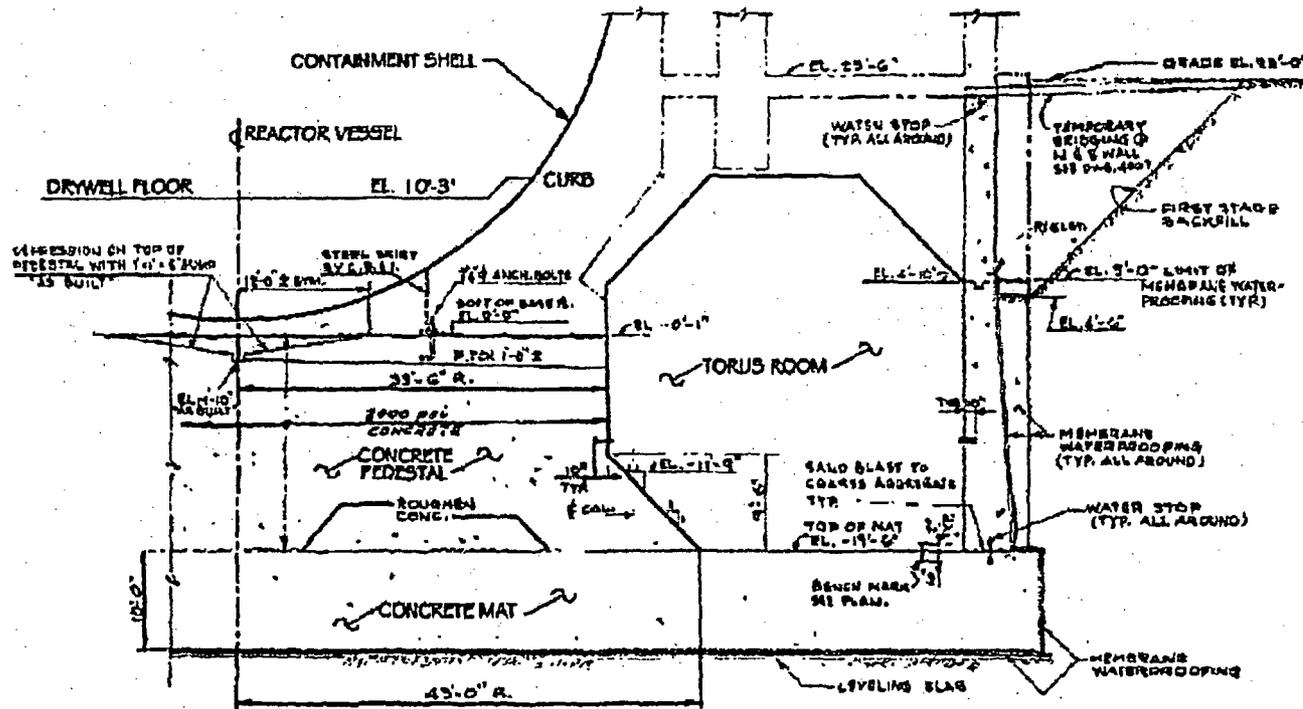
ELEVATION
FIGURE 4

This discussion addresses the potential for corrosion of the interior surface of the drywell shell that is embedded in the concrete floor inside the drywell (i.e., below the concrete floor at Elevation 10' 3"). See Figure 4 in Section 3 of this Enclosure. This area includes the shell behind the concrete curb at the edge of the concrete floor. All elevations of the interior drywell shell were presumed to be coated with primer (except those areas to be embedded in concrete) that was applied following fabrication of the material to protect the steel prior to and during installation.

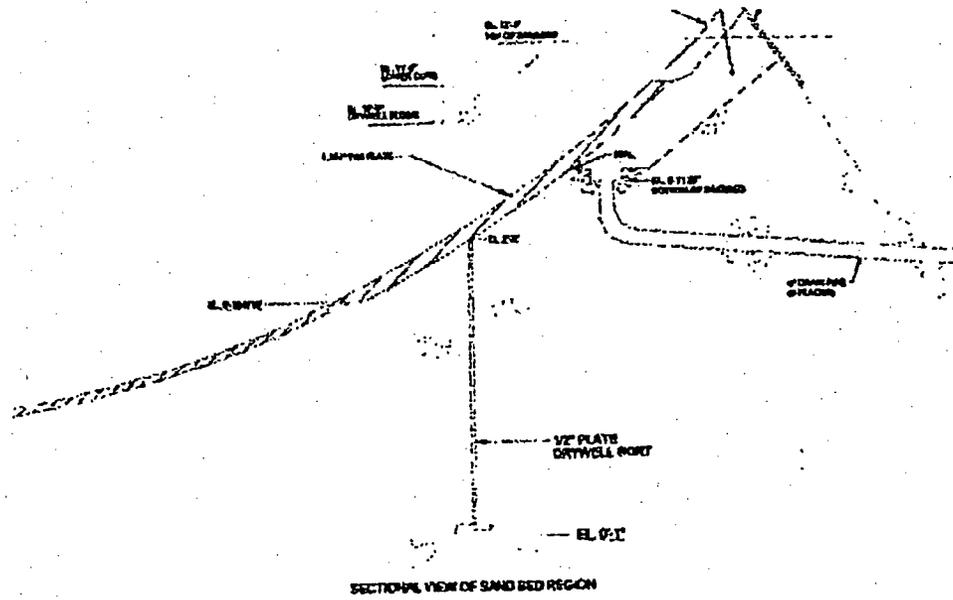
FIGURE 7

A review of the drywell construction and fabrication details shows that the drywell skirt is welded to the 1.154 inch thick plate below the sand bed floor before the end of the 1.154" thick plate. This thick plate is welded to the 0.676" plate at elevation 6 foot 10 1/4 inches. One of the purposes of the skirt, which is also now embedded in concrete, was to support the drywell during construction. The presence of the skirt prevents moisture intrusion into the 0.676" plate. Reference Figure 7 in Section 3 of this Enclosure.

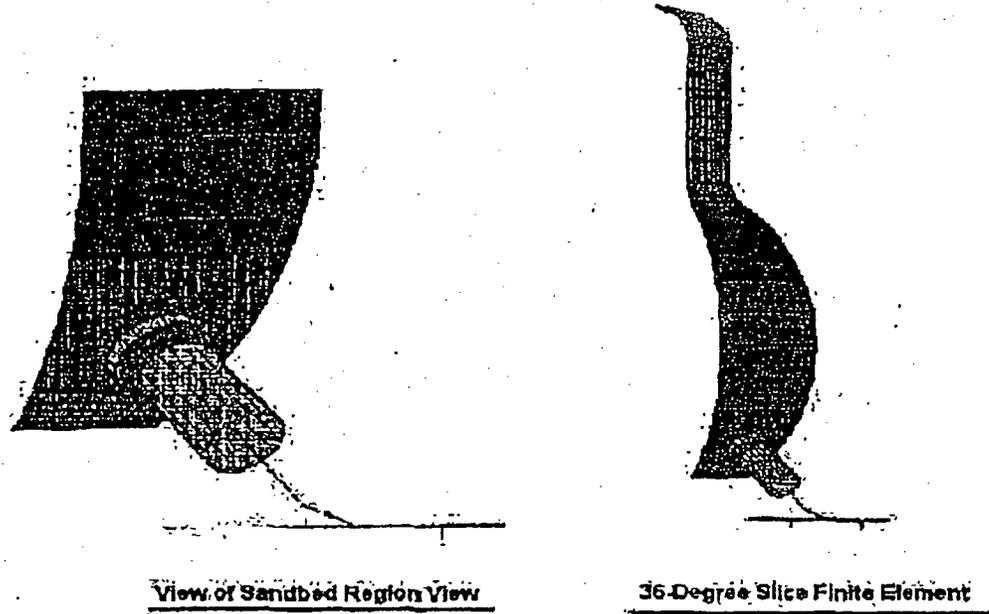
Fig. 1 – Drywell Analysis ANSYS Finite Element Model

An engineering analysis, based on ASME Code requirements, was conducted in the early 1990's to establish the minimum required general thickness without sand for both pressure and buckling stress (Ref [15], Ref [16], Ref [32]). The analysis was based on a partial finite element model (36-degree slice - Fig. 1) of the drywell. Loads and load combinations were in accordance with the original design basis requirements as follow: (Ref [16])
