Oyster Creek Generating Station
Facility Operating License No. DPR-16
NRC Docket No. 50-219

Subject: Submittal of Information to ACRS Plant License Renewal Subcommittee Related to AmerGen's Application for Renewed Operating License for Oyster Creek Generating Station (TAC No. MC7624)

**Oyster Creek
License Renewal Project
Drywell Monitoring Program**

Information for ACRS Subcommittee

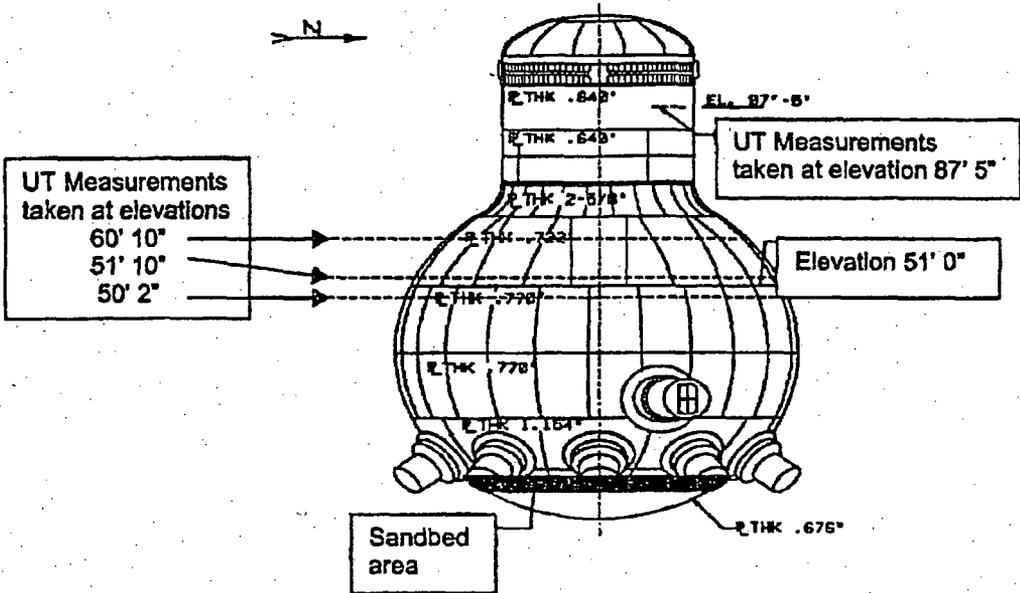
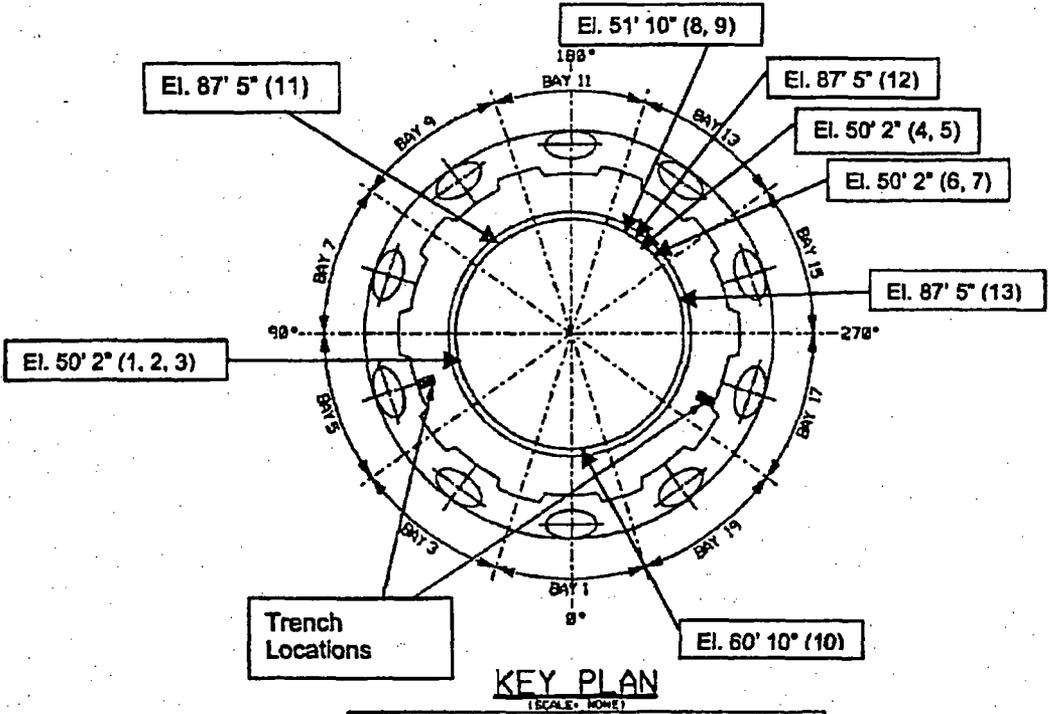
Ongoing Upper Drywell Thickness Monitoring
UT Measurement Locations

1. The average thickness is based on 49 Ultrasonic Testing (UT) measurements performed at each location.
2. Multiple inspections were performed in the years 1988, 1990, 1991, and 1992.
3. The 1993 elevation 60' 10" Bay 6-22 inspection was performed on January 6, 1993. All other locations were inspected in December 1992.
4. Accuracy of Ultrasonic Testing Equipment is plus or minus 0.010 inches.
5. Reference SE-000243-002 (Ref [26]).
