## IR 0553792-02, Drywell Structural Integrity Basis from 1R21 Inspections

The purpose of this Technical Evaluation is to present current and projected (until 1R22) margin in Drywell Vessel Thicknesses and the bases to further confirm that the drywell structural integrity continues to maintain design basis requirements as established in references 1 through 3. The intent of this evaluation is to demonstrate that the Drywell Vessel thicknesses are adequate to satisfy current licensing and design bases requirements.

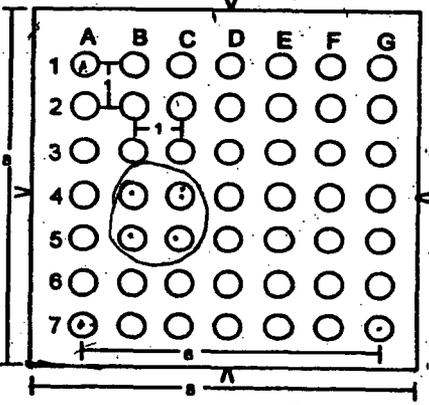
Location ID	9D			Bay	9	Elev.	11' 3"
	A	B	C	D	E	F	G
1	1.005	1.068	0.985	1.133	1.132	1.136	1.101
2	<del>0.896</del>	0.927	1.067	1.037	0.974	1.077	1.069
3	<del>0.751</del>	0.883	0.975	1.071	1.033	1.105	1.123
4	0.885	0.993	0.949	0.984	0.995	1.022	1.041
5	0.980	0.968	0.936	0.942	0.880	0.927	0.998
6	0.960	0.869	0.976	0.987	0.967	0.965	0.949
7	0.968	0.967	0.963	1.004	0.947	0.892	0.943

COMMENTS:  
Core Plug located at C04, C05, B04, B05.  
*excluded*

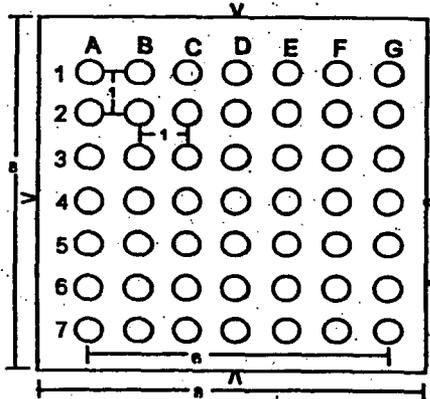
Location ID	86-20			Bay	9	Elev.	87' 5"	Calibration Check: 14:30	
	A	B	C	D	E	F	G	Tscr.	AVG.
1	0.621	0.625	0.628	0.606	0.620	0.606	0.633		
2	0.611	0.619	0.623	0.607	0.634	0.599	0.641		
3	0.605	0.603	0.588	0.623	0.630	0.621	0.622		
4	0.614	0.604	0.615	0.586	0.620	0.630	0.623		
5	0.623	0.599	0.640	0.639	0.617	0.632	0.602		
6	0.602	0.631	0.611	0.624	0.619	0.628	0.638	0.545	0.617
7	0.593	0.596	0.596	0.585	0.629	0.636	0.620

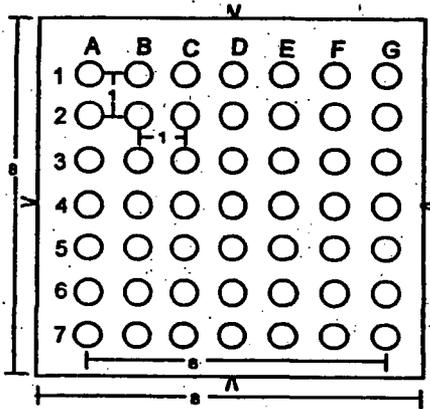
Location ID	86-28 (13/28)			Bay	13	Elev.	87' 5"
	A	B	C	D	E	F	G
1	0.605	0.610	0.646	0.642	0.648	0.644	0.616
2	0.634	0.642	0.649	0.650	0.624	0.639	0.622
3	0.636	0.643	0.649	0.610	0.647	0.653	0.654
4	0.607	0.637	0.636	0.563	0.601	0.653	0.653
5	0.632	0.624	0.639	0.626	0.649	0.656	0.658
6	0.597	0.640	0.639	0.656	0.652	0.640	0.654
7	0.636	0.633	0.630	0.658	0.652	0.640	0.648

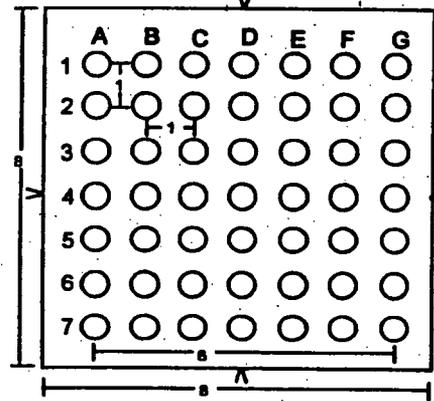
Location ID	51-5			Bay	5	Elev.	50' 2"
	A	B	C	D	E	F	G
1	0.739	0.655	0.734	0.765	0.768	0.769	0.716
2	0.762	0.747	0.758	0.748	0.774	0.772	0.716
3	0.769	0.755	0.650	0.678	0.756	0.759	0.758
4	0.739	0.761	0.690	0.660	0.704	0.768	0.772
5	0.693	0.755	0.707	0.767	0.750	0.770	0.750
6	0.758	0.751	0.725	0.715	0.729	0.767	0.724
7	0.758	0.763	0.764	0.732	0.772	0.761	0.766

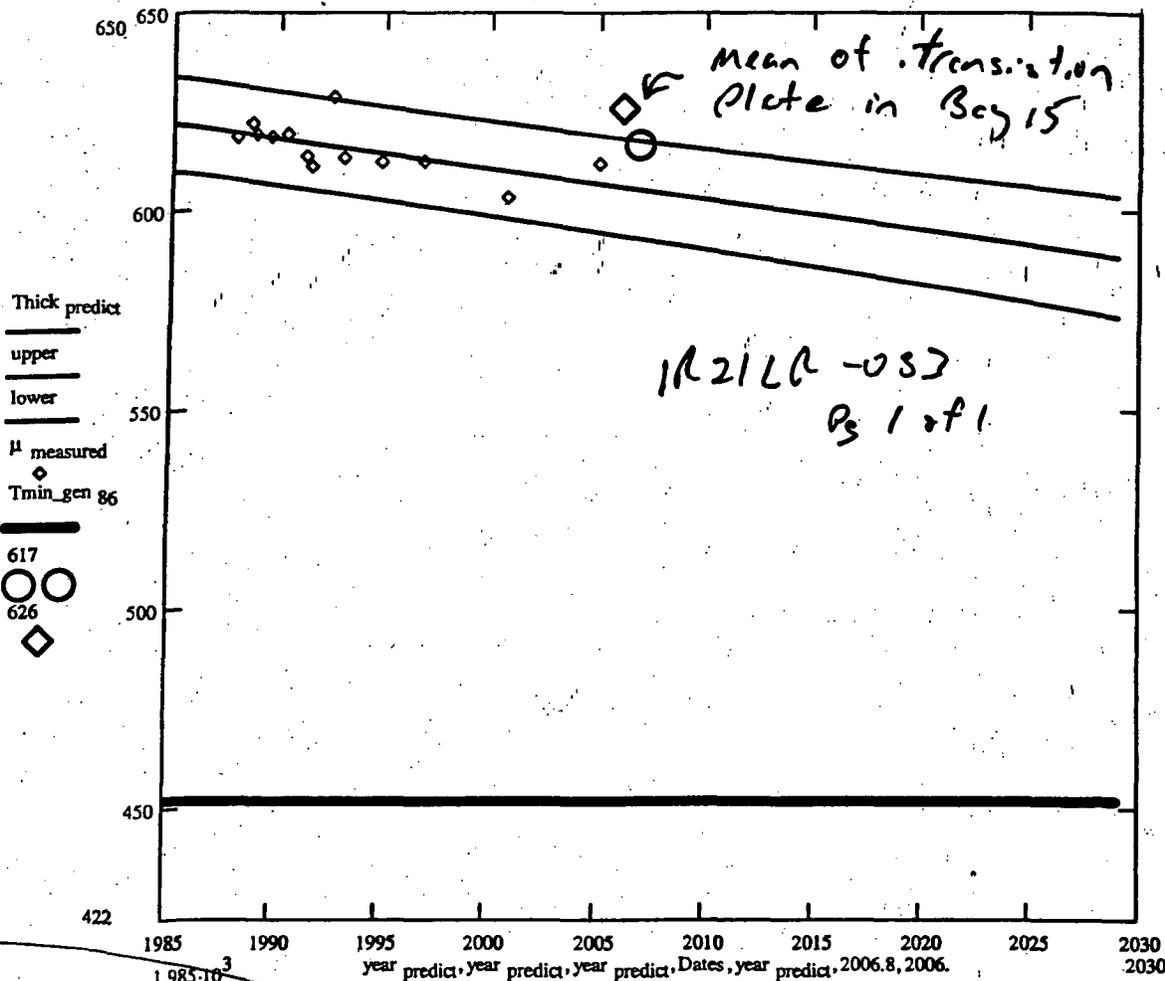
Bay 9 Area 20  
Subject: Drywell Corrosion

The 2004 calculation identified location 9-20 as the most critical since it was the thinnest at this elevation. The calculation concluded that this location was experiencing a corrosion rate of 0.00075 inches per year with 95% confidence. Figure 6 provides the trend of the means of data collected from 1987 through 2004 for these locations taken from calculation C-1302-187-E310-037 Revision 2. The 2006 mean for this location is plotted on this figure. This shows that the 2006 mean is consistent with and is bounded by the 2004 projection. Therefore the margin and projection from 2004 remain valid and bounding. Table 1 provides the means and margin calculated in 2004.

Therefore the regression model shows that even at the lower 95% confidence band this location will not corrode to below Drywell Vessel Minimum required thickness by the plant end of life.

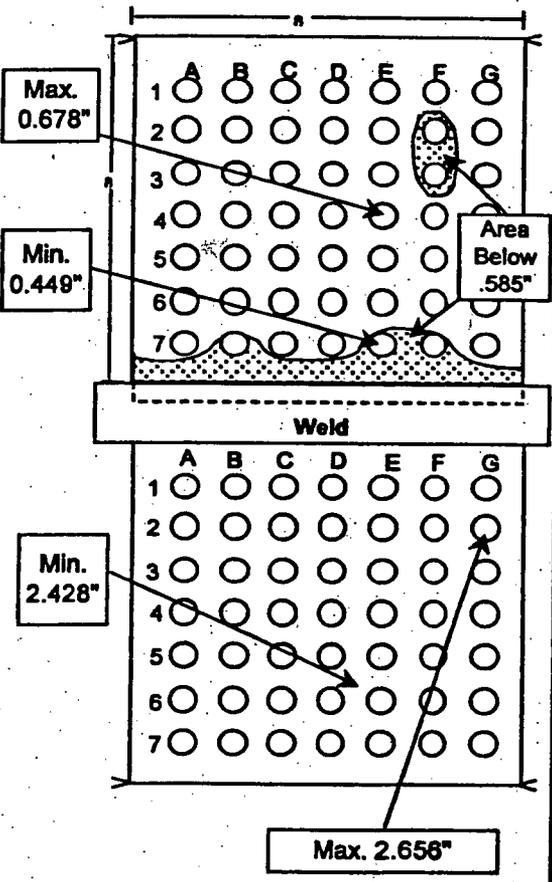
Location ID	71-15 welddn			Bay	15	Elev.	71' 6"
	A	B	C	D	E	F	G
1	2.527	2.575	2.518	2.499	2.560	2.620	2.648
2	2.536	2.529	2.471	2.597	2.565	2.633	2.656
3	2.534	2.513	2.485	2.485	2.466	2.562	2.527
4	2.509	2.451	2.492	2.514	2.490	2.549	2.528
5	2.549	2.508	2.536	2.518	2.481	2.530	2.526
6	2.512	2.513	2.547	2.511	2.548	2.523	2.489
7	2.601	2.530	2.536	2.533	2.515	2.455	2.483

**COMMENTS:**  
 Forty nine (49) readings were taken using the 8"x 8" template to determine the average reading.  
 A 100% scan within the 8"x 8" area to determine the minimum and the maximum thickness.  
 A scan of the uppermost 1" of horizontal weld was performed, the minimum reading on the weld was 0.700" the maximum reading on the weld was 0.893". Unable to obtain readings on the lower part of weld due to rough and non-parallel surfaces.  
 Inspection area centered 13" right of vertical seam weld between plate 71-1 and plate 71-2, looking outward. Reference drawing 2E-187-29-001 R0.

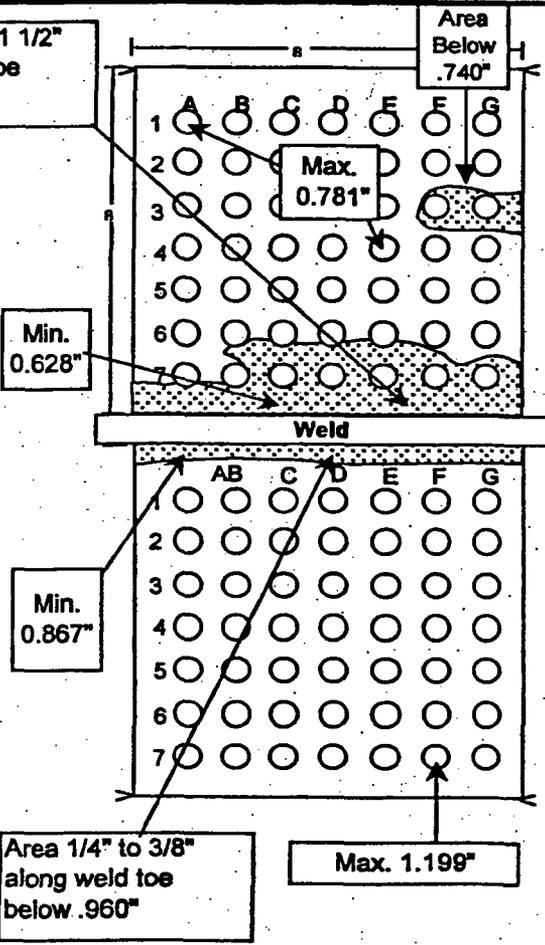
Location ID	23-17 weldn			Bay	17	Elev.	23' 6"
	A	B	C	D	E	F	G
1	1.157	1.169	1.141	1.154	1.168	1.162	1.147
2	1.176	1.170	1.161	1.152	1.156	1.171	1.160
3	1.175	1.183	1.170	1.166	1.165	1.162	1.176
4	1.172	1.189	1.188	1.188	1.190	1.171	1.151
5	1.190	1.195	1.185	1.192	1.192	1.195	1.189
6	1.195	1.176	1.188	1.190	1.184	1.193	1.180
7	1.177	1.175	1.180	1.181	1.183	1.199	1.192

**COMMENTS:**  
 Forty nine (49) readings were taken using the 8"x 8" template to determine the average reading. 100% scan of the weld and 100% scan within the 8"x 8" area to determine the minimum and the maximum thickness. Minimum reading on weld was 0.689", Maximum reading on weld was 0.918".

Inspection area centered 55" left of vertical seam weld between plate 23-19 and plate 23-20, looking outward. Reference drawing 2E-187-29-001 R0.

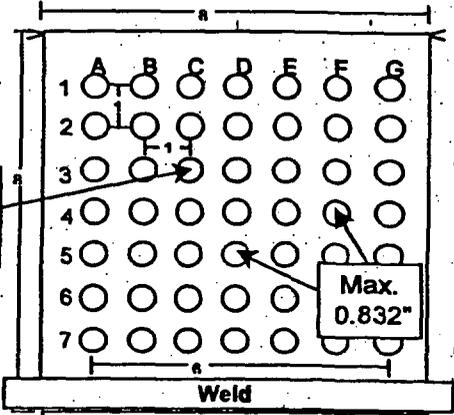
Location ID	23-15 weldup			Bay	15	Elev.	23' 6"
	A	B	C	D	E	F	G
1	0.792	0.773	0.757	0.728	0.827	0.759	0.813
2	0.796	0.765	0.770	0.765	0.827	0.738	0.831
3	0.745	0.728	0.655	0.787	0.827	0.826	0.823
4	0.798	0.795	0.786	0.810	0.826	0.832	0.829
5	0.799	0.790	0.789	0.832	0.825	0.822	0.830
6	0.799	0.798	0.792	0.825	0.813	0.799	0.811
7	0.791	0.794	0.797	0.828	0.808	0.803	0.805

Min. 0.655"

Max. 0.832"

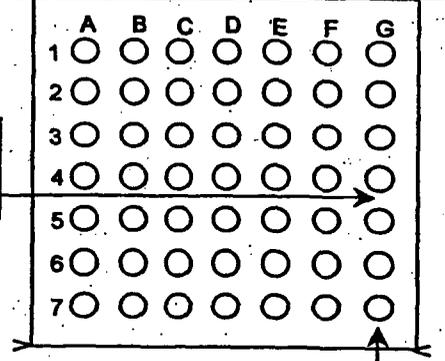
Location ID	23-15 welddn			Bay	15	Elev.	23' 6"
	A	B	C	D	E	F	G
1	1.154	1.153	1.149	1.154	1.156	1.187	1.147
2	1.156	1.160	1.165	1.154	1.150	1.165	1.161
3	1.154	1.160	1.158	1.154	1.157	1.153	1.171
4	1.157	1.161	1.149	1.160	1.149	1.158	1.165
5	1.167	1.155	1.145	1.170	1.157	1.160	1.150
6	1.175	1.157	1.158	1.167	1.157	1.156	1.164
7	1.175	1.177	1.177	1.168	1.154	1.167	1.186

Min. 1.141"

Max. 1.186"

Inspection area centered 15" left of vertical seam weld between plate 23-18 and plate 23-19, looking outward. Reference drawing 2E-187-29-001 R0.
