**Inspection of Motor Operated Valve Limitorque AC Motors with  
Magnesium Rotors**

BWROG-TP-09-005  
Revision 0  
March 05, 2009

A Technical Product of the BWR Owners Group  
Valve Technical Resolution Group

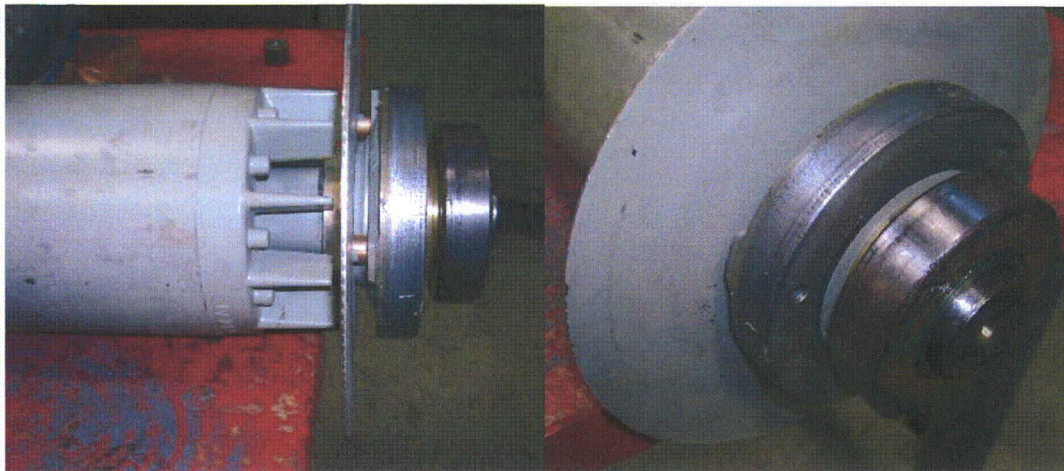
Type LR motors cannot be inspected via borescope (type can be found on the nameplate of the motor under "insulation type"). This is due to an internal shield installed between the bearing bracket and motor rotor. These motors require disassembly to be inspected.

*Figure 14 - Type LR motor rotor. Note the large shield inboard of the bearing. This prevents field inspection of the rotor via borescope.*

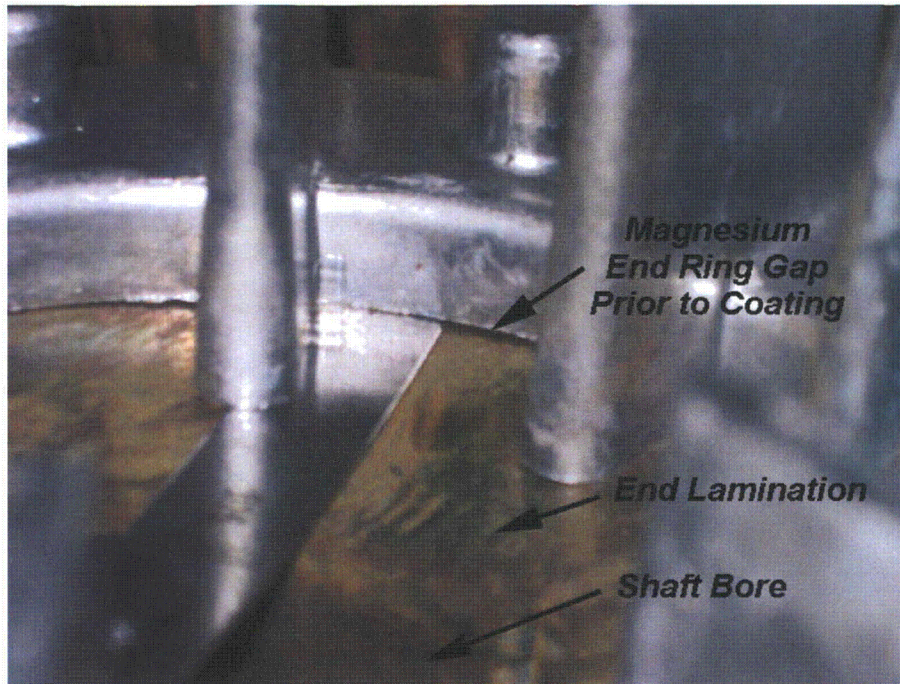
Figure 25 – Unpainted magnesium rotor after casting and quenching process.

It should be noted that it is normal to have some separation of the magnesium end ring relative to the end lamination. According to the motor manufacturer, the rotor manufacturing process calls for quenching after the magnesium casting process to assist in the surface separation of these materials to improve motor efficiency. The gap is the result of this process and alone is not cause for motor rejection during inspection. This gap is normally 0.030" but can vary from this average value. The image above shows a type end ring separation between the magnesium end ring and end lamination.

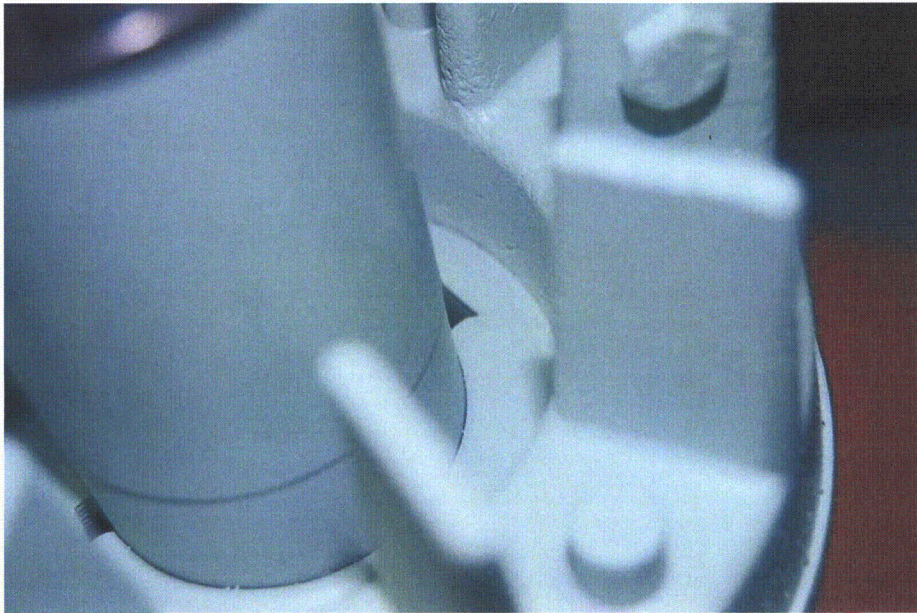
*Figure 35 – Properly coated rotor at magnesium end ring to lamination interface.*

The motor rotor can be cleaned by glass bead blasting and coating with Ranvar B-5-346 or BT-7455A air dry primer. This is the coating used by the motor OEM to coat magnesium rotors. Two coats should be used to achieve a proper coating with no visible magnesium showing.

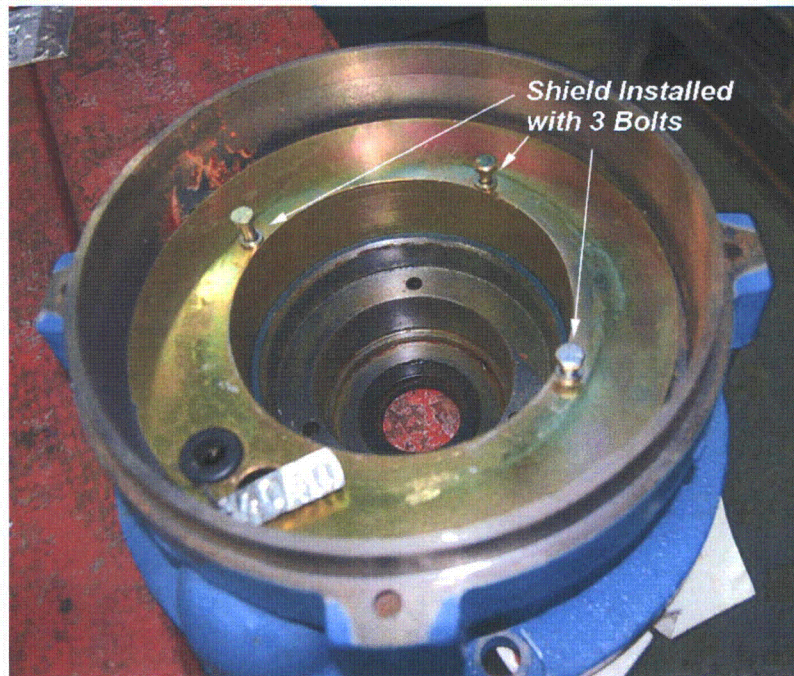
*DE bearing bracket with shield installed. Bolts are shown NOT screwed all the way in.*

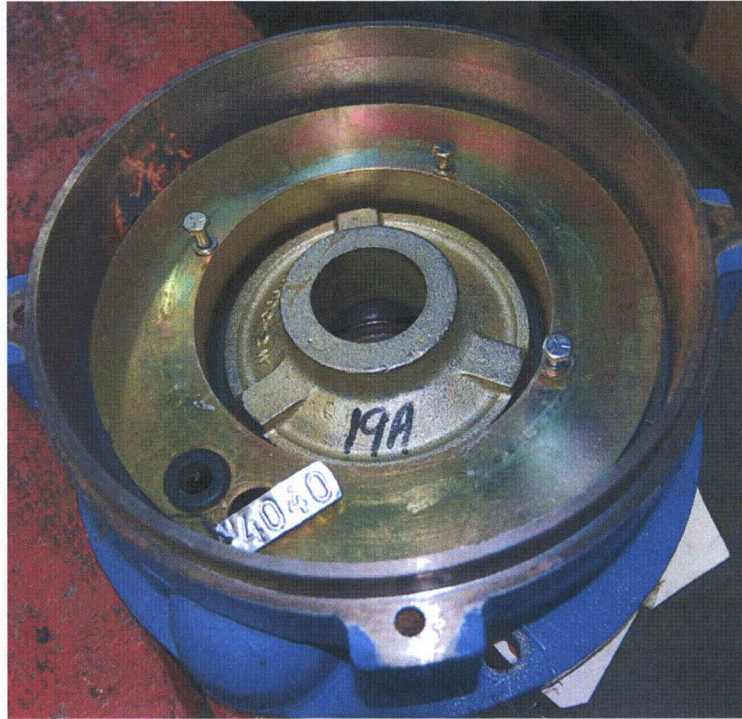
*DE bearing bracket with shield installed and bearing cap in place.  
Shield bolts are shown NOT screwed all the way in.*

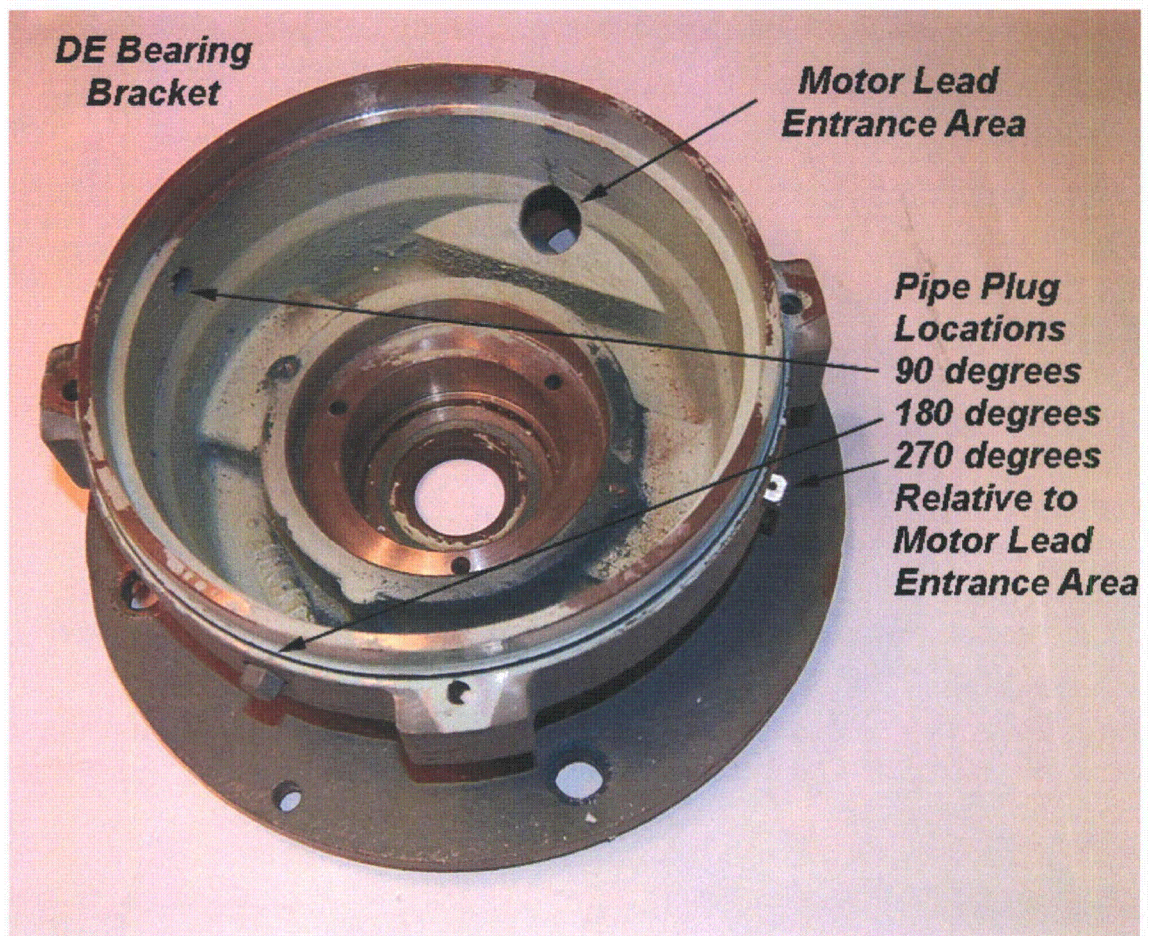
4.2.1 Drive End Bearing Bracket

The DE bearing bracket will have no more than three holes drilled. These holes should be 180 degrees across from the motor lead entrance area (1 hole) and (2) holes 90 degrees relative to the lead entrance area. Once the hole location is determined, mark location with a center punch.

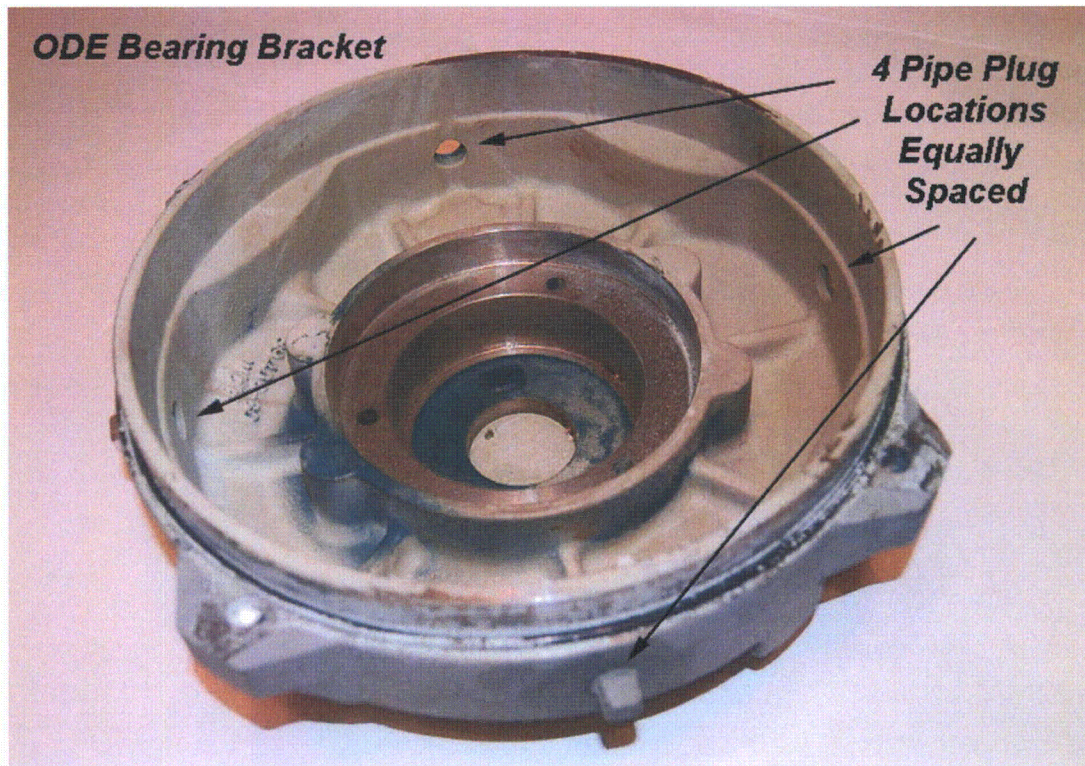
*ODE Bearing Bracket. Pipe plug locations equally spaced between bearing bracket-to-stator frame bolting locations.*

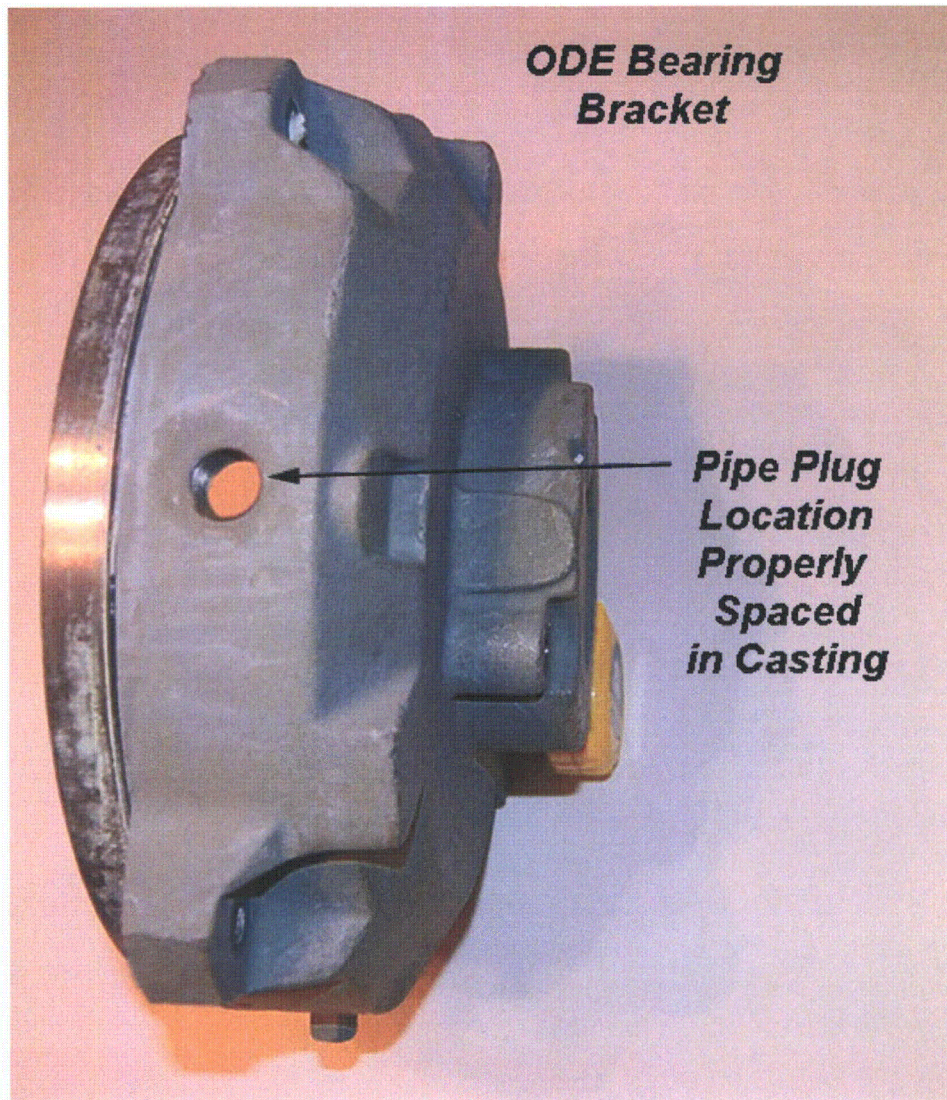
*Locate the hole for the pipe plug in the proper location radially and axially in the bearing bracket casting. Consideration must be taken when determining drilling location for both the inside and outside of the casting.*
