ANP-10280NP
Revision 2

Poolside Postirradiation Examination of MOX Lead Assemblies

April 2009

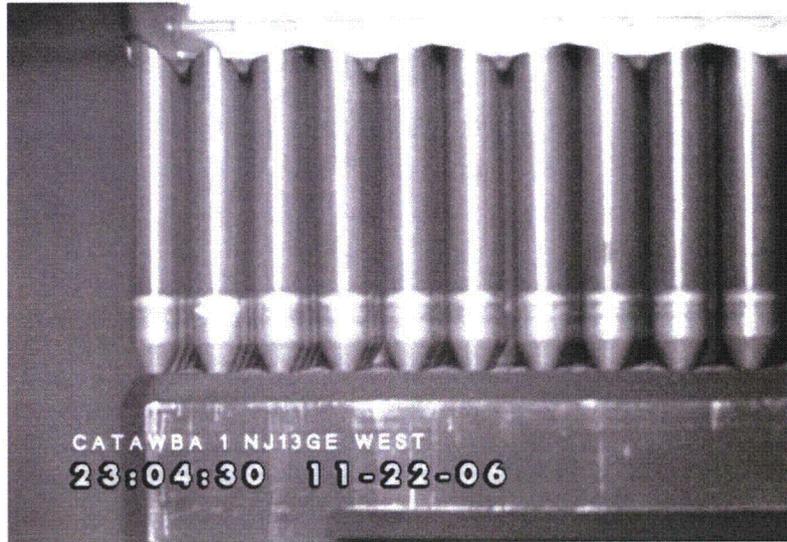
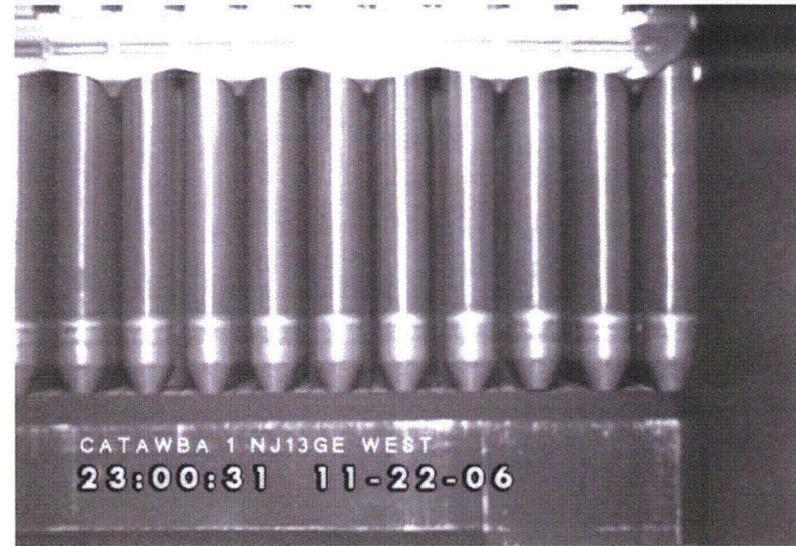
Figure 4-6—Bottom Ends of Fuel Rods as Seen on West Face of MX01, End of Cycle 1

A complete video record was made of all faces of all four lead assemblies. The record was stored in digital form for later review. The visual inspections indicated that the fuel assemblies were performing normally, that is, like low enriched uranium fuel assemblies. Sample photographs from the video record are shown in Figure 4-1 through Figure 4-6. As is described in Section 3.1, the individual video images do not cover the full width of a fuel assembly, so each of these figures shows first the left side followed by the right side. There is some overlap between the two images. To indicate the extent of overlap, the center (ninth) rod on the face is marked with "9" below each image.

The video record mentioned in Section 4.1.1 documents the appearance of the peripheral fuel rods. All fuel rods appeared to be in excellent condition, with light, uniform oxidation.

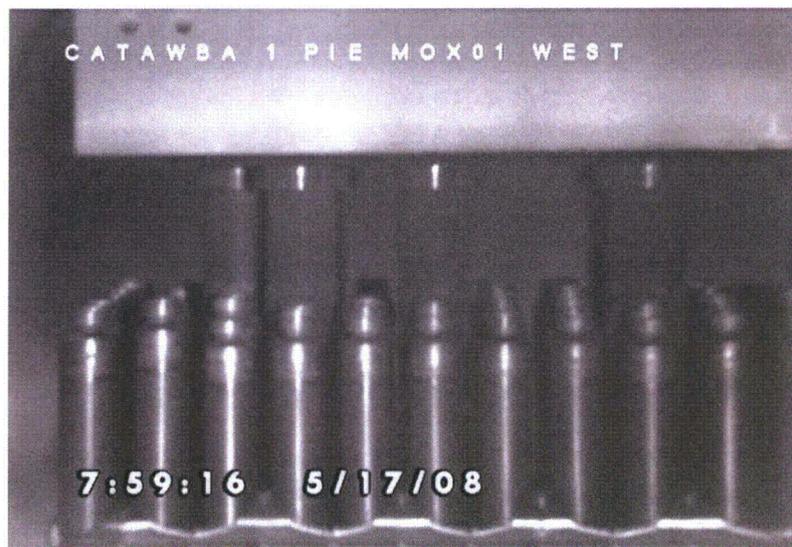
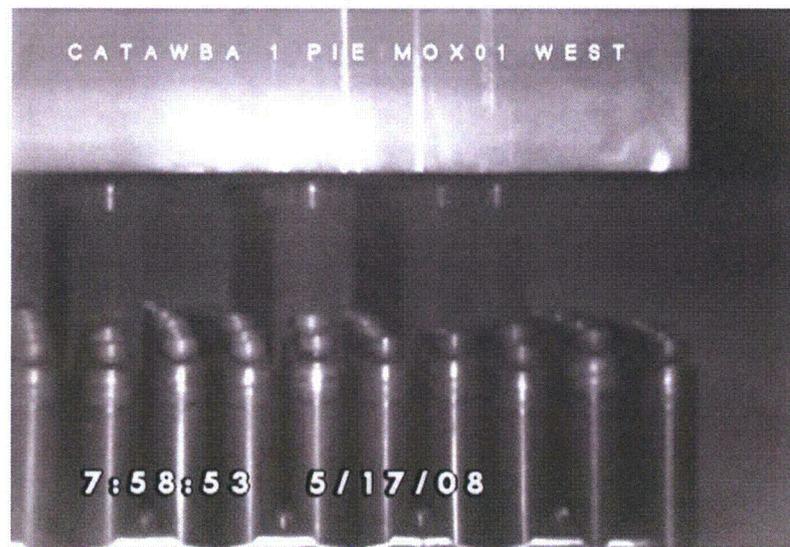
Figure 4-7—Top Ends of Fuel Rods as Seen on West Face of MX01, End of Cycle 2

A complete video record was again made of all faces of all four assemblies and stored in digital form. The visual inspections indicated that the fuel assemblies were performing normally, that is, like low enriched uranium fuel assemblies. Sample photographs from the video record are shown in Figure 4-7 through Figure 4-12; these may be compared to Figure 4-1 through Figure 4-6. See Section 4.1.1 for a discussion of how the images overlap.

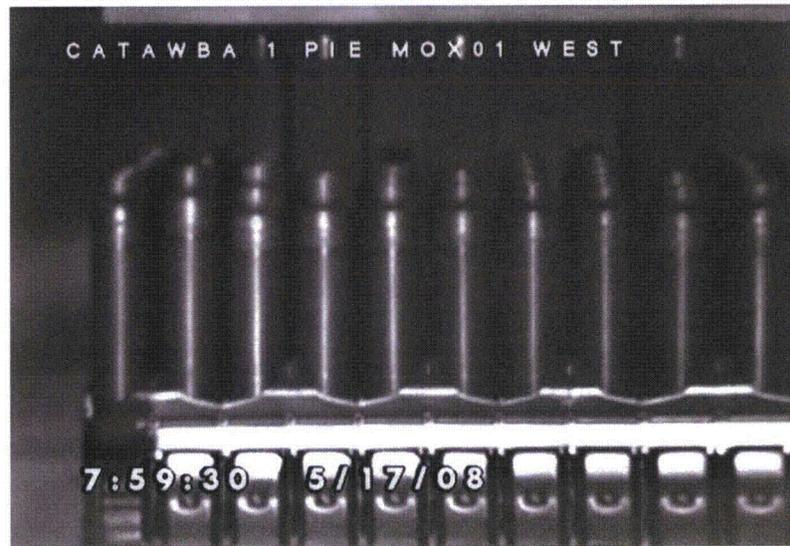
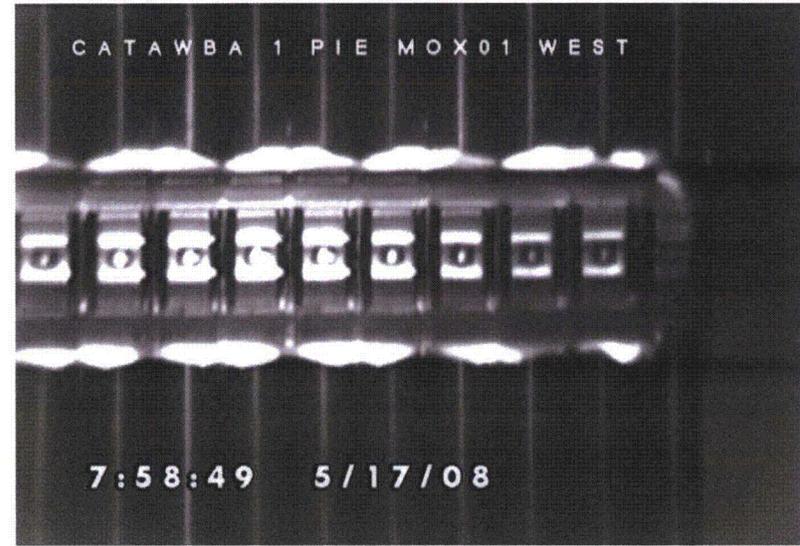
Figure 4-8—Top End Grid as Seen on West Face of MX01, End of Cycle 2

The video record documents the appearance of the periphery of the assembly, including fuel rods, spacer grids, mid-span mixing grids, and nozzles. All grids were found to be in excellent condition, with very little corrosion and no mechanical damage. Some grids showed evidence of crud deposition; see Figure 4-10 for an example.
