AERIAL PHOTOGRAPHIC MONITORING, FLORIDA POWER CORPORATION, CRYSTAL RIVER POWER PLANT SALT DRIFT STUDY

FINAL REPORT 1993 AERIAL PHOTOGRAPHY

March 8, 1994

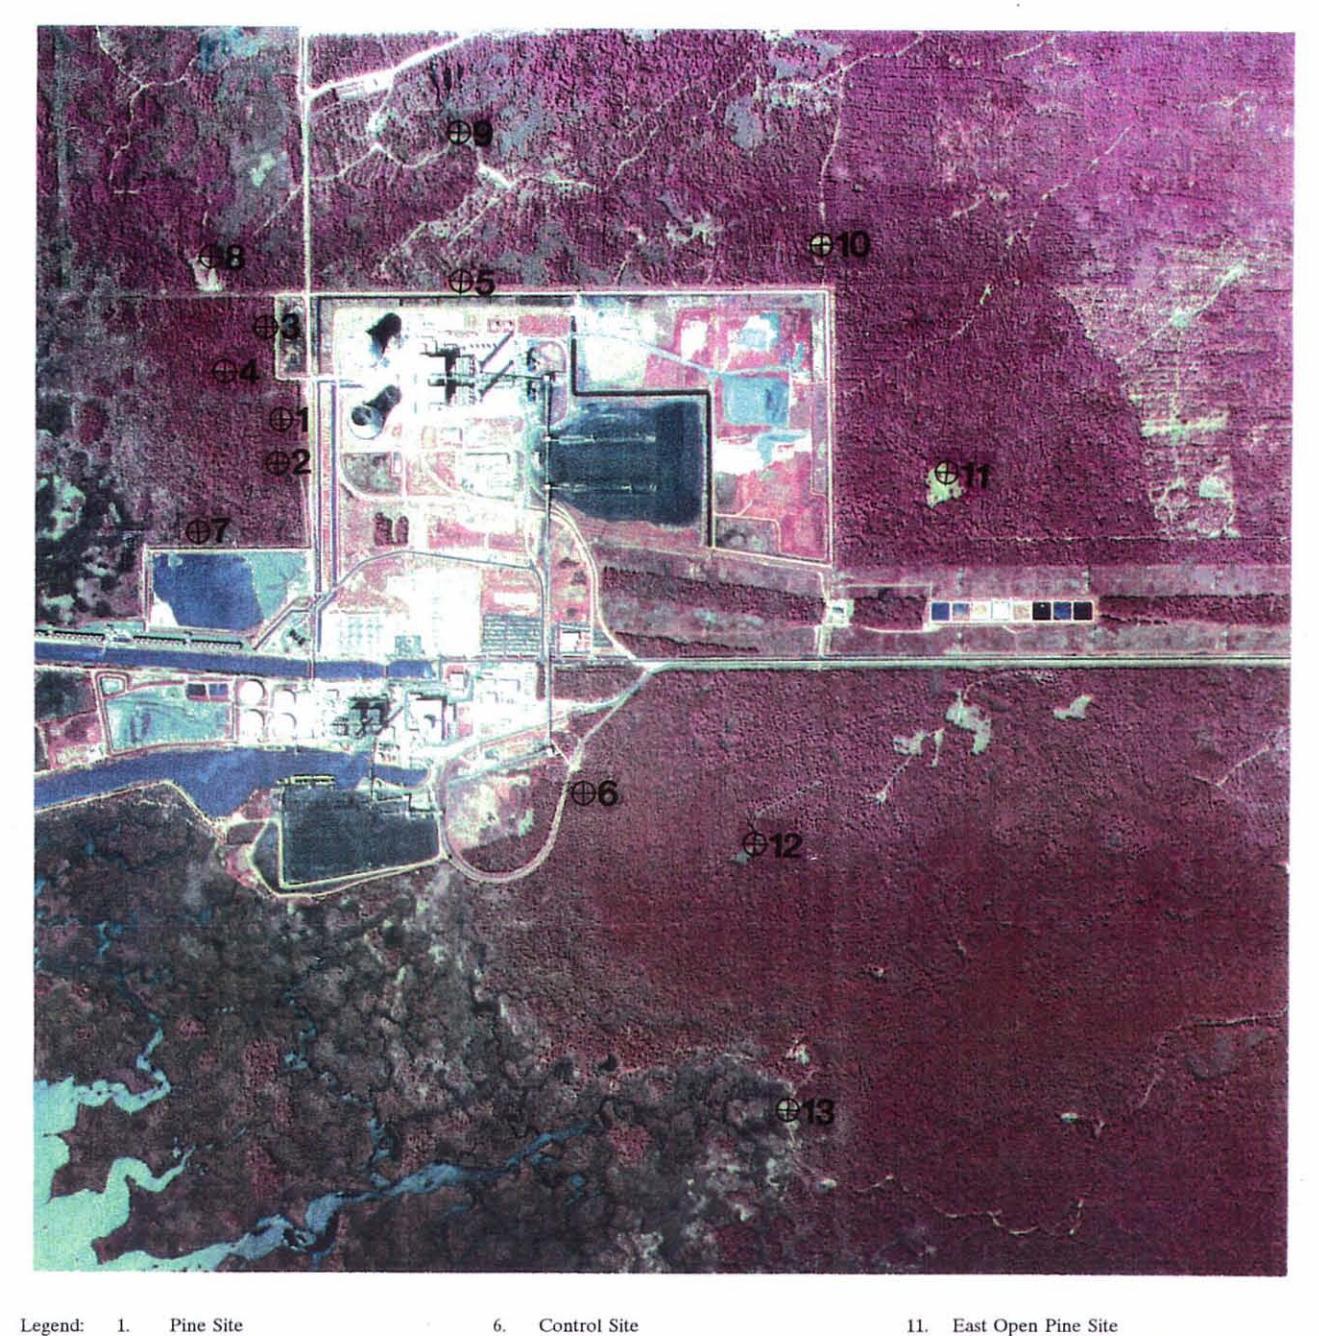
Figure 1 is a high-altitude aerial photograph taken during the 1993 monitoring year. It documents the general conditions of the overall study area, and also serves as a reference for specific areas of interest which are discussed in the Results section of this report. All of the permanently established monitoring stations are identified on this aerial, and thus correlate with data and related information from previous monitoring reports. Appendix 1 demonstrates the orientation and approximate locations of flight lines used for the third aerial photography mission. Photograph exposure index numbers for the high- and low-altitude aerials are provided on this exhibit.

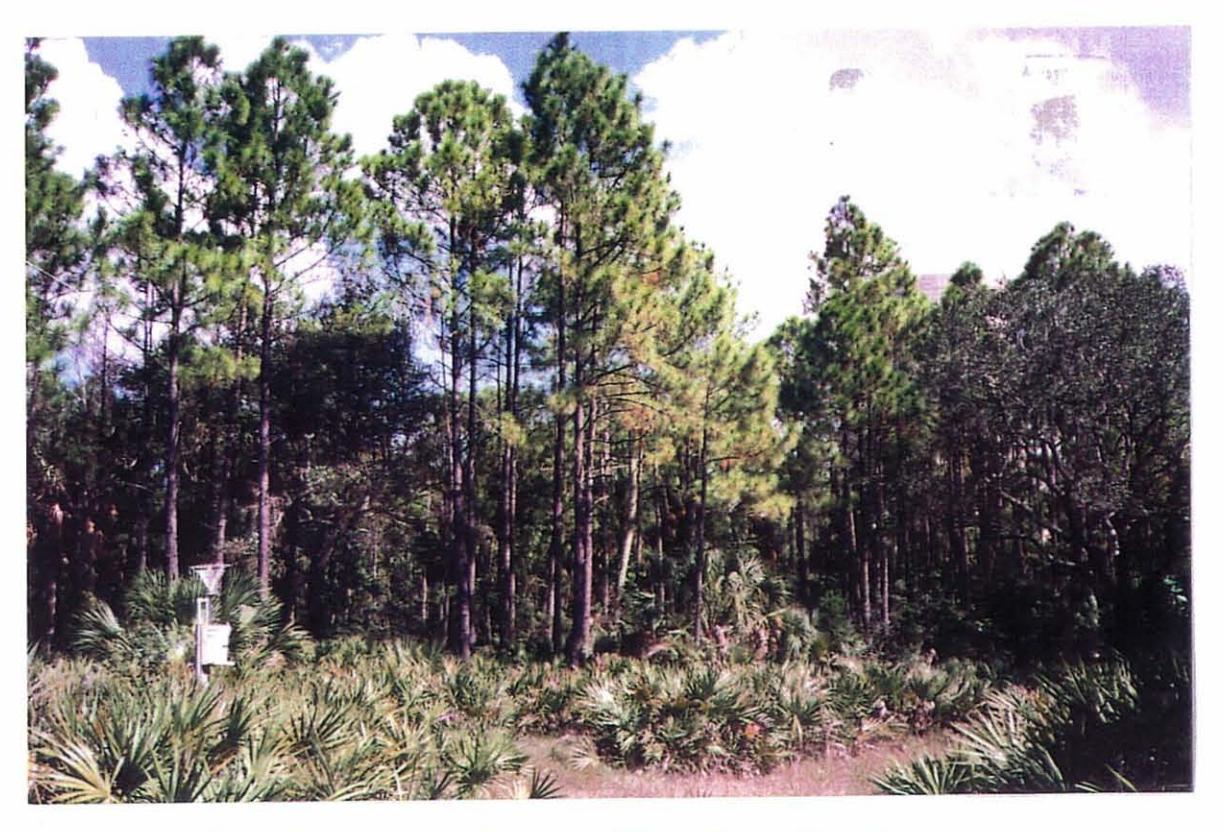
Figure 3A: Mixed Oak/Pine Forest in the Vicinity of West Open Pine Site.

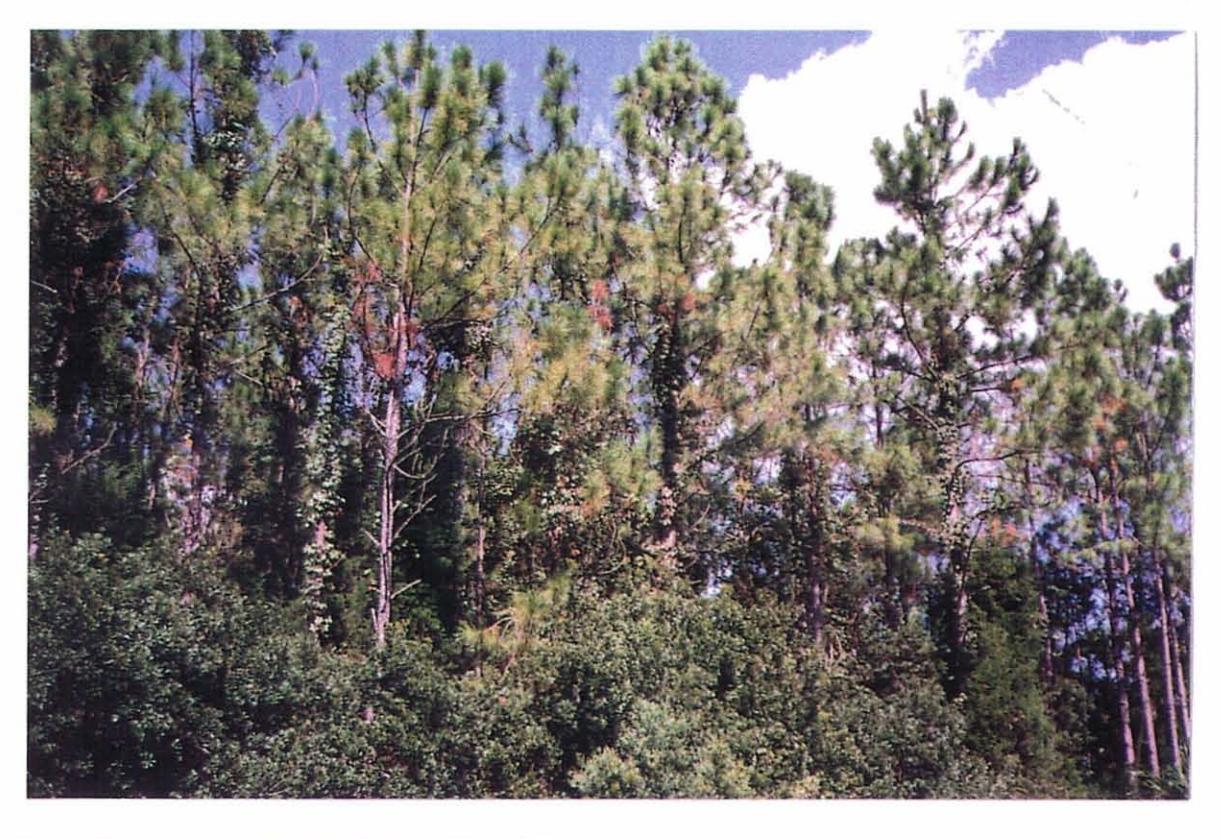
Figure 3B: Pine Forest, Northwest Open Pine Site.

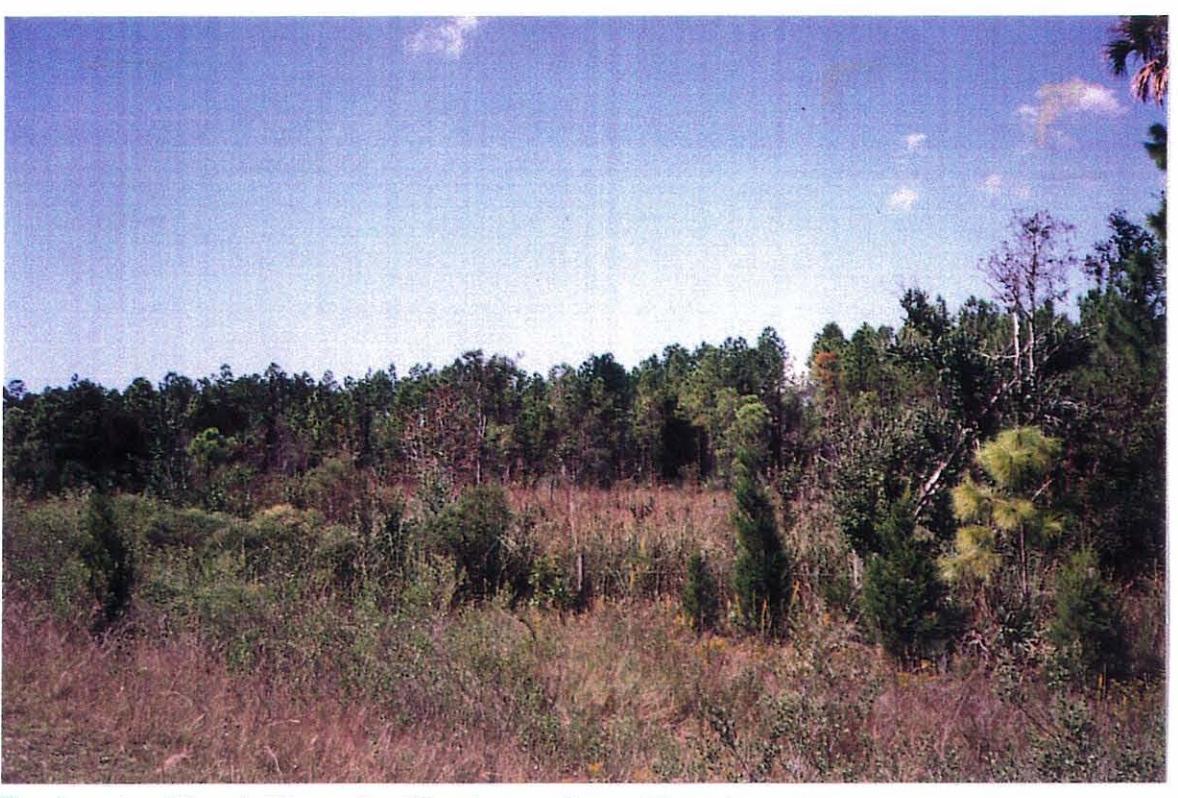
Figures 4 and 5 demonstrate the current conditions immediately north of the fossil-fuel plant. Selective timbering of pine (little or no clear-cutting) has occurred in this area. Otherwise, conditions are generally typical of the forested and herbaceous communities observed in previous years. It is possible that a slight increase in stress or mortality of the pines, may occur following the timbering, due to their sensitivity to disturbance. The timbering disturbance may also provide an opportunity for some temporary invasion of opportunist herbaceous or shrubby species which may be reflected in slight differences of color signature in the future growing seasons. This is considered a normal vegetative response.

Figure 5A: Freshwater Marsh Near the Northeast Open Test Site, North of the Power Plant.

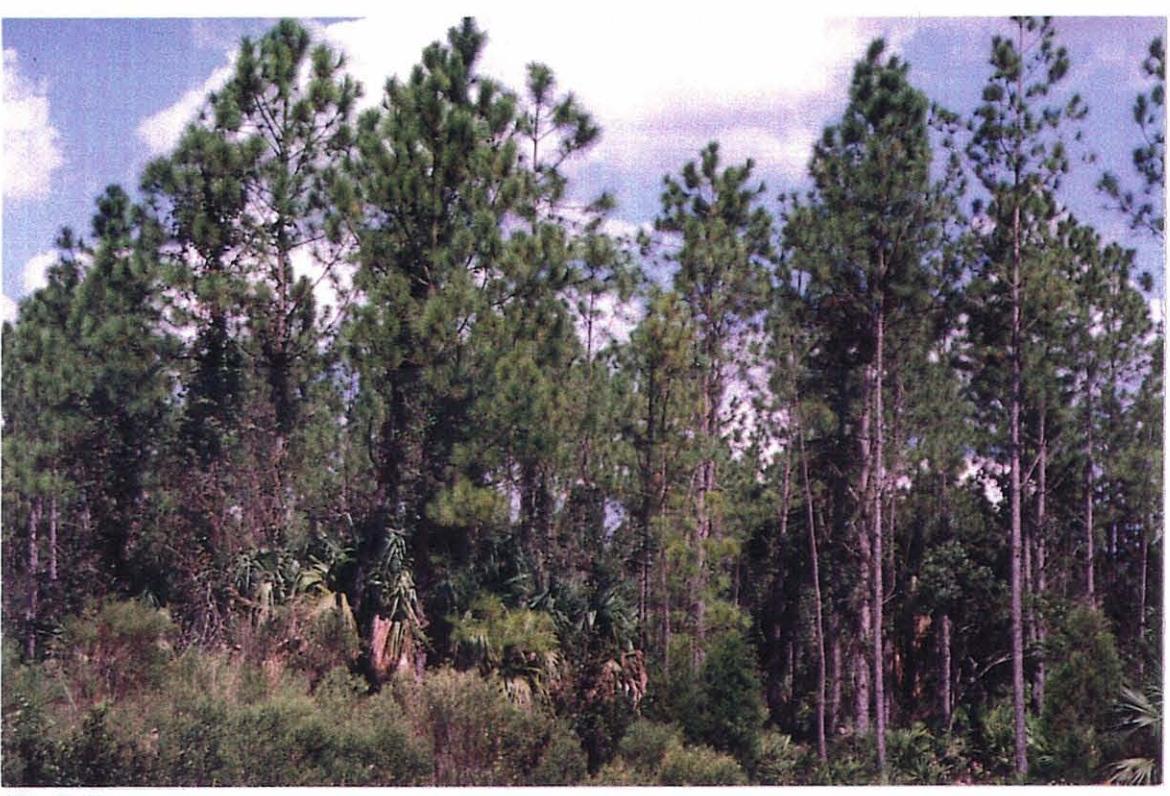
Figure 5B: Slash Pine Forest North of the Northeast Open Test Site.

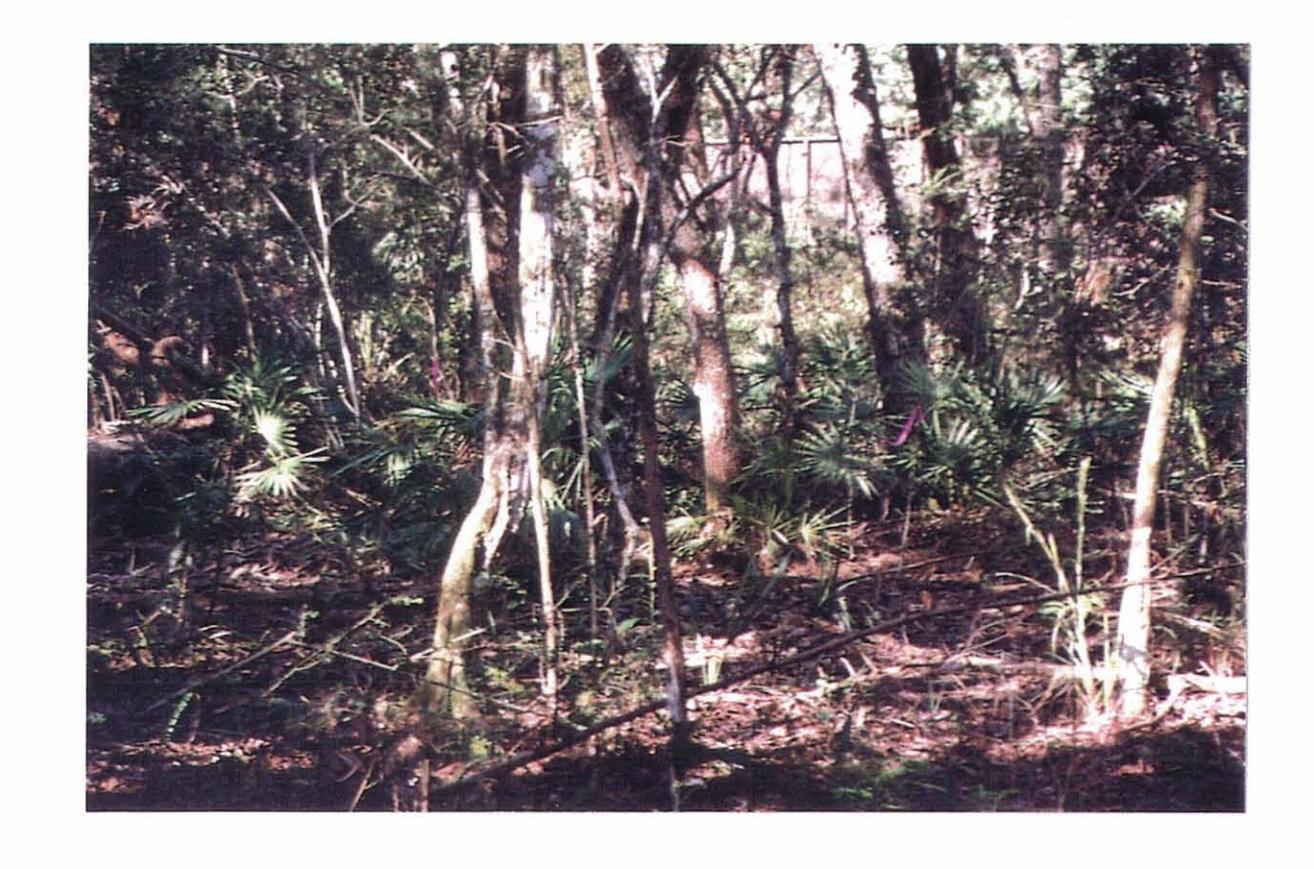
Figure 7B: Vegetation Sampling Area, Control Site.

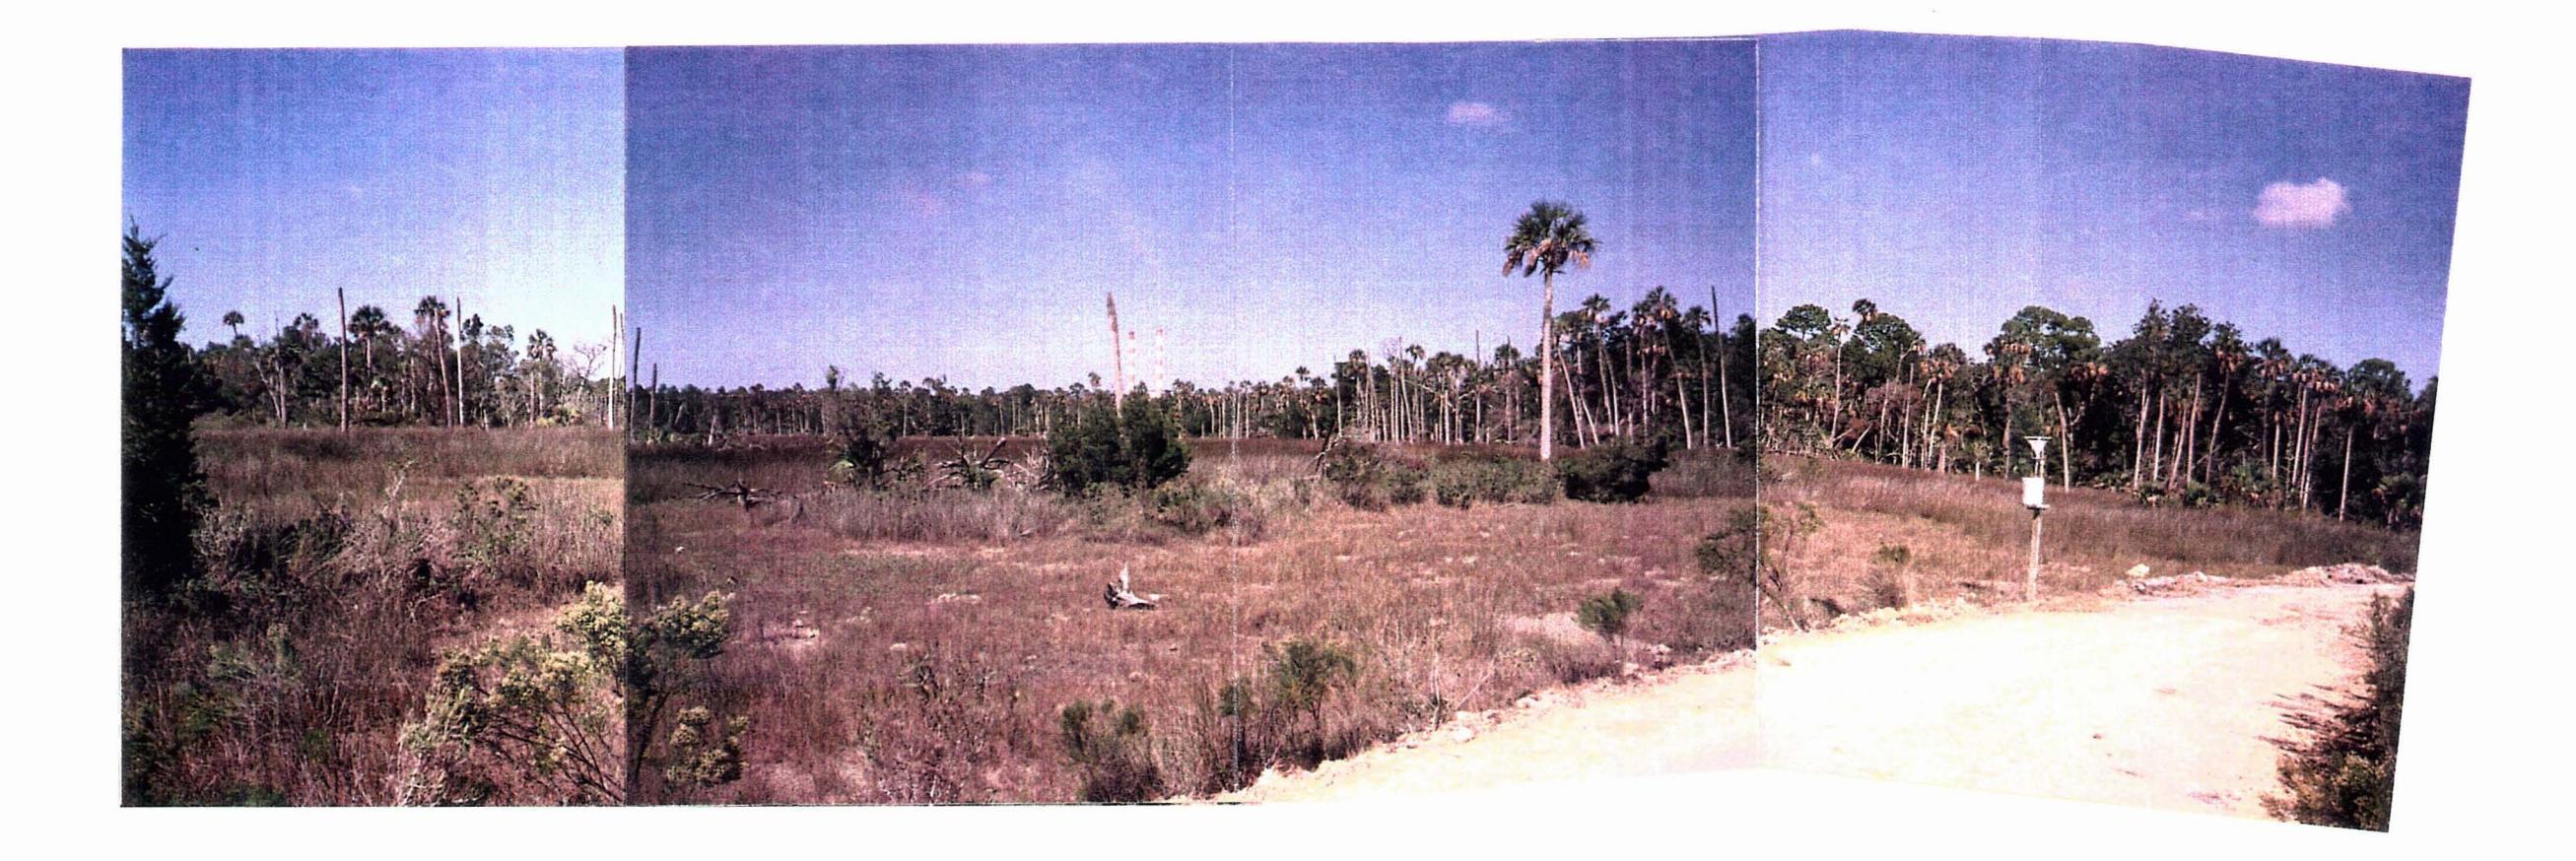
Figure 14: Aerial Photograph (Fall 1993) Demonstrating conditions of Planted Pine and Hardwoods in the Vicinity of the Northeast Open Pine Site (10) Figure 15 demonstrates the conditions of the coastal strand forested and brackish marsh community south of the power plant, in the vicinity of the Coastal Control Site. It reveals a similar, large-scale pattern as observed west and north of the plant site. Some of the outlying island hammocks reveal stress and mortality to the woody species (including some pines); lower-lying areas along the forested edge have similar conditions of stress (particularly cabbage palm), while the higher areas appear relatively unaffected. Figure 16 is a panoramic view taken in the vicinity of the Coastal Control Site.

Figure 16: Panoramic View of Hammock and Brackish Marsh Conditions at Coast Control Site, Fall 1993.

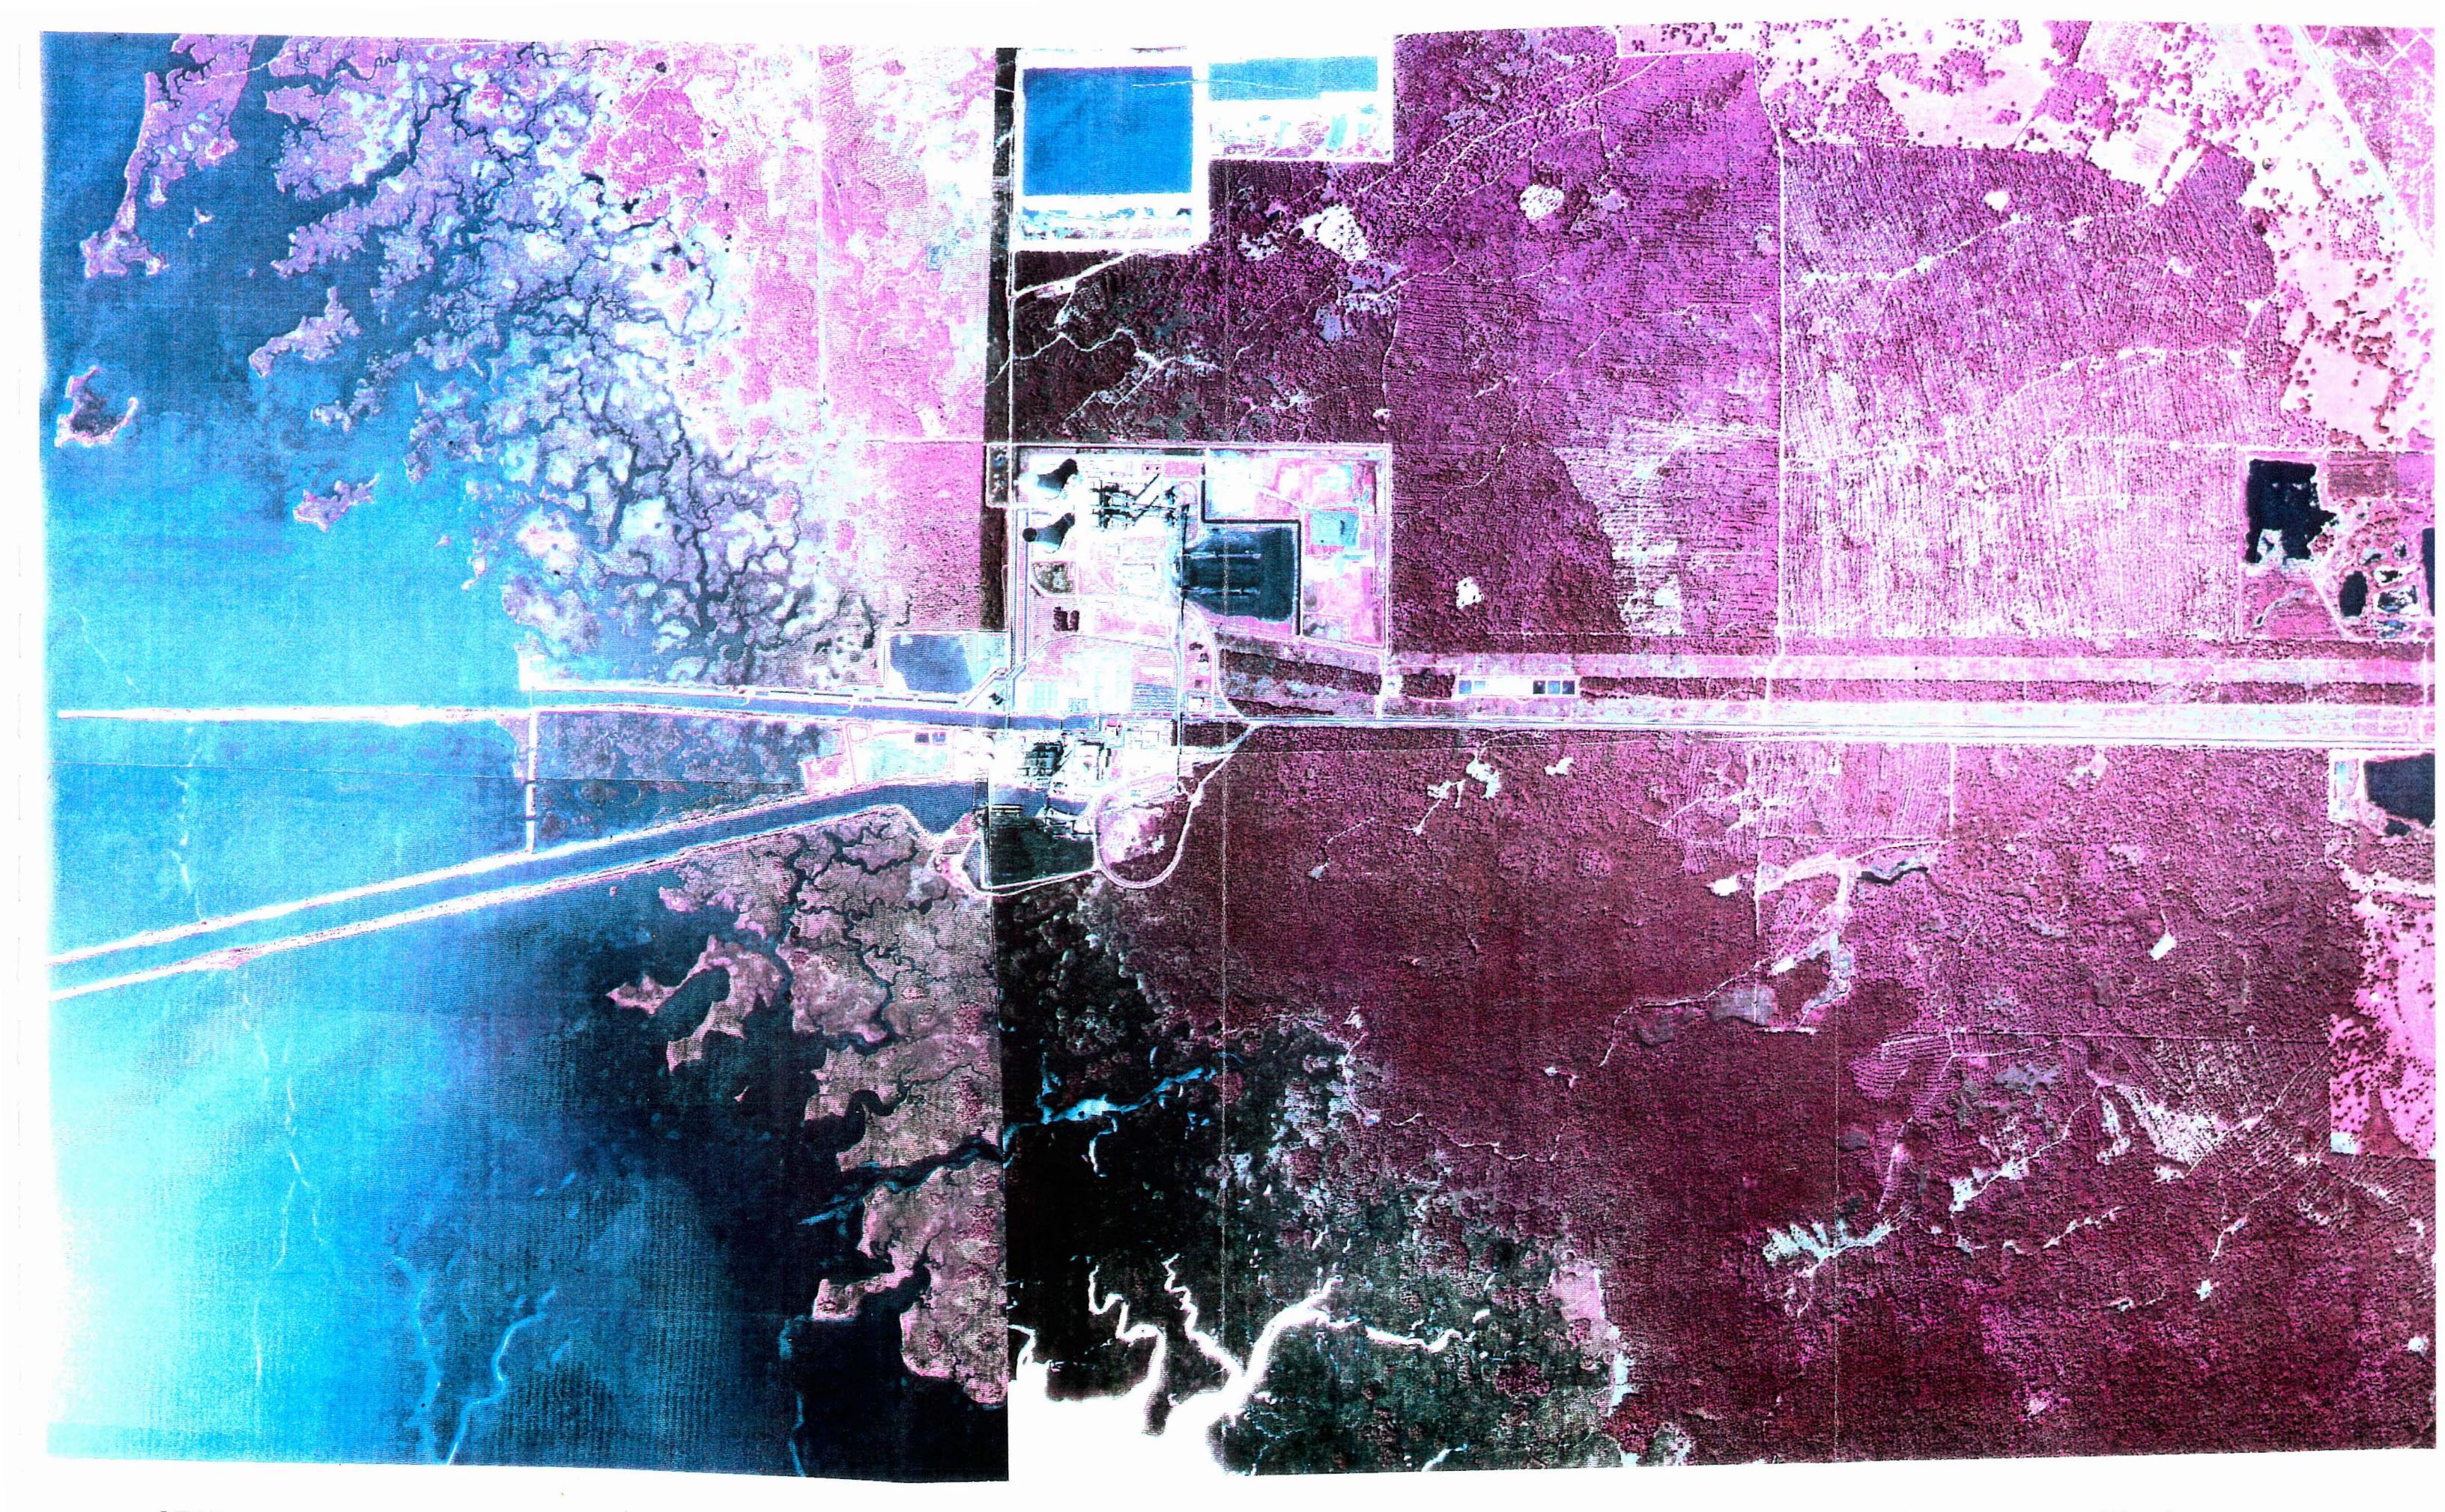
Finally, Appendix 2 is a high-altitude composite aerial which provides coverage of the vegetation and land-use conditions extending from U.S. Highway 19 on the East to the Gulf of Mexico to the west of the power plant facility. When compared to the aerial photography of previous monitoring years it reveals most of the major changes to the landscape in the study area.

APPENDIX 2: September 1993 High-Altitude Aerial Photograph of the Florida Power Plant Corporation Crystal River Power Plant.
