## 6 Destructive Testing and Results

### 6.1 Cutting Plan

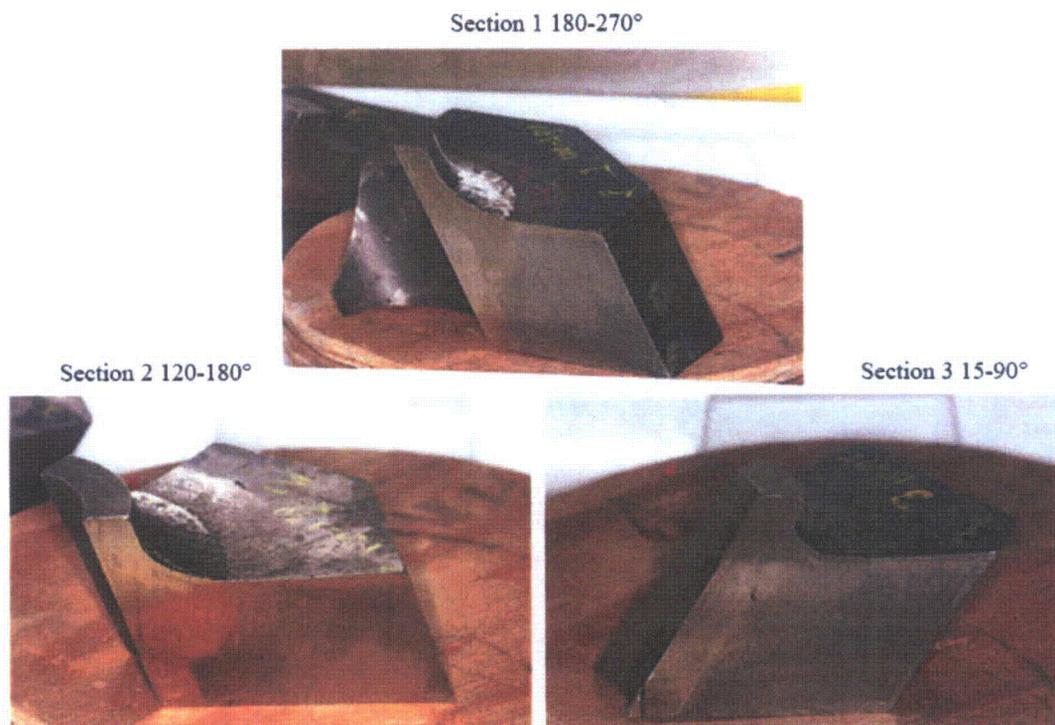
Figure 6.10 Areas of Interest After Sectioning

The three regions identified in the cut plan were cut from Nozzle 31 using the large band saw. These regions were cut from the nozzle after removal of the excess carbon steel. After the sections were cut from the nozzle, the position and extent of the weld, buttering, and triple point were obvious. The pieces were cut just above the triple point to release the penetration tube and allow direct inspection of the buttering above the triple point to determine which of the NDE responses was associated with the through-weld crack. Figure 6.10 shows the three sections after removal from the nozzle, and Figure 6.11 shows Section 2 after further cutting to allow inspection of the buttering.

Careful ET examination and high-resolution photography did not find any evidence of through-weld cracking in Sections 1 and 3. A through-weld crack was immediately apparent, however, in the buttering of Section 2 at 135 degrees. This crack was clearly visible with the naked eye and was confirmed with ET and photography. This crack is shown in Figure 6.12. Because this crack was in a region shown to have crack-like indications and none of the other sections showed any indications of through-weld cracking, all attention was focused on Section 2 near this crack.

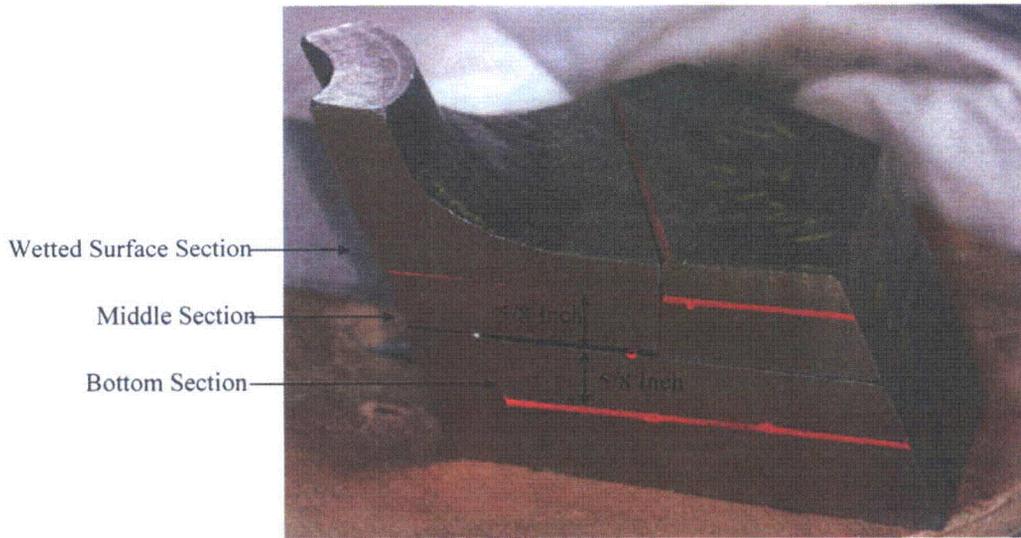
**Figure 6.13 Section 2 After Cutting to Find Cracks**

Because five crack-like indications were found by ET centered around 150 degrees, it was not known which crack had propagated through the weld to this point. Additionally, to facilitate destructive testing, the largest piece needed to be less than 16 mm (0.6 in.) thick, so the wetted section was cut into two

pieces 8 mm (0.3 in.) below the wetted surface. Figure 6.13 shows Section 2 after it was cut below the wetted surface.

After the cutting, it was clear, based on the position and spacing of the cracks, which cracks were associated with which ET indications. Figure 6.14 shows the three cracks on the cut face 8 mm below the wetted surface. One interesting aspect of the cracks and the ET indications is how much longer the cracks are 8 mm into the weld than they were at the wetted surface. ET indication 9 is 8 mm long on the surface, and the visible crack length is 21-mm long at the cut surface. ET indication 10 is 6 mm long at the surface and is 25 mm long at the cut surface. Indication 11, which is 10 mm long at the wetted surface, is 15 mm long at the cut surface. The crack spacing is preserved; cracks 10 and 11 are 5 mm apart on both surfaces, and cracks 9 and 10 are 11 mm apart on the wetted surface and 10 mm apart on the cut surface. By contrast, ET indication 8 is 16 mm apart from ET indication 9. It is worth noting that ET indications 8 and 12 do not represent cracks that penetrated 8 mm into the weld.

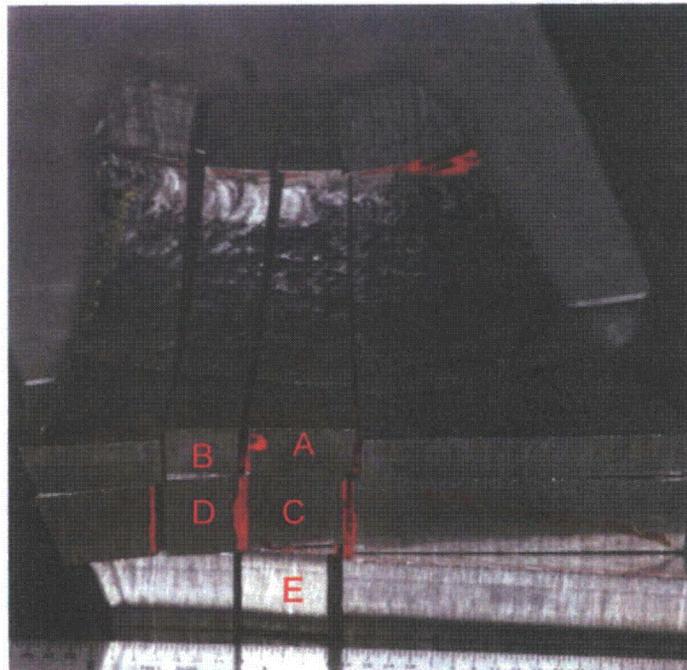
**Figure 6.15 Cracked Metal Coupons Removed from Section 2**

As final preparation for the destructive evaluation, the cracked sections were cut out in small pieces for easier fine cutting and polishing. The cracked specimens were cut out in five pieces labeled A through E. The cut nozzle Section 2 is shown in Figure 6.15. The through-weld crack associated with ET indication 10 and the nearby crack associated with ET indication 11 are contained in pieces A, C, and E. The nearby crack associated with ET indication 9 is contained in pieces B and D.

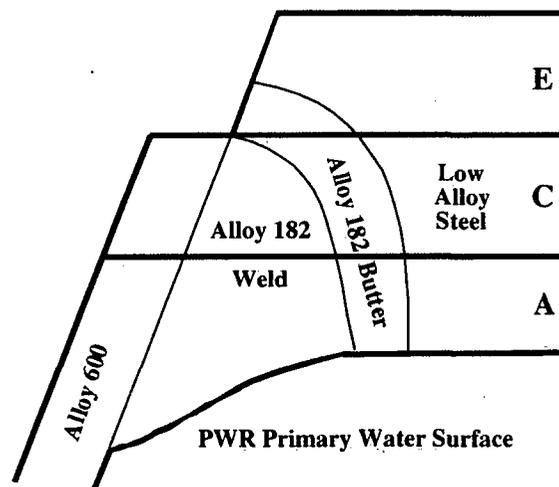
Observation of an apparent through-wall crack in Section 2 of Nozzle 31 prompted its further cutting into smaller pieces for destructive examination. Five smaller pieces were received labeled A, B, C, D, and E as shown in Figure 6.15. Pieces A and B are from the inner surface in contact with the PWR primary water, while pieces C and D were from directly above these two sections, respectively. The final piece, E, was from directly above Section C. The positions for pieces A, C, and E are illustrated in Figure 6.16. Pieces A and C contain the Alloy 600 nozzle, Alloy 182 J-groove weld, Alloy 182 butter passes, and low-alloy steel plate. Piece E was above the J-groove weld and was not joined to the Alloy 600 tube. All initial destructive examinations were performed on A, C, and E because they appeared to contain the main through-wall crack. A long secondary crack also was indicated in A that extended into B and D.

**Figure 6.16** Sections A, C, and E Cut from Section 2 of Nozzle 31. Relative locations are indicated for the Alloy 600 nozzle, the Alloy 182 J-groove weld, the Alloy 182 butter passes, and the low-alloy steel.

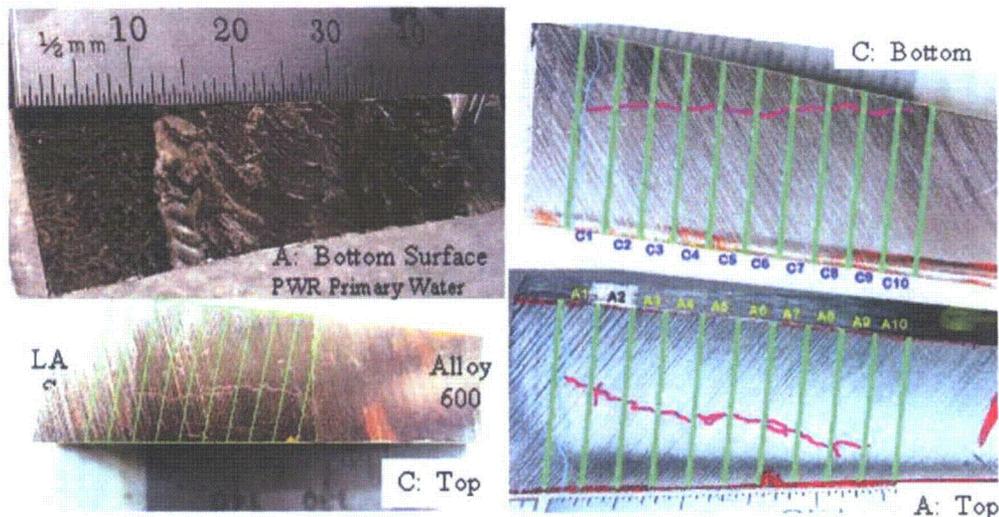
**Figure 6.17** Top and Bottom Surfaces for Pieces A and C with Highlighted Cracks and Proposed Serial Sectioning. The bottom surface for piece A was exposed to primary water during PWR service.

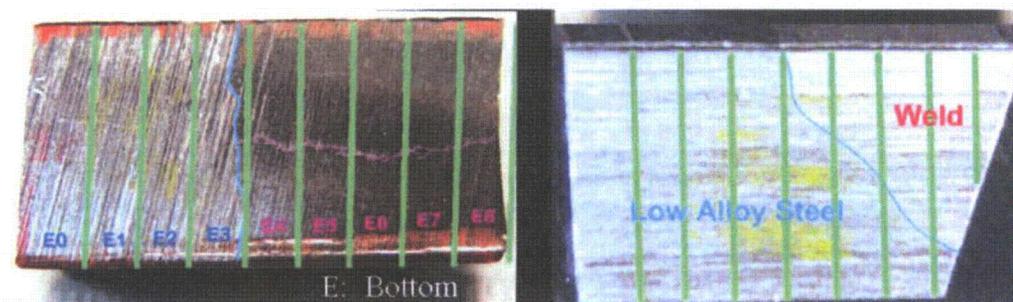
**Figure 6.18** Bottom (left) and Side (right) Surfaces for E with Proposed Serial Sectioning. Note that these images are not to scale with those in Figure 6.17.

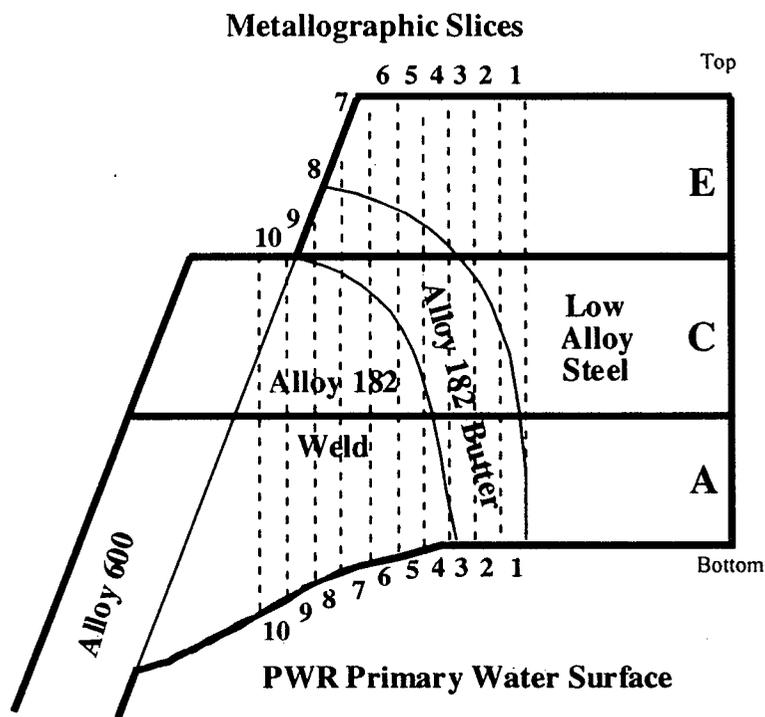
The sectioning diagram is illustrated in Figure 6.19 on the same schematic for Section 2 of the Nozzle 31 weldment presented in Figure 6.16. The zero cut was made in the low-alloy steel where no cracking was present, and the remaining cuts were produced parallel to this section. Individual metallographic cross-section samples were identified as A1–A10, C1–C10, and E1–E8. Piece E was shorter than pieces A and C because it was above the J-groove weld and the adjoining Alloy 600 tube detached during initial cutting.

**Figure 6.19** Approximate Locations (dashed lines) of Metallographic Sections Through Pieces A, C, and E

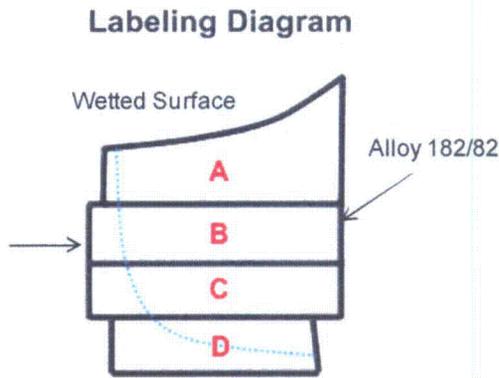
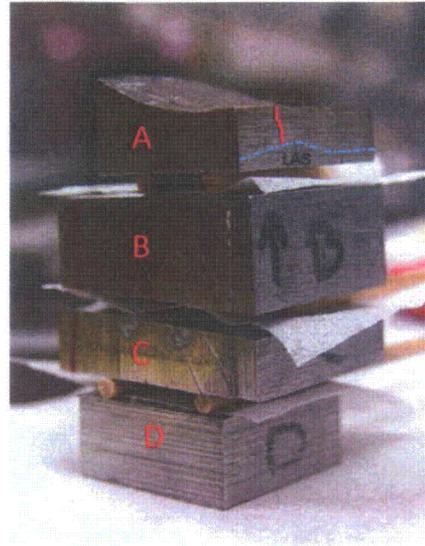
**Figure 6.41 Sectioning Diagram for the Region Around 255 Degrees**

The region around the crack was sectioned to allow a profile to be developed. The sectioning diagram and an image of the cut region are shown in Figure 6.41.

A similar but less extensive reconstruction was performed for the deep crack located at 255 degrees. This crack is interesting in that it is one that may have leaked given more time but has not yet reached the annulus. The crack appears to propagate along the buttering/carbon steel interface and grow from this interface into the weld metal. As with the crack located at 155 degrees, the crack at 255 degrees is very short at the wetted surface and grows in length under the surface. A profile of the crack at 255 degrees is shown in Figure 6.46.

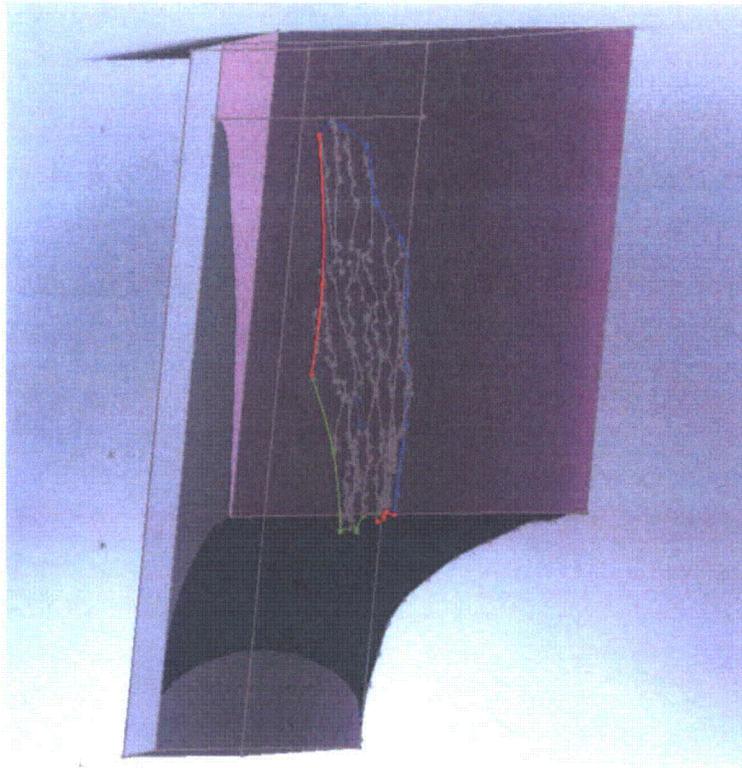
Now that the basic framework has been created, much more detail can be built into this rendering to better elucidate the crack morphology through the weldment. Even at this stage, rotating the constructed image allows insights into the through-thickness crack path. For example, a nearly edge-on view of the crack is shown in Figure 6.44. Here it can be seen that the crack meanders during propagation through the weld material, possibly following the residual stress pattern. However, the path is relatively straight overall compared to component dimensions. In a more tilted orientation as shown in Figure 6.45, the small amount of propagation of the crack into the Alloy 600 pipe is more evident.

Figure 6.44 Crack Viewed from a Nearly Edge-On Orientation

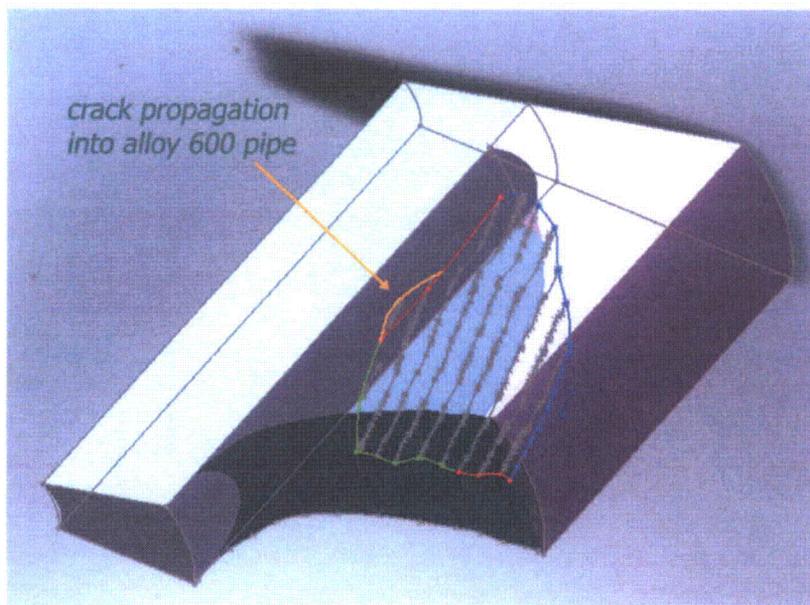
Figure 6.45 Component Section Viewed from a Tilted Orientation Where the Propagation of the Crack into the Alloy 600 Pipe Can Be Seen

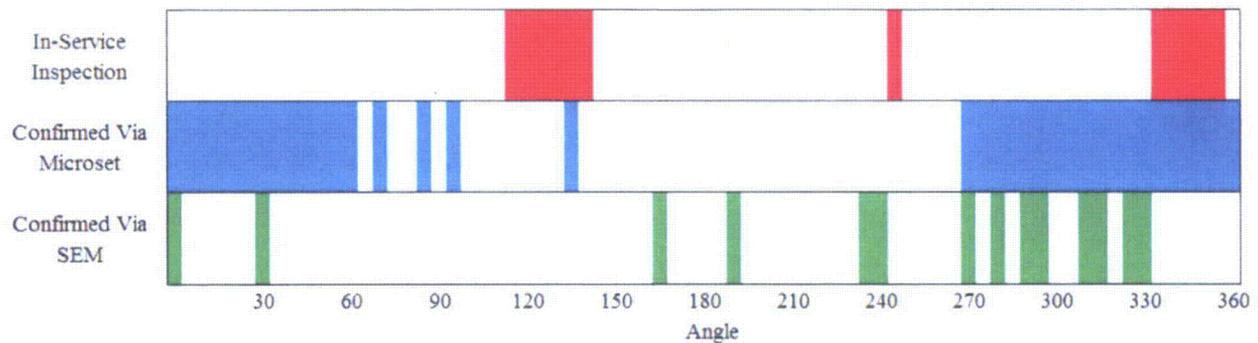
Cracking was confirmed in the outer portions of the J-groove weld crown of Nozzle 54. SEM examinations of the surfaces and the cut faces showed cracking at several locations around the outer regions of the J-groove weld in or near the buttering and penetrating into the buttering at some of the cut faces. The visual examination of the replica showed a string of defects from 270 to 60 degrees and individual defects at 70, 85, and 95 degrees. Some of the cracks were sectioned further and examined via microscopy and fractography. While some cracks were confirmed as PWSCC, none was more than a few millimeters deep, and all were contained in the buttering. No confirmation of deep cracking was found during the destructive evaluation of this CRDM.

The destructive evaluation agreed only partially with the ISI eddy current examination of the J-groove weld. Only one ISI ET indication was confirmed using SEM—the indication at 245 degrees. The string of ISI ET indications from 115–140 degrees is coincident with an indication at 135 degrees found using a replica of the weld surface. The J-groove weld results for Nozzle 54 are shown in Figure 7.1.

**Figure 7.1 Crack Indication Locations at Outer Region of J-Groove Weld**

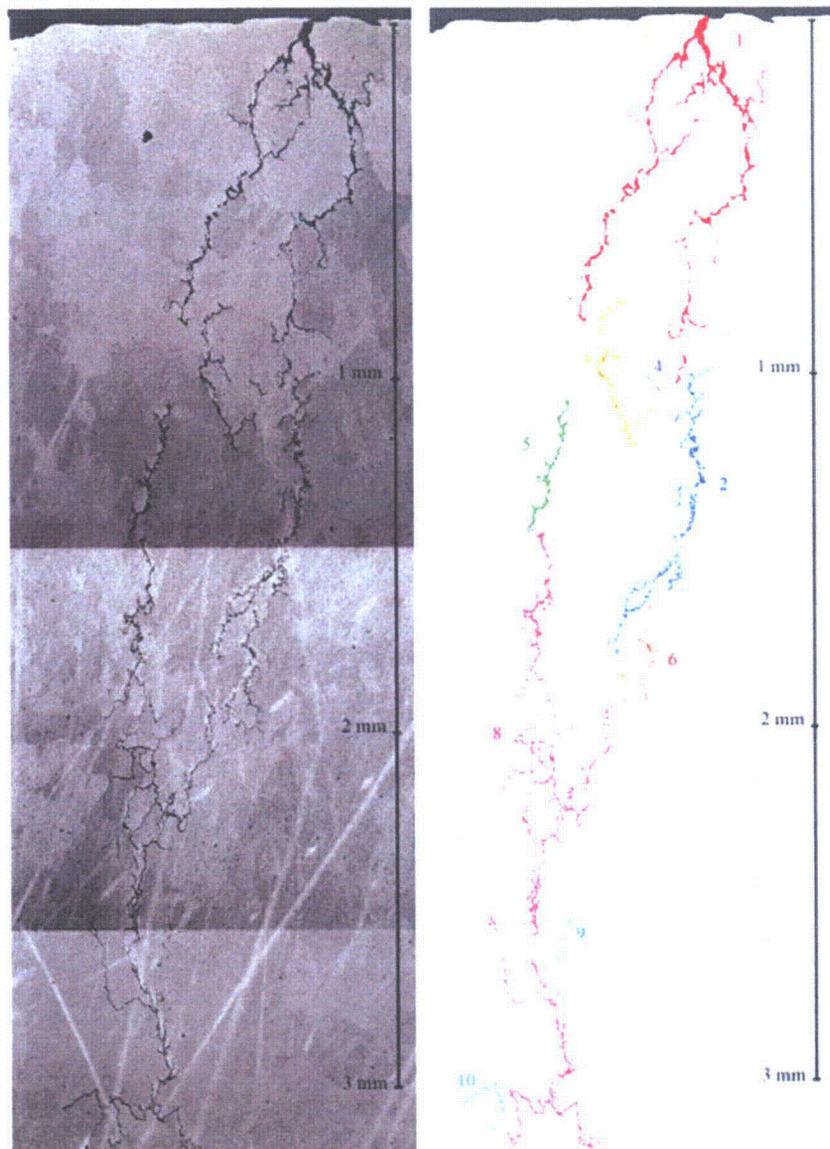
As described in Section 6, the crack segments were polished and examined using SEM. The crack has a branching and discontinuous morphology in the through-weld orientation. Images of the crack and a color-coded image showing the various crack segments are shown in Figure 8.3. The first 3 mm show nine separate segments with ligaments between them. All the segments are part of the same crack, but they connect with each other outside the plane shown in the slice.

Figure 8.3 Crack Segments. SEM image (left) and color-coded image (right).

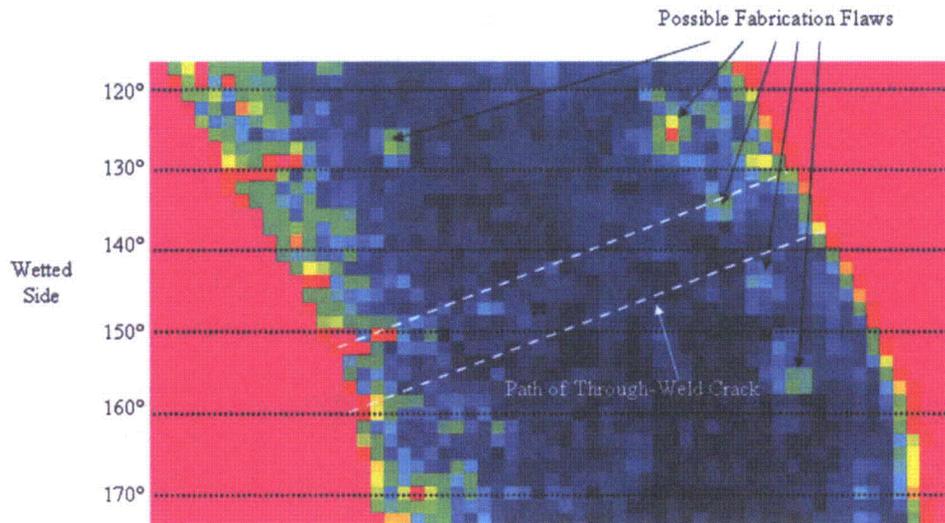
The ultrasonic inspection of the J-groove weld yielded no discernable signal from the through-weld crack. The UT data for the region around 135–155 degrees does show some likely fabrication flaws similar to the fabrication flaws found in the DE, such as in slice C10 (Figure 6.33). This lack of signal from the crack is interesting, as the crack is directly against the penetration tube for most of its length. The UT calibrations and the imaging of fabrication flaws in Nozzles 31 and 59 show that the UT can image small defects at the same depth into the weld metal. Even knowing exactly where to look, using the most sensitive frequency at the correct depth (5 MHz) and using high gain, it is not possible to find any significant crack signal. Figure 8.5 shows the 5-MHz results in the cracked area of the J-groove weld. The crack is in an unfavorable orientation, essentially presenting a knife's edge to the beam, which likely accounts for the lack of signal. It was known that the UT inspections would be less sensitive to an axially oriented flaw, and this has been confirmed by these inspections. Performing a UT inspection through the J-groove weld would need to use different angles to be sensitive to the axial cracks present in the weld.

**Figure 8.5** 5-MHz Ultrasonic Testing Data for the Cracked Region of the Nozzle 31 J-Groove Weld Metal

It is worth noting that the PNNL, round-robin, and ISI ultrasonic examinations missed the presence of the cracks at 145, 155, 160, 200, 225, and 255 degrees. The crack at 155 degrees was completely through the weld and leaking, and the crack at 255 degrees was through the weld and into the buttering. However, these results are not unexpected because the orientation and location of the flaws made them very challenging for UT to detect them reliably.

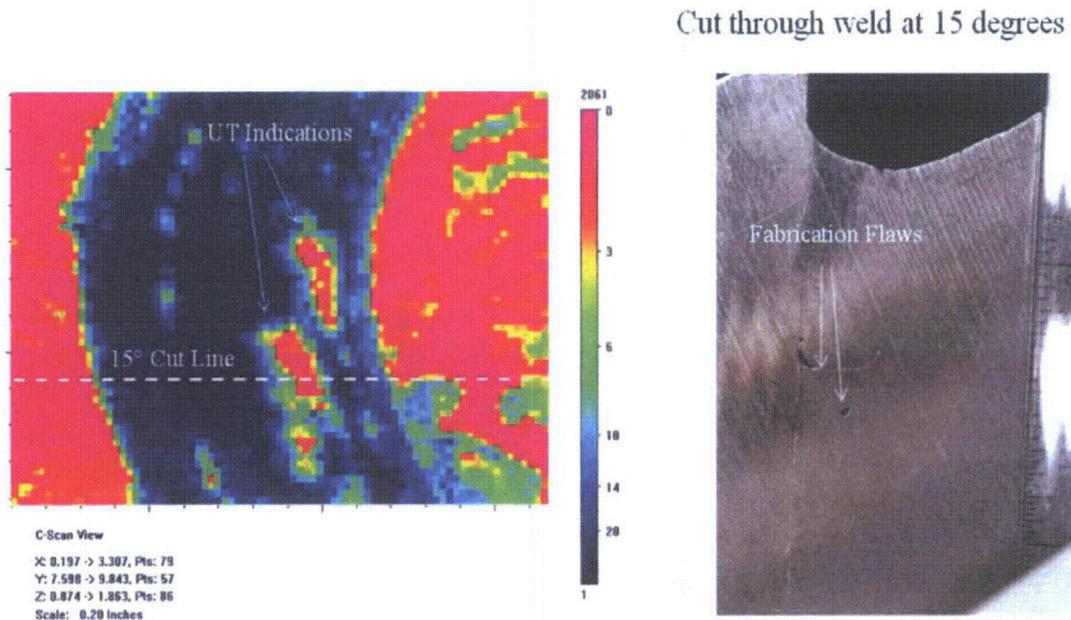
The zero-degree ultrasound was effective at detecting fabrication flaws. Some of the UT indications were intersected by the saw cuts. The cut faces showed the presence of welding flaws. One such exposed welding flaw at 15 degrees is shown in Figure 8.6.

**Figure 8.6 PNNL UT Results Showing the Cut Line at 15 Degrees and the Cut J-Groove Weld Surface**

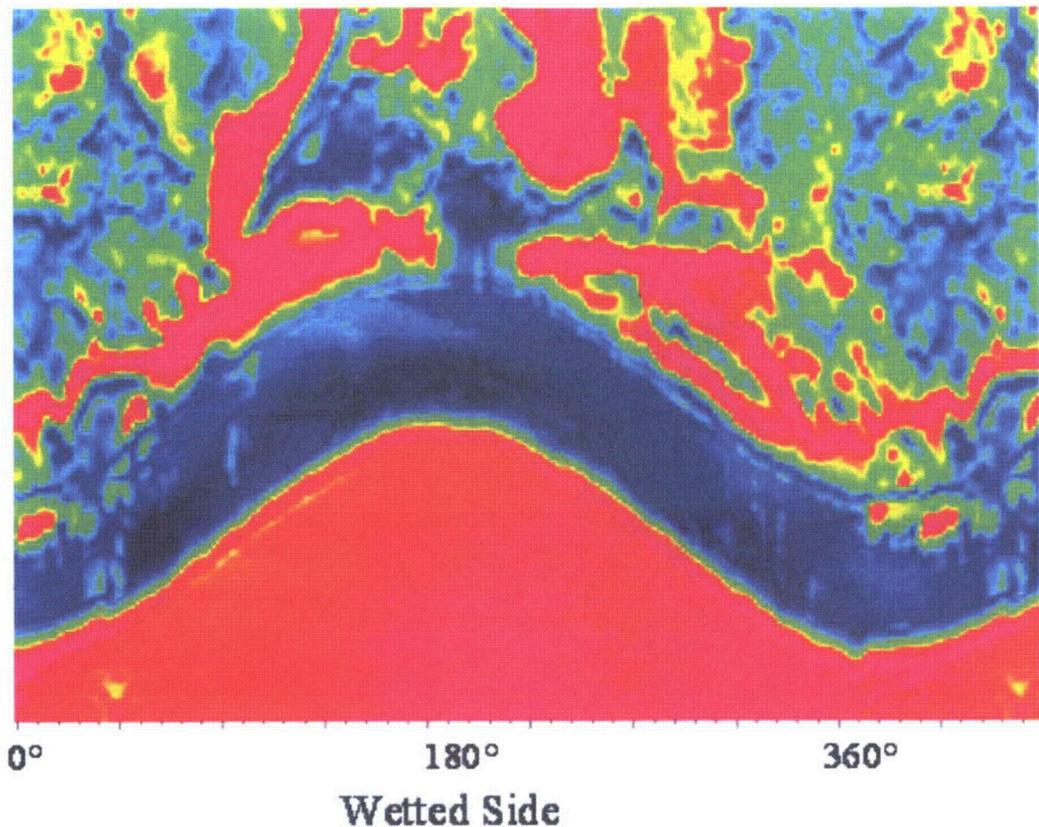
The ultrasonic data of the annulus and interference fit were obtained by PNNL while examining the J-groove weld. The data obtained by PNNL and industry (Figure 5.21) were very similar and showed the same pattern, including the river delta and apparent exit path. The industry-acquired data on the interference fit are shown in Figure 5.21. The data acquired by PNNL, with the region of interest focused on the annulus region, are shown in Figure 8.13. The ultrasonic data taken at PNNL were optimized for the J-groove weld, and the signal in the interference fit is often saturated, making it less quantitative.

**Figure 8.13 PNNL-Acquired Data on the J-Groove Weld and Part of the Interference Fit of Nozzle 31 After the Nozzle Had Been Removed from the Head**

Despite the different techniques and goals, there are many similarities between the PNNL and industry data. Both data sets find the same pattern and the same signal that was called as a leakage path. When the ultrasonic data and the photographs of the annulus are compared, it is clear that the pattern of the boric acid deposits matches the ultrasonic data patterns. The called leakage path corresponds directly with the clean band in the annulus that starts near 90 degrees. Some of the other features in the boric acid deposit patterns are replicated in the UT data as well. Some correlations between the UT data and the boric acid pattern are shown in Figure 8.14.

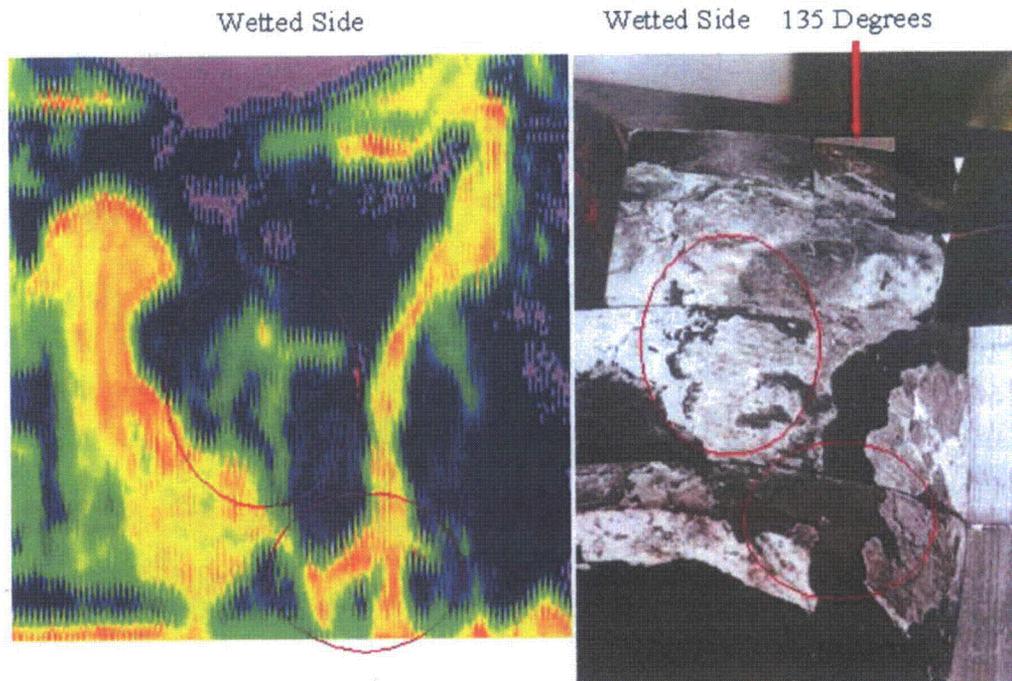
**Figure 8.14** Comparison of Boric Acid Patterns on the Carbon Steel Annulus and UT Patterns on the Left

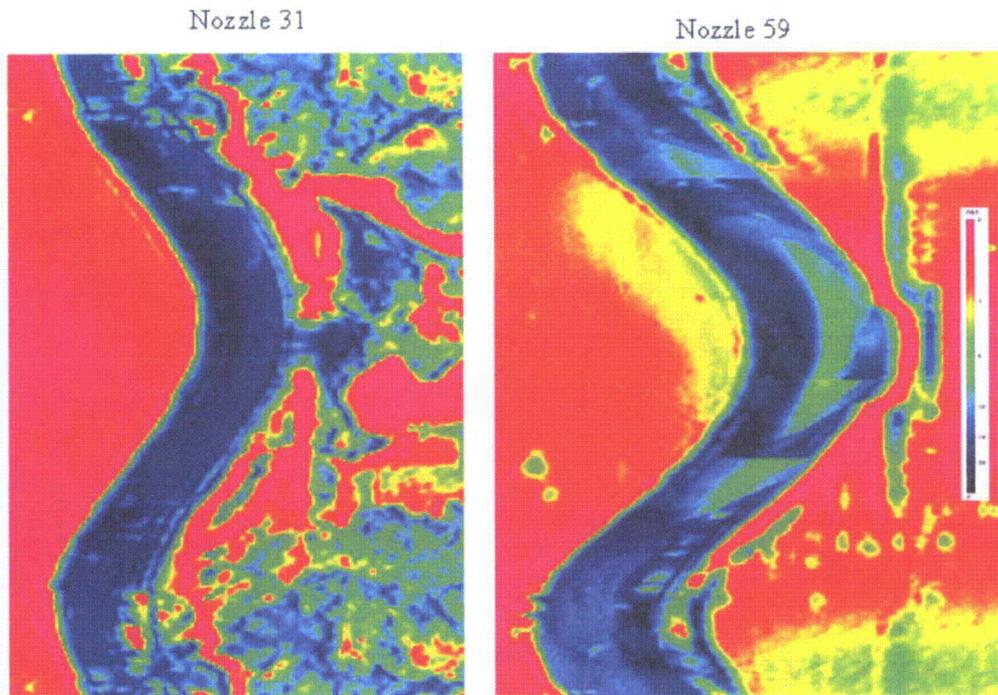
It is also useful to compare the results of a confirmed leaking nozzle such as Nozzle 31 with a likely non-leaking nozzle. PNNL performed similar UT examinations on Nozzle 59, which did not appear to have any through-weld leaks. The UT pattern in the annulus was very different than in Nozzle 31. In Nozzle 31, the UT revealed a complex pattern where the UT signal is transmitted and reflected, while in Nozzle 59, the annulus appeared to be a good reflector of ultrasound almost everywhere in the annulus. The difference in UT patterns is shown in Figure 8.16.

Figure 8.16 Comparison of the UT Patterns Found for the Interference Fit in Nozzles 31 and 59
