NUREG/CR-6996
PNNL-18372

**Nondestructive and
Destructive Examination
Studies on Removed-from-Service
Control Rod Drive Mechanism
Penetrations**

In late 2002, widespread cracking in CRDM nozzles and associated Alloy 182 and 82 J-groove attachment welds was discovered at North Anna Unit 2. Accordingly, the utility decided to replace the reactor pressure vessel head. The NRC and the Electric Power Research Institute (EPRI) developed a joint program to study some of the defective North Anna Unit 2 CRDMs.

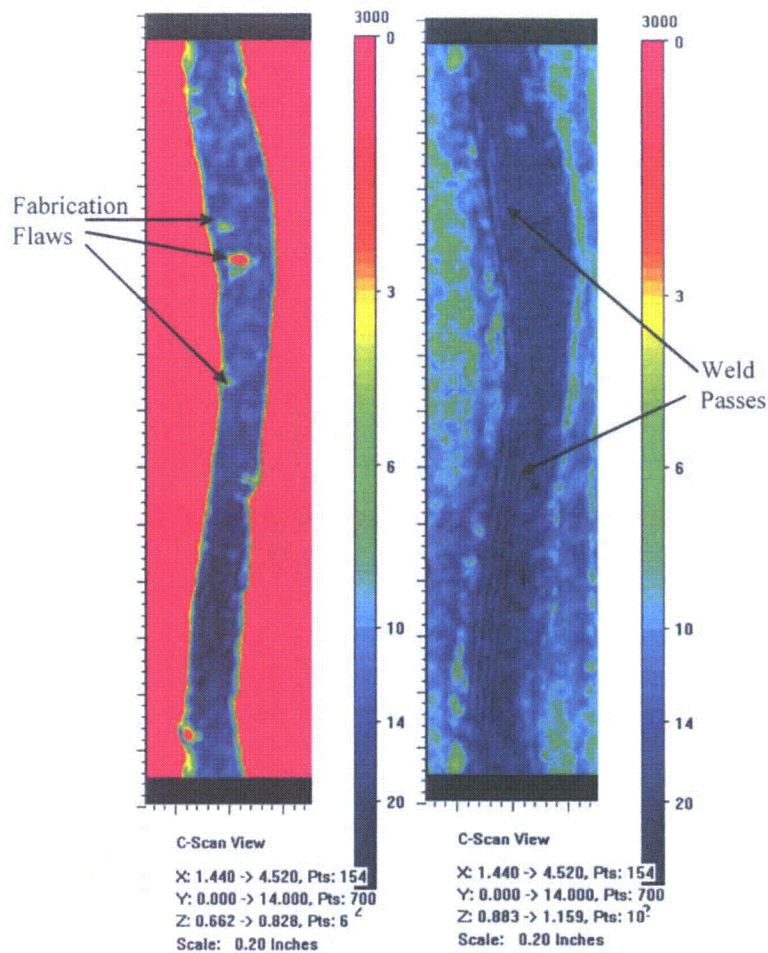
Although the Midland CRDM specimen contains no cracks, the weld contains several fabrication flaws in the fusion zone between the penetration tube and the weld metal. These fabrication flaws are isolated and point-like and likely are very small lack-of-fusion defects or slag inclusions. The immersion UT was able to penetrate into the weld and was sensitive to features such as the small differences in reflectivity along the weld beads. Figure 4.12 shows a 2.25-MHz UT scan of the Midland CRDM focused first on the fusion zone and then deeper into the weld. The wetted tube is to the left and shows up in the left-hand image as pink. The interference fit is to the right and also shows up as pink. The blue stripe in the middle of the figure is the J-groove weld. The fabrication flaws show up as green or red spots in the blue stripe (left-hand image). In the section focused deeper into the weld, the weld passes are visible, demonstrating good sensitivity for flaws in the weld.

Figure 4.12 Ultrasonic Testing Responses for 2.25-MHz in Midland Control Rod Drive Mechanism. The first image shows the fusion zone of the weld where fabrication flaws were detected. The second image shows the J-groove weld area where the individual weld passes were detected.

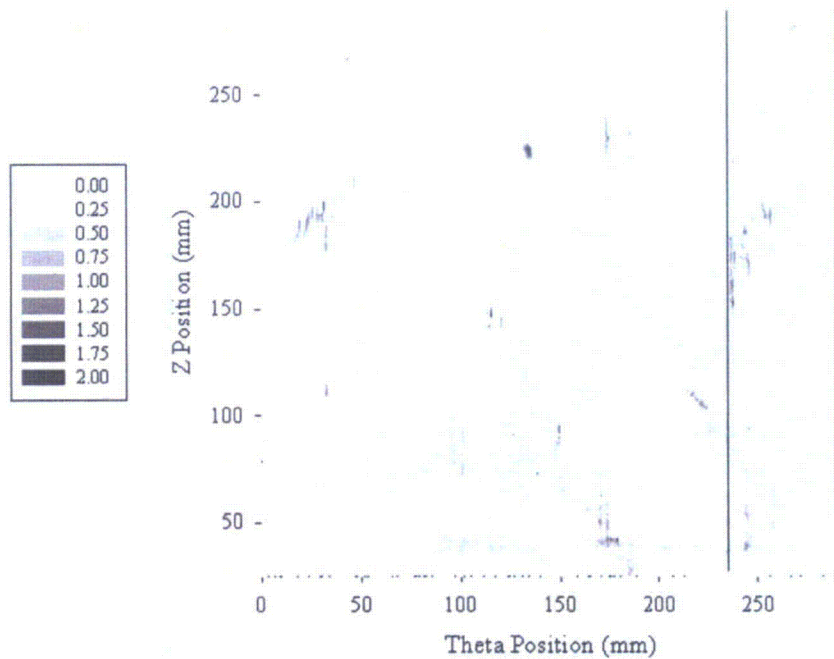
Data from Nozzle 59 showed some high-amplitude indications, as shown in Figure 5.1 (150-kHz data). The horizontal line is shown to mark 360 degrees (233 mm, 9.2 in.), where the data begin to repeat. Figure 5.2 shows data at 350 kHz from the same scan.

Figure 5.1 Eddy Current Data (150 kHz) on Nozzle 59. Indications are shown in grey to white scale. Horizontal line shows 360 degrees (233 mm, 9.2 in.). Indications in grey-black are greater than 1 V.

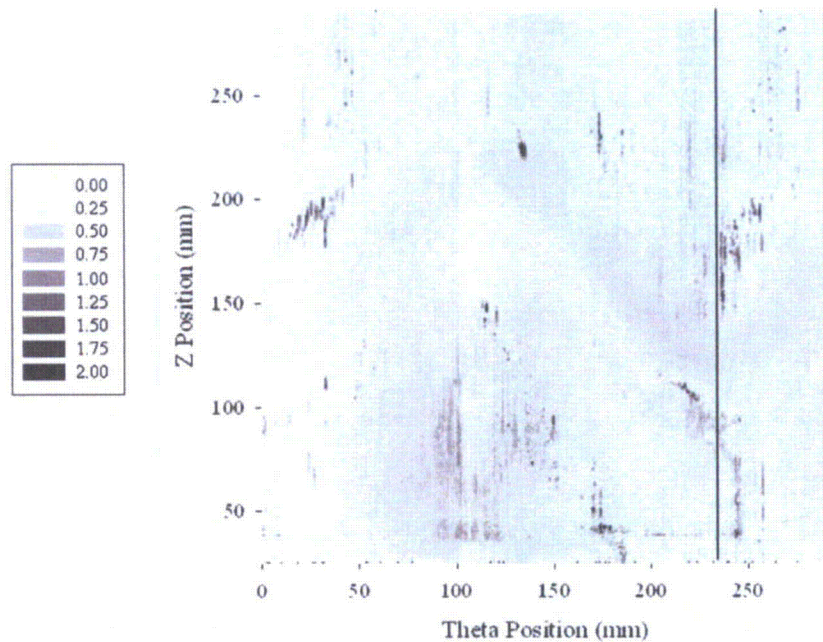
Figure 5.2 Eddy Current Data (350 kHz) on Nozzle 59. Indications are shown in grey to white scale. Vertical line shows 360 degrees (233 mm, 9.2 in.). Indications in grey-black are greater than 1 V.

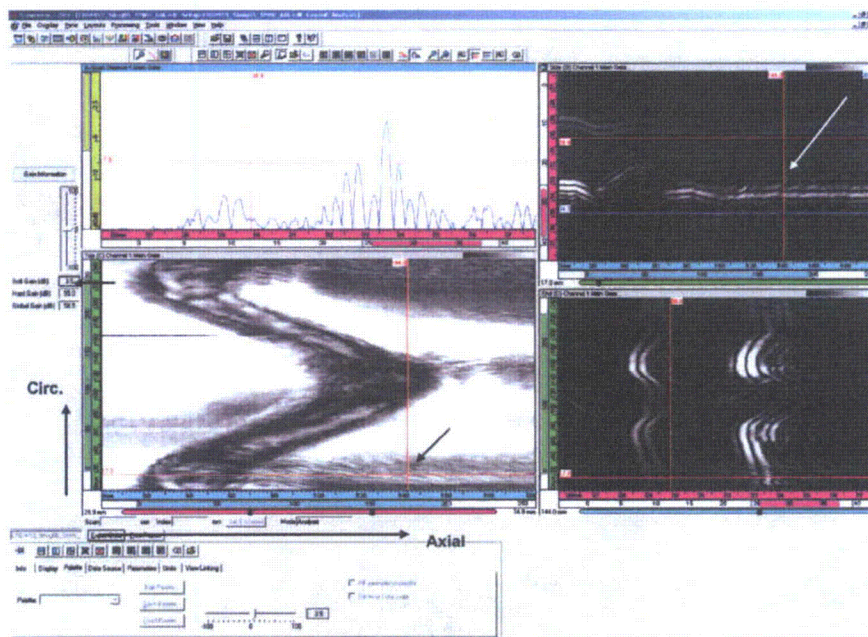
Interesting indications or regions with many indications based on response were noted from the 5- and 7.5-MHz data. No TOF shapes were seen in Nozzle 59 data outside of the weld repair penetration indications. Additionally, the indications appeared to be axial and did not break the inner surface, noted by a lack of lateral wave interruption. Two typical indications are shown in Figures 5.6 and 5.7. The indication in Figure 5.6 is closer to the back surface signal, while the indication in Figure 5.7 is closer to the front surface lateral wave signal. Figure 5.7 also shows a region with numerous indications with approximately double the response amplitude of the indication in Figure 5.6.

Figure 5.6 Nozzle 59, 5-MHz Time-of-Flight Diffraction Data Showing Typical Indication. The indication is at 17 mm (0.67 in.) CCW, 144 mm (5.7 in.) axial, with a response of -7.5 dB.

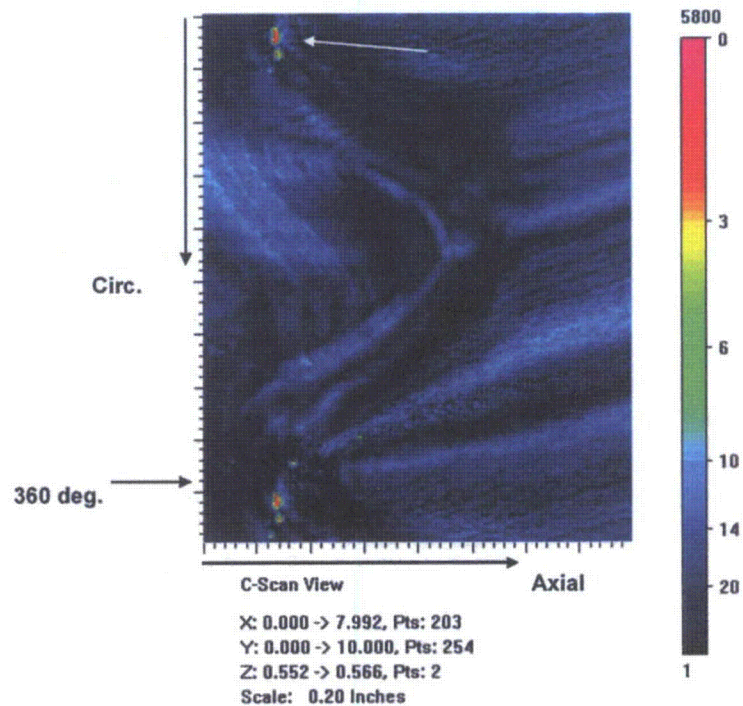
Figure 5.8 Nozzle 59, 5-MHz Immersion Data Showing Potential Indications Starting in the Nozzle Material

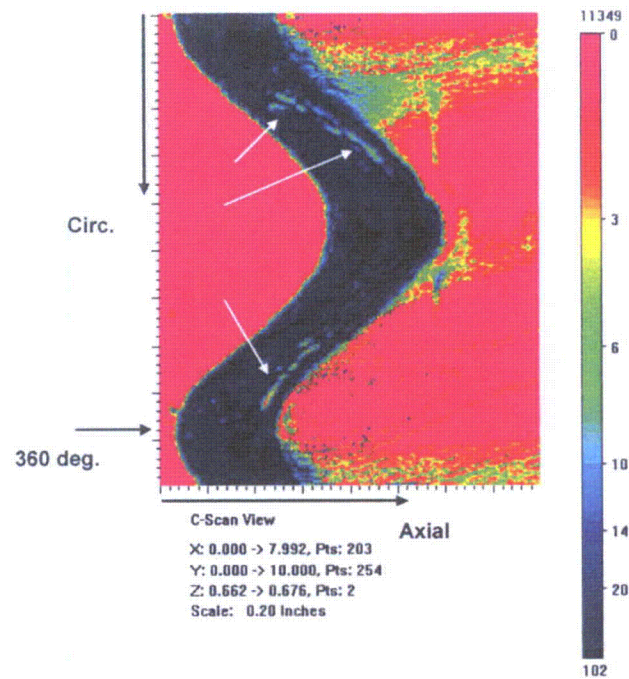
Figure 5.9 Nozzle 59, 5-MHz Immersion Data Showing Indications That Respond Like Lack of Fusion Starting in the J-Groove Weld Material

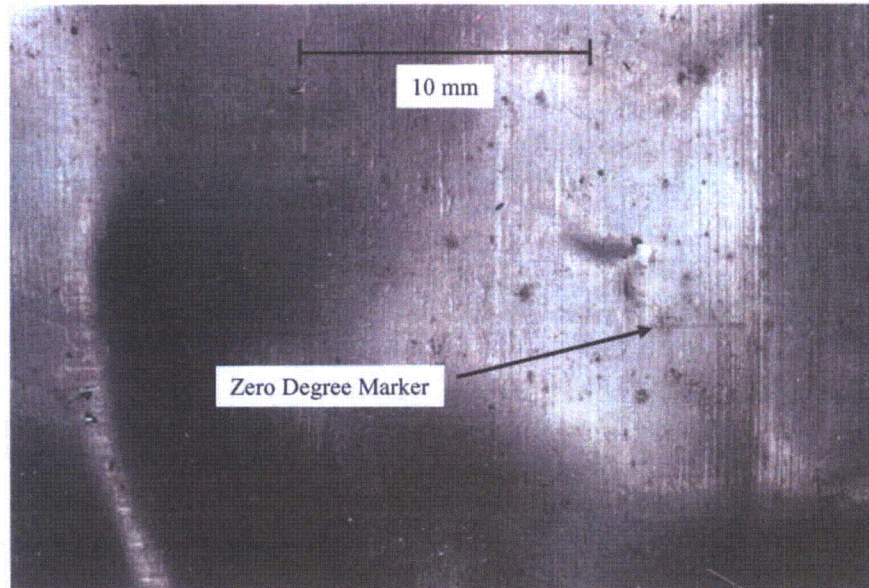
A 0-degree mark had been scribed onto the interior surface of the penetration tube in previous tests, and this mark was found and used to orient the results from the visual tests. The 0-degree mark was very shallow and wide, which is likely why it did not show up in the eddy current tests. The 0-degree mark is shown in Figure 5.13.

Figure 5.13 Zero-Degree Marker and Wetted End of Penetration Tube Imaged Using Replicant

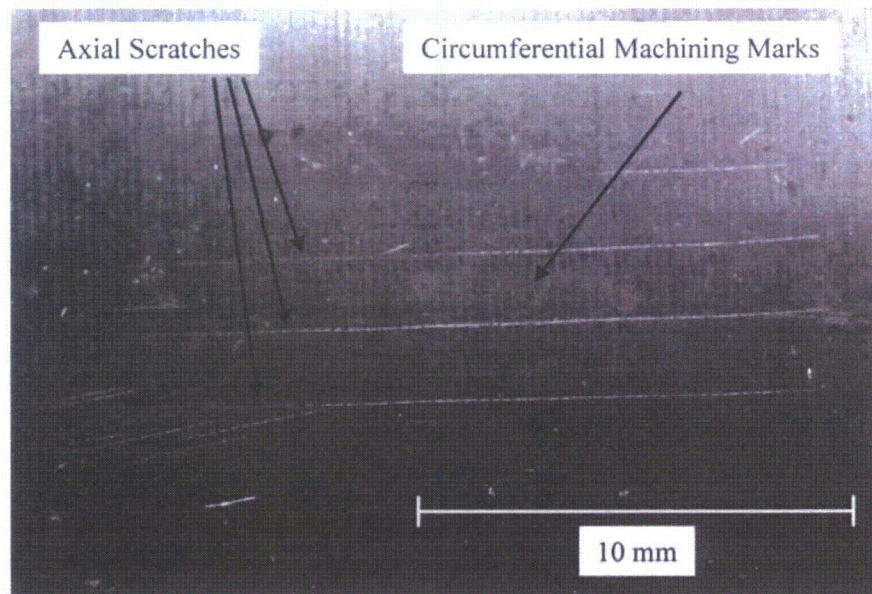
The photographs were examined individually at 100% magnification using a variety of sharpness, brightness, and contrast settings. The interior of the tube showed regular circumferential machining marks and many axial scratches. Some of the deepest axial scratches were coincident with the larger voltage responses seen using ET. Figure 5.14 shows deep axial scratches cutting through the circumferential machining marks.

Figure 5.14 Machining Marks and Axial Scratch-Like Indications on the Interior of the Penetration Tube in Nozzle 59

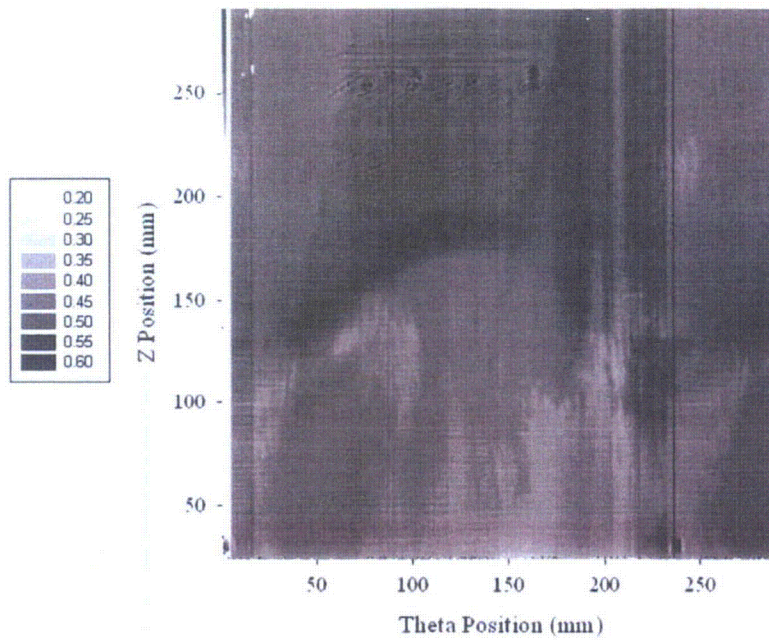
Nozzle 31 had only low-level indications (Figure 5.22). The rectangular indication at the left corresponds to a visible 0-degree mark, repeated at 360 degrees (233 mm). The set of diagonal indications, extending from 50 to 150 mm (2 to 5.9 in.) circumferential and 220 to 270 mm (8.7 to 10.6 in.) axial, corresponds to a visibly scratched region. The scan with the probe oriented at 45 degrees displayed a low-level linear indication (boxed in Figure 5.23), but it was not visible in either of the scans with the probe oriented to 0 degrees.

Figure 5.22 Nozzle 31, Scan Taken with Probe Oriented to 0 Degrees, 350 kHz, with the Image Set To Display Scratches

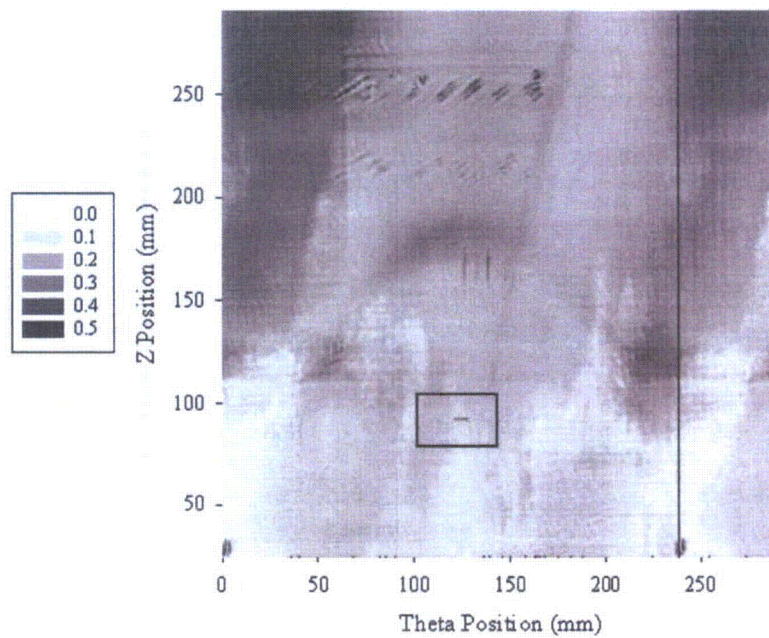
Figure 5.23 Nozzle 31, 45-Degree Rotated Probe Scan, 350 kHz, Showing Linear Indication (centered in box, about 125 mm [4.9 in.] circumferential and 100 mm [3.9 in.] axial)

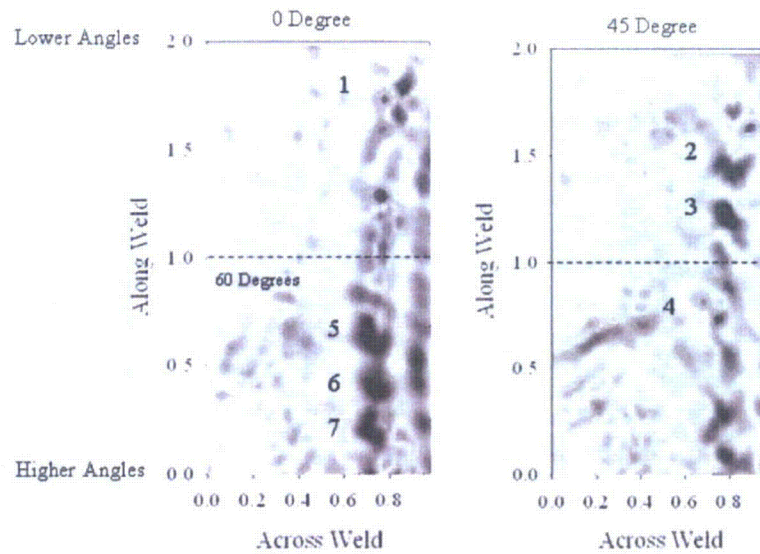
The area near 60 degrees has seven indications between 2 to 5 mm (0.08 to 0.2 in.) in length and with ET responses from 1.8 V to 3.3 V over a 50-mm (2-in.) range at the weld/buttering interface. The flaws appear to be point-like or circumferential, and the responses from the flaws are strongly affected by the probe direction. This cluster of seven indications is unique in the J-groove weld, and no such indications are present at the mirror-image position at 300 degrees, which should have a similar stress field while in service. These indications are numbered 1 through 7 from Table 5.5. Figure 5.26 shows the 0-degree and 45-degree rotation scans of the region near 60 degrees.

Figure 5.26 0- and 45-Degree Scans Centered on 60 Degrees on the J-Groove Weld of Nozzle 31

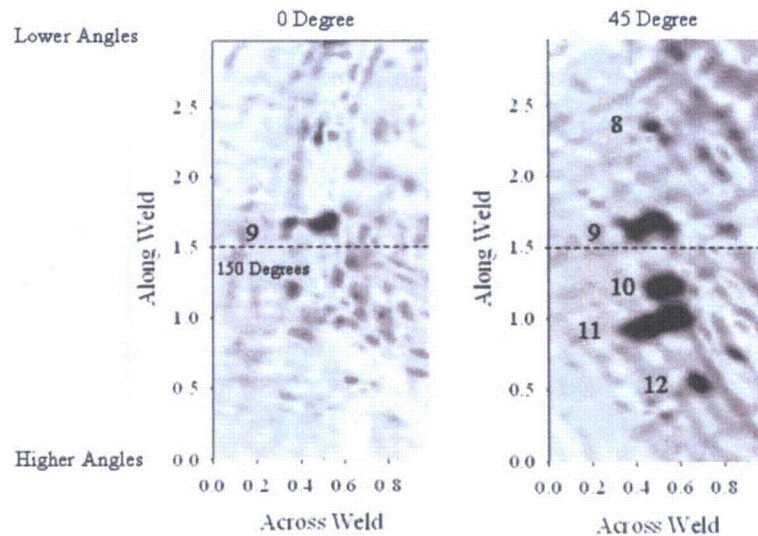
The area near 150 degrees was also re-scanned to quantify the indications in this area. Five indications were found at the weld/buttering interface, ranging from 4 mm to 14 mm and from 2.3 V to 4.1 V. Two of the indications—8 and 12—were point-like, and three—9, 10, and 11—were linear. Only indication 9 gave a significant ET response to both probe rotations. It is worth noting that indications 9, 10, and 11 are axial and are angled slightly toward 180 degrees. The ET results for this region are given in Figure 5.27.

Figure 5.27 0- and 45-Degree Scans Centered on 150 Degrees on the J-Groove Weld of Nozzle 31

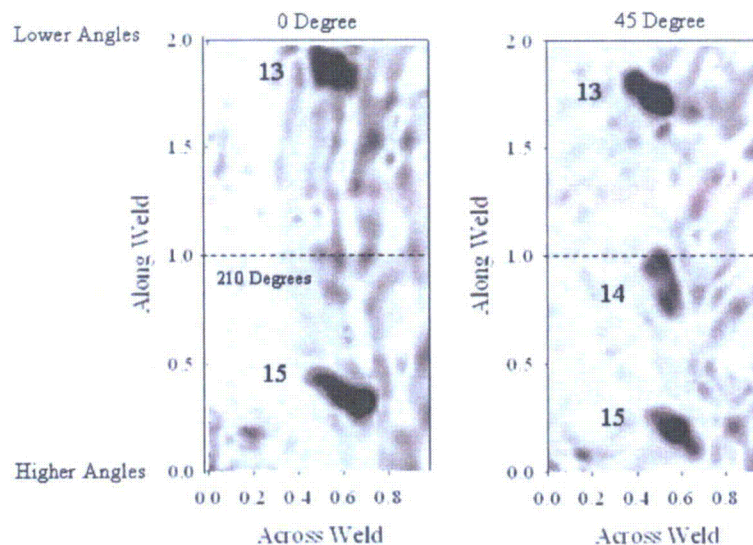
The next region of interest was centered around 210 degrees at the weld/buttering interface. Three indications were found—13 through 15 from Table 5.5. Indications 13 and 15 are 8–9 mm (0.3–0.35 in.) long and have responses of 4.6 V. Indications 13 and 15 show up clearly in both probe orientations. Both indications are axial in orientation but are also slightly angled toward 180 degrees, much like the indications centered around 150 degrees. Indication 14 is circumferential, has an ET response of 1.8 V, and has a discernable response only when the probe is oriented at 45 degrees. The ET results for this region are given in Figure 5.28.

Figure 5.28 0- and 45-Degree Scans Centered on 210 Degrees on the J-Groove Weld of Nozzle 31

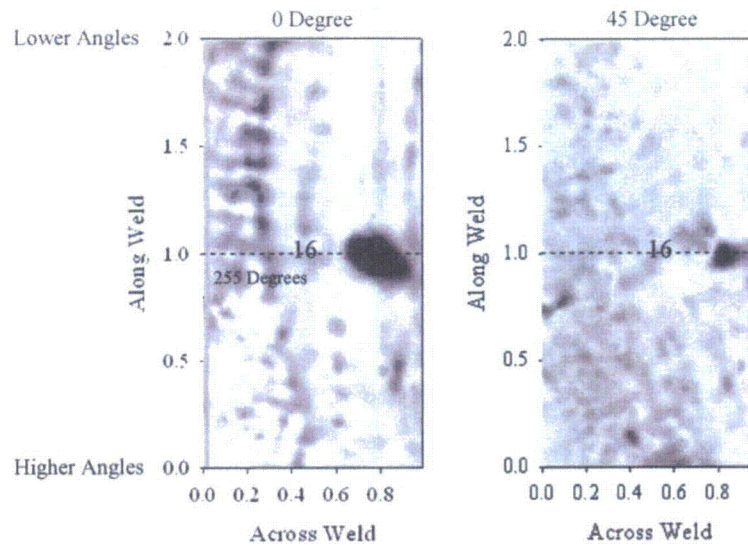
The last ET indication was found at 255 degrees at the weld/buttering interface. This indication is 8 mm (0.3 in.) long and has an ET response of 4.2 V. The indication is much more pronounced when the probe is at 0 degrees but is still present at 45 degrees. The ET results for this region are given in Figure 5.29. It should be noted that while the scans show indications at certain locations in the penetration tube wall or weld, the indications shown in a particular scan may not be indicative of leakage. For example on Nozzle 31, volumetric inspection of the J-groove weld was not able to detect the through-weld crack, and eddy current testing also exhibited inconsistencies.

Figure 5.29 0- and 45-Degree Scans Centered on 255 Degrees on the J-Groove Weld of Nozzle 31

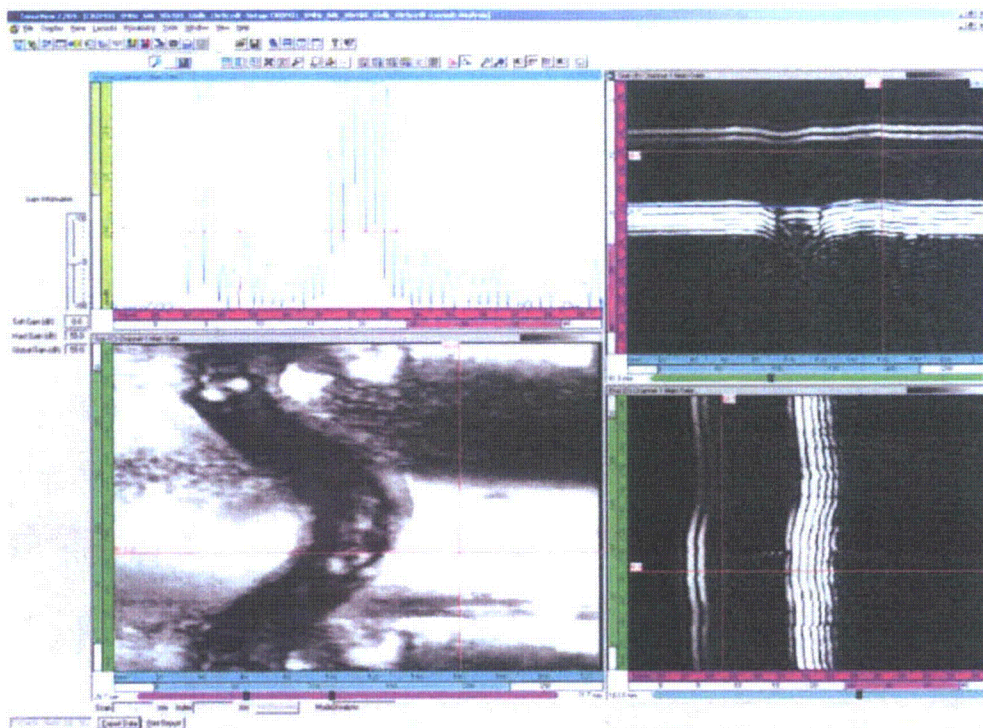
In general, the higher-frequency 7.5-MHz probe set generated many more responses than the 5-MHz set. Figure 5.30 shows a weak TOF-shaped indication located at 91 mm (3.6 in.) from the start. A stronger indication without the TOF shape acquired also at 5 MHz is shown in Figure 5.31. Figure 5.32 shows a TOF shape and two other indications acquired at 7.5 MHz. The TOF-shaped indication in Figure 5.26 is lower in amplitude at -7.2 dB than the other two indications in Figures 5.33 and 5.34, with responses of -5.3 and -3.0 dB, respectively. These response levels are comparable to the responses from the axial calibration notches shown earlier in Table 4.3.

Figure 5.30 Time-of-Flight Shape in 5-MHz Time-of-Flight Diffraction Data from Nozzle 31 at 91 mm (3.6 in.) CCW, 163 mm Axial, with -9.4-dB Response

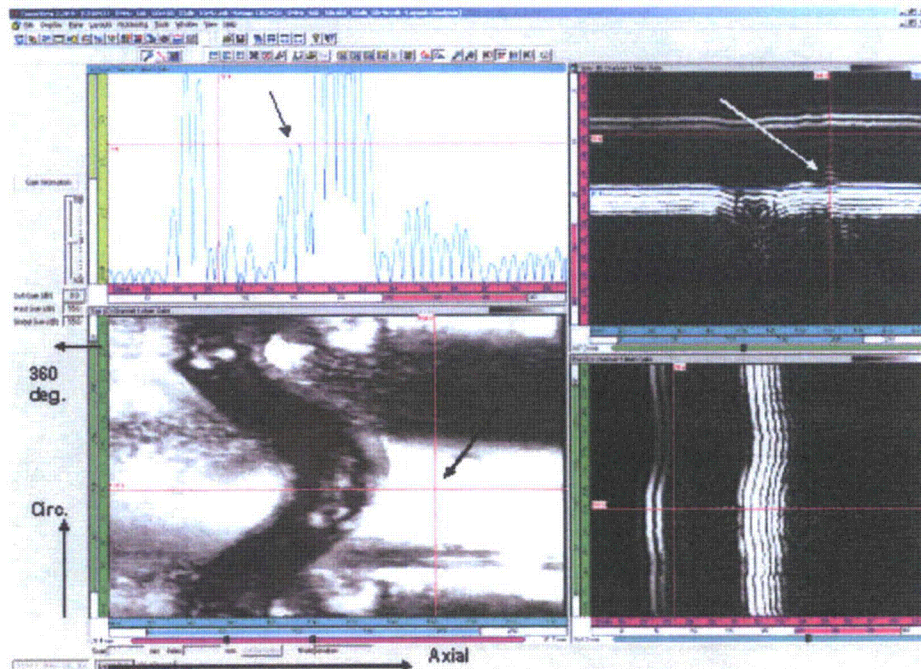
Figure 5.31 Interesting 5-MHz Time-of-Flight Diffraction Indication from Nozzle 31 at 107 mm (4.2 in.) CCW, 164 mm (6.5 in.) Axial, with -3.6-dB Response

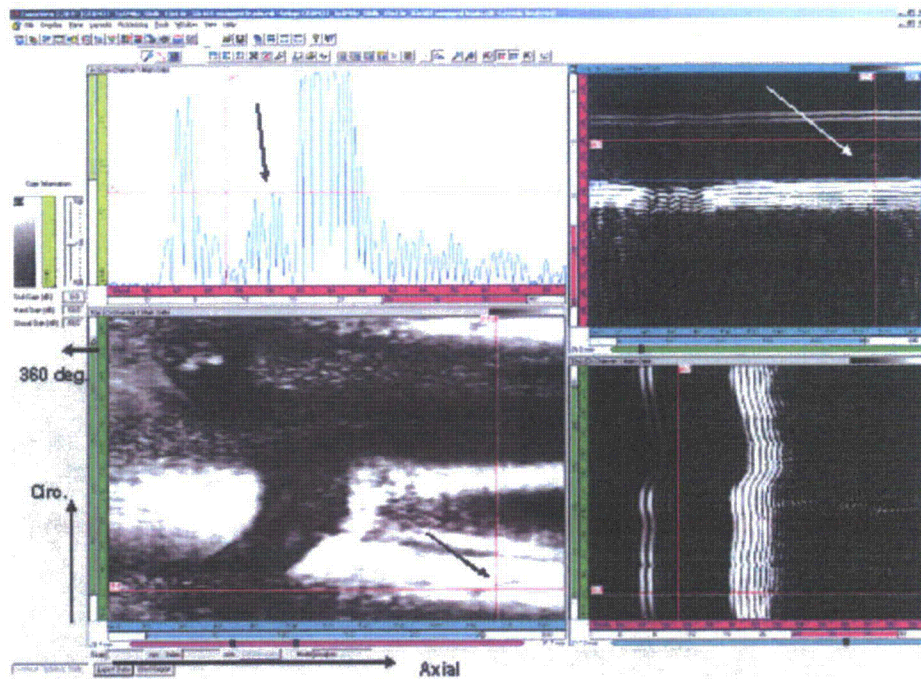
Figure 5.32 Time-of-Flight Shape in 7.5-MHz Time-of-Flight Diffraction Data from Nozzle 31 at 25 mm (1 in.) CCW, 217 mm (8.5 in.) Axial, with -7.2-dB Response

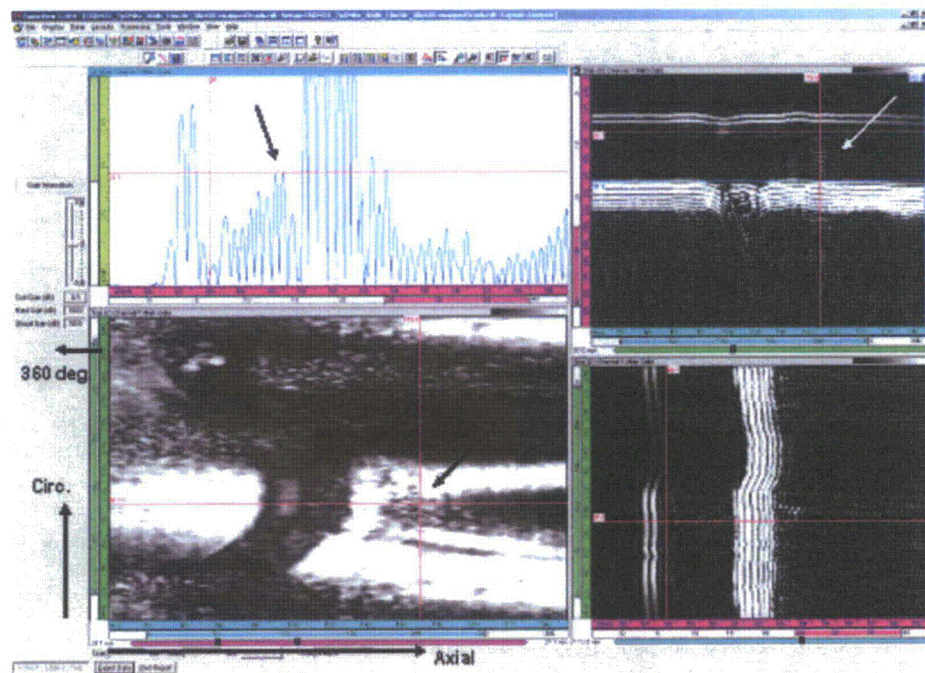
Figure 5.33 Interesting 7.5-MHz Time-of-Flight Diffraction Indication from Nozzle 31 at 97 mm (3.8 in.) CCW, 173 mm (6.8 in.) Axial, with -5.3-dB Response

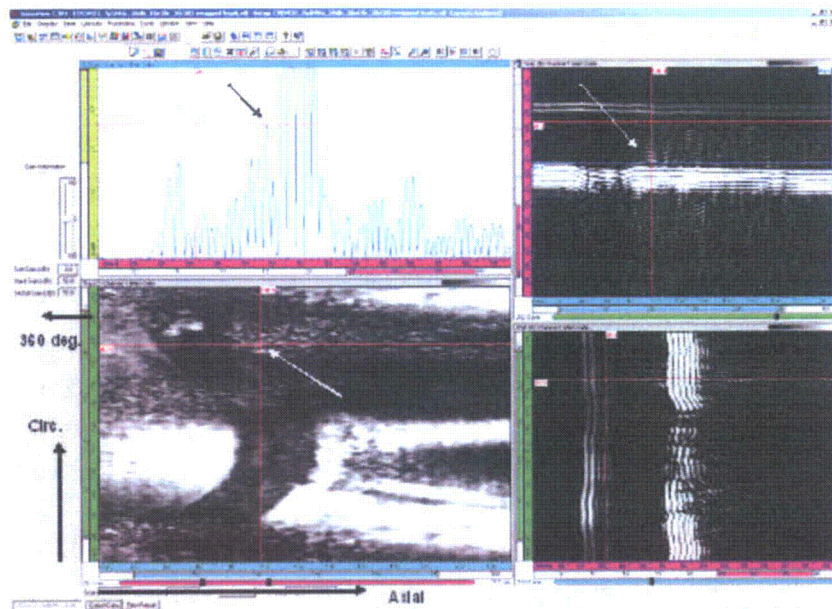
Figure 5.34 Interesting 7.5-MHz Time-of-Flight Diffraction Indication from Nozzle 31 at 202 mm (8 in.) CCW, 100 mm (3.9 in.) Axial, with -3.0-dB Response

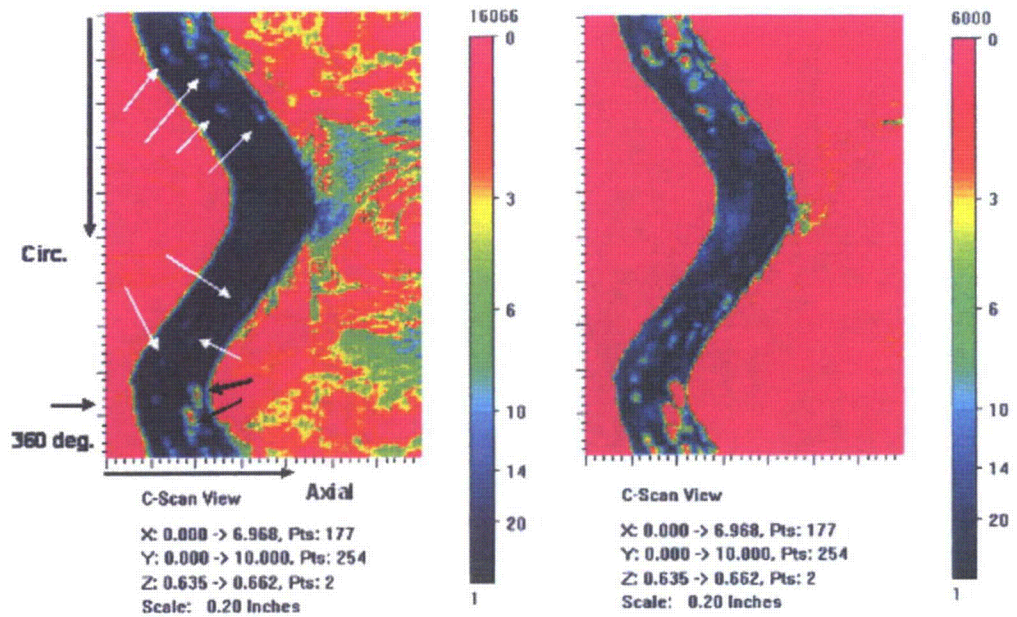
C-scan images of indications from the J-groove weld material at the four inspection frequencies are shown in Figures 5.35 through 5.39. The 5-MHz data in Figure 5.35 show a large-amplitude indication near 360 degrees. This same indication is seen also in the 2.25-, 1.0-, and 0.5-MHz data (Figures 5.36 through 5.39). Although in almost all cases the SAFT process was able to improve the signal-to-noise ratio without causing any significant change to the shape or nature of the indications, the 2.25-MHz data showed some interesting elongated indications prior to SAFT process application that became rounded when SAFT was applied. Figure 5.37 shows the unprocessed data. The elongated indications are at 90 degrees and from 270 to 300 degrees and appear to start in the weld metal, not the penetration tube. It should be noted that the Z data shown in Figure 5.26 are not compatible with the others, as the data in Figure 5.37 were not processed in the same way and there is no correction for the curvature of the data. The lower-amplitude lack of fusion indications at 178 mm (7 in., 286 degrees) in the circumferential direction are seen at all frequencies except 500 kHz.

Figure 5.35 Nozzle 31, 5-MHz Immersion Data Showing Indications in the J-Groove Weld Material at Two Different Displayed Amplitude Settings

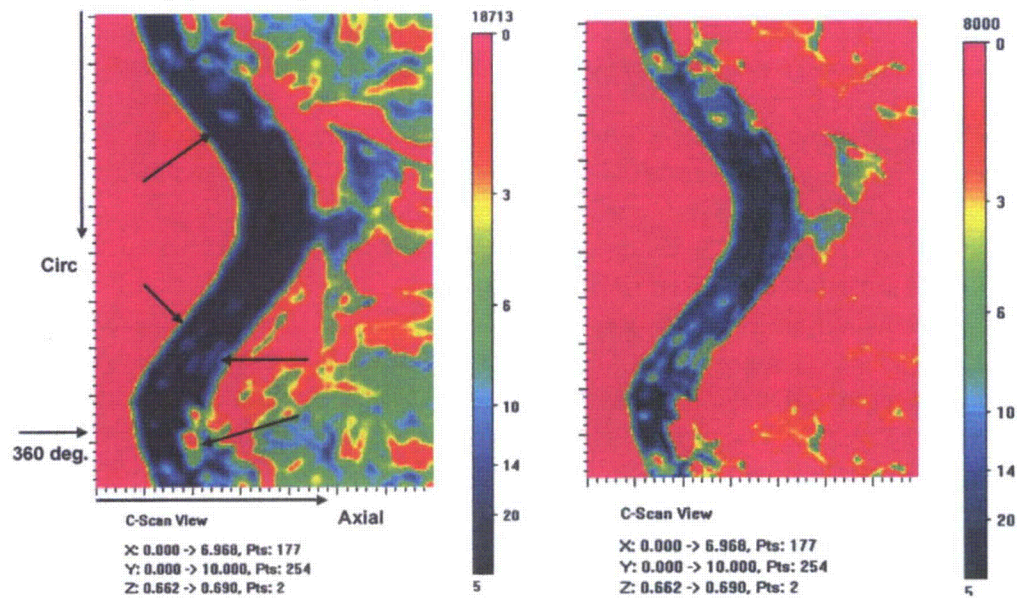
Figure 5.36 Nozzle 31, 2.25-MHz Immersion Data Showing Indications in the J-Groove Weld Material at Two Different Displayed Amplitude Settings

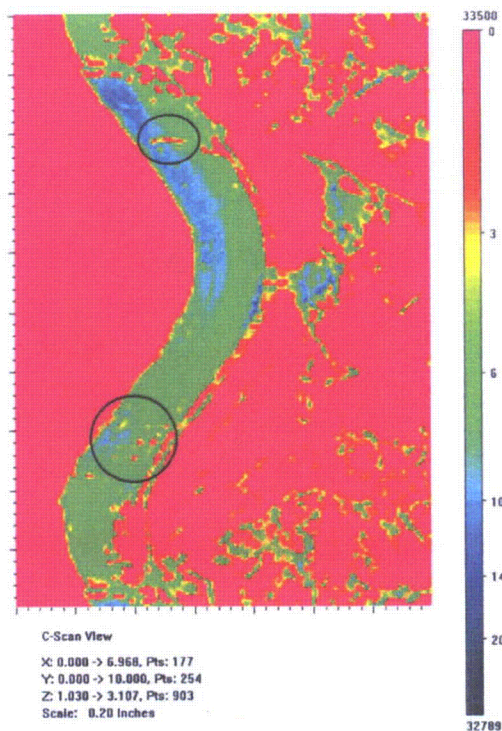
Figure 5.37 Unprocessed 2.25-MHz Data Showing Elongated Indications at 90 Degrees and from 270 to 300 Degrees (circled). These elongated indications are rounded by the SAFT processing.

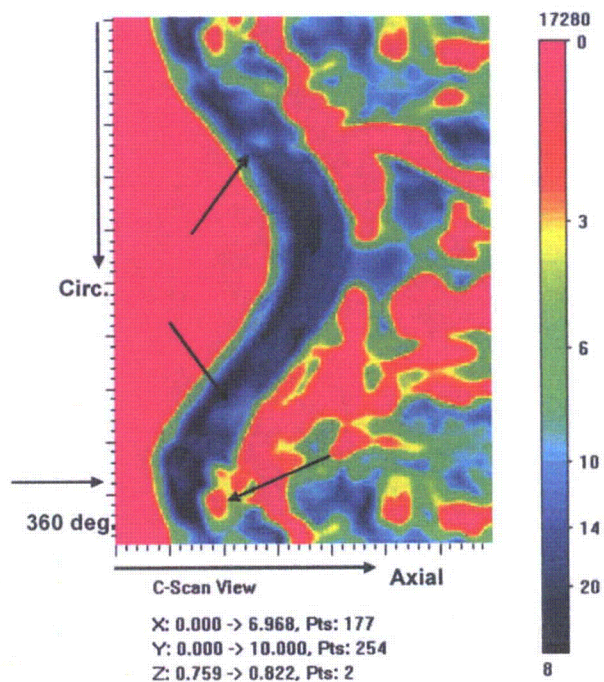
Figure 5.38 Nozzle 31, 1-MHz Immersion Data Showing Indications in the J-Groove Weld Material

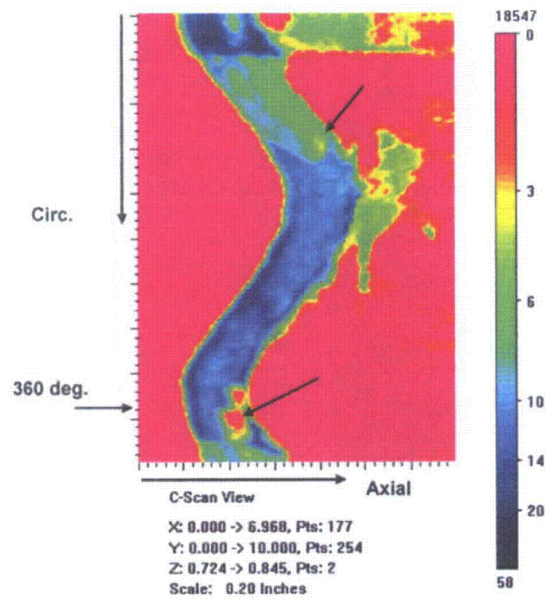
Figure 5.39 Nozzle 31, 500-kHz Immersion Data Showing Indications in the J-Groove Weld Material

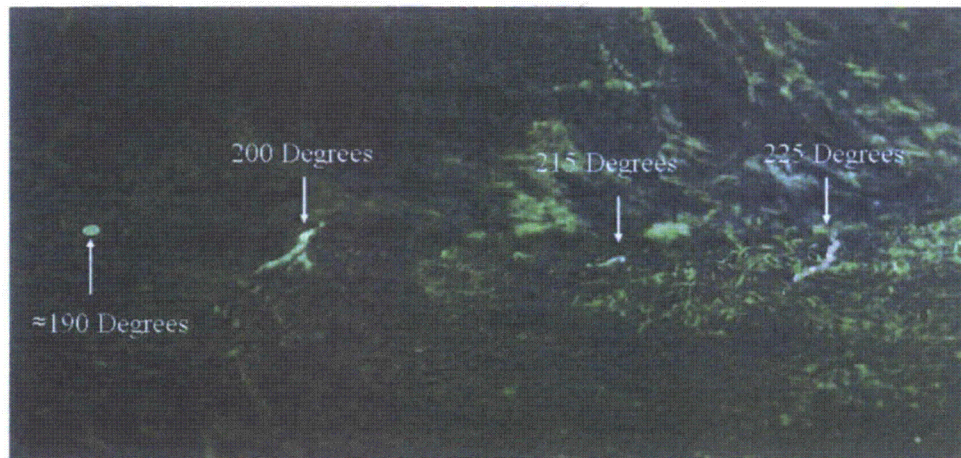
The PT testing showed that the major indications found by the examination of the J-groove weld using a replicate were scratches, not cracks. Two short crack-like indications were found using PT, one at 200 degrees and one at 225 degrees. A pore-like indication was found at 190 degrees, and a small linear indication was found at 215 degrees as well. These indications are shown in Figure 5.44. After the penetrant developer was cleaned off, these areas were re-photographed with the 16.7-megapixel Canon camera using the macro lens. The pore at 190 degrees and the linear indication at 215 degrees could not be detected, but the cracks at 210 and 235 degrees were confirmed using the photographs. Figure 5.44 shows these crack-like indications and the pore-like indication.

Figure 5.44 Penetrant Results at the Weld/Butter Interface Around 210 Degrees

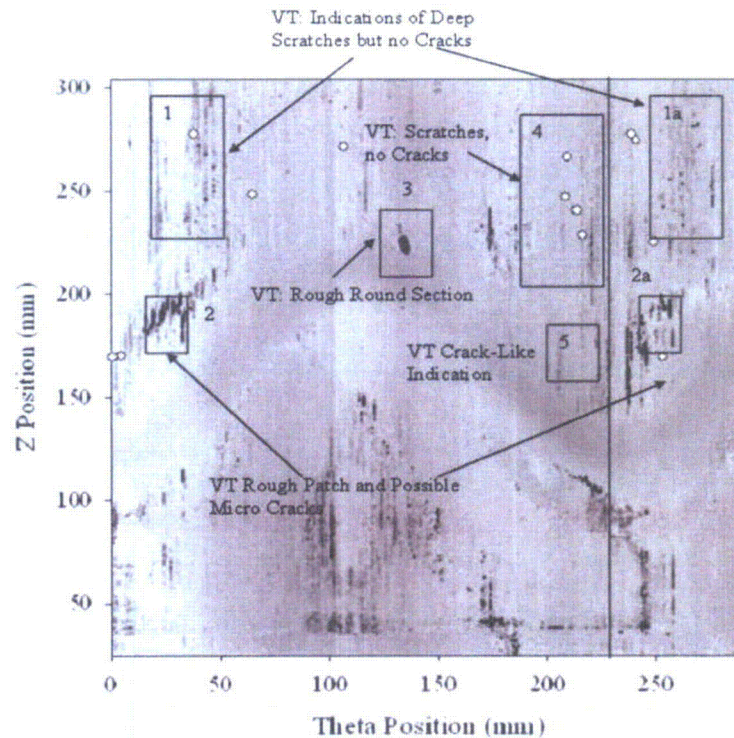
The area highlighted in Figure 5.47 Region 1 (and 1a, a repeat of 1) has the low-voltage ET responses but has only one TOFD indication, and the VT results showed deep scratches but no crack-like indications.

The ET indication at 140 mm (5.5 in.) rotation and 225 mm (8.9 in.) axial (indication 3) was determined via VT to be a round, rough patch on the interior of the penetration tube. The cause of this rough patch is not known.

The results show where the TOFD and the ET results find a common area of interest (Region 4 of Figure 5.47). This area is at 210 mm (8.25 in.) rotation and 225 to 260 mm (8.9 to 10.2 in.) axially into the tube. The VT results for this region show only scratches, however.

Figure 5.47 Combined Eddy Current Data with Overlaid Time-of-Flight Diffraction Indications and Visual Testing Characterization of the Results for the Penetration Tube of Nozzle 59

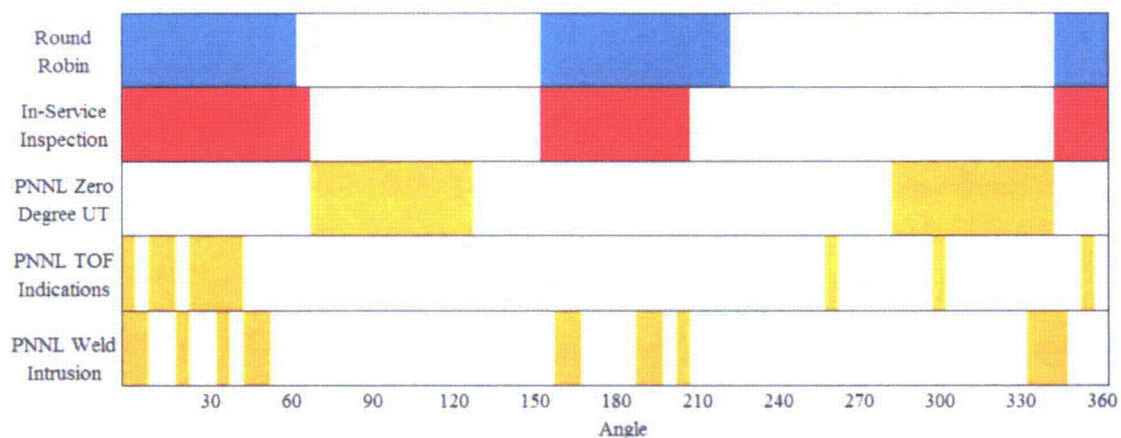
The compiled ultrasonic examinations of Nozzle 59 are shown in Figure 5.48, which summarizes the angular locations of reported indications from the round robin, the in-service inspections, and the PNNL inspections. For simplicity the indications are shown only by angle and not by the height of the indications in the penetration tube because nearly all of the ultrasonic indications are located at or near the J-groove weld. When the round-robin and in-service inspection data are examined, the two sets of indications correlate strongly with the weld intrusion indications found by PNNL. The embedded TOFD indications are not reflected in the round-robin or ISI results. The welding defects found using zero-degree ultrasound also were not reported by the round-robin or the ISI data.

Figure 5.48 Compiled Ultrasonic Data for Nozzle 59

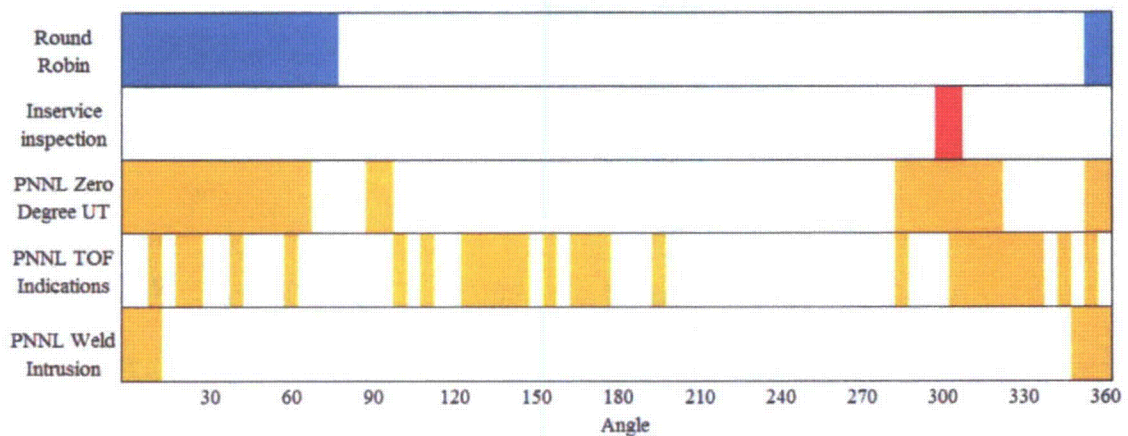
A comparison of the PNNL, ISI, and round-robin tests of the penetration tube yields interesting results. The PNNL TOFD examination of the penetration tube of Nozzle 31 again found apparent weld intrusions and embedded indications in the penetration tube. The PNNL zero-degree ultrasound found a very large indication in the J-groove weld metal near zero degrees. The round-robin examinations of the penetration tube shows indications that are coincident with the apparent weld intrusion found by PNNL and possibly some of the large indication around zero degrees. The in-service inspection of the penetration tube was different from the PNNL and round-robin results, calling only one region near 300 degrees as having an indication described as “mid wall.” PNNL called several embedded indications in the weld metal using TOFD near the 300-degree mark.

Figure 5.50 Compiled Ultrasonic Data for Nozzle 31

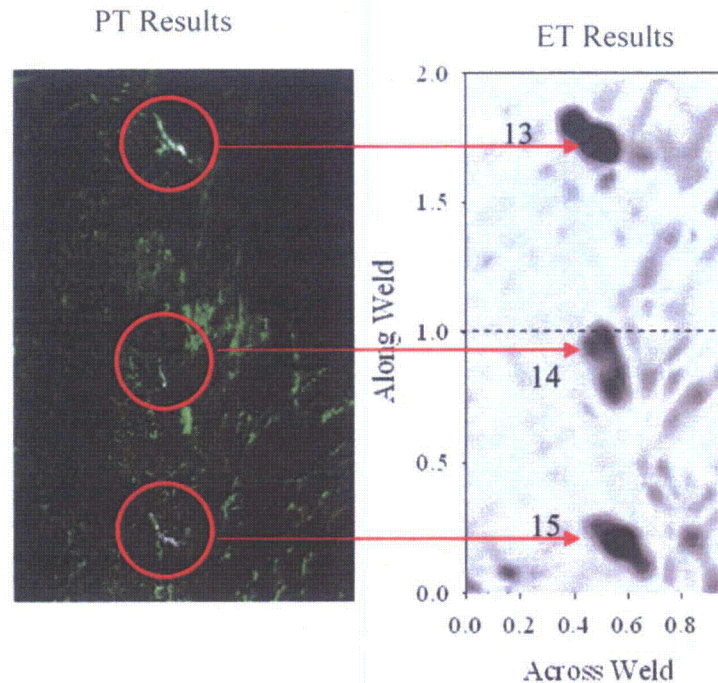
Sixteen crack-like indications were found by ET in four distinct areas. Seven small crack-like indications were found clustered around 60 degrees, five were found clustered around 150 degrees, three were found clustered around 210 degrees (Figure 5.52), and one was found at 255 degrees. The ET indications at 200 and 225 degrees were confirmed as cracks using PT and bare-metal VT.

Figure 5.52 Correlated Penetrant Dye and Eddy Current Testing Results for the Weld/Butter Wetted Surface Interface in Nozzle 31 Centered at 210 Degrees

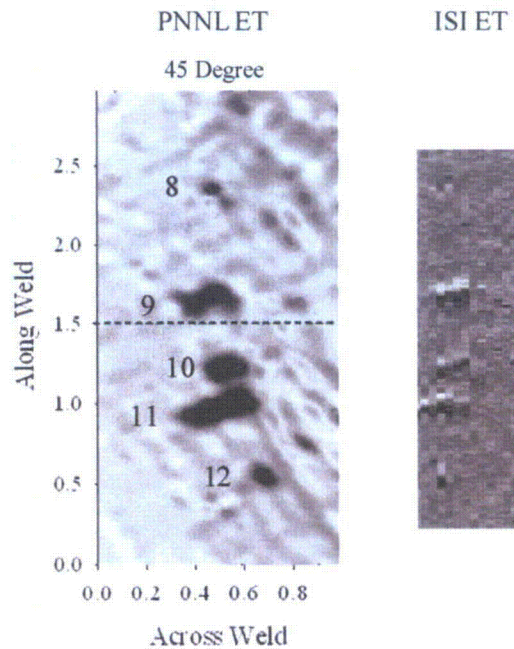
PNNL has acquired the ET results for the ISI examination of Nozzle 31. A review of the data shows that the ISI ET detected more indications than were called in the ISI report. When plotted side by side, it appears that the ISI ET examination found indications 9, 10, 11, and 12, and possibly 8. A side-by-side comparison of the PNNL and ISI ET results is shown in Figure 5.53.

Figure 5.53 PNNL and ISI ET Results for the Weld-Buttering Interface Centered Around 150 Degrees

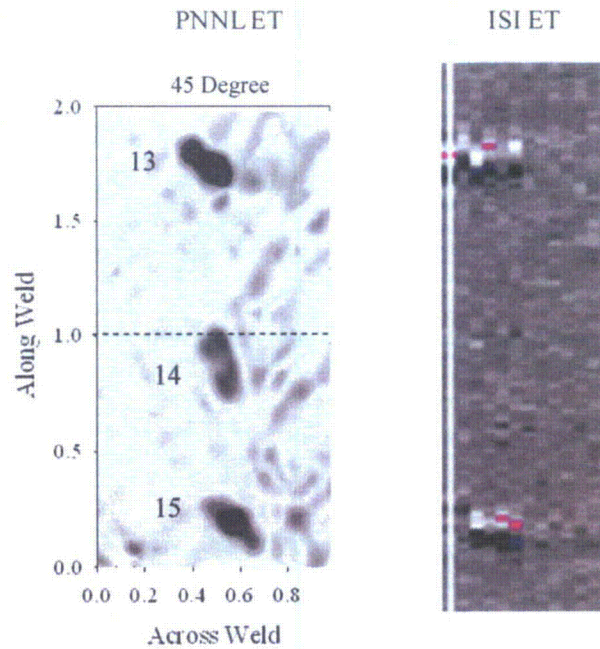
The region around 210 degrees also was compared, showing that the PNNL and ISI results were similar. The ISI ET examination detected indications 13 and 15 but not 14. The comparison between the PNNL and ISI results centered around 210 degrees is shown in Figure 5.54.

Figure 5.54 PNNL and ISI ET Results for the Weld-Buttering Interface Centered Around 210 Degrees
