4.1.4 Analysis of Corrosion Product from Neutronit Specimen SSE2 from the LTCTF

5. CONCLUSIONS

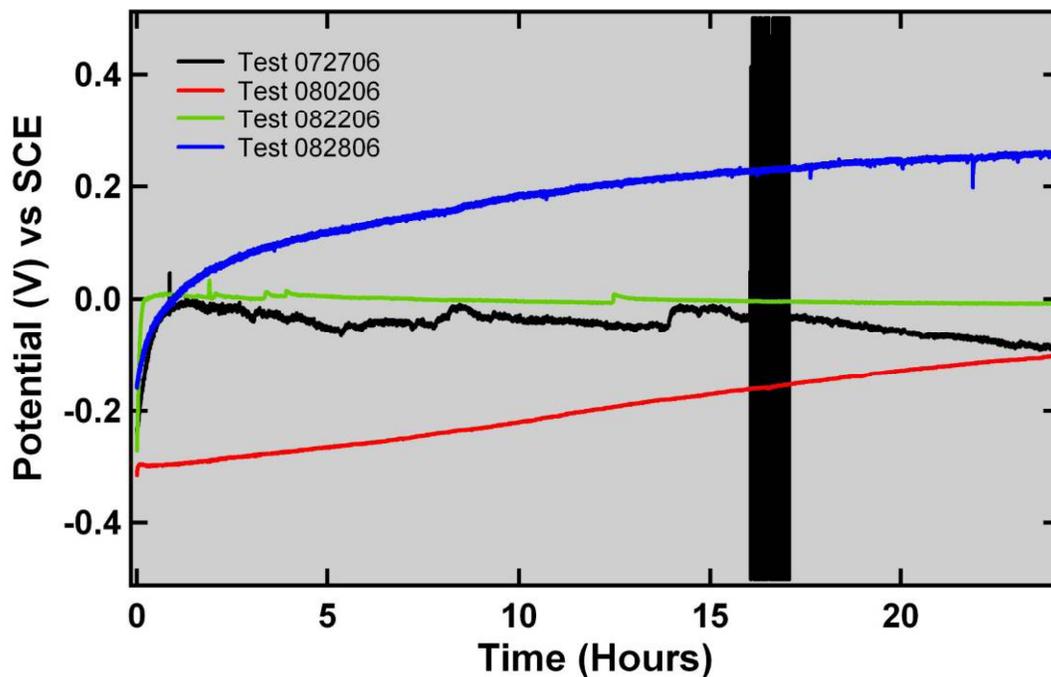
Figure A1. Plots of E_{corr} versus time for A978 specimens with aeration.

Figures A1 and A2 show the E_{corr} measurement for the A978 tests under aerated and N_2 purge. There does not appear to be a consistent common behavior in the E_{corr} data except of the two epoxy coated specimens under N_2 purge.

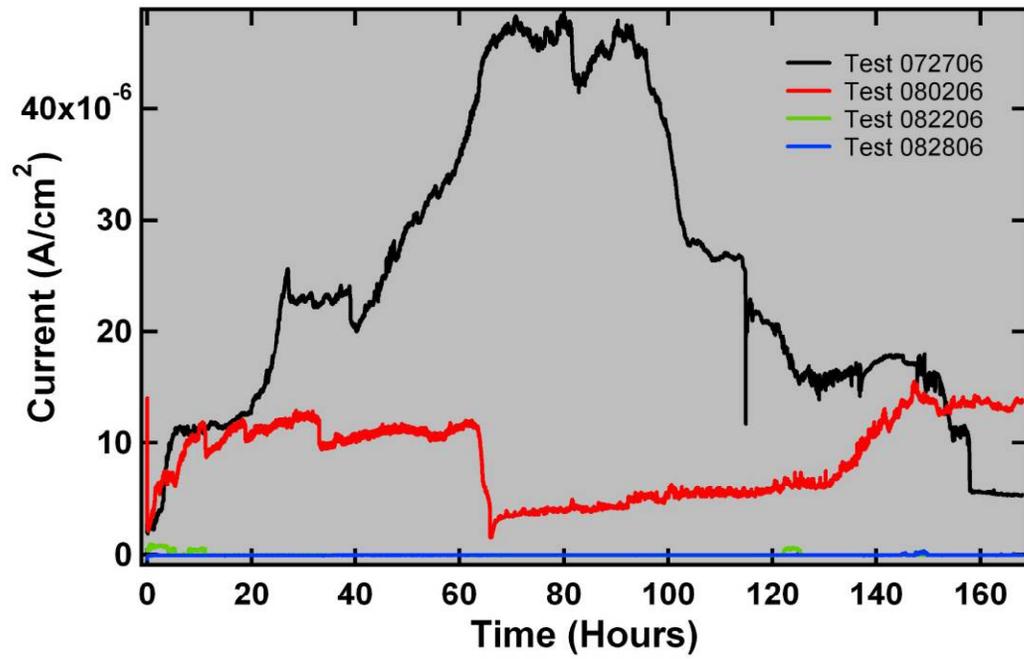
Figure A3. Plots of current versus time for PS tests of A978 specimens.

Figure A3 shows the PS data obtained from the four A978 specimens. The two specimens using an epoxy coating have much higher current. After examination of the specimens after the test (see Figure A4), it was noticeable that the contact to the specimens was corroded. The specimens using only a bare, platinum-wire contact showed low negative currents with a short positive current excursion due to localized corrosion. This negative current is evidently due to the exposed platinum wire and is likely an electrochemical reaction with dissolved species. Thus, in all cases a corrosion rate cannot be ascertained because the current is dominated by other reactions at the contact wires. Because the net current was negative, this suggests that the anodic corrosion current for the A978 was low.
