**UNITED STATES
NUCLEAR REGULATORY COMMISSION**
WASHINGTON, D.C. 20555-0001

September 8, 2009

SUBJECT: SUMMARY OF SEPTEMBER 2, 2009, POST-SUBMITTAL PUBLIC MEETING WITH EXELON GENERATION COMPANY, LLC, TO DISCUSS BYRON STATION, UNIT NO. 2, RELIEF REQUEST FOR ALTERNATE EXAMINATION FREQUENCY UNDER ASME CODE CASE N-729-1 FOR REACTOR VESSEL HEAD PENETRATION WELDS (TAC NO. ME1066)

Proposed Relief Request from
ASME Code Case N-729-1
Inspection Frequency
Byron Station Unit 2

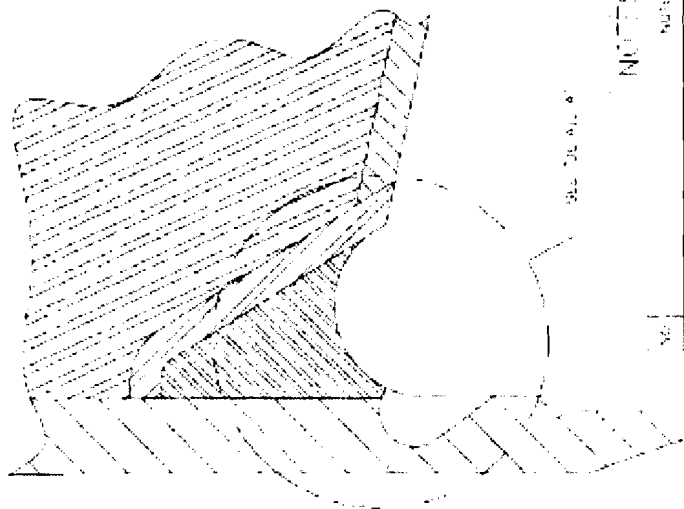
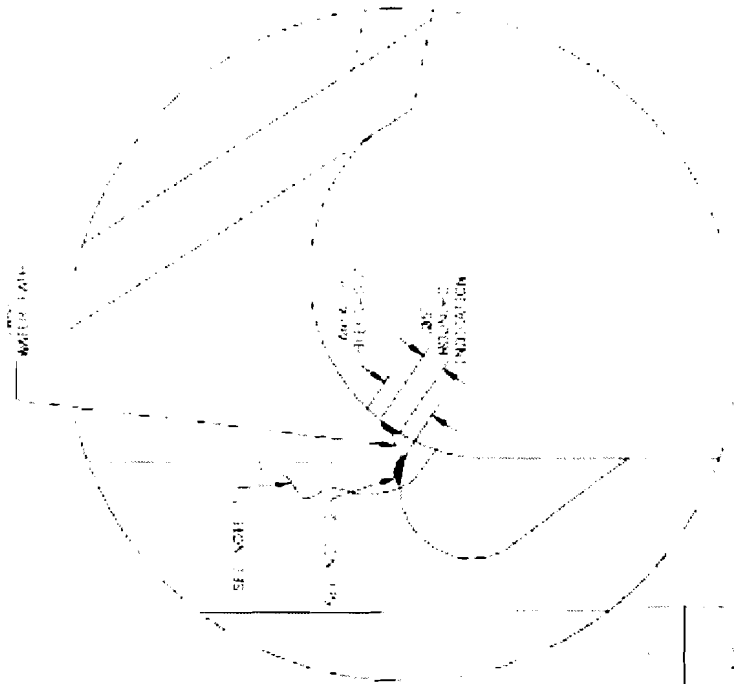
Boat Sample Results

- ✓ Subsurface linear defect is connected to the lack-of-fusion defect
- ✓ Evidence indicates a high probability that the rounded PT indication not captured by the boat sample was connected below the surface to the lack-of-fusion defect
- ✓ A surface flaw the size of the rounded indication would have been considered acceptable by ASME Code of fabrication for Byron Station
- ✓ Heavy grinding in this area may have masked the indication during fabrication exams

1. Rounded PT indication
2. Subsurface portion of axial indication
3. Subsurface linear defect connected to lack of fusion

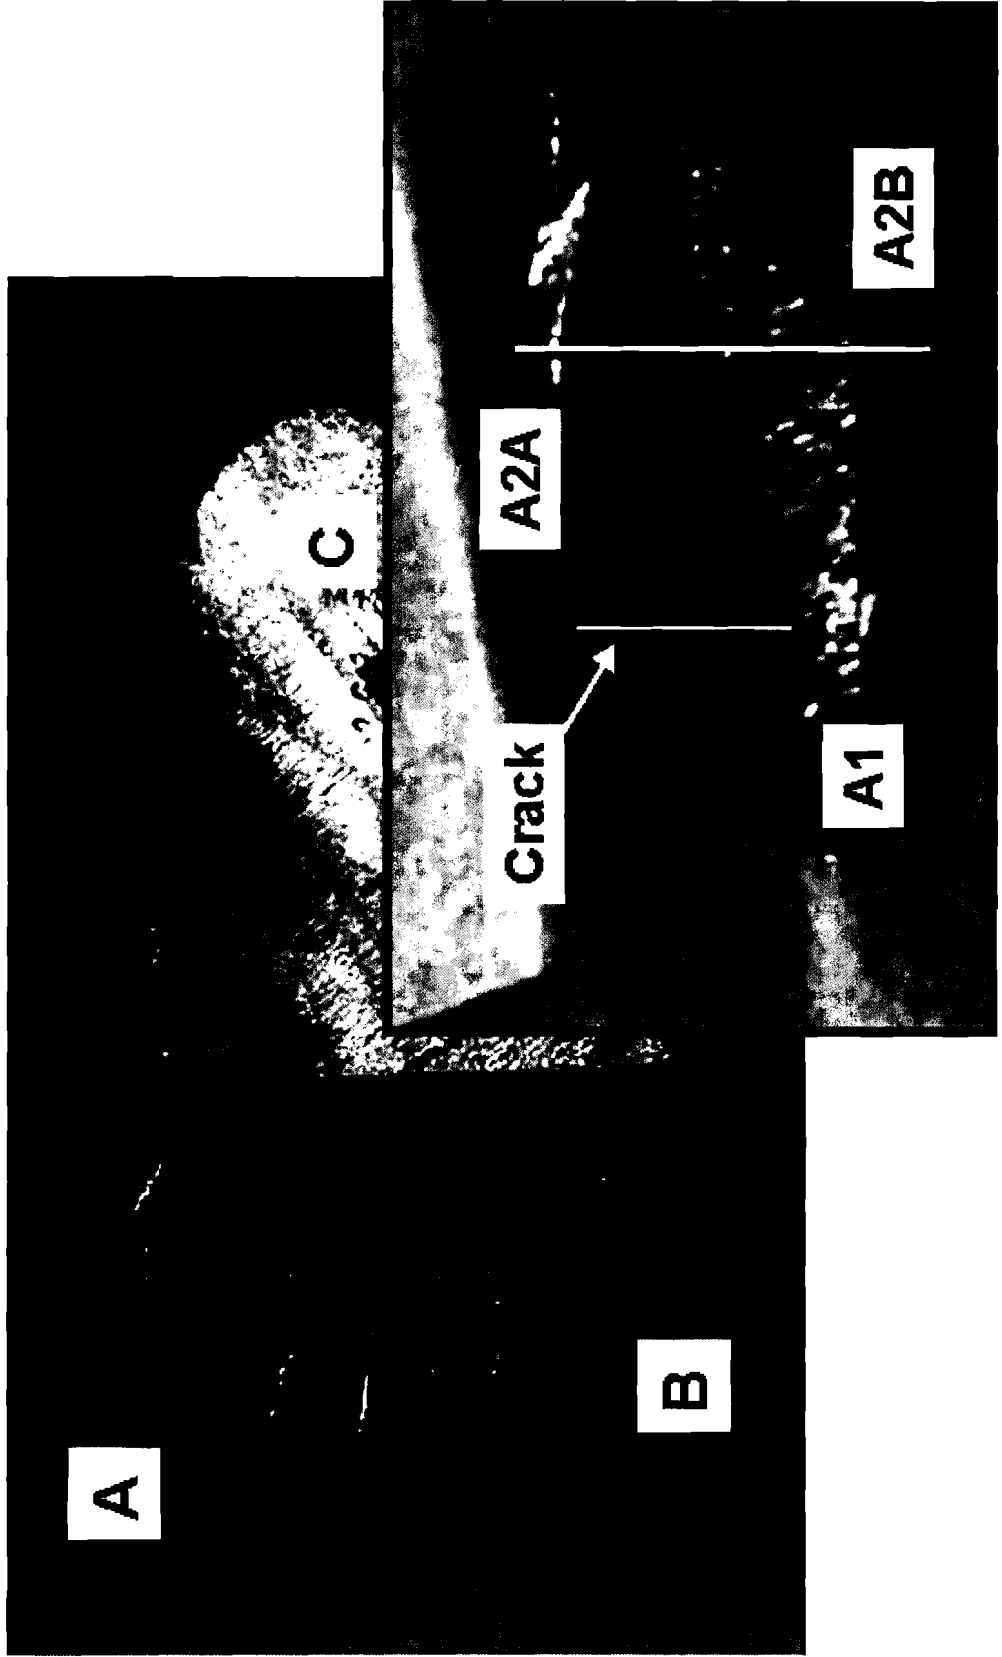
Section A

- ✓ Linear indication exhibited multiple defect/crack morphologies including lack of fusion, hot cracking, and PWSCC
 - In the weld, the direction of PWSCC propagation was from the subsurface location toward the wetted surface
 - In the tube material, none of the PWSCC was connected to the outer surface of the tube below the J-groove and/or fillet weld

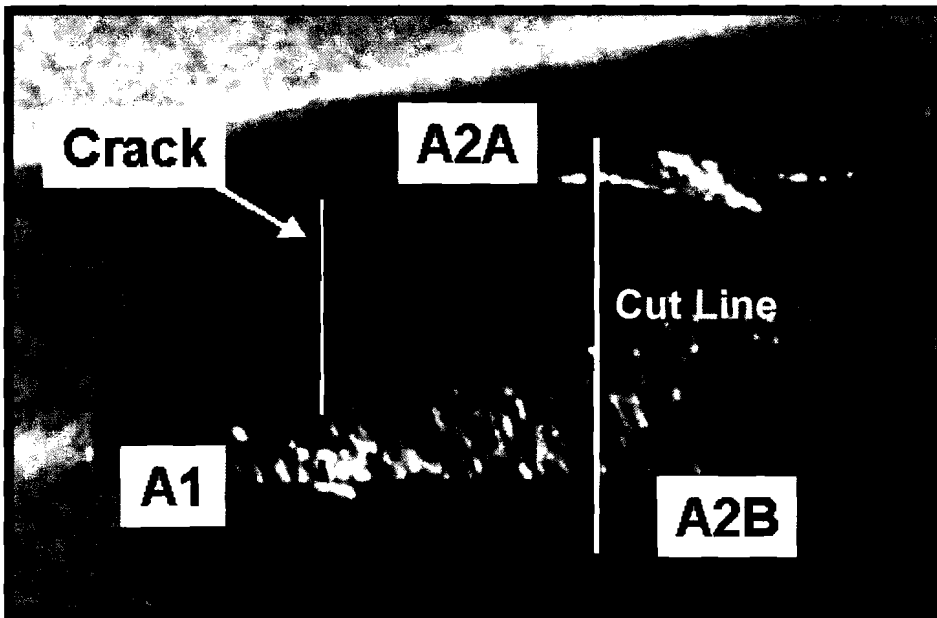
Section A2 -- Cut Surface

Cut Line Located Adjacent to Rounded Indication on EDM Surface

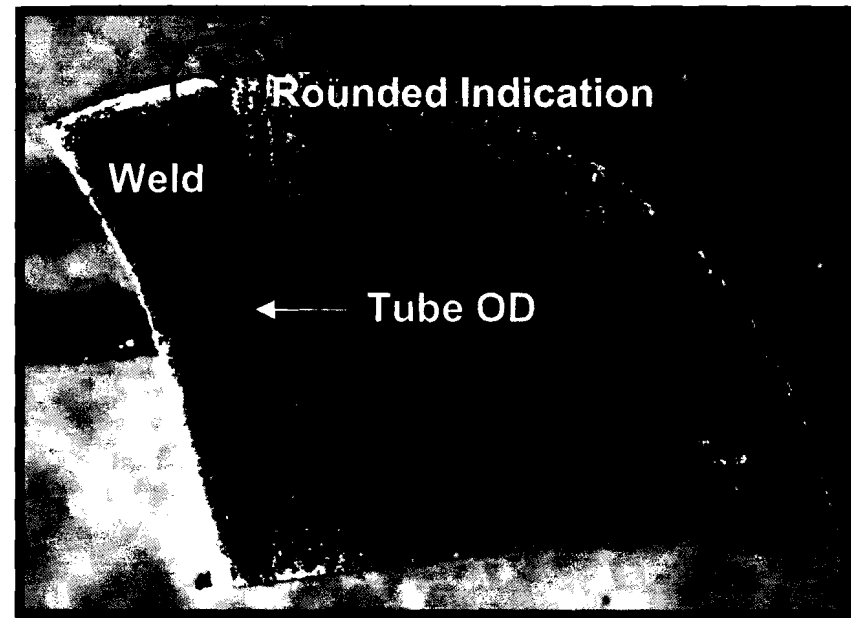
- ✓ Rounded subsurface defect captured by the boat sample identified as lack of fusion between the weld and tube surfaces
 - Incipient cracks were observed emanating from the defect
 - Weld defect produced during original fabrication process

Section A2A Ground to Reveal Rounded Indication

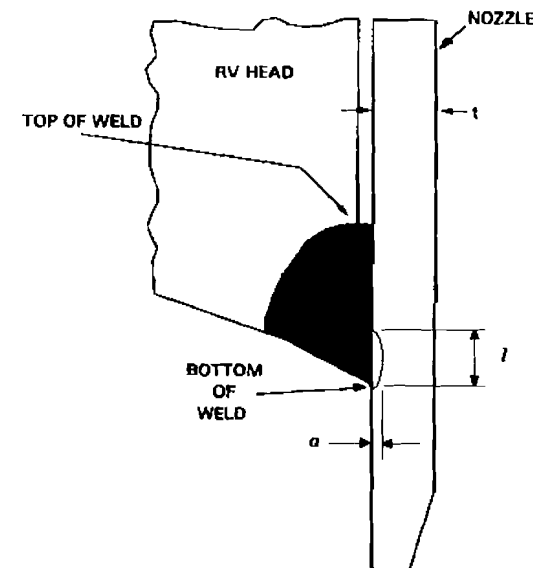
Growth Projections

- ✓ Performed analyses to determine the PWSCC project growth rates for RPV head penetrations
 - Tube OD axial flaw growth studies for five RPV head penetration groups (0° , 25.4° , 42.8° , 43.8° and 47°)
 - Growth based on operational plus weld residual stresses
 - PWSCC growth rates per MRP-55 Rev 1 for Alloy 600 tube material
 - Postulated initial flaw sized at the limit of UT detection, 0.075" by 0.150"
 - Postulated flaw located at highest stressed locations on the uphill and downhill sides of the penetration
 - Growth limited to the top of the J-groove weld where pressure boundary leak would initiate

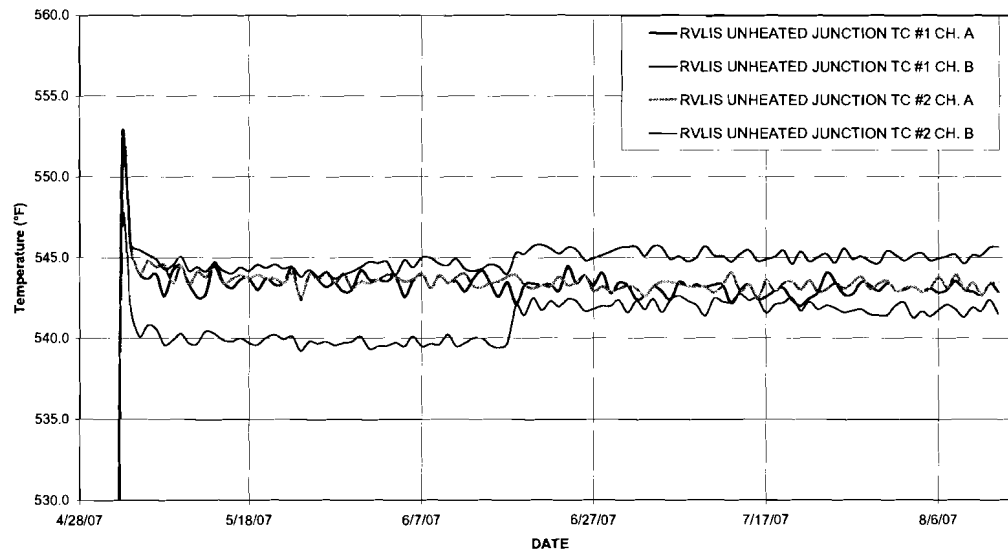
Byron Unit 2 RVLIS TC #1 & #2 Channels A and B

- ✓ Byron 2 RPV head operating temperature for Cycle 14 indicates head temperature is typically 545°F

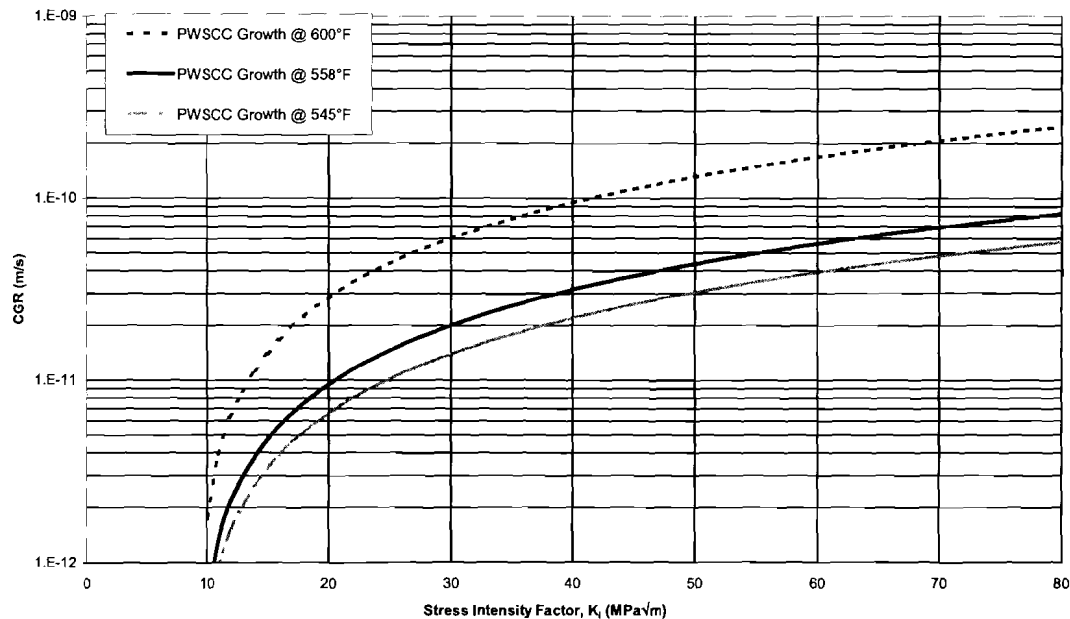
Growth Projections (continued)

- ✓ Using MRP-55 Rev 1 formulation growth rates for a typical hot head at 600°F, are compared to the evaluation temperature of 558°F and the typical Byron 2 head temperature of 545°F
- ✓ At 30 $\text{ksi}\sqrt{\text{in}}$ (33 $\text{MPa}\sqrt{\text{m}}$), margin factors of 1.4 from 545°F to 558°F and 4.4 from 545°F to 600°F are seen

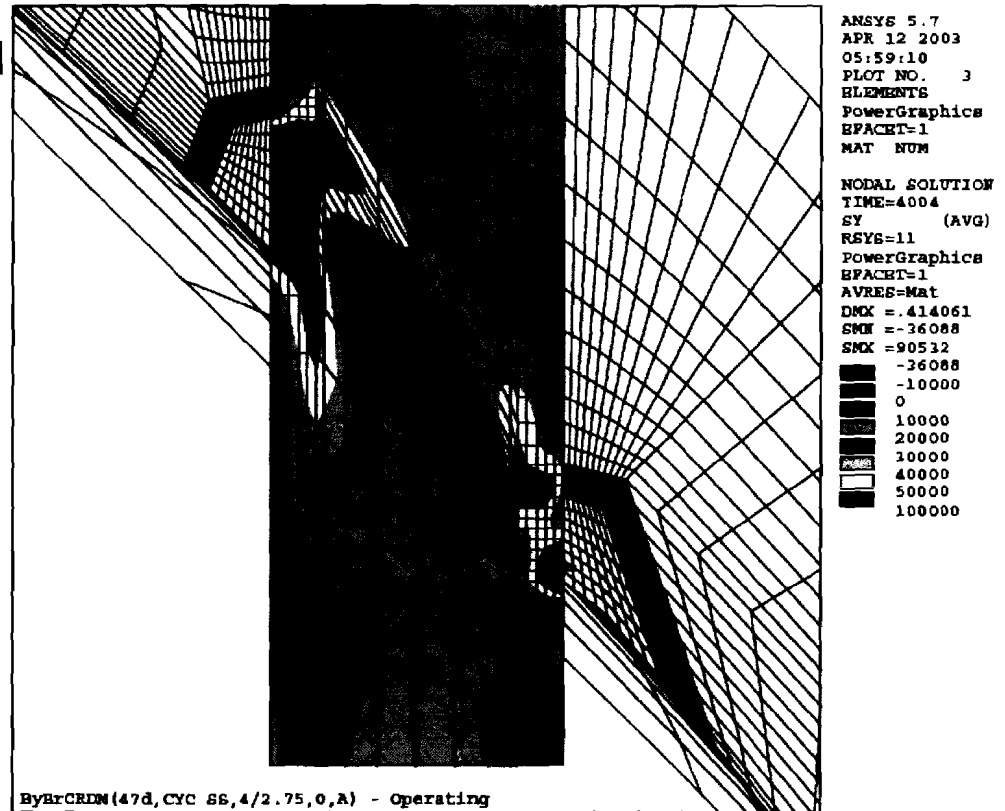
Growth Projections (continued)

- ✓ Typical operating plus weld residual hoop stress field used for crack growth – RPV head 47° nozzle (psi)
- ✓ Comparison studies performed by D. Rudland and J. Broussard and reported in ASME PVP2007-26045 demonstrated the methodology used to define the hoop welding residual stresses was conservative
