San Onofre Unit 3 Replacement Steam Generator

Divider Plate-to-Channel Head Weld Separation

September 15, 2009

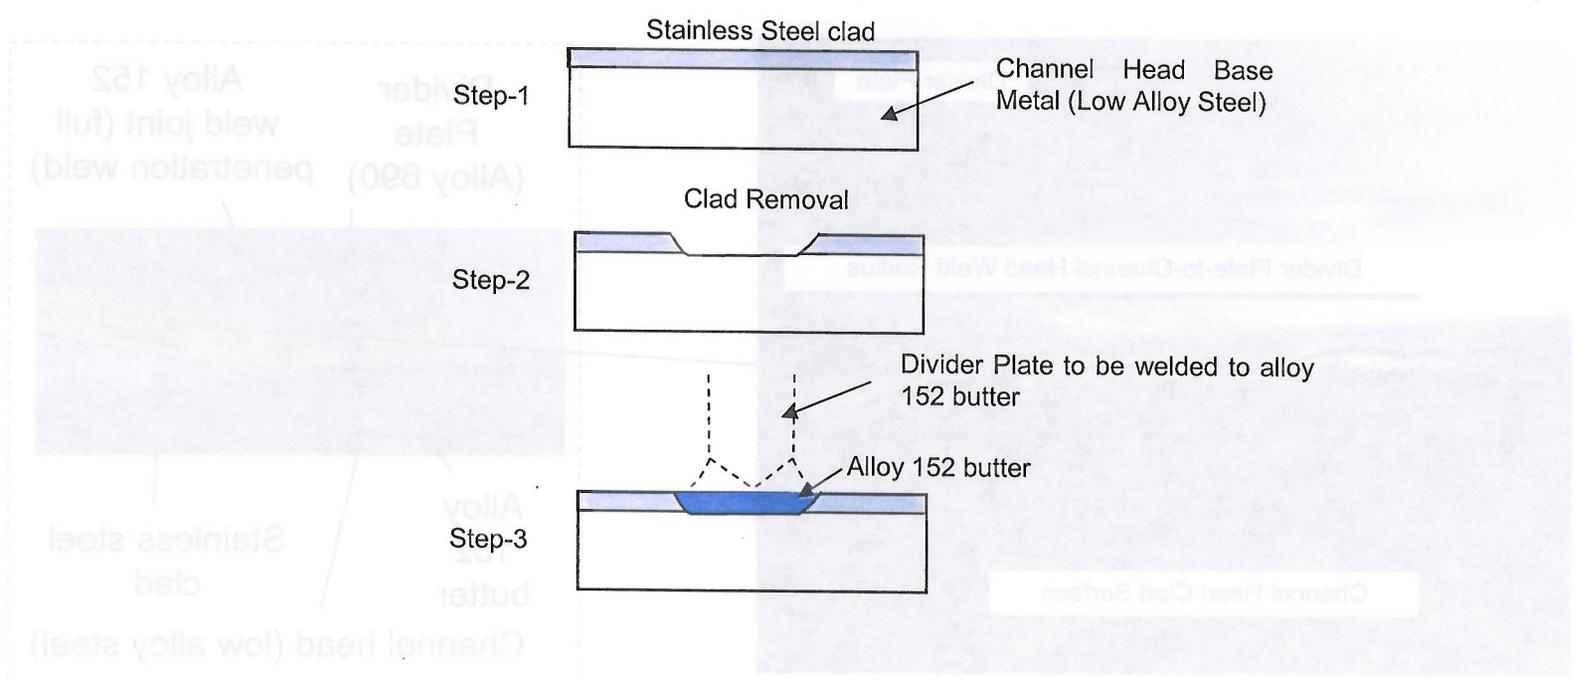
A crack in the weld between the RSG 3B divider plate and the channel head was reported on March 18, 2009 after completion of the hydrostatic pressure testing.

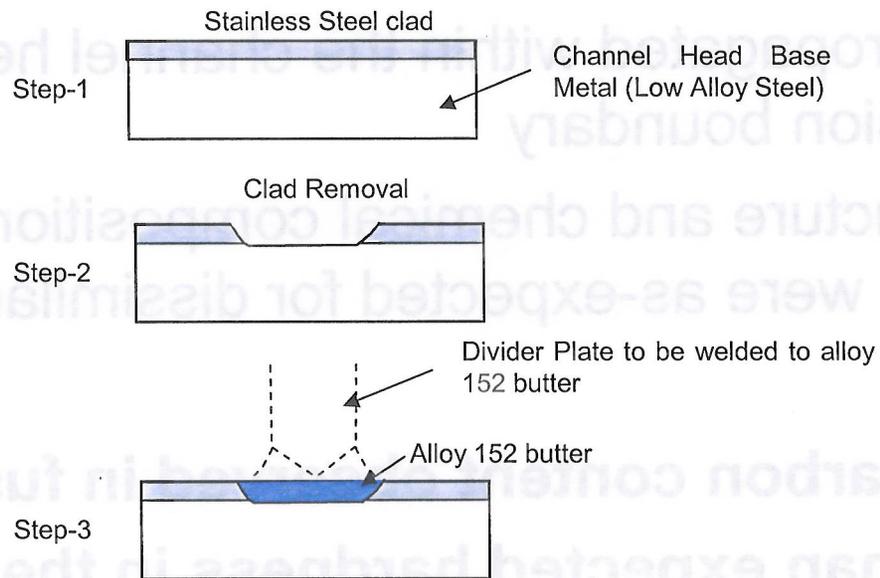
RSG Fabrication Process

- Entire channel head surface clad with stainless steel for corrosion protection
- Clad removed to prepare for Inconel buttering
- Air carbon-arc gouging (gouging) removed clad
 - Gouging the surface followed by grinding
 - Gouging process results in martensite formation and case hardening of surface from the increased carbon content and rapid quenching caused by the large heat sink of the channel head
 - Hardened surface was not completely removed by grinding

Higher hardness regions and variations in surface conditions led to weak weld bonding with less than design strength
