***San Onofre Unit 3
Replacement Steam Generator***

**Divider Plate-to-Channel Head Weld
Separation**

September 15, 2009

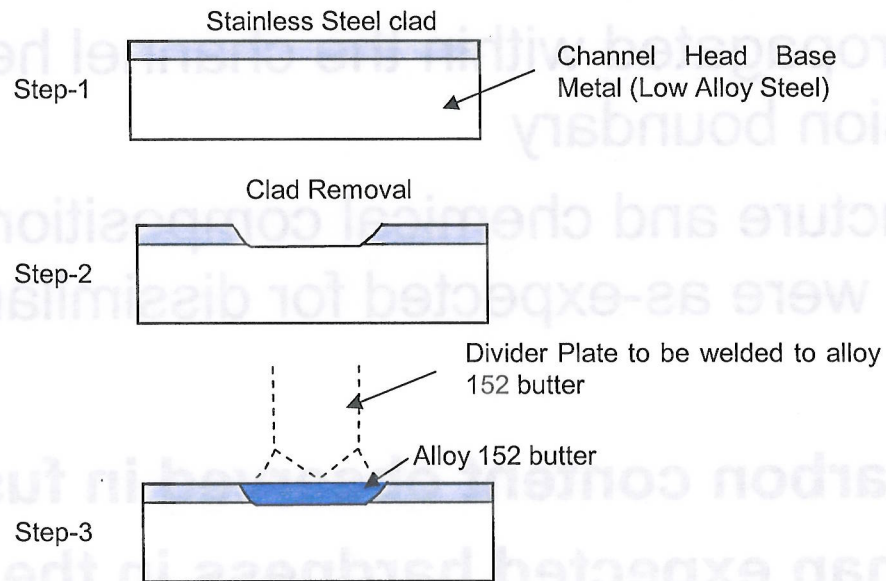
RSG Fabrication Process

- Entire channel head surface clad with stainless steel for corrosion protection
- Clad removed to prepare for Inconel buttering
- Air carbon-arc gouging (gouging) removed clad
 - Gouging the surface followed by grinding
 - Gouging process results in martensite formation and case hardening of surface from the increased carbon content and rapid quenching caused by the large heat sink of the channel head
 - Hardened surface was not completely removed by grinding

Higher hardness regions and variations in surface conditions led to weak weld bonding with less than design strength
