| 8.3.2 Impact (Free-Drop) Test Report

**Test Report:  
Drop Tests of the  
Alpha Omega Services Shipping Cask  
for Radioactive Material**

**Report No. 2007533 Rev 1  
May 25, 2007**

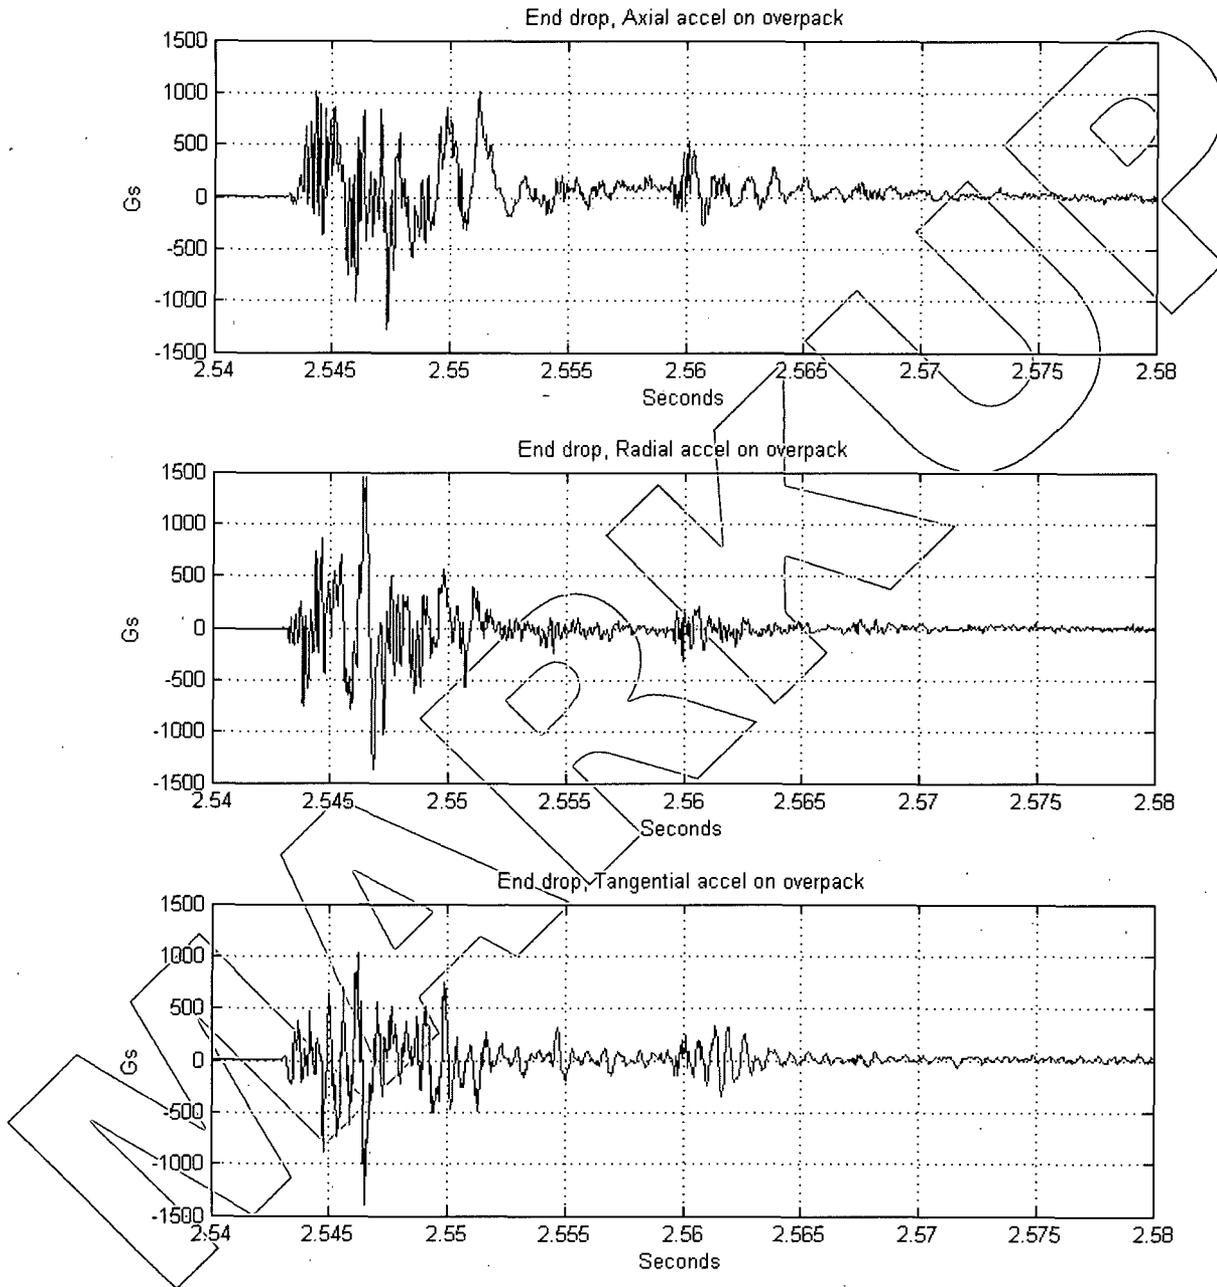
Figure 25 Accelerations measured on the impact limiter during the end drop.

Figure 25 shows data from the accelerometers on the impact limiter (Figure 13). Signals from all accelerometers showed a large amount of “ringing” or resonant response from the cask and impact limiter. This was not surprising considering the sharp blow applied to the package when it struck the steel plate of the target block. However the ringing makes it difficult to estimate the

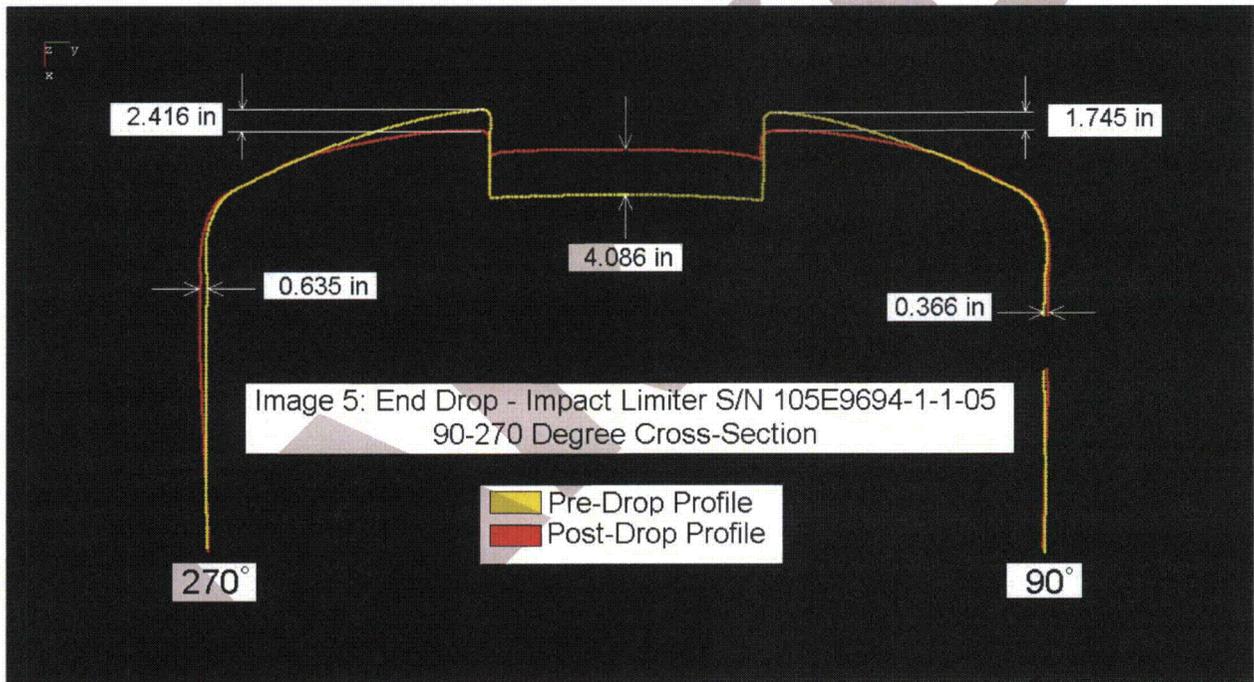
Figure 31 Profiles of the impact limiter before and after the end-drop

Figure 31 shows an overlay of the profile of the impact limiter before and after the end drop.

Figure 32 shows the impact end of the impact limiter after the end drop. The previously flat surface in the large center relief on the end of the impact limiter has been bulged out over four inches by the force from the cask transmitted through the foam. The weld around the edge of the relief has split over a small part of the circumference.

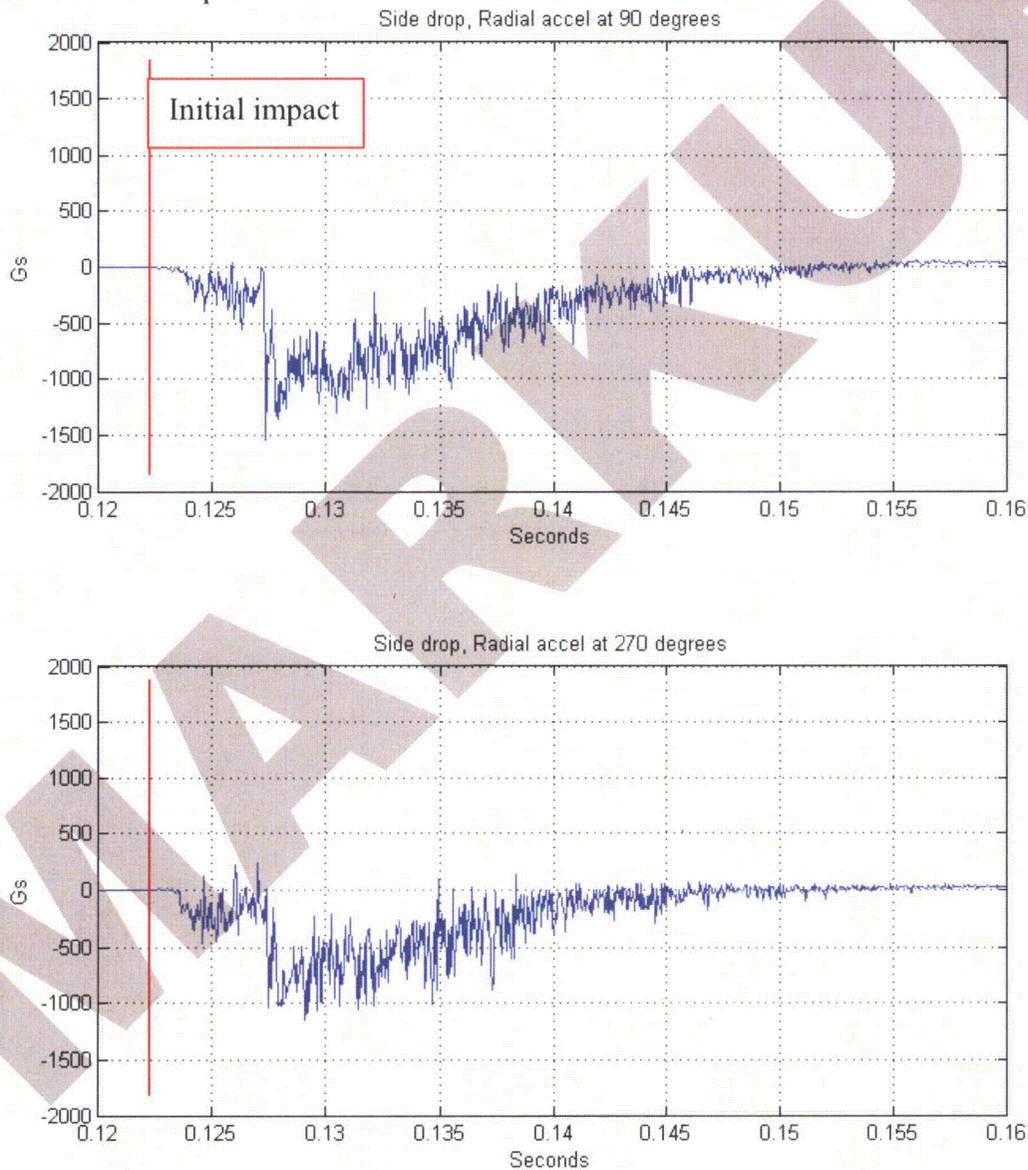
Figure 33 Vertical accelerations measured at impact inside the cask for the side drop.

For the side drop, the two radial accelerometers inside the cask were oriented in the vertical direction but facing in opposite directions. The sensor at 90 degrees azimuth faced downwards so upwards acceleration gave a negative signal. Figure 33 shows the signals from these two sensors during the initial impact.. Initial contact as sensed by the impact trigger was at time = 0.1217 seconds<sup>11</sup> in the plot.

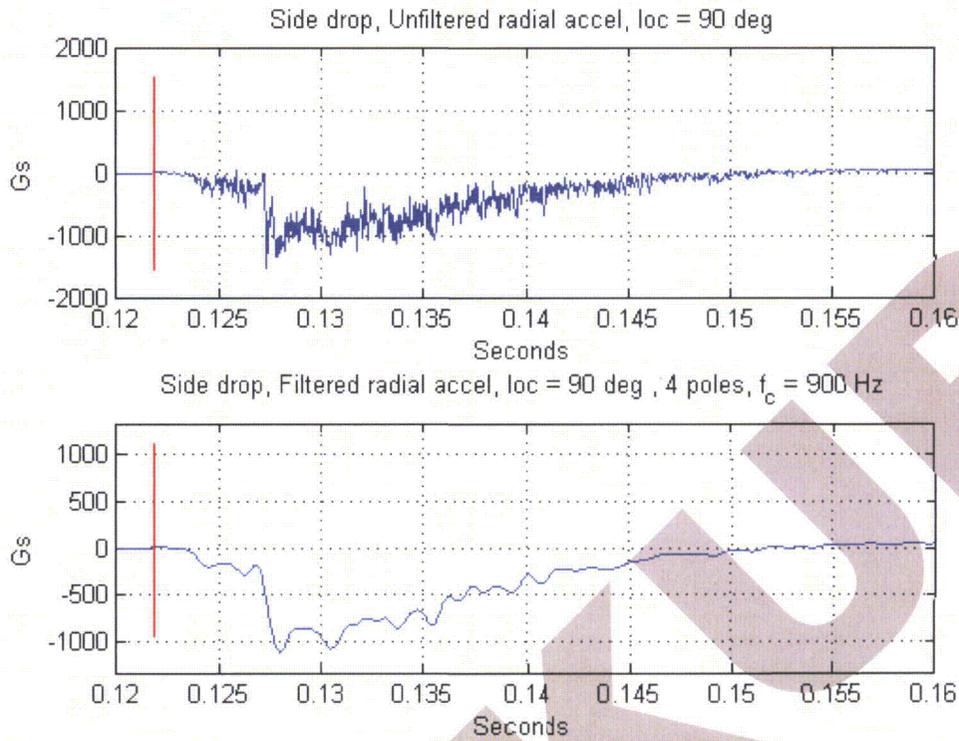
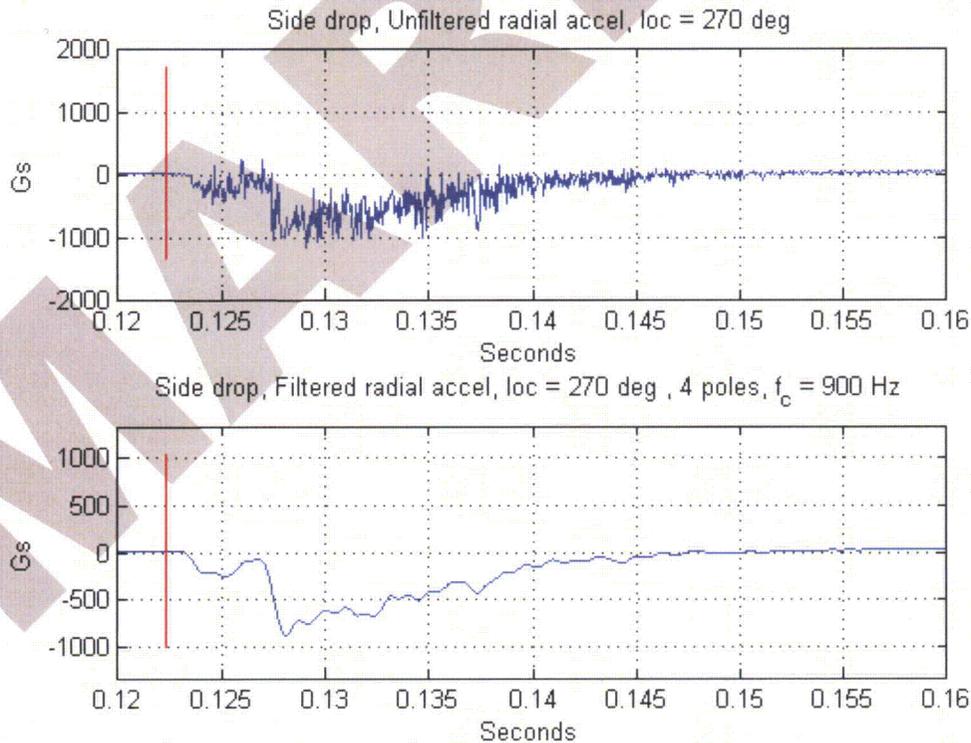
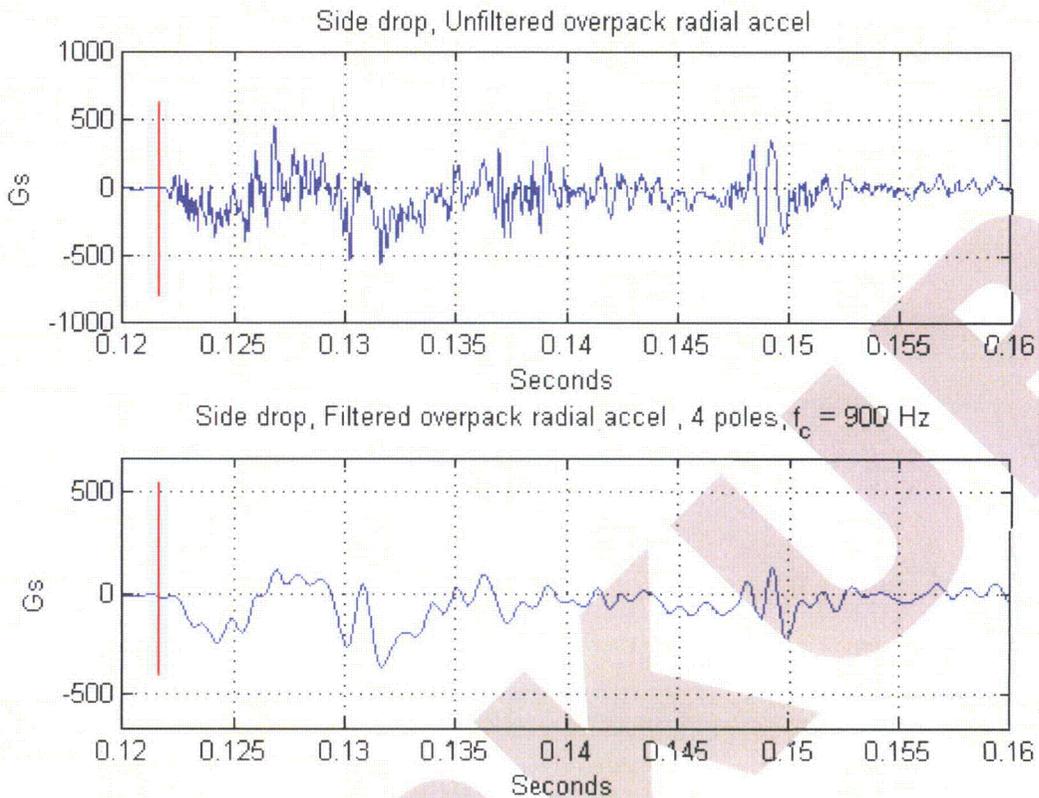
Figure 35, Figure 36, and Figure 37 show unfiltered and filtered signals from the three vertical accelerometers. The most important feature of these signals is that the in-cask accelerometers all over-ranged. They hit their 1000-g limit at time equal to approximately 0.127 seconds when a sudden negative step occurred in the acceleration. Typically with ICP accelerometers, the signal following such an over-range is not valid for a few tenths of a second. Thus, the only thing that can be said with certainty regarding cask acceleration is that it exceeded 1000 g's at the sensor location. This high level was probably caused by the secondary collisions between the heavy tungsten bricks of the shielding layer and the steel body of the cask. It's likely that the steel wool packing did not restrain the tungsten bricks as well in the radial and tangential directions as it did in the axial direction. This would account for the higher peak levels seen in the side drop compared to the end drop.

Referring to Figure 35 and Figure 36, the initial and secondary impacts are clear. The initial impact gives a peak acceleration of about 250 g's and the secondary impact gives over 1000 g's (over-range). However there is one unresolved anomaly in the data. Both radial signals go negative at both initial and secondary impacts. However the two sensors face in opposite directions and thus have signals of opposite polarities relative to upwards. One would expect their signals to be approximately the negatives of each other, at least during the initial smaller impact. At present there is no explanation for this pattern, which also occurred in the slap-down drop.

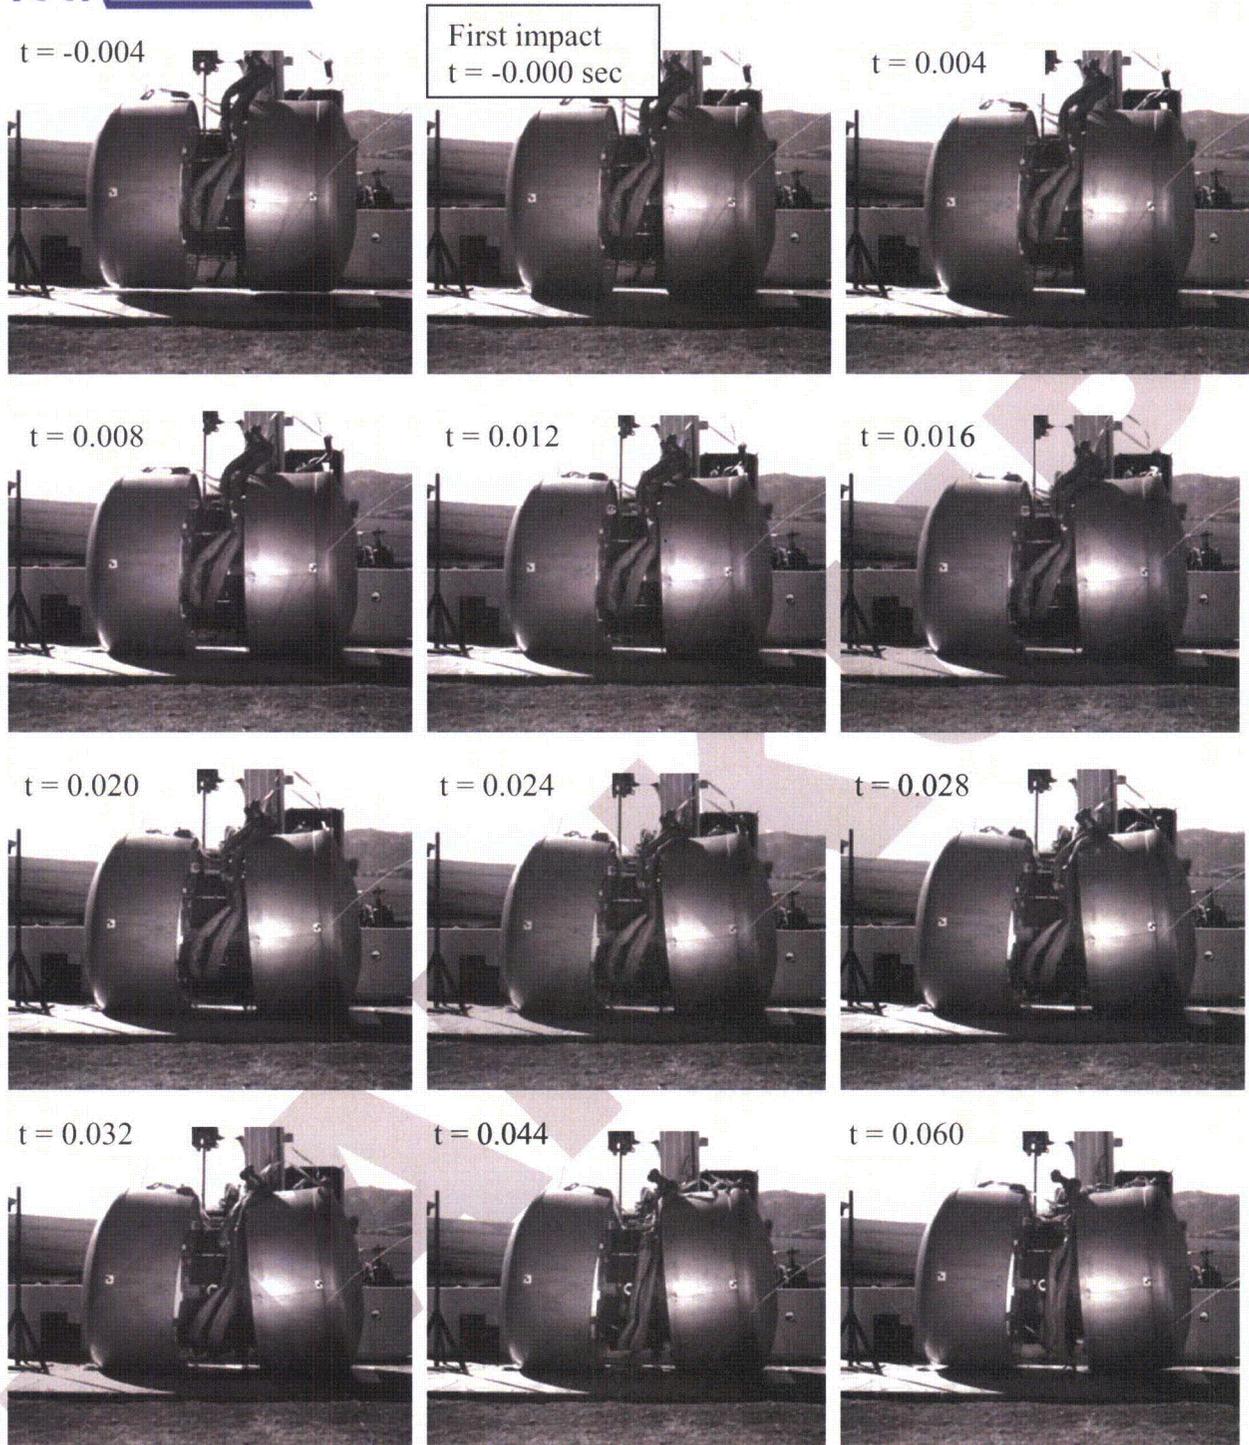
Figure 39 Frames from high-speed video of side drop

Figure 39 shows frames from one of the three high-speed video cameras. The impact time denoted as  $t = 0.000$  seconds in the video frames corresponds to  $t = 0.1217$  seconds in the acceleration time histories. The video sequence shows clearly how the lower sides of the two impact limiters pulled away from each other at impact, causing the lower turnbuckles to fail. This may have been due to a wedging action of the chamfered ends of the cask against the conical section of the mating recess in the impact limiters. It might also have been caused by the centroid of the impact force against the lowest surface of each impact limiter being outboard of the cask ends, causing a rotational moment on the impact limiters.

Following the initial impact, the package bounced to a height of about 17 inches, indicating that over 95% of the kinetic energy had been dissipated.

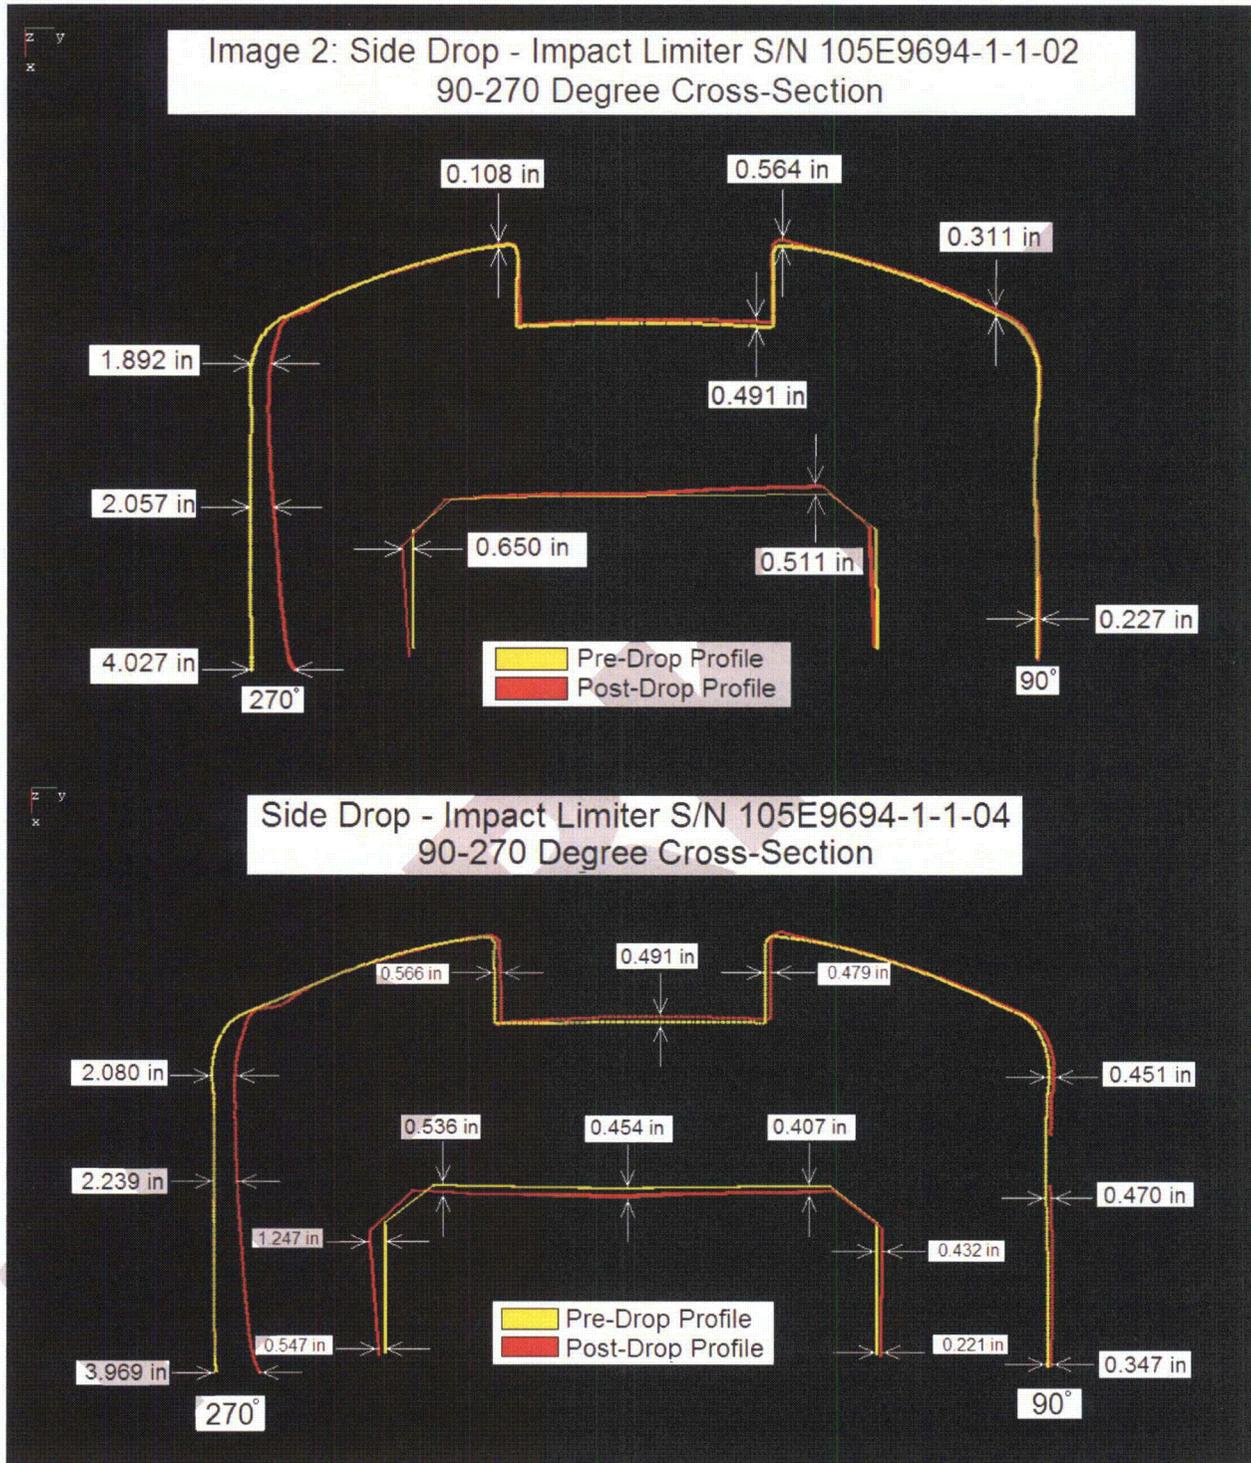
Figure 42 Profiles of the impact limiters before and after the side drop.

Figure 41 shows one of the impact limiters after removal from the cask. One of the welds between the conical and cylindrical sections has split open, revealing the energy absorbing foam within. Figure 42 shows an overlay of the measured impact limiter profiles before and after the side drop.

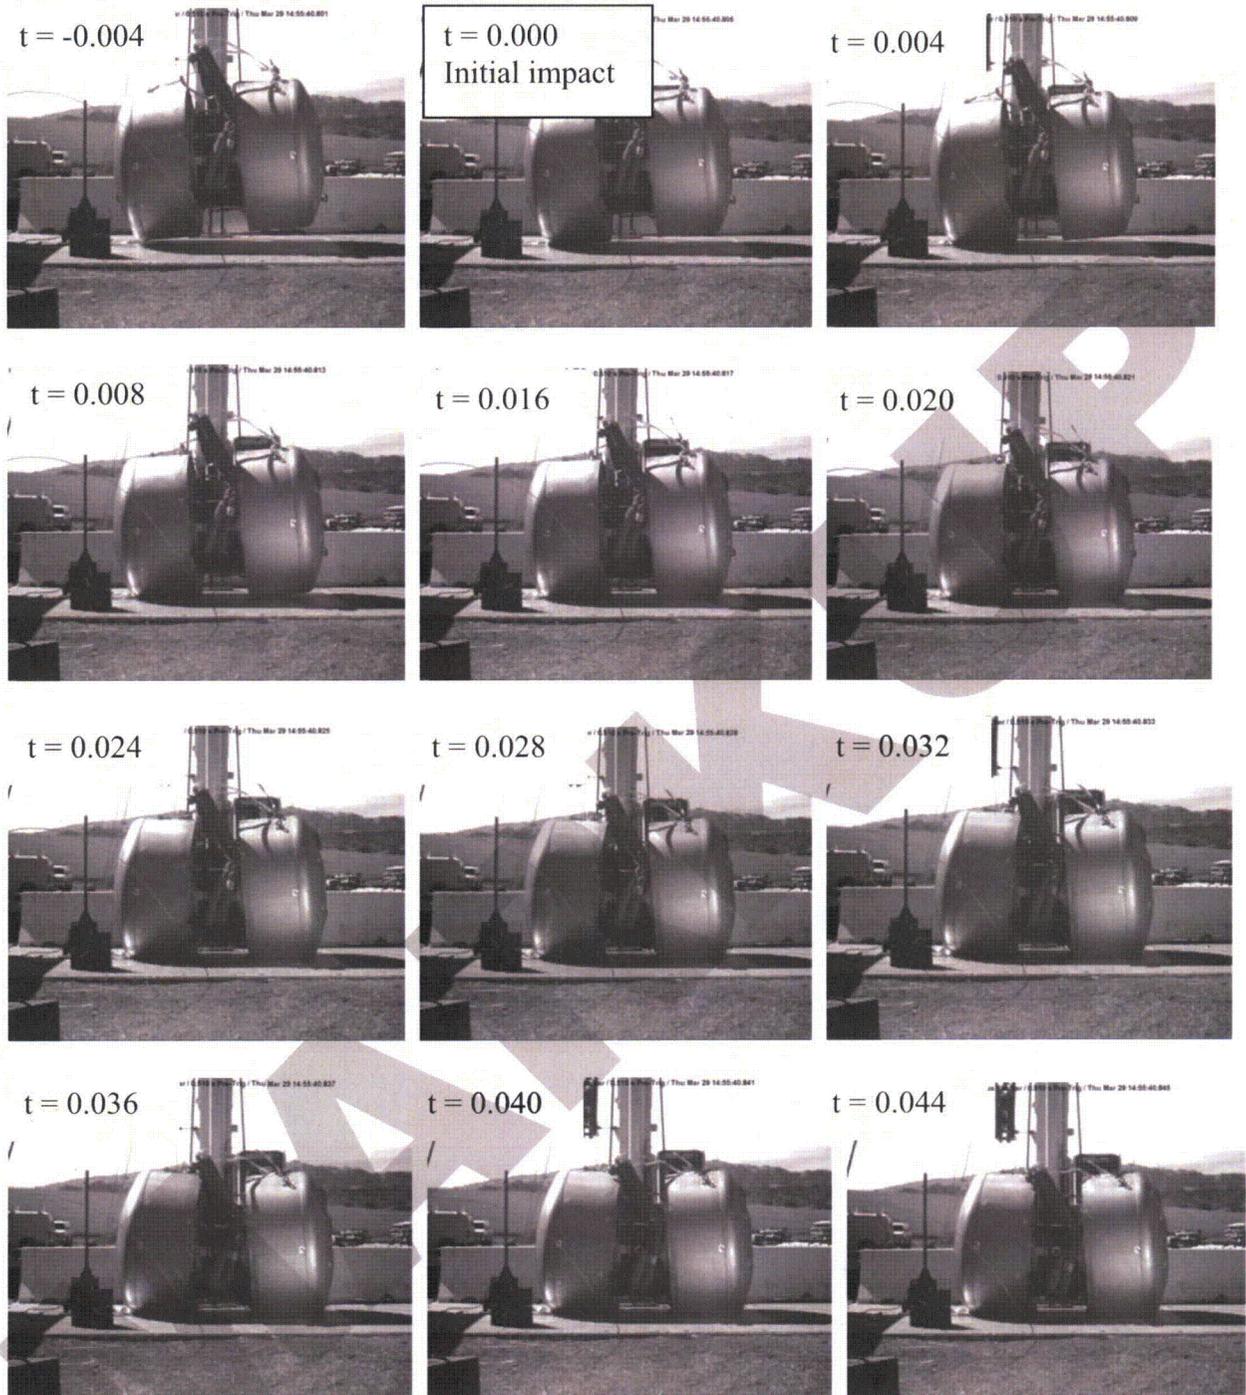
Figure 49 Frames from high-speed video of slap-down drop.

Figure 49 shows frames from one of the three high-speed video cameras from the slap-down drop. The impact time denoted as  $t = 0.000$  seconds in the figure corresponds to  $t = 0.0746$  seconds in the acceleration time histories. The turnbuckles holding the impact limiters for this

drop used heavier clevis pins which did not break on impact. However the upper turnbuckles buckled which caused them to become shorter so there was still considerable relative rotation between the two impact limiters, as evident in the video frames. Figure 50 shows the uppermost turnbuckle following the drop.

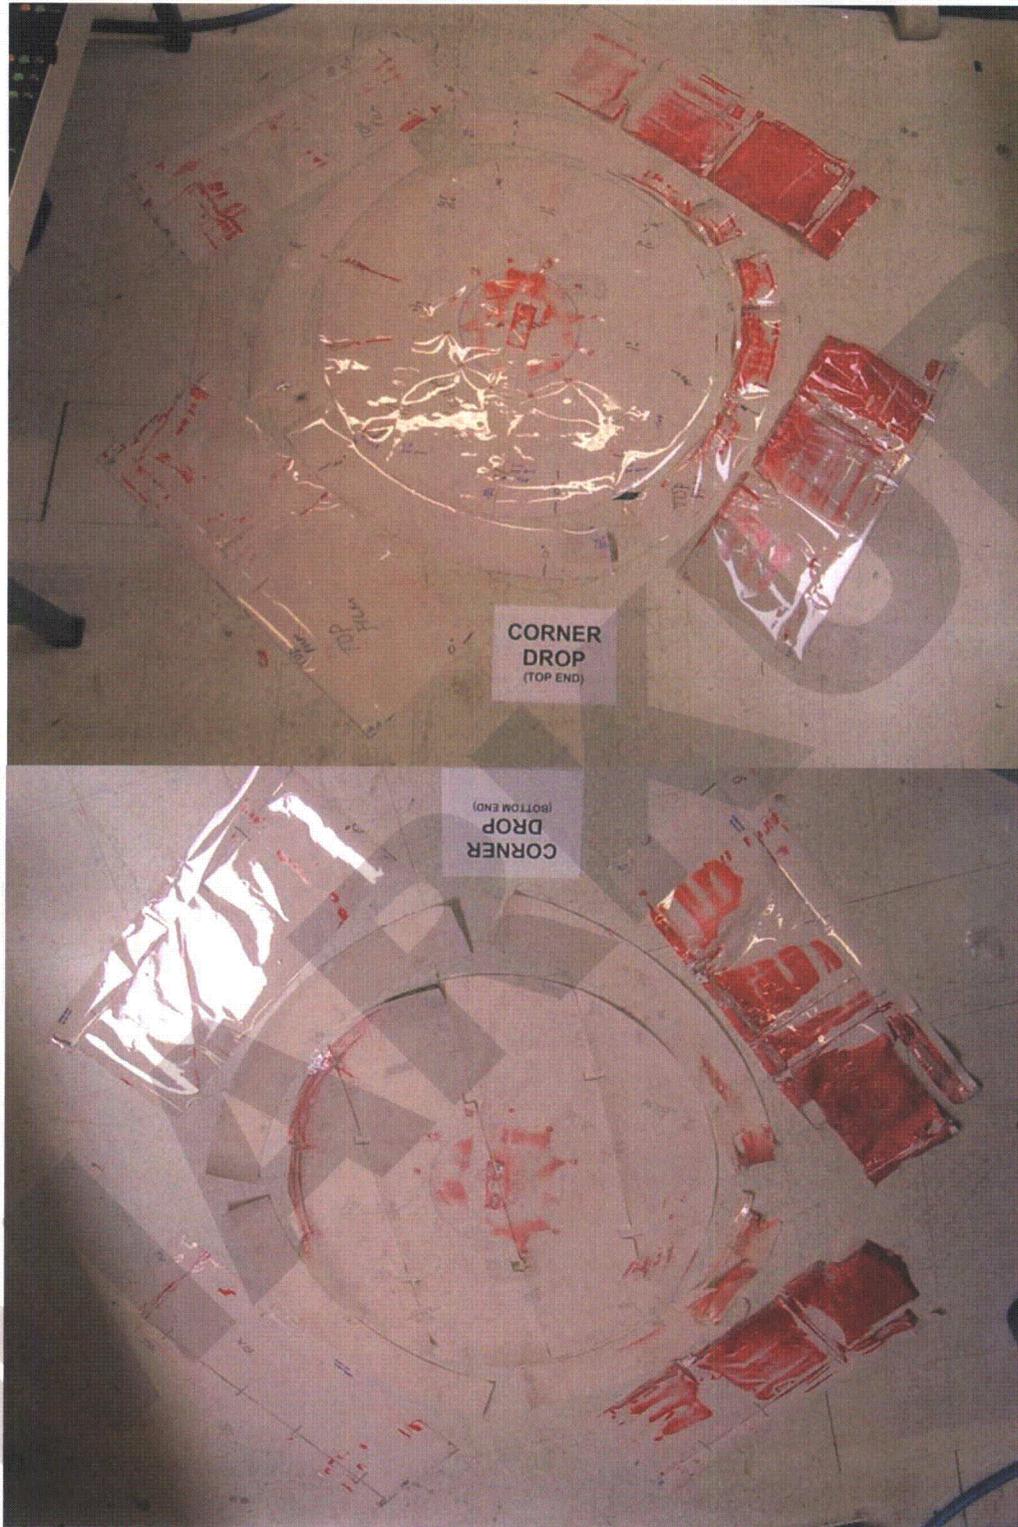
Figure 52 Pressure sensing film removed from the cask and impact limiters after the slap-down drop.

Figure 52 shows the pressure sensing film removed after the slap-down drop. The pattern of pressure between the cask and impact limiter is quite similar to that from the side drop.

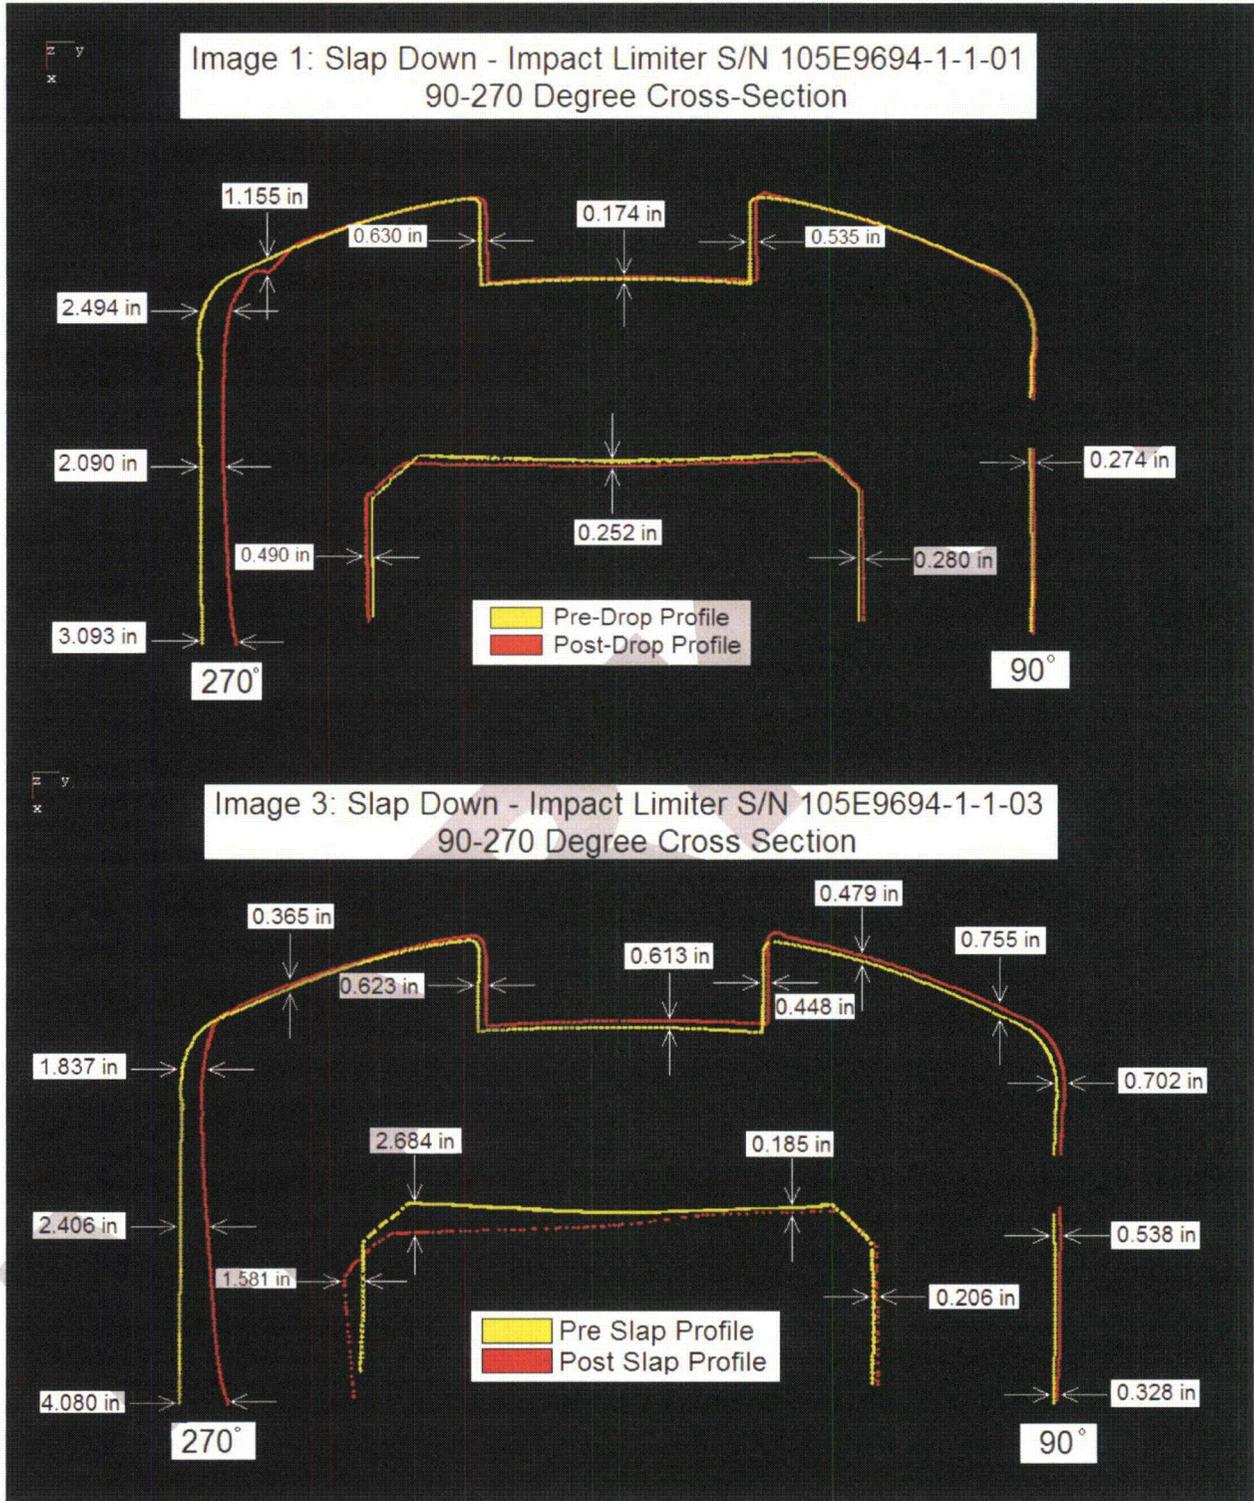
Figure 54 Profiles of the higher (top) and lower (bottom) impact limiters before and after the slap-down drop.

Figure 53 shows the deformation suffered by the impact limiter that was on the higher end of the cask. Figure 54 shows overlays of the measured impact limiter profiles before and after the slap-down drop. The lower part of the figure shows how much the inner diameter of the impact limiter was deformed when it rotated relative to the cask on impact.
