Unit 1 Cook Nuclear Plant Turbine Event Status Report

***Nuclear Regulatory Commission
Presentation
November 2, 2009***

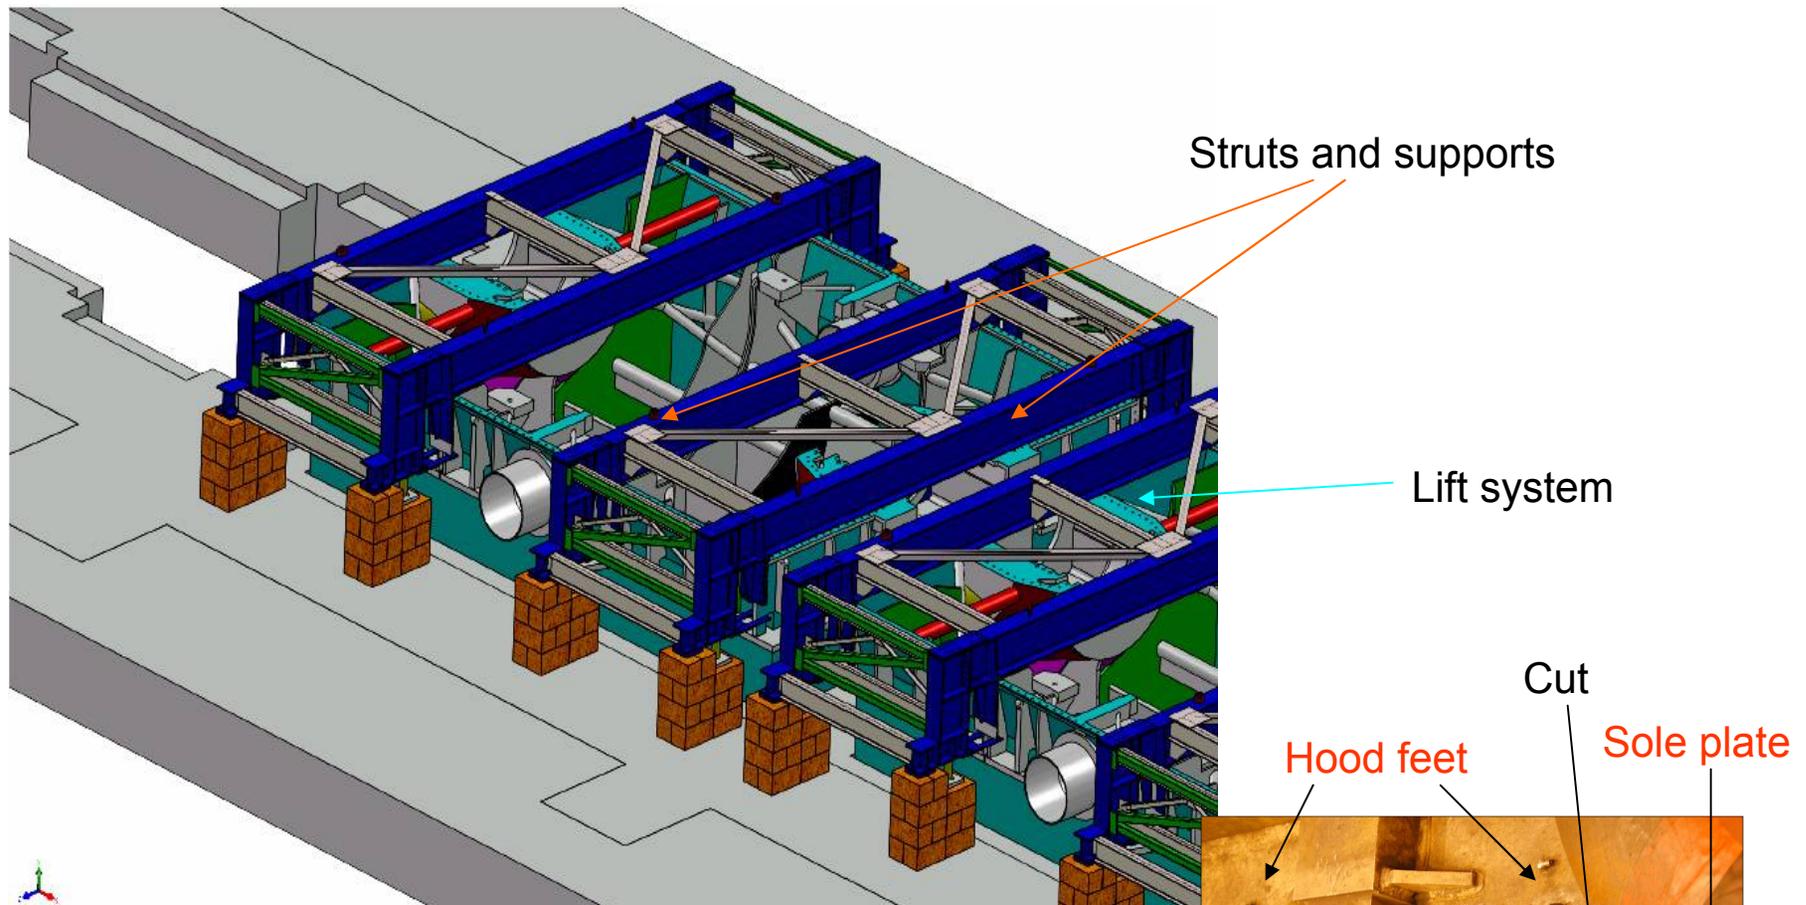
Lifting LEH's

Issue on first lift attempt:

- Sole plates between hoods were welded, due to event, to bottom of LEH feet. Had to be cut without effecting hood supports.
