VIRGINIA ELECTRIC AND POWER COMPANY SURRY POWER STATION UNIT 1 STEAM GENERATOR TUBE INSERVICE INSPECTION REPORT FOR THE 2009 REFUELING OUTAGE

SURRY UNIT 1 180-DAY NRC REPORT REGARDING STEAM GENERATOR TUBE INSPECTION PER TECHNICAL SPECIFICATION 6.6.A.3

180-DAY NRC REPORT REGARDING STEAM GENERATOR TUBE INSPECTION SURRY UNIT 1 - SPRING 2009 END-OF-CYCLE 22 (EOC22) / REPLACEMENT-END-OF-CYCLE 17 (REOC17)

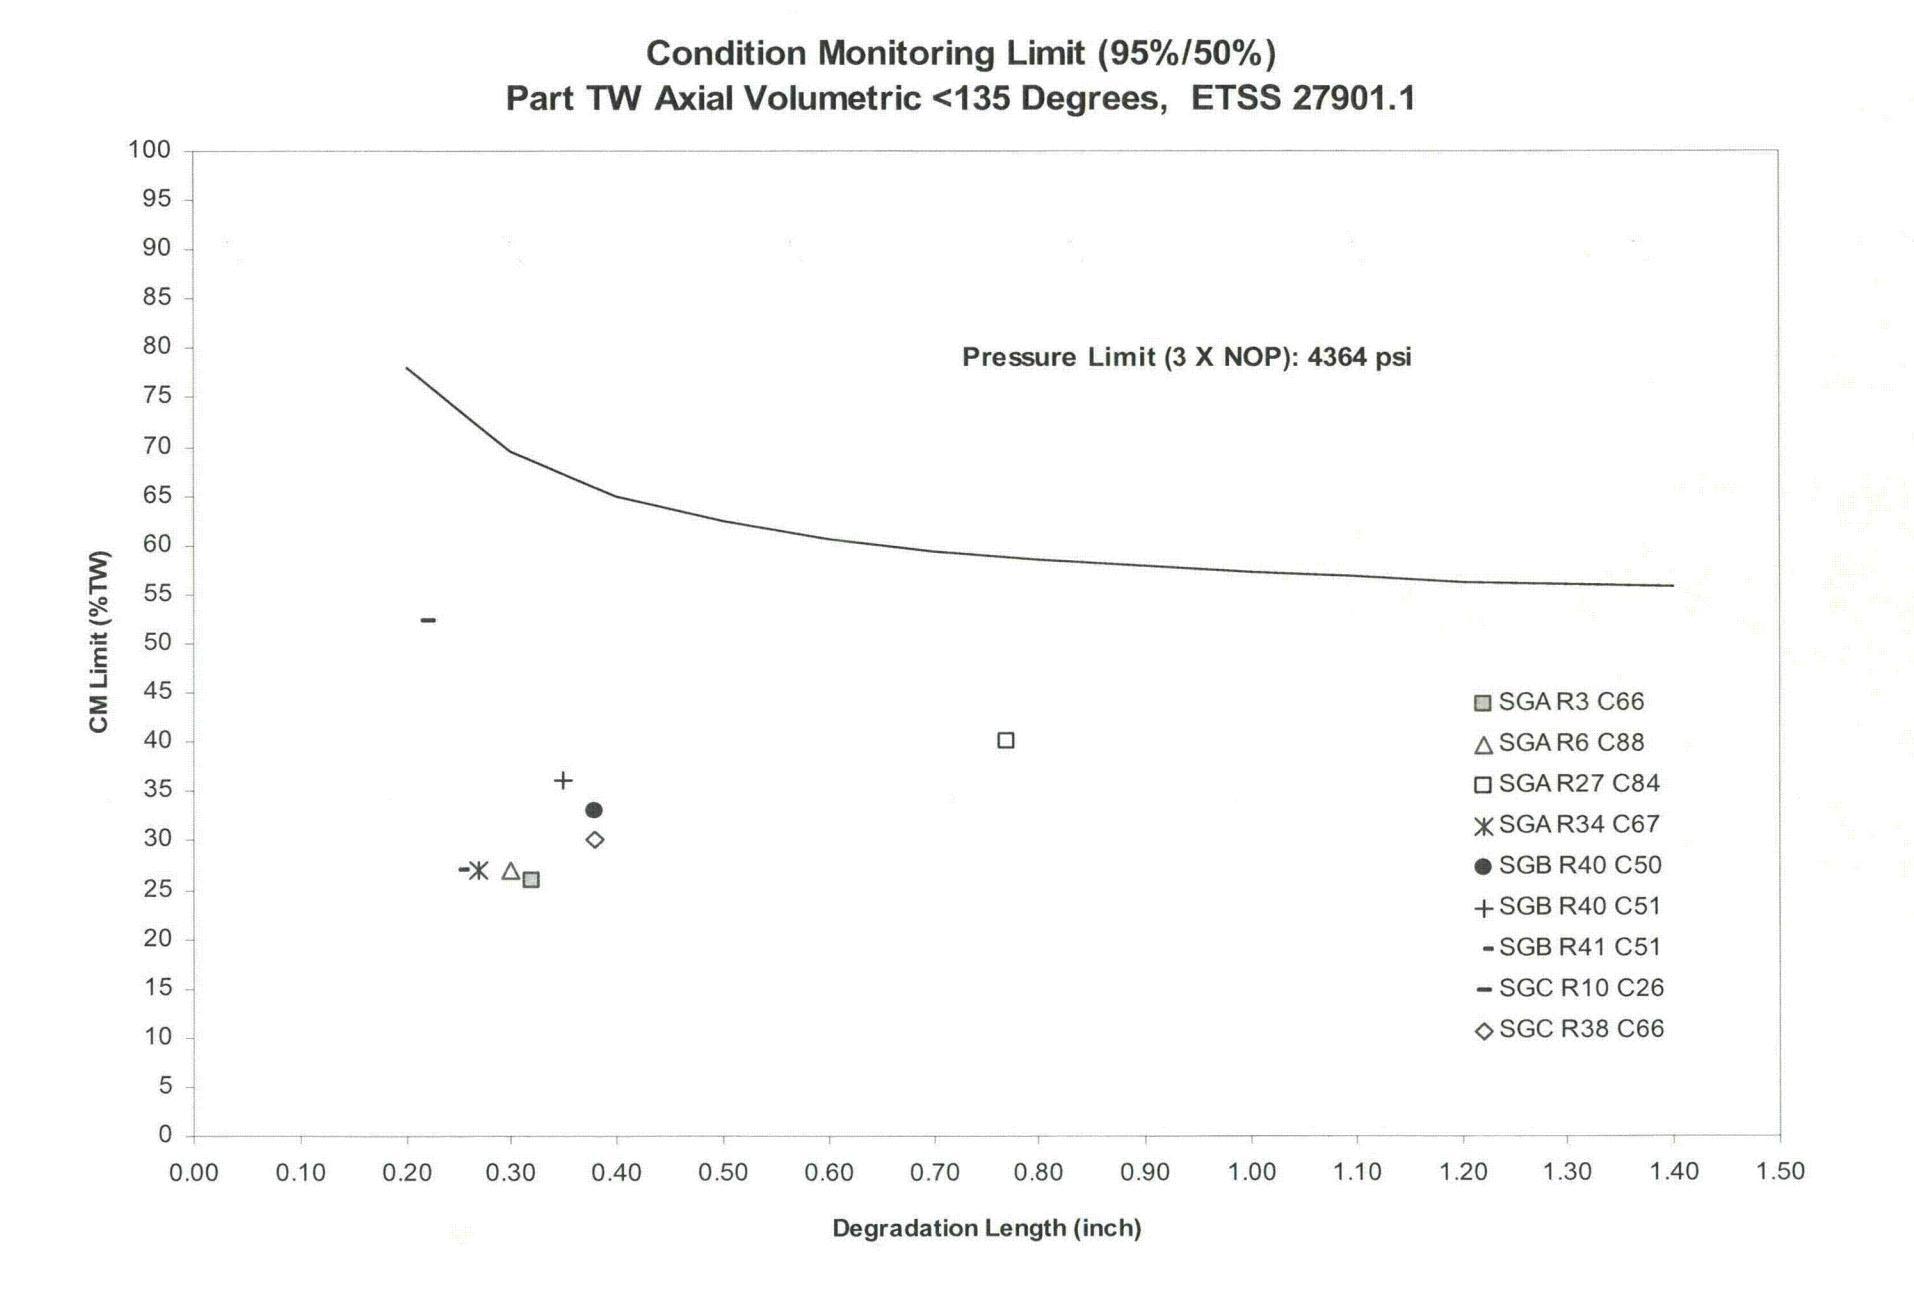
Figure 2

TSP wear indication in SG "A" R2 C57 reported as 14%TW X 0.29 inches axially using ETSS 96910.1. This flaw is the same depth now as it was when initially detected in 2006. Applicable NDE sizing uncertainty with respect to this flaw is that associated with ETSS 96910.1:

In summary, none of the reported non-AVB-wear volumetric flaws exceed the condition monitoring structural performance criteria set forth by the Surry Technical Specifications. Based on this it is also concluded that none of these flaws would have leaked under accident conditions.
