#### INTERIM REPORT ON THERMOSTATIC VALVE FAILURE ON PALO VERDE EDG

**Report No. 10CFR21-0098**  
Rev. 0: 12/01/09

**10CFR21 REPORTING OF DEFECTS  
AND NON-COMPLIANCE**

COMPONENT: Amot thermostatic valve element  
P/N: 9760X

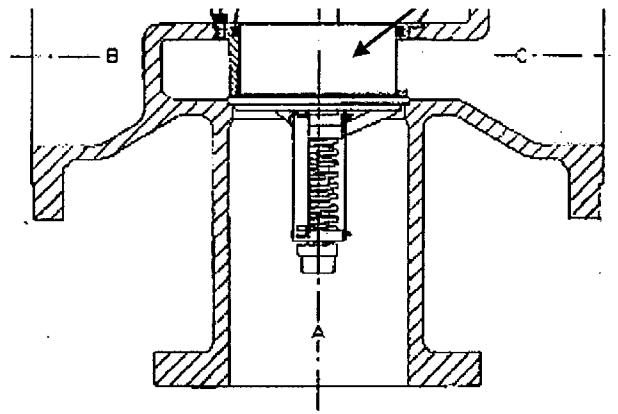
**FIGURE 1: AMOT THERMOSTATIC VALVE**

The Palo Verde failure analysis determined that one of two elements within the valve was defective. The element failure was attributed to wax leakage past the diaphragm seal on one of two power pills within the element. Evidence of mechanical binding of the piston is believed to have caused the wax leakage. If the piston was jammed, the expanding wax could have over-pressurized the diaphragm seal leading to wax leakage. The failure analysis noted the following to support piston binding:

- The piston was initially difficult to remove from its guide tube.
- A gouge was observed on the piston surface.
- The rubber plug within the power pill exhibited brass machining chip debris.

- The primary cause of the failure is believed to be the gouge found in the pill stem. The gouge could have occurred during the conversion process as the stem is removed and handled at that time.

Each valve uses 2 thermostatic elements, Amot type 9760X (item 2 in Figure 1). The element being investigated for the Palo Verde application has a nominal temperature setting of 160°F and therefore the element part number is 9760X-160.

The element failure at Palo Verde is considered to be an isolated incident related to a gouge in the pill stem. Thus, there is no recommended corrective action for users of the Amot 9760X element.
