August 22, 1985
IPN-85-44

Subject: Indian Point 3 Nuclear Power Plant
Docket No. 50-286
Steam Generator Eddy Current Testing Results

INDIAN POINT 3
RESULTS OF STEAM GENERATOR INSPECTIONS
AGENDA

AUGUST 20, 1985

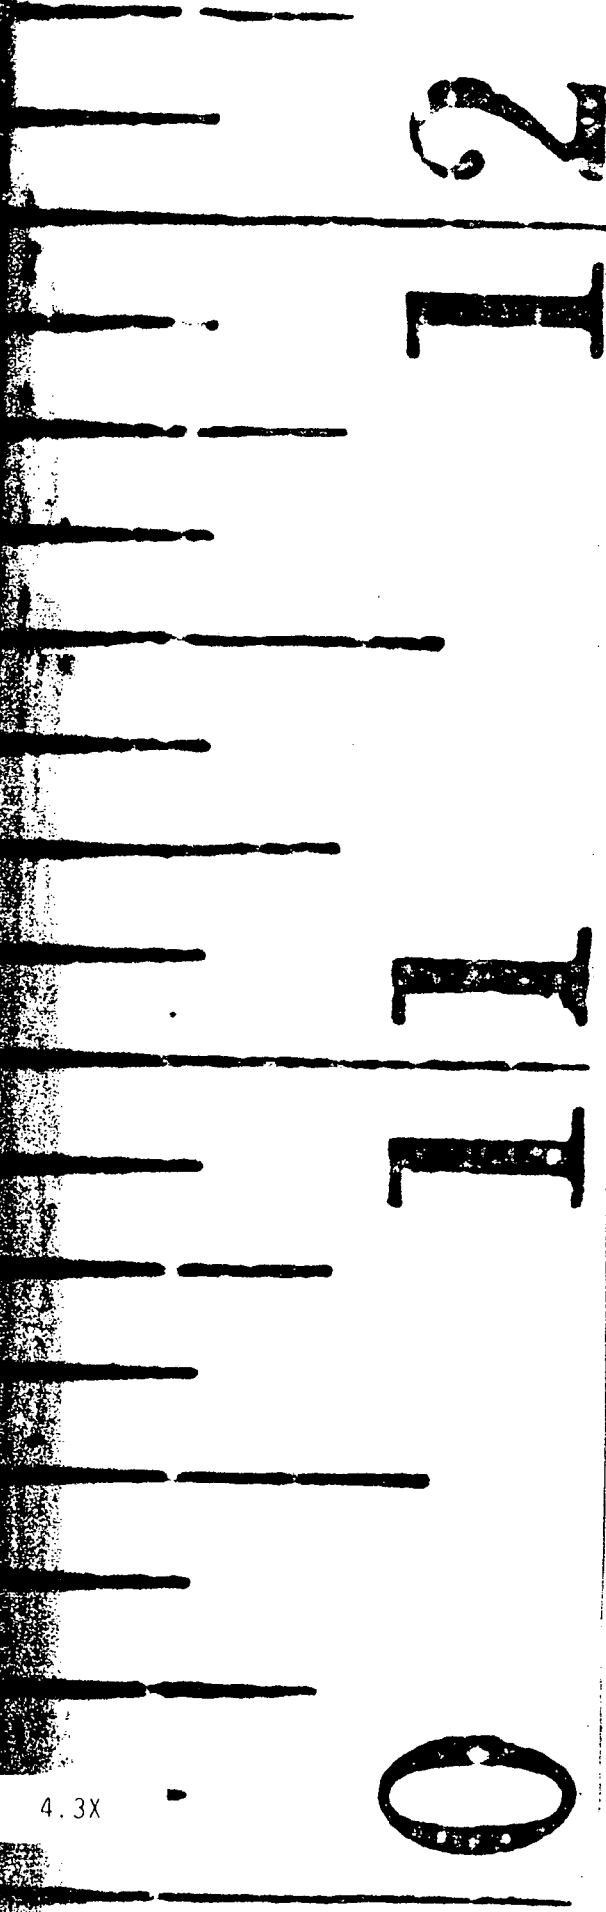
- o PRINCIPAL CORROSION MECHANISM ON THE TUBES IS PITTING.
- o ONE LARGER INDICATION ON EACH TUBE IS DUE TO WASTAGE.
- o NO CRACKING WAS FOUND.
- o CHARACTERISTICS OF CORROSION DEPOSITS INCLUDE
 - CHROMIUM RICH OXIDE
 - SULFUR
 - COPPER
 - CHLORIDE NOT IDENTIFIED

FIGURE 1. COLOR OPTICAL PHOTOGRAPH OF THE PRINCIPAL DEFECT ON TUBE R30C46 4.3X
