The MacArthur Maze and Newhall Pass Fires and Their Implications for Spent Fuel Transport - 10536

Christopher S. Bajwa, Earl. P. Easton
U.S. Nuclear Regulatory Commission
Washington, DC 20555

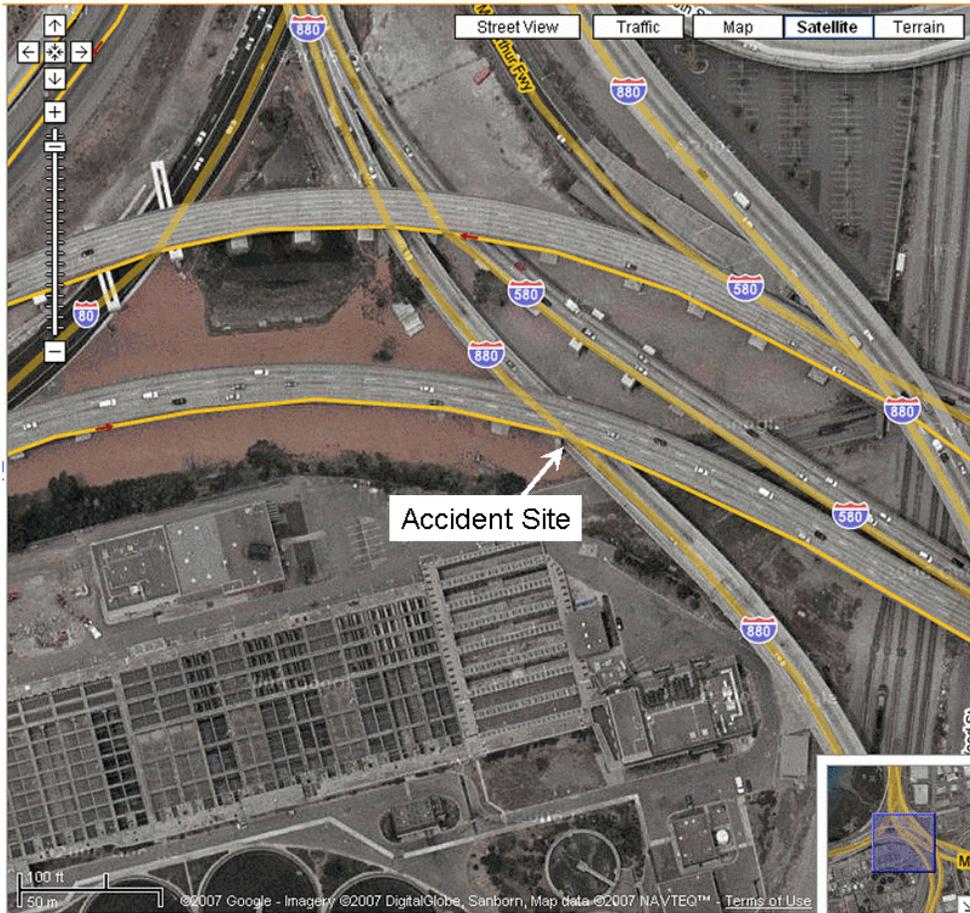
The main portion of the fire, fueled by the gasoline leaking from the tanker, spread along a section of the I-880 roadway. Some of the gasoline went through the scupper drain on I-880 and burned on the ground around an I-880 roadway support pillar. The fire on the I-880 roadway heated the steel girders on the underside of the of the I-580 overpass to temperatures where the steel strength was reduced and was insufficient to support the weight of the elevated roadway. The I-580 overpass collapsed onto the I-880 roadway about 17 minutes after the fire started, based on surveillance video taken from a water treatment plant adjacent to the highway interchange. An aerial photograph of the area with the accident site identified is shown in Figure 1 [2]. A photograph of the scene after the fire was extinguished is shown in Figure 2¹ [3].

Fig. 1. Aerial photograph of I-880 and I-580 Interchange

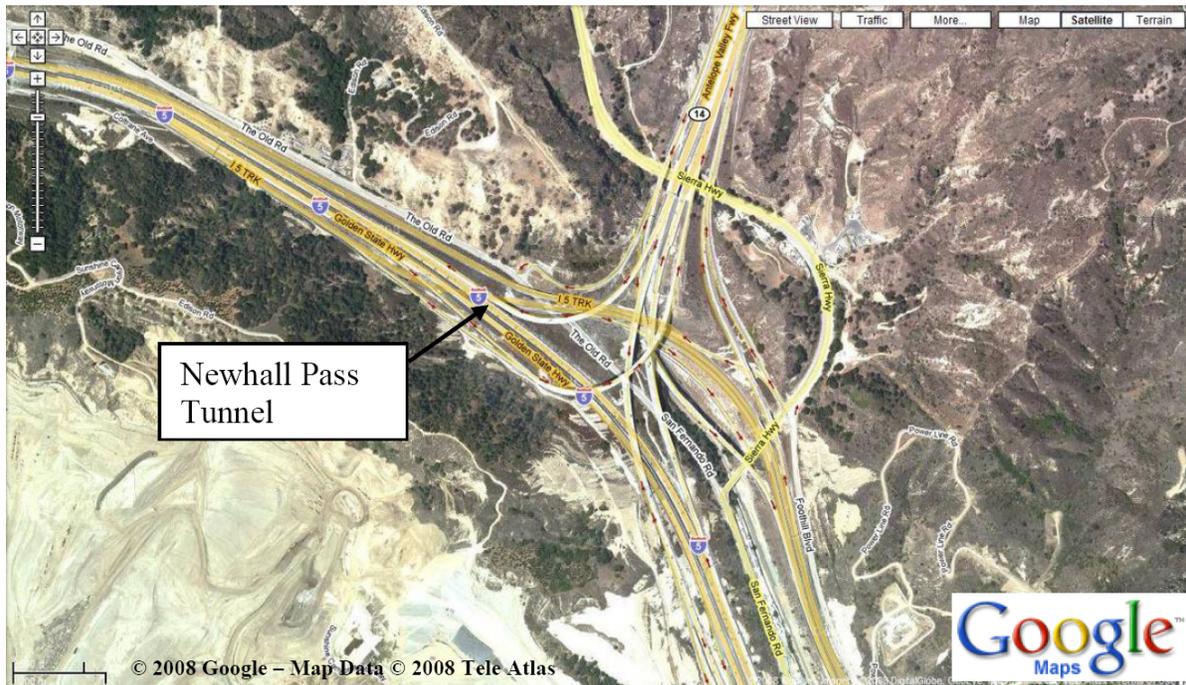
On October 12, 2007, a major fire occurred in the Newhall Pass tunnel near Santa Clarita, California at approximately 10:40 p.m. The Newhall Pass tunnel is part of the Interstate 5 southbound truck lane as it passes below Interstate 5 main lanes. The tunnel is a 165.8-m [544-ft] long reinforced concrete boxed girder, which was built in 1971. The tunnel fire was a result of a truck accident that led to a 34-vehicle pile-up in and around the Newhall Pass tunnel. One of the vehicles caught on fire and ignited the other vehicles in the tunnel. It was reported that the fire appeared to emanate from both ends of the tunnel within 15 minutes of its start (See Figure 3). An aerial map of Newhall Pass tunnel is shown in Figures 4 and 5.

Fig. 4. Aerial Photograph of Interstate 5 and Highway 14 Interchange

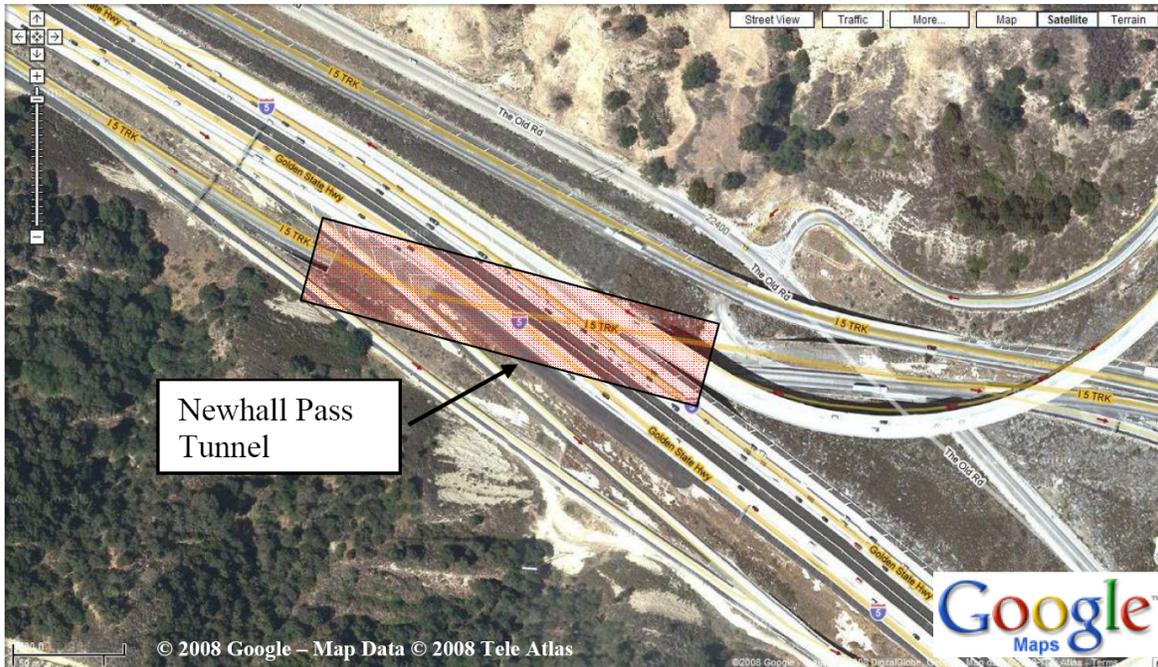
Fig. 5. Aerial Photograph of Interstate 5 and Highway 14 Interchange. The Accident Initiated on the Exit (Southwest Side) of the Tunnel.
