TECHNICAL REPORT NO. 7164

METALLURGICAL EXAMINATION OF SHELL
GIRTH WELD COUPON FROM
STEAM GENERATOR 32
INDIAN POINT 3
NUCLEAR POWER PLANT

POWER AUTHORITY OF THE STATE OF NEW YORK
10 COLUMBUS CIRCLE
NEW YORK, NEW YORK

OCTOBER 19, 1982

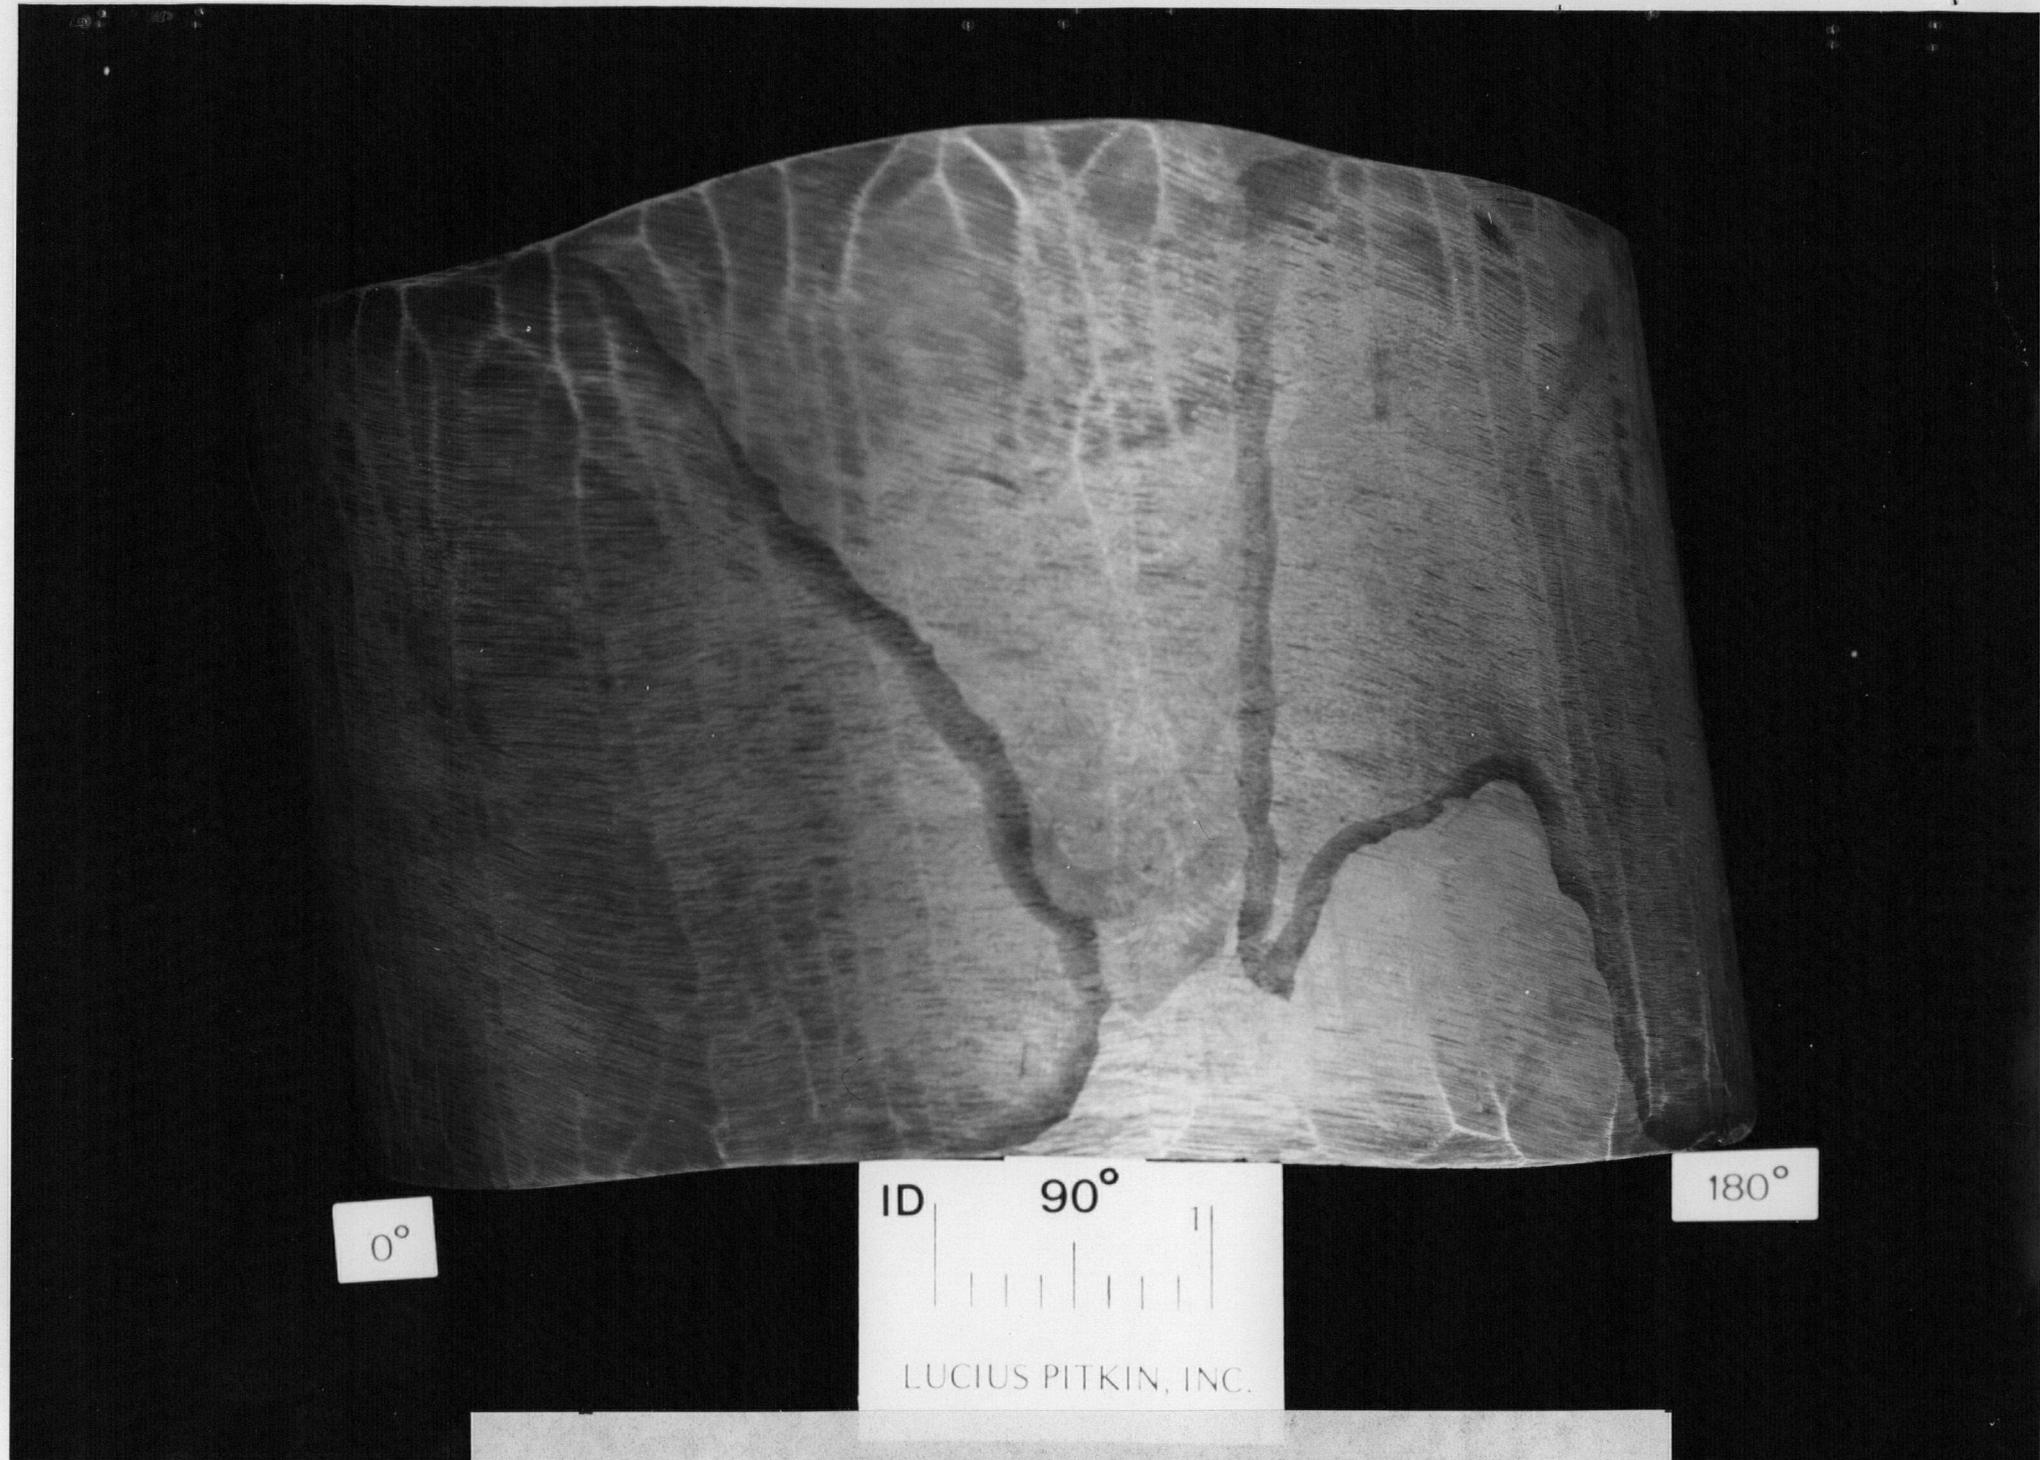
Fig. 11 PERIPHERY OF 6-IN. DIAMETER COUPON - AFTER
LIGHT ETCHING

Light etching of the periphery of the coupon revealed the presence of a major weld repair at the root or inner surface of the circumferential weld. The weld repair, which was about 1-1/2 in. deep by 2 in. wide, was confined to the transition cone and extended across the diameter of the coupon. Figs. 11 through 14 are photomicrographs showing the periphery of the lightly etched coupon at 90-degree intervals. One of the the inner surface cracks which had extended into the periphery of the coupon is shown in Fig. 15.

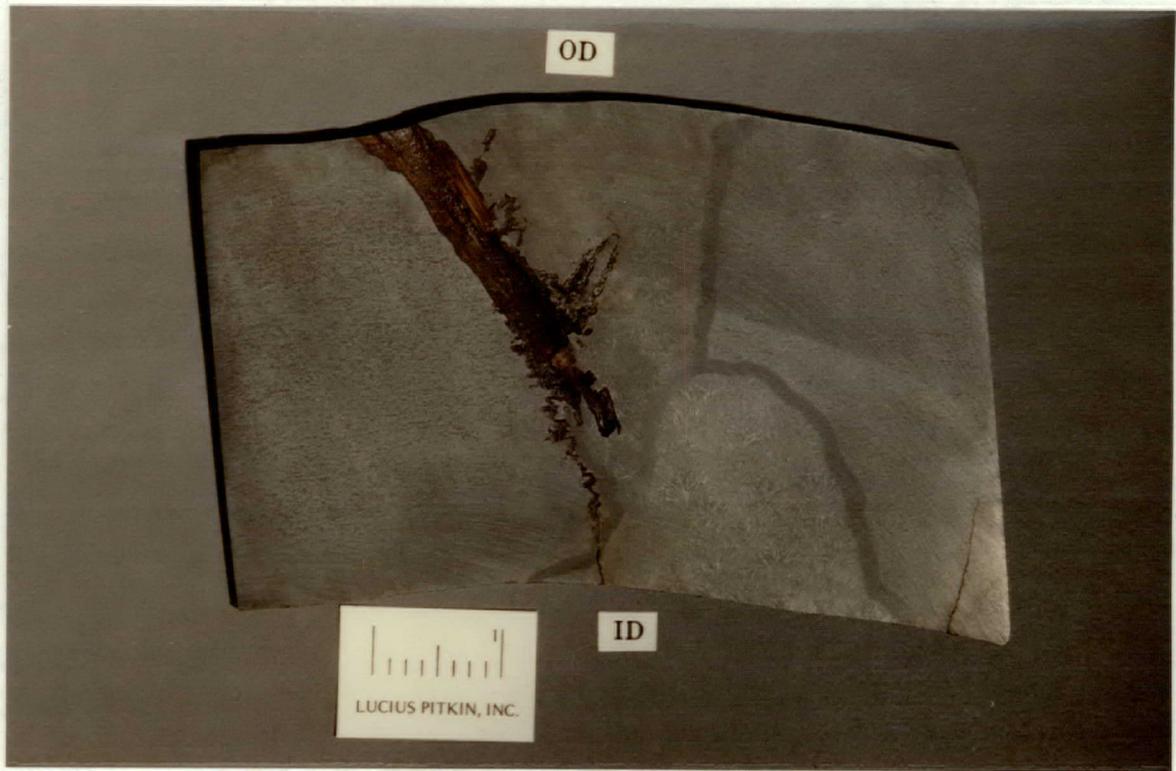
Fig. 20

fibrous material was the remnants of a wood plug inserted into the hole by plant personnel after the unit was placed in cold shutdown. No evidence of charring or coking was associated with the wood-like material. Fig. 19 is a photomicrograph showing the ground surface. Figs. 20 through 23 are color photographs showing the longitudinal section containing the through-thickness discontinuity.

COLOR PHOTOMACROGRAPH OF VERTICAL CROSS-SECTION
INTERSECTING THROUGH-THICKNESS DISCONTINUITY

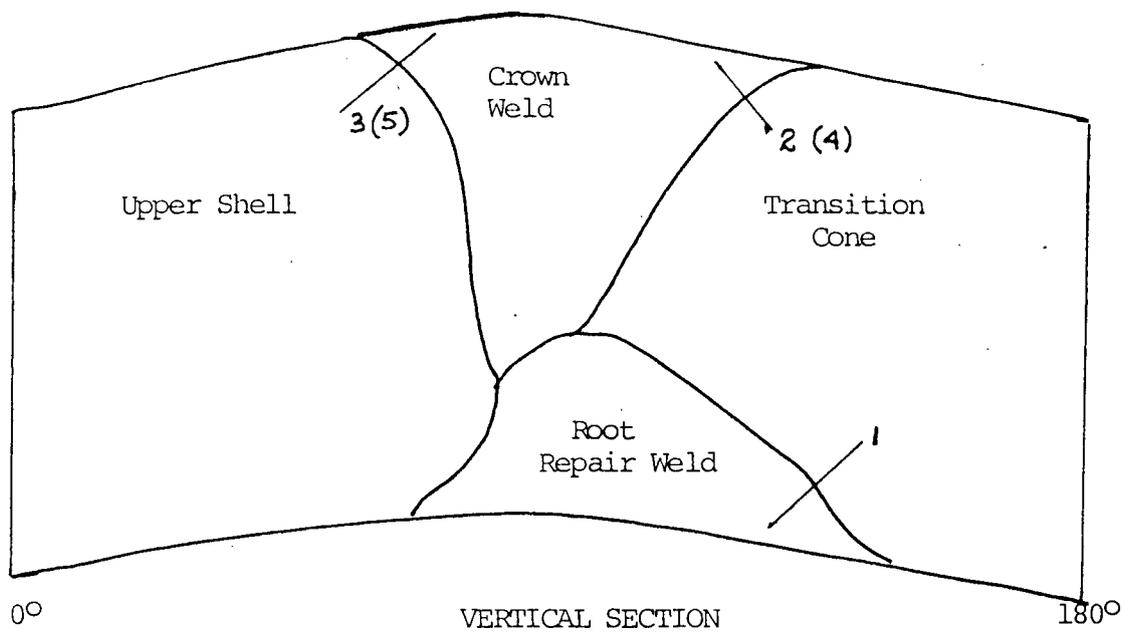
Fig. 25 KNOOP MICROHARDNESS SURVEY (CONVERTED TO ROCKWELL.) AS-RECEIVED AND LABORATORY HEAT-TREATED SPECIMENS

Results of the Knoop microhardness survey showed the heat-affected zone in the three areas to be inordinately high at KHN 390 to 425. This converts to Rockwell C 39 to 42. The high hardness exhibited by the girth weld heat-affected zone is indicative of insufficient stress relief which would also imply the presence of residual stresses (see Fig. 25).

Location and results of the microhardness surveys are shown in Fig. 25. The heat-affected zone microstructure for the

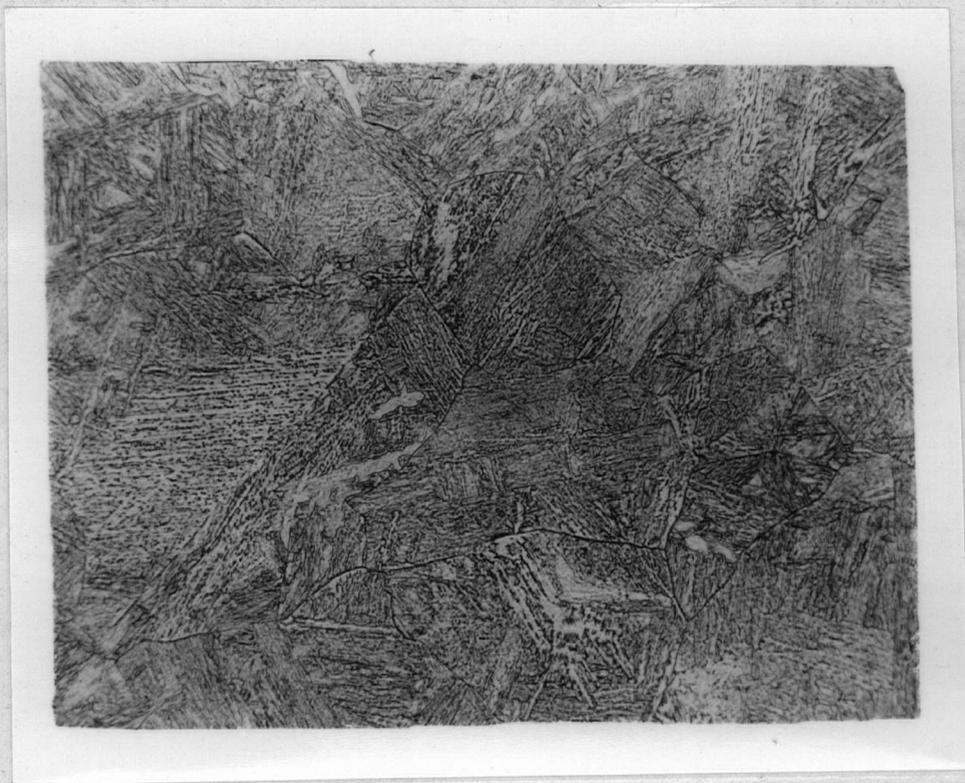
Fig. 25B

HEAT-AFFECTED ZONE MICROSTRUCTURE - 400 X
1000 F ONE HOUR

Photomicrograph showing the heat-affected zone microstructure exhibited by the crown weld/upper shell after laboratory heat treating at 1000 F for one hour. The microstructure shown here consists of uniformly tempered martensite and had a hardness of Rockwell C 31-32.

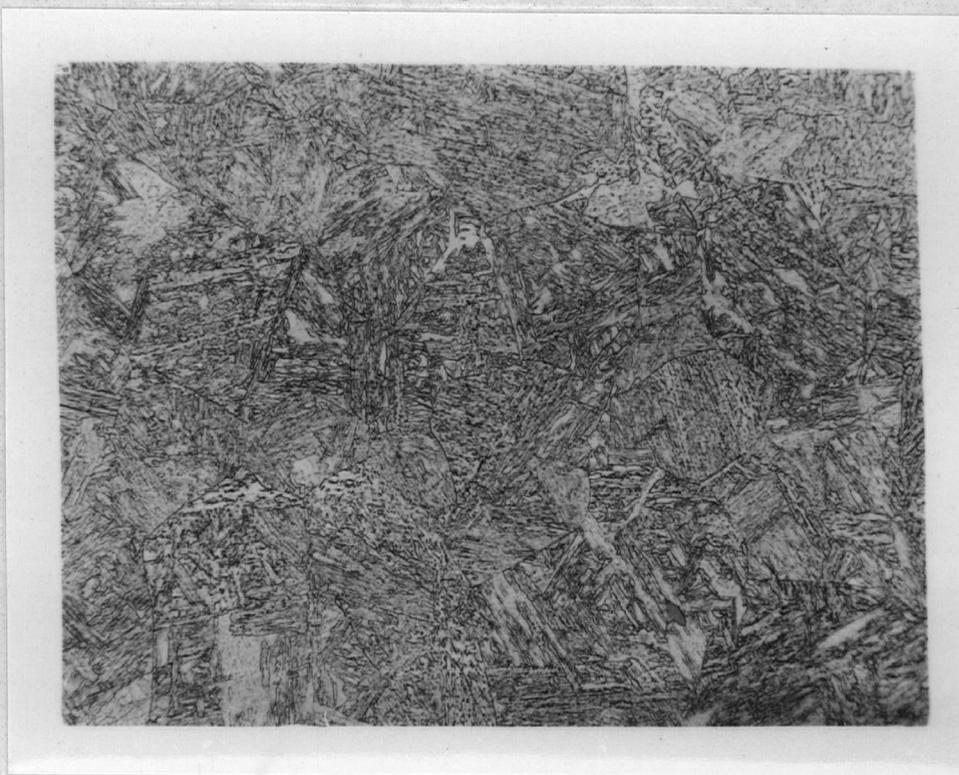
Fig. 25C

HEAT-AFFECTED ZONE MICROSTRUCTURE -
1100 F ONE HOUR

Photomicrograph showing the heat-affected zone microstructure exhibited by the crown weld/upper shell after laboratory heat treating at 1100 F for one hour. The microstructure shown here consists of uniformly tempered martensite and fine carbides and had a hardness of Rockwell C 28-29.

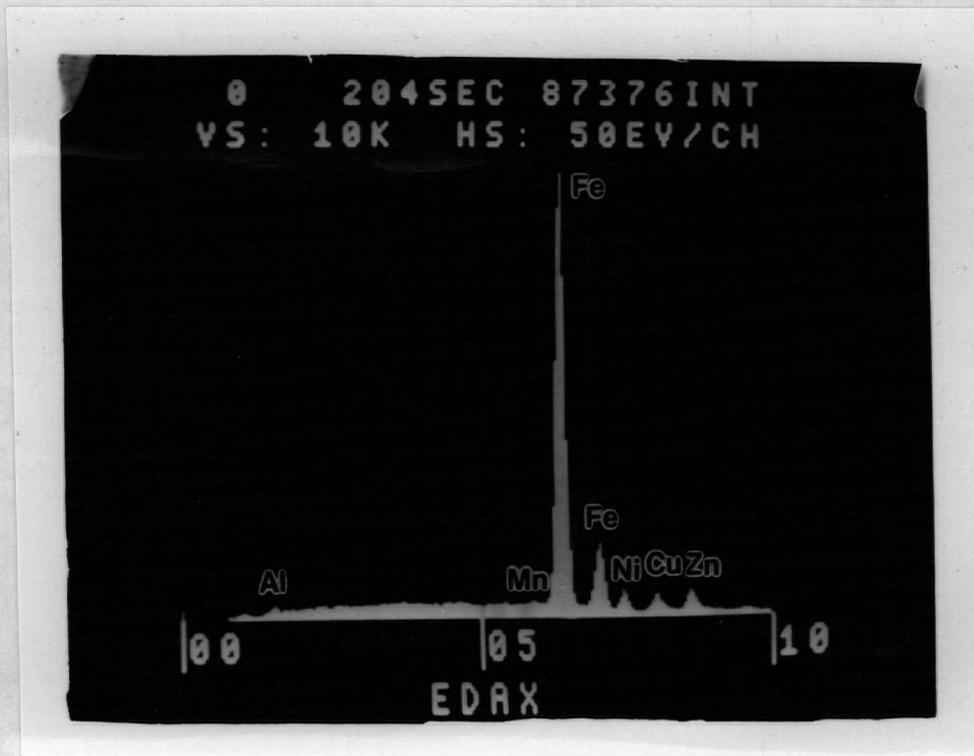
components in the secondary system. Fig. 31 is a photograph showing a typical EDAX spectrum obtained.

ENERGY DISPERSIVE X-RAY SPECTRUM

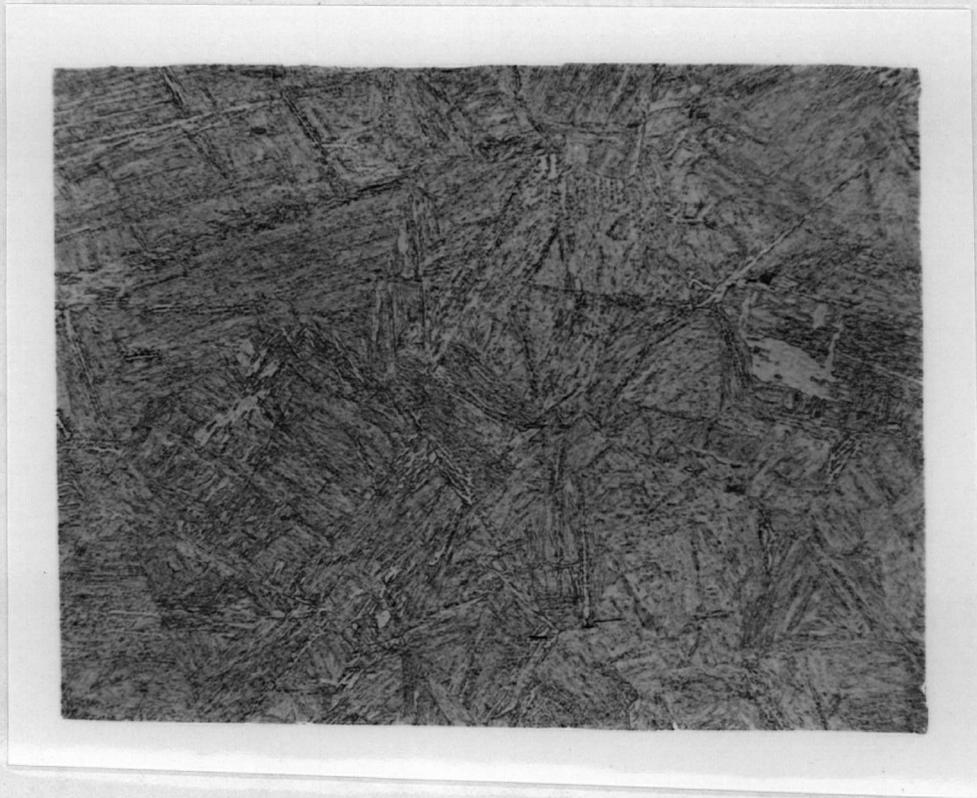
Fig. 41

Examination of the weld heat-affected zones, both crown and repair, revealed the heat-affected zone microstructure to consist of coarse, lightly tempered martensite as illustrated in Figs. 40 and 41.

HEAT-AFFECTED ZONE MICROSTRUCTURE

Photomicrograph similar to that shown in Fig. 40, except at higher magnification, showing the general microstructure exhibited by the heat-affected zone between repair weld and transition cone. The heat-affected zone microstructure consists of lightly tempered martensite.

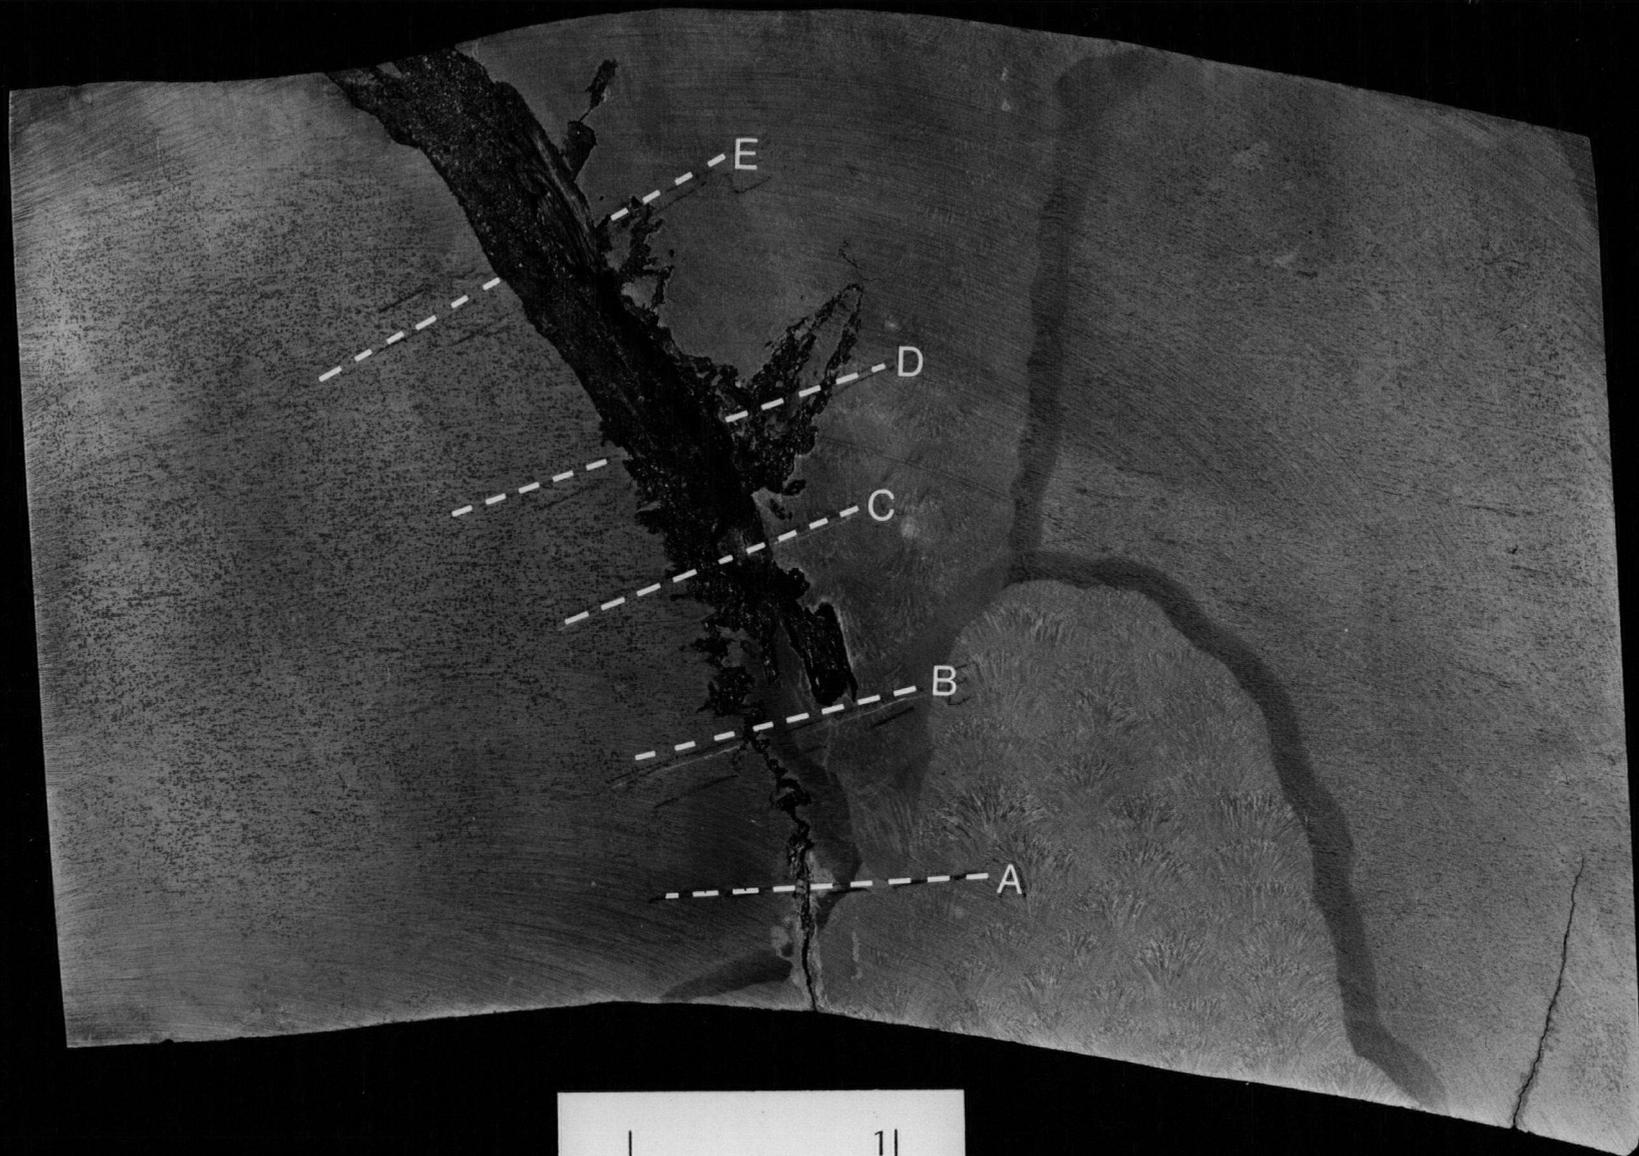
Fig. 42 PHOTOGRAPH SHOWING THE LOCATION OF MICROSPECIMENS TAKEN THROUGH THROUGH-WALL DISCONTINUITY

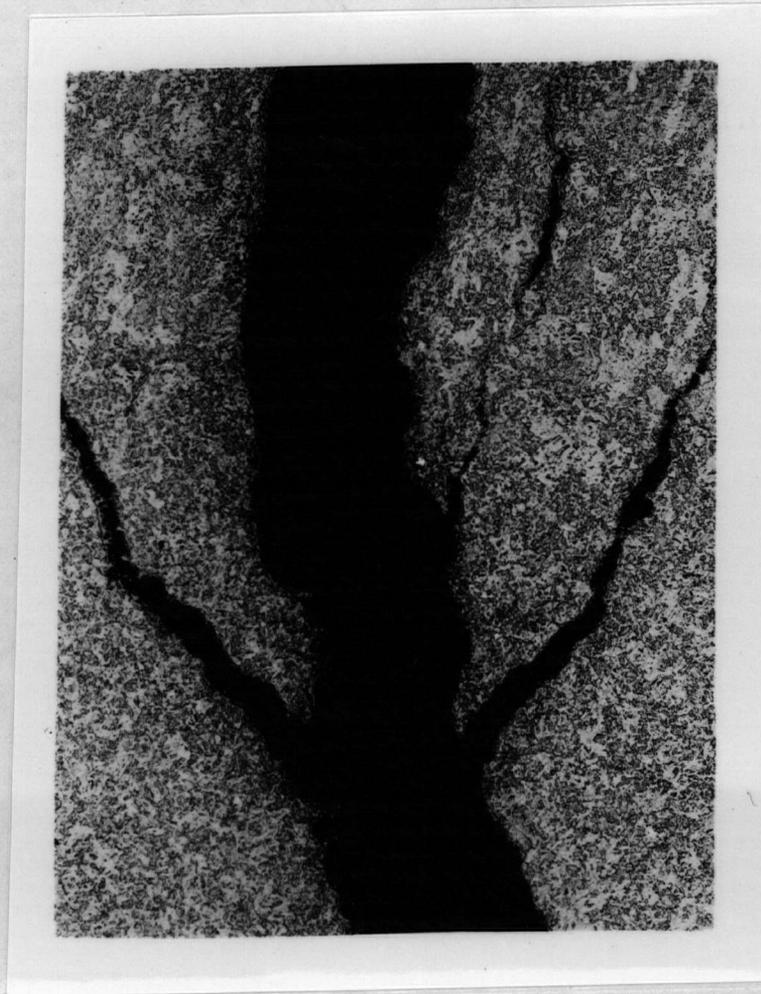
Fig. 45 is a photomicrograph showing the oxide-filled crack exhibited by specimen C, shown in Fig. 43. The corrosion-filled crack also contains particles of copper. Fig. 46 is a photomicrograph showing the heat-affected zone in specimen D, shown in Fig. 44. Fig. 47 is another photomicrograph showing the cracking associated with the through-wall discontinuity. In all cases, no welding defects of any type were observed.

Photomicrograph showing the vertically oriented through-wall crack in the area of upper shell/crown weld heat-affected zone. It can be seen that the crack profile is smooth and slightly eroded as would occur from steam/water escaping from the generator.

THROUGH-WALL CRACK
