Preliminary Examination of Cracks in Alloy 152, 52, and 52M Weld Metals

MB Toloczko
MJ Olszta

January 2010

Prepared for
U.S. Nuclear Regulatory Commission
under a Related Services Agreement
with the U.S. Department of Energy
Contract DE-AC05-76RL01830
NRC Project JCN N6547

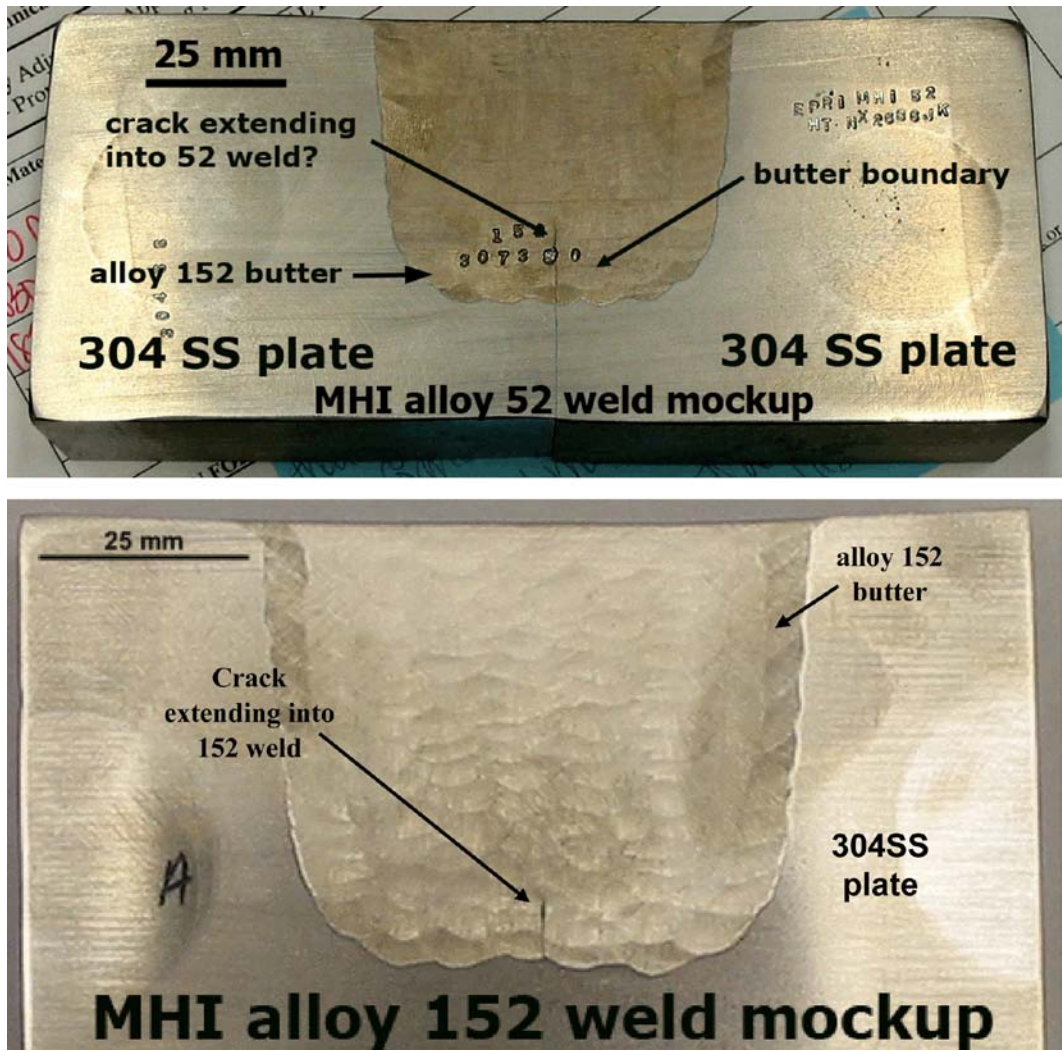
One prominent feature in these mockup welds is the presence of a crack starting at the 304SS butt joint at the bottom of the U-groove and extending up into the weld. It appears that the 304SS plate on either side of the butt joint acted as an anchor for the weld, resulting in a stress riser across the slit that drove crack formation and extension into the fill weld. As will be shown in the next section, the extent of the cracking around this stress riser was much greater in the MHI 52 weld mockup.

Figure 2.1. Optical Images of MHI Alloy 52 and Alloy 152 Weld Mockups Showing U-groove Weld in Cross Section. Both welds were made to 304SS plate using an Alloy 152 butter layer.

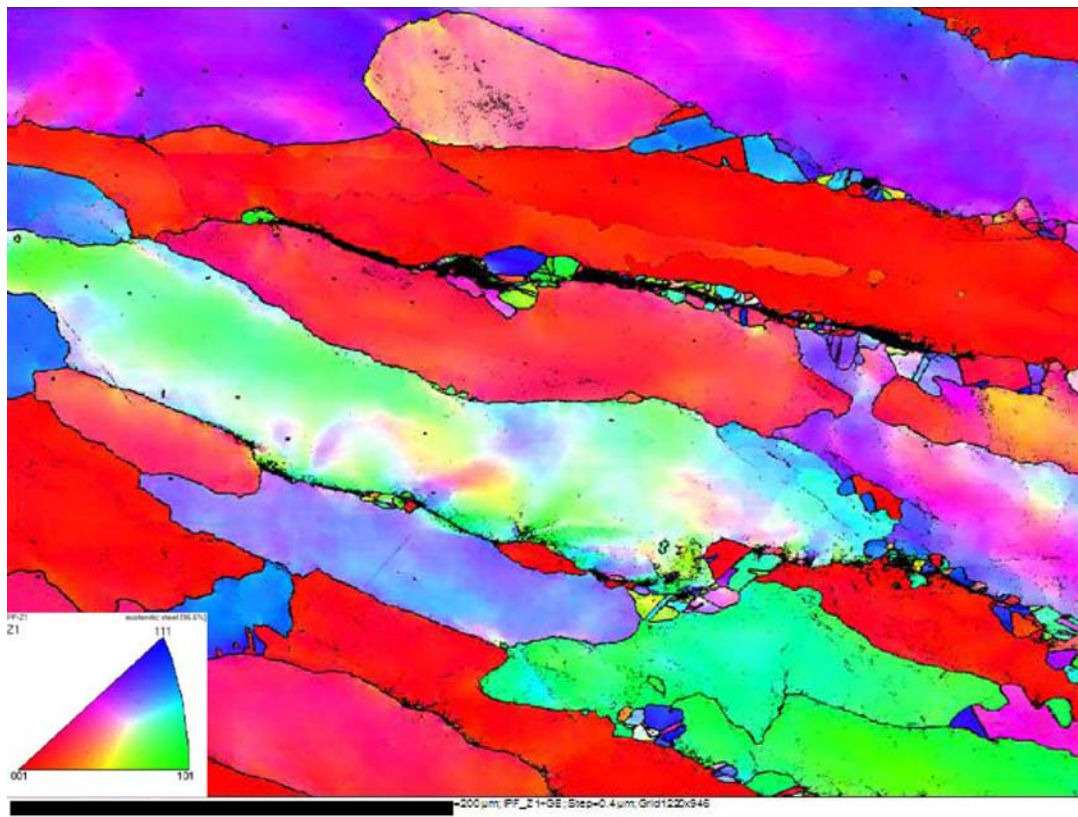
examined in more detail by EBSD techniques and examples are shown in Figure 4.4 through Figure 4.6. The EBSD IPF-Z image in Figure 4.4 enables a better visual image of the individual weld metal grains and highlights areas of plastic deformation. The typical large, elongated grains can be seen plus a collection of very fine grains along certain grain boundaries. The fine grains present along the cracks suggest that local recrystallization may play some role in the cracking process. High strains depicted by large changes in crystal orientation within a grain in Figure 4.4 are found at many of the high-angle grain boundaries and within the interior of many of the grains.

Figure 4.4. EBSD IPF-Z Illustrating the Differences in Grain Orientations and Deformation in the Vicinity of the MHI Alloy 52 U-groove Weld Cracks

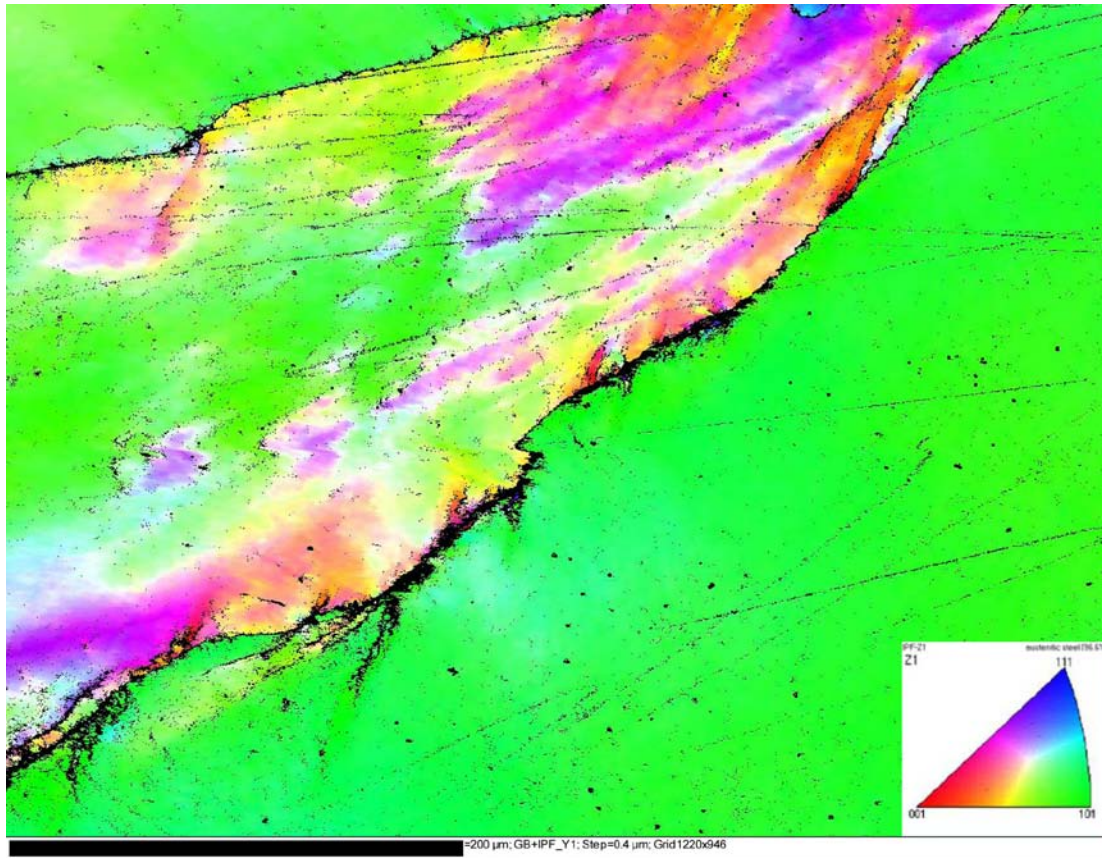
Cracks following two boundaries encompassing a large weld metal grain are presented in Figure 4.5. The EBSD IPF-Z image shows a significant change in orientation near the cracks and within the large grain itself indicating very large strains within this grain. The grains bounding the other side of the cracks, however, have very little indication of strain. The lack of indicated strain in this grain may be a limitation of the IPF-Z image because crystal rotations around the normal axis to the image are not captured by an IPF-Z image.

Figure 4.5. EBSD IPF-Y Image Illustrating Differences in Grain Orientation and Rotation Around Weld Cracks that Formed Along High-Energy Grain Boundaries in the MHI Alloy 52 U-groove Weld

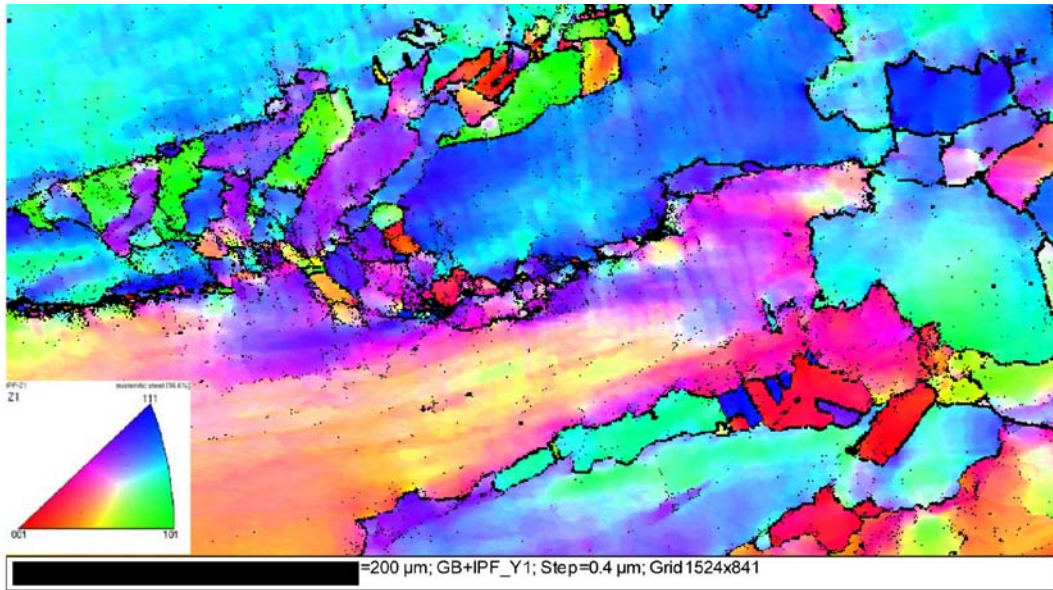
The final cracked region examined (Figure 4.6) also shows a mixture of large, elongated grains and local regions of very fine, recrystallized grains. A complex distribution of open and tight cracks is present in this region. As expected, high strains indicated by the strong color variations within many of the grains are found associated with cracks and grain boundaries in this entire region.

Figure 4.6. EBSD IPF-Y Image of the MHI Alloy 52 U-groove Weld Illustrating Differences in Grain Orientation and Deformation Near Weld Cracks Situated Along High-Energy Grain Boundaries and Regions of Fine Grains

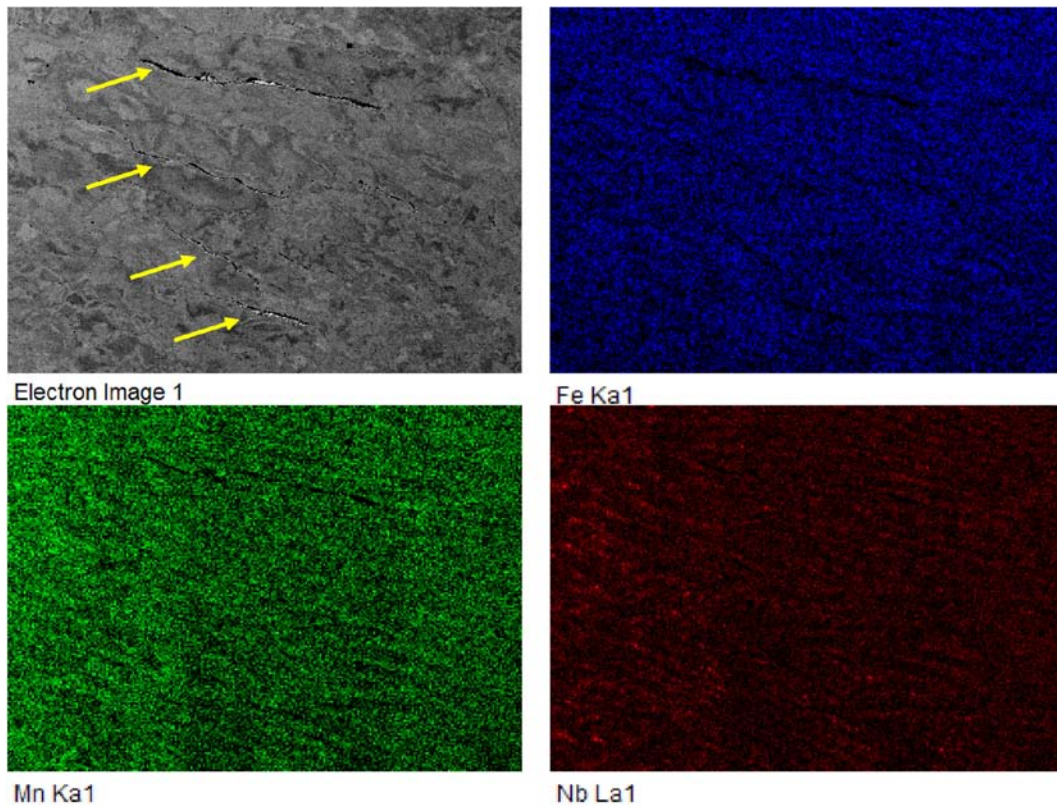
Additional general characterizations were performed by SEM and SEM-EDS techniques on the MHI Alloy 52 U-groove weld mockup. Compositional variations in the Alloy 52 weld metal and in the cracked regions were assessed by selected SEM-EDS maps as illustrated in Figure 4.7. Minor indications of Mn and Nb segregation were seen associated with matrix dendrites, but no local enrichment of alloying or impurity elements to grain boundaries could be detected at the resolution level attained with this instrument.

Figure 4.7. SEM-EDS Maps of the MHI Alloy 52 U-groove Mockup Show Very Little Variation in Elemental Composition with the Weld Cracks

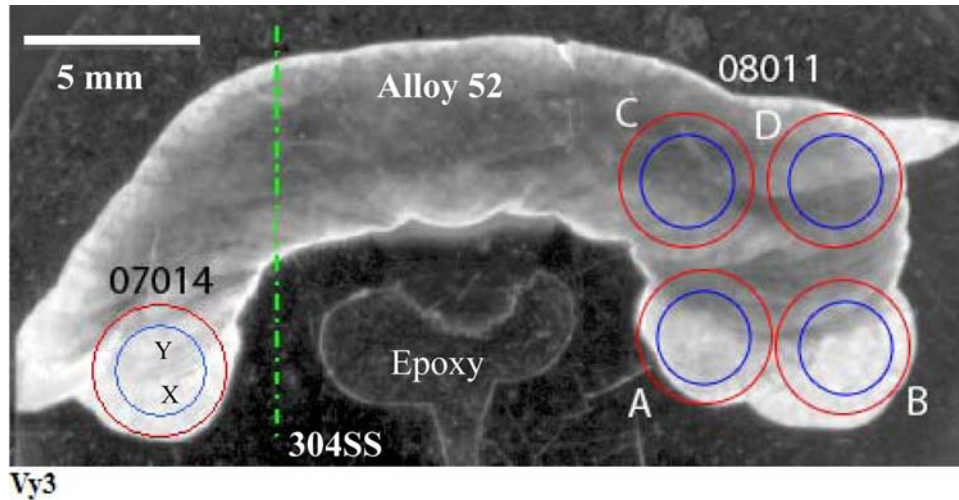
Light oxalic etching of the metallographic samples clearly delineated the Alloy 52 weld metal and the 304SS based metal as shown in Figure 4.10. Weld cracks were found in the brighter re-melted regions adjacent to the 304SS, that is, regions identified as A, B, X, and Y. General compositions in these regions were obtained by SEM-EDS and found to be at an intermediate composition between the Alloy 52 and the 304SS. These estimated compositions are listed in Table 4.1 and reveal Fe at levels of 25–36 wt% and Ni levels of 35–46 wt% for regions with hot cracks.

Figure 4.10. Optical Image Providing Overview of the Ringhals Alloy 52 Weld Overlay Sample VY3 After Light Etching and Identifying Various Regions Where TEM Samples were Prepared

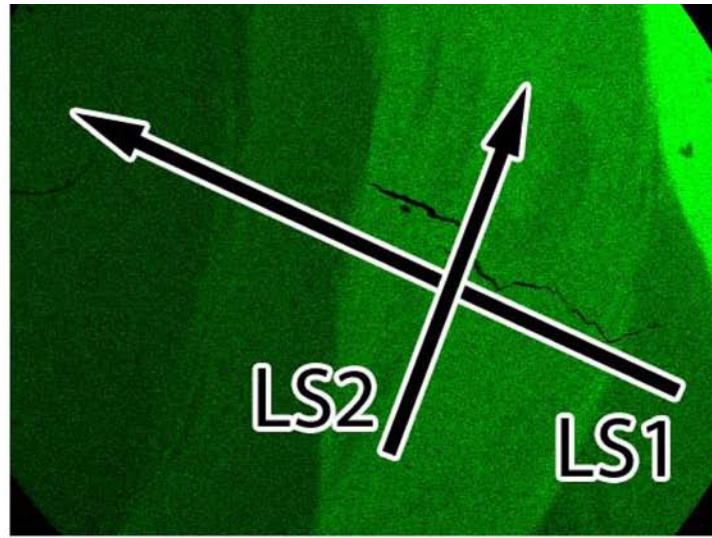
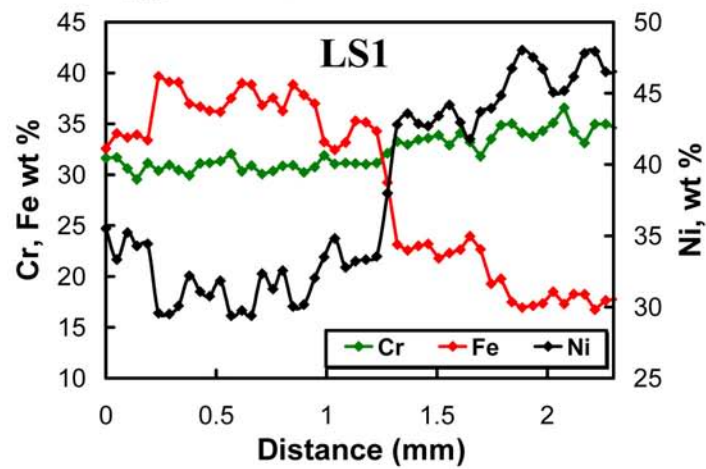
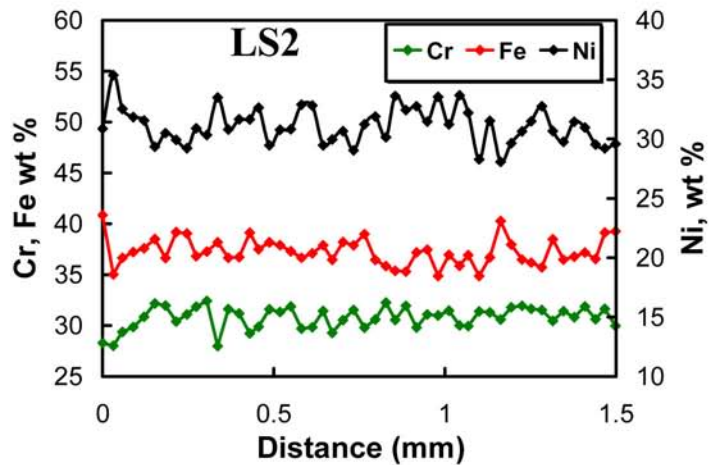
Figure 4.12. Compositional Variation as Measured by SEM-EDS Along the Length and Across a Weld Crack in the Extensive Dilution Zone of the Alloy 52 Overlay

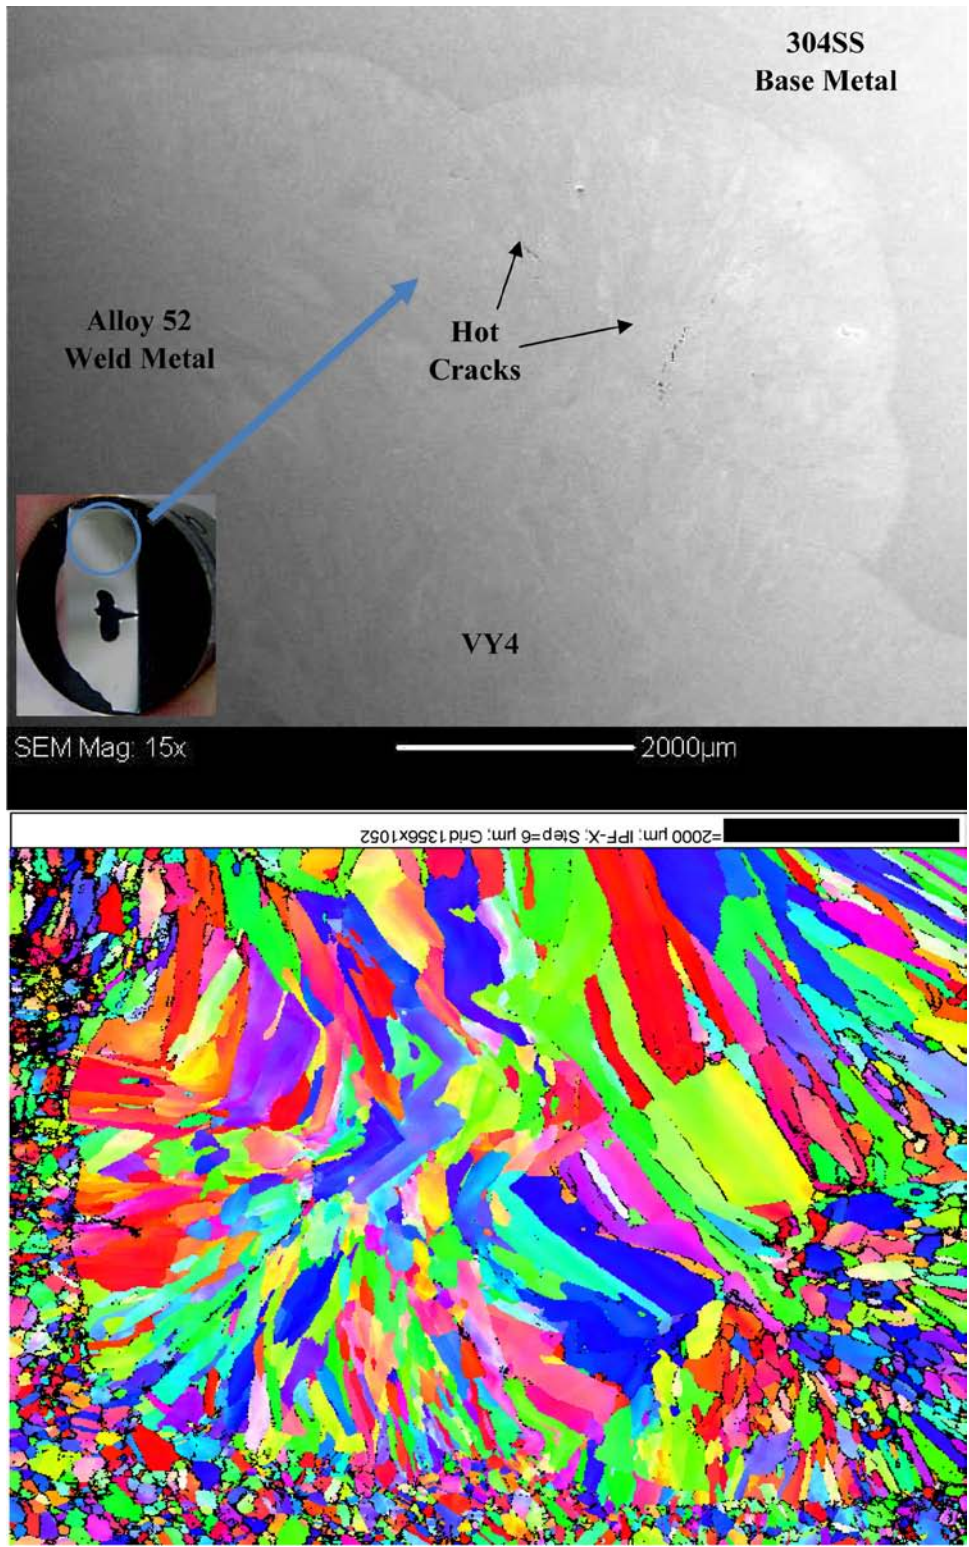
Figure 4.13. SEM and EBSD IPF-X Images Illustrating the Microstructure Across the 304SS Base Metal and Weld Metal Interface Region in Overlay Sample VY4

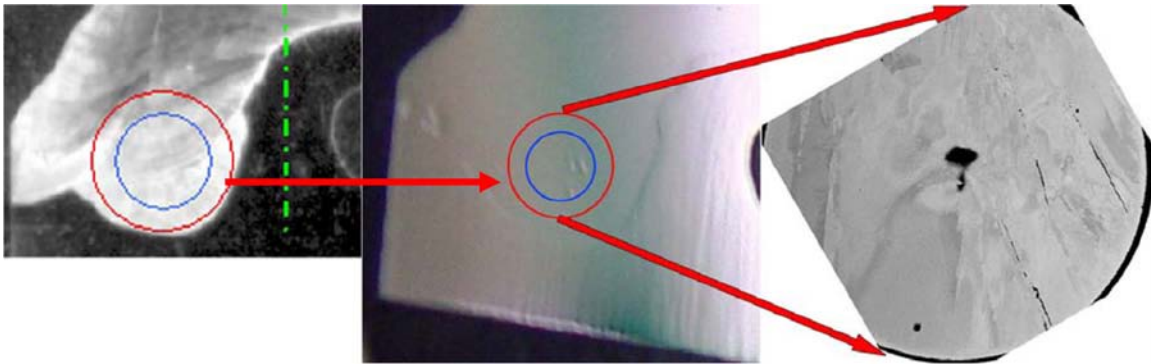
A large number of crack tips have been examined and analyzed from the dilution zone regions of the Ringhals overlay samples VY3 and VY4. All cracks were IG following high-energy grain boundaries containing second-phase precipitates. The most consistent feature at grain boundaries leading the weld cracks was the presence of TiN either as an elongated thin phase or film on the boundary or discrete fine particles. The TEM image and elemental maps in Figure 4.16 highlight the thin elongated Ti-rich phase along a grain boundary leading an IG weld crack. In some locations, the less than 50-nm-thick TiN platelet reaches more than 1 μm in length. Cr-rich M_{23}C_6 carbides are also common at grain boundaries, but tend to be well spaced and nearly spherical.

Figure 4.14. Optical and SEM Micrographs Illustrating Region where TEM Sample VY3 Originated in the Original Weld Overlay. The two optical micrographs on the left were obtained using different polishing/etch preparations shown in Figure 4.9 and Figure 4.10.

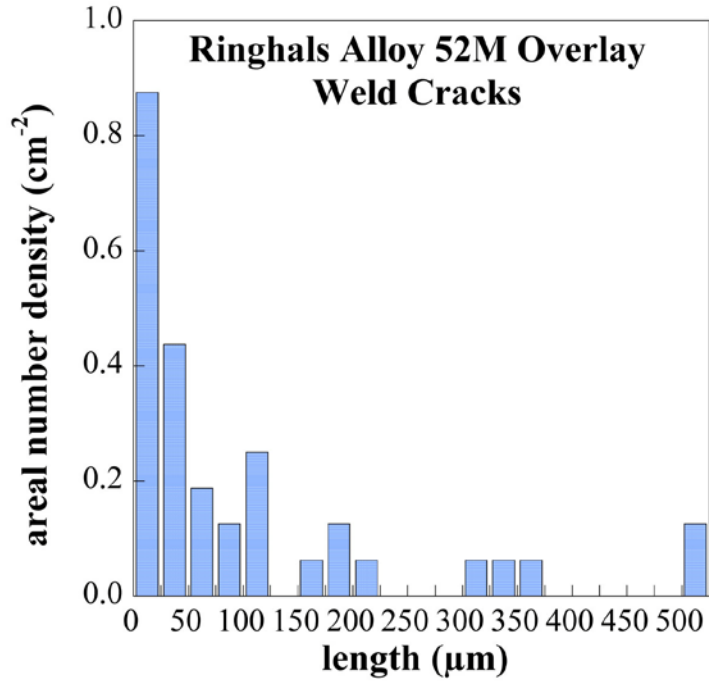
Attempts were made to quantify aspects of the metallographic results for the weld cracks. Overall observations of the weld cracks indicate a relatively low density of small cracks generally less than 100 μm in length. For all but the MHI Alloy 152 weld, a sufficient number of cracks were found to permit measurement of crack length density and length distribution plots. The areal number density versus size distribution for the Alloy 52M overlay material is shown in Figure 5.1. The peak in the weld crack length is approximately 25 μm with the number density falling off rapidly as the weld crack length increases. The areal density of the Alloy 52M inlay mockup is shown in Figure 5.2. As with the overlay, the crack length peaks at approximately 25 μm with the distribution tailing off to a very low density of longer cracks, almost 0.5 mm in length. The density of cracks in the inlay is approximately one third of the overlay for the 25- μm -size range, but only slightly lower density for cracks longer than 25 μm . The areal number density versus crack length of the MHI Alloy 52 slice is shown in Figure 5.3. Although the weld cracks were isolated to the region around the large macroscopic weld crack that grew from the base of the U-groove, the entire area of the slice was used to calculate the areal number density. Based on this area, the density of cracks in the MHI Alloy 52 U-groove weld is approximately one-half the density of cracks in the Ringhals overlay mockup. If the area used in the calculation is confined to the region around the macroscopic crack, then the number density would increase approximately by a factor of 10. The density of cracks in the MHI Alloy 152 mockup was too low to obtain a statistically relevant size distribution of cracks. The total areal number density of cracks was less than 0.05 cm^{-2} with cracks no longer than 300 μm .

Figure 5.1. Areal Number Density Versus Crack Length for the Weld Cracks Observed in the Ringhals Alloy 52M Overlay Mockup

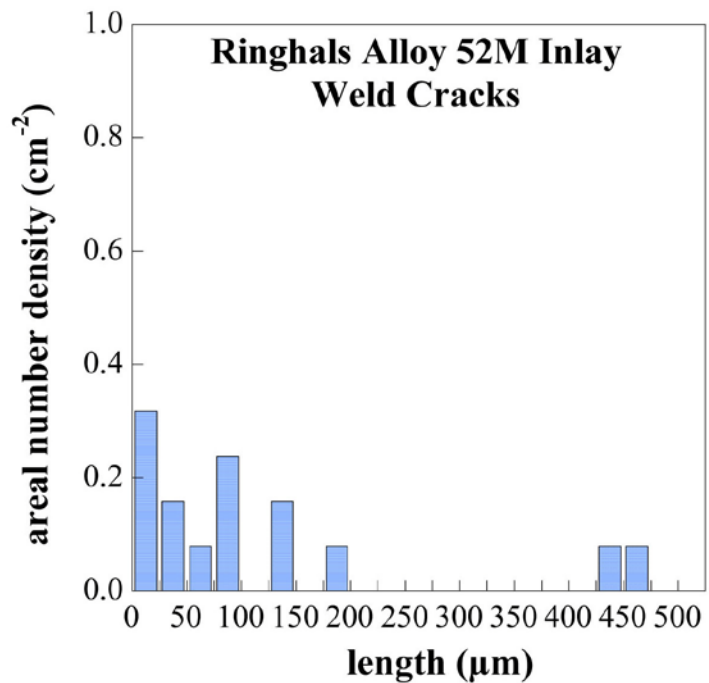
Figure 5.2. Areal Number Density Versus Crack Length for the Weld Cracks Observed in the Ringhals Alloy 52M Inlay Mockup

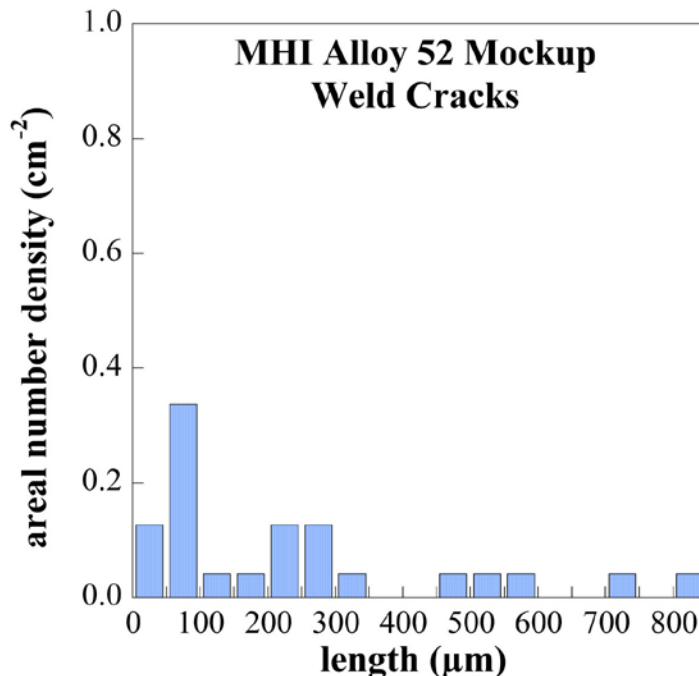
Figure 5.3. Weld Crack Areal Number Density Versus Length Observed in the MHI Alloy 52 U-groove Mockup. Although the weld cracks were isolated to the region around the large macroscopic weld crack, the entire area of the slice was used to calculate the areal number density.
