Subject: 10CFR21 Reporting of Defects and Non-Compliance -
Engine Systems, Inc. Report No. 10CFR21-0100, Rev. 0

EMD Water Pump, P/N 8324589

Report No. 10CFR21-0100

COMPONENT: EMD water pumps

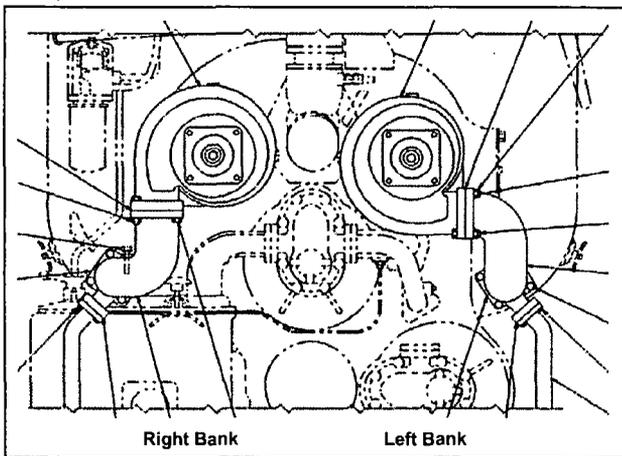
EMD diesel engines utilized for emergency diesel generator sets use two engine jacket water centrifugal pumps (one for each bank) to circulate fluid throughout the engine for cooling. Each pump is mounted on the front of the engine and rotates in the opposite direction of the engine crankshaft. For single engine generator set applications (i.e. left hand rotation engine, viewed from the rear of the engine), the pumps used on each bank contain identical components; the only difference is the position of the impeller housing in relation to the pump shaft housing. When viewed from the front of the engine, these water pumps rotate counterclockwise (see Figure 1 below).

Water Pumps for LH Rotation Engine

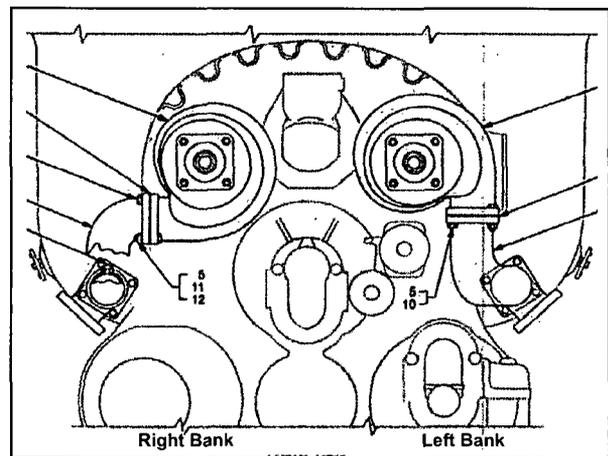
For tandem generator set applications, one engine is left hand rotation and the other is right hand rotation. For each engine, the pumps used on each bank contain identical components and the only difference is the position of the impeller housing in relation to the pump shaft housing. However, for a right hand rotation engine the water pumps rotate clockwise when viewed from the front of the engine (see Figure 2 below).

Water Pumps for RH Rotation Engine
