SAND2010-4936
Unlimited Release
Printed July 2010

A Preliminary Look at the Fire-Induced Electrical Failure Behavior of Kerite® FR Insulated Electrical Cables

A Letter Report to the U.S. NRC/RES

Steven P. Nowlen and Jason Brown

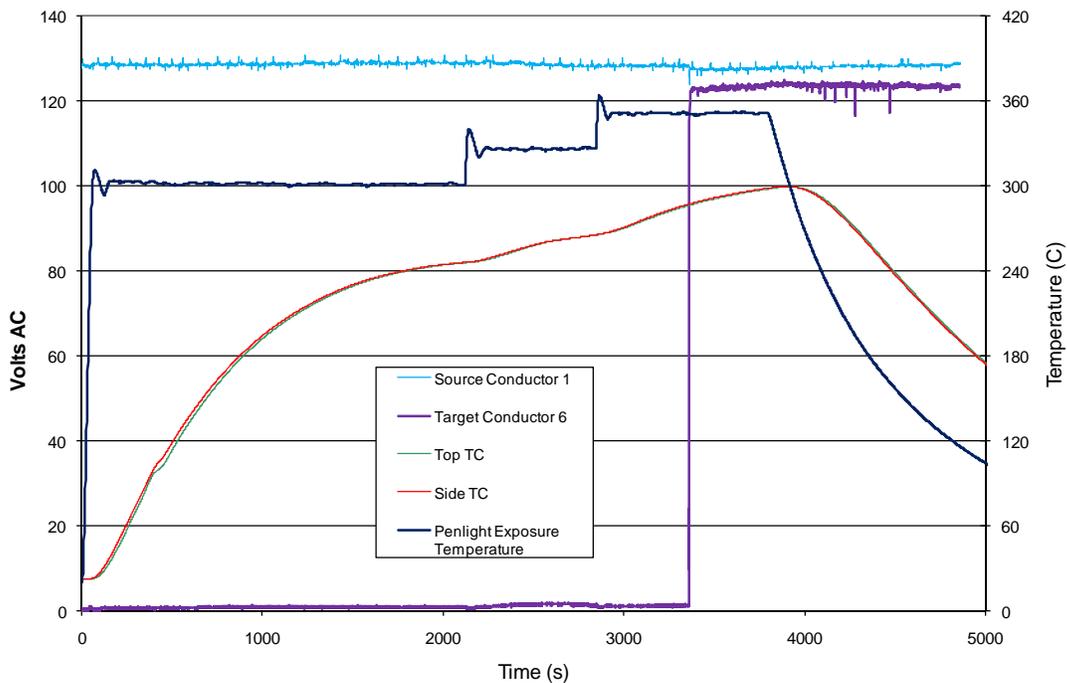
Figure 10: Electrical and temperature data for Test 13-qual.

During this test, the cable experienced a conductor-to-conductor short circuit between two conductors on the outer ring resulting in actuation of the T6 target relay. A summary data plot is provided in Figure 10. Note in particular that the spurious actuation is indicated by the purple line in this plot which increases from zero to 120Vac suddenly at the time of failure. The data from the temperature response cable is also shown in Figure 10 including both the shroud temperature (black) and the two thermocouples inserted below the jacket of the thermal response cable (green “Top TC” and red “Side TC”). Note that the sub-jacket thermocouples were reading 285-287°C at the time of electrical failure.

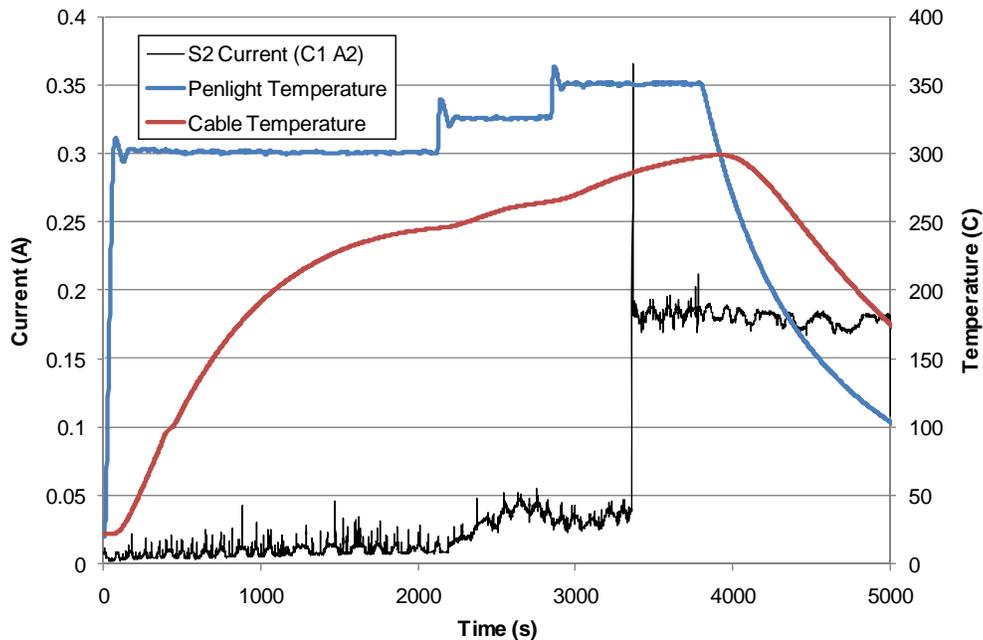
Figure 11: Source 2 Current data for Test 13-qual.

The first signs of cable degradation were noted somewhat before the time of ultimate failure. This is best illustrated by the current data rather than by the voltage data for this case. The current for the S2 circuit path (C1A2) is shown in Figure 11. In order to emphasize the data

trends, and to de-emphasize point to point variability, the raw current data have been plotted as a running average of five consecutive data points (i.e., the plot shows the simple average of the value at the actual time, the two previous values, and the two subsequent values). The first indications of a definite trend towards increasing leakage currents are seen at approximately 2200 s. At this point in the test, the measured cable temperature was 246-247°C.

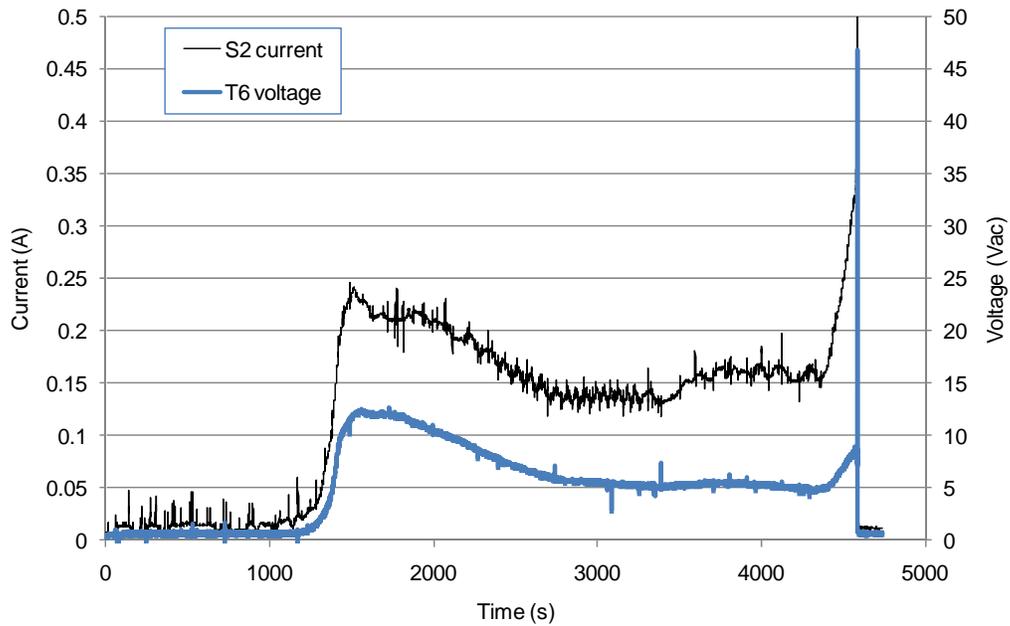
Figure 17: Source 2 (S2) current and Target 6 (T6) voltage data for Test 13.

Based on the results of Test 13-qual, the Penlight shroud was initially set to 350°C which was expected to induce electrical failure within 15-20 minutes. While the cable did not experience outright circuit failure (i.e., either a fuse blow or spurious actuation fault) at temperatures below 300°C, as had the cable in Test 13-qual signs of electrical degradation were observed. The first signs of substantive degradation are again best indicated by the current trace for the S2 circuit path as illustrated in Figure 17. For reference, this figure also includes the measured voltage on T6. At approximately 1320s, both the voltage and current began notable trends of steady increase. At this time the corresponding temperature for the 10/C cable (item 1) was 264-265°C. Also note that the S1 and T5 circuit paths show similar behavior.

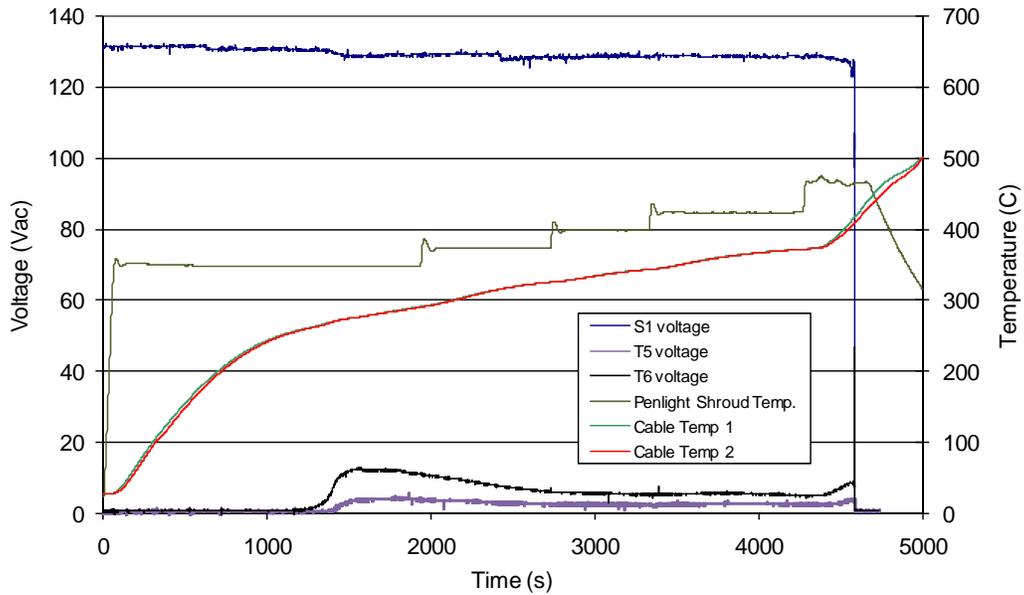
Figure 18: Test results for the 10/C cable in Test 13.

The overall circuit fault and cable temperature data for 10/C cable in Test 13 are illustrated in Figure 18. At its peak, around 1471s, the voltage on the T6 conductor increased to approximately 12V (a bit less than 1/10 of the source voltage). In this case it is possible to estimate of the effective insulation resistance (IR) between the source and target conductor groups. The conductor-to-conductor electrical contact can be assumed to be purely resistive for this case. Hence, the effective IR can be calculated based on the voltage difference between the source and target cable and the corresponding current measurement for the target conductor.

$$R \approx \Delta V / I = (116 \text{ V}) / (0.19 \text{ A}) = 610 \Omega$$

Note that this value represents the approximate resistance between the 4 conductors in the S2 source grouping and the four conductors in the T6 grouping (i.e., see the wiring configuration as specified in Table 5) rather than the IR between any two individual conductor pairs. It is not clear whether the IR behavior was dominated by interactions between one conductor pair or was

reflective of a more general degradation of, and interactions between, multiple conductors in the two conductor groups.

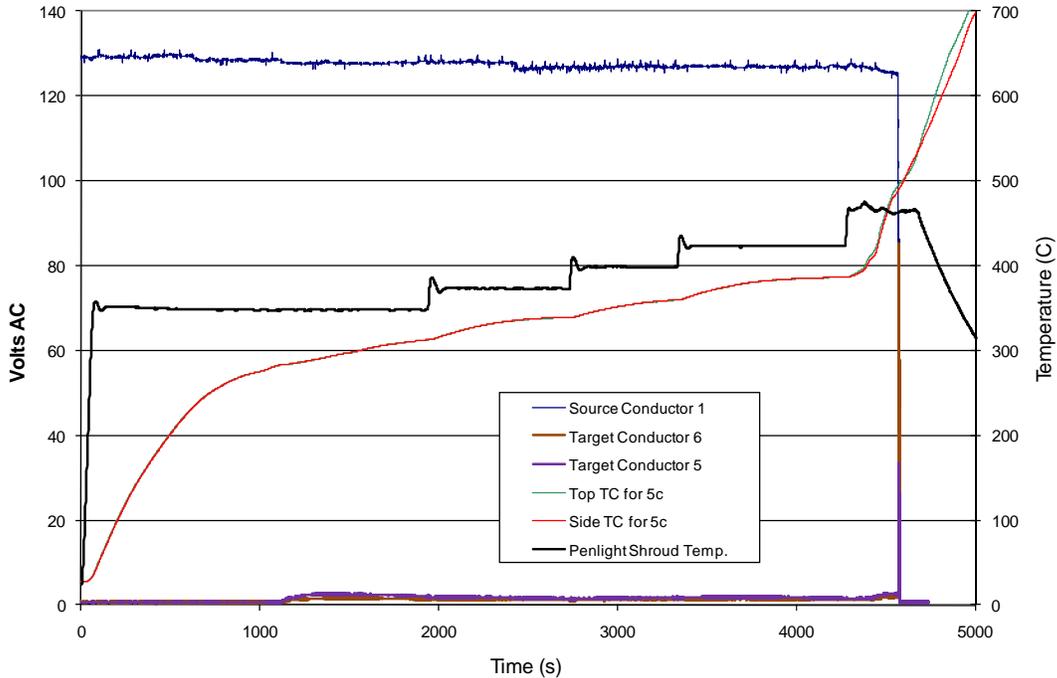
Figure 19: Test results for the 5/C cable in Test 13.

The 5/C cable in Test 13 also showed signs of degradation at roughly the same temperature range, although the degradation was less pronounced. The voltages on the two target conductors reached a peak of roughly 2.5V before retreating to 2V where they remained until gross failure was observed much later in the test. This behavior is illustrated in Figure 19. The first signs of current leakage from the two source conductors are noted at approximately 1020s. At this point in the test, the 5/C cable temperature was about 276°C.

Temperatures recorded for the cables after ignition are not considered reliable indicators of the actual insulation temperature due to exposure of the thermocouple to the flames. Note in the data plots that the ignition time is clearly evident from the departure of the measured temperature response data from its more general heating trends and towards sharply increasing temperature. The thermocouple temperatures rise above the shroud temperature rather quickly after ignition, again indicating exposure to the much hotter flames from the burning cable. However, the 5/C cable had reached a relatively stable temperature of approximately 385°C just prior to the final increase in shroud temperature and ignition of the cable. Hence, it can be concluded that the

ultimate gross failures for the 5/C cables occurred at cable temperatures in excess of 385°C. At about the same time, the 10/C cable thermocouples were reading about 370°C.

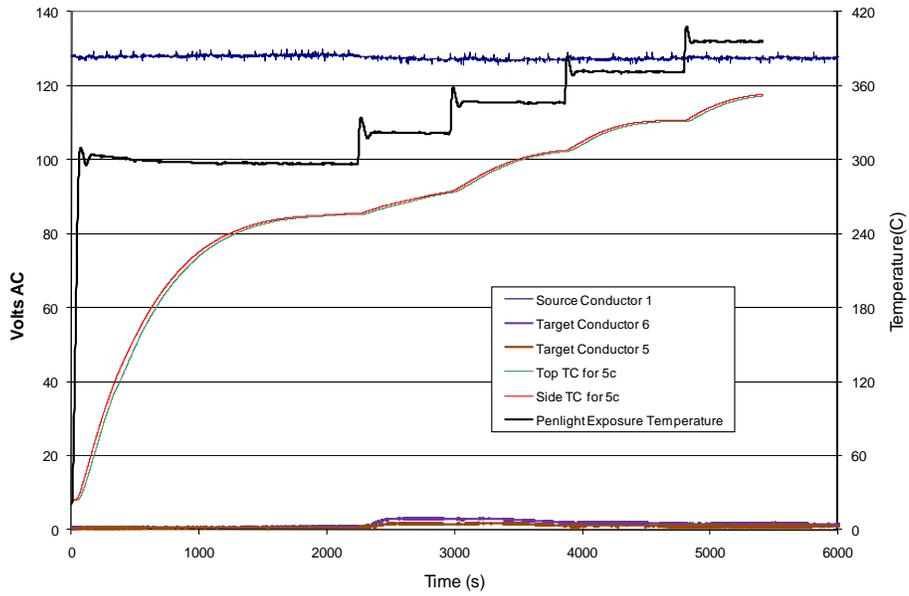
Figure 21: Test results for SCDU 1 and the 5/C cable in Test 15.

Once again, signs of lower temperature cable degradation were observed. The voltage increase during thermal exposure for the cables powering SCDU 1 (5/C-12AWG) and SCDU 2 (10/C-12AWG) are illustrated in Figure 21 and Figure 22, respectively. For the 5/C cable (item 2) the first signs of current leakage from the source conductors are noted at about 2200s when the cable temperature was about 255-256°C. For the 10/C cable (item 1) the first signs of current leakage are noted at about 2300s. At this point the cable temperature was 251-254°C.

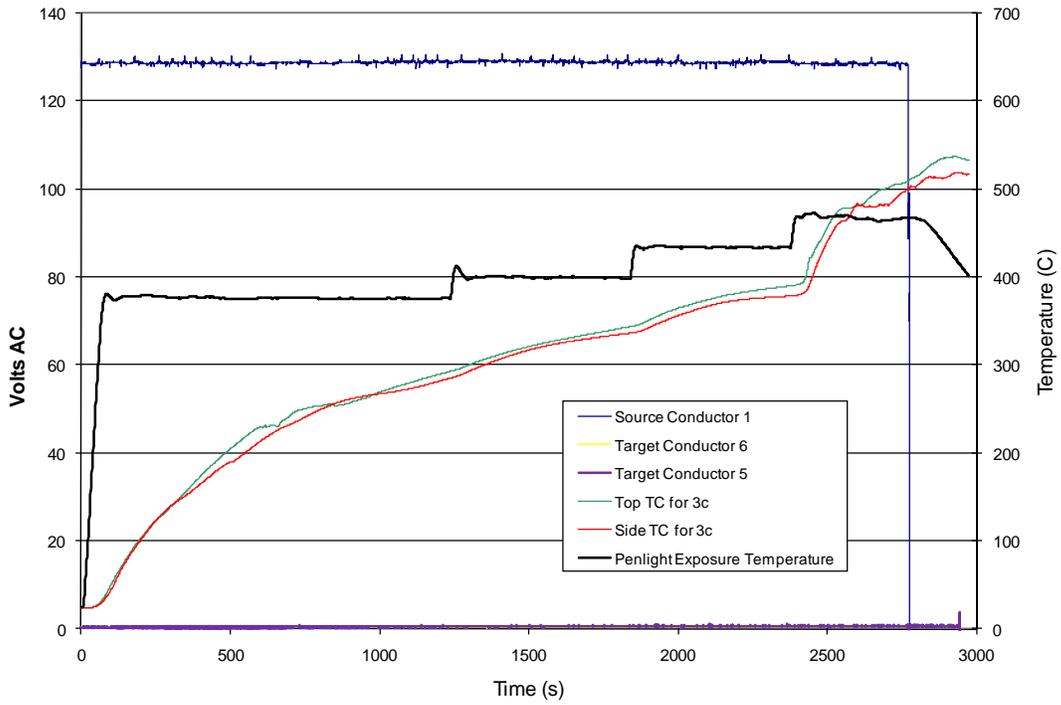
Figure 27: Test results for the HT-insulated cable in Test 17-qual.

Figure 27 illustrates the typical results for this cable type. The case shown is that from test 17-qual, but Tests 17 and 18 show virtually identical behavior, in particular, during the earlier stages of the test (at cable temperatures below 350°C).

For the HT insulated cables, there are no indications of early cable degradation as were noted when testing the FR-insulated cables. Note that the target voltages (T5 and T6) as shown in Figure 27 remain at essentially zero until the cable temperature nears 400°C or higher. This is further illustrated by Figure 28 which shows the source conductor (S1) current flow through the course of the test. Note that no discernable trend is evident until approximately 2600s which is after the time of cable ignition. In this case, the cable ignited spontaneously at about 2370s when the internal cable temperature 378-389°C. Shortly thereafter, a more typical and abrupt failure occurs (in this case, a fuse-blow failure indicating the source conductor shorted to ground. Note that beyond the time of ignition, the measured cable temperatures are not considered reliable indicators of the actual cable condition due to exposure of the thermocouple to the flames.

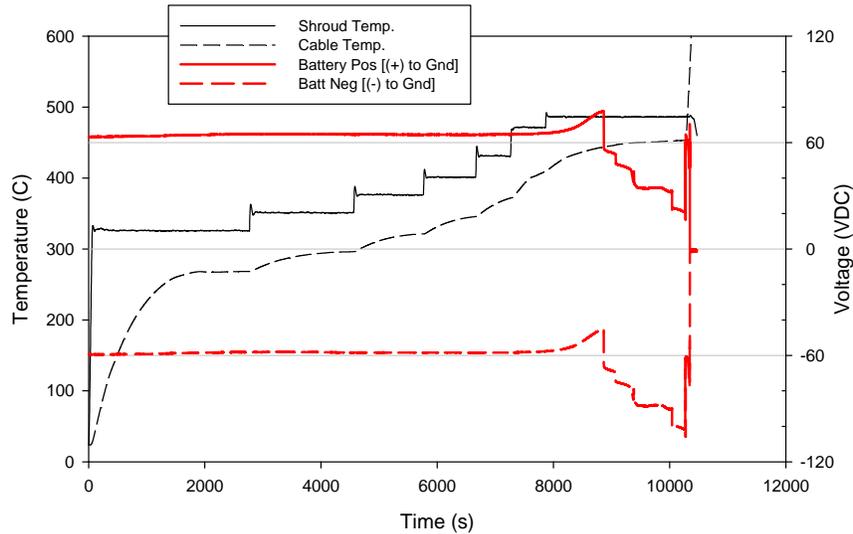
Figure 31: Test results for Test 44.

The test results for Test 44 are illustrated in Figure 31. Note that in this test there are some signs of early cable degradation as had been noted in previous tests, although they are less pronounced than in prior tests. The degradation begins at approximately 1400 s into the test and at a time when the cable temperature was near equilibrium. The cable temperature measured between 1400 and 2000 s ranged from 256-267°C. A voltage increase of approximately 4V was detected on the coil power circuit path for MOV1 motor contactors a few minutes after leaking of liquid materials from the cable ends was first noticed. This occurred about 31 minutes (1860 s) into the test and, at that time, the cable sub-jacket temperature was about 265°C. MOV2 also experienced similar but somewhat lower voltage increases (about 3V) around the same time.

At about 133 minutes (8000 s) more significant signs of degradation are evident. The drift in battery voltages relative to ground actually began roughly 1000s into the test, but the early drift

was minor and was not accompanied by substantive electrical currents. However, beginning at about 8000s, both the battery positive (+) and battery negative (-) begin a more pronounced drift upwards in voltage indicating that a ground fault was forming initially on the negative side of the battery. At this point, the cable internal temperature had just risen above 415°C. The ground developed over a prolonged period and could be associated with either of the two MOV circuits present. The final stages of cable failure (just past 10,000s) occurred after the cable ignited.

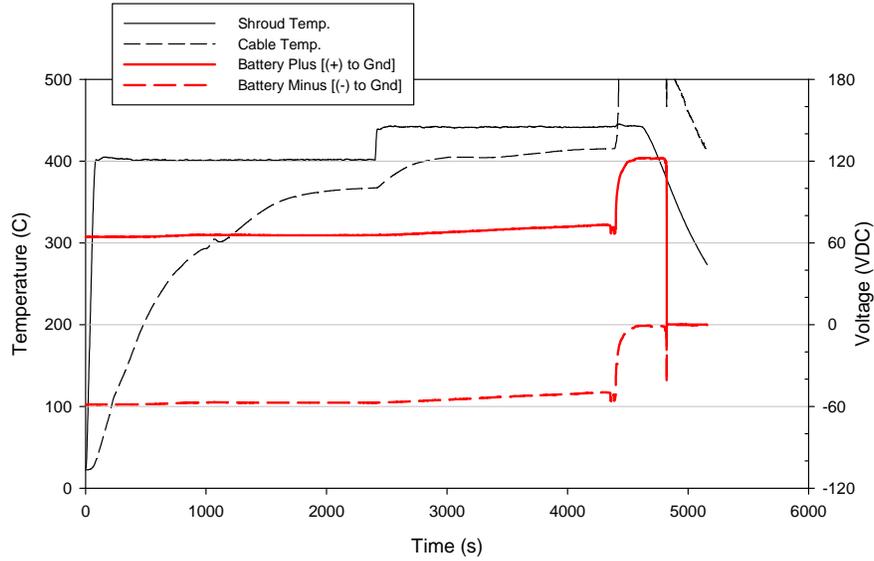
Figure 32: Voltage and temperature profile from Test 49.

The test results for Test 49 are shown in Figure 32. As with the previous tests, liquid residue was observed coming from the cut end of the thermocouple cable in both tests. Again, a discernable drift in the ground fault detection is seen relatively early in the test, beginning at about 600s and peaking at about 1000s. The cable temperature at the beginning of this time period was about 234°C and had climbed to 293°C by the end of that time period. The voltage increases on the motor contactor target conductors during the early stages of test 49 were minimal, reaching approximately 1V prior to cable ignition and ultimate circuit failure. Again, more substantive signs of degradation were noted after the cable passed 400°C when signs of a drift were noted in the ground fault detection circuit. Cable ignition and failure of MOV 1 were both noted at about 4360 s (just under 73 minutes) when the cable temperature was about 415°C.

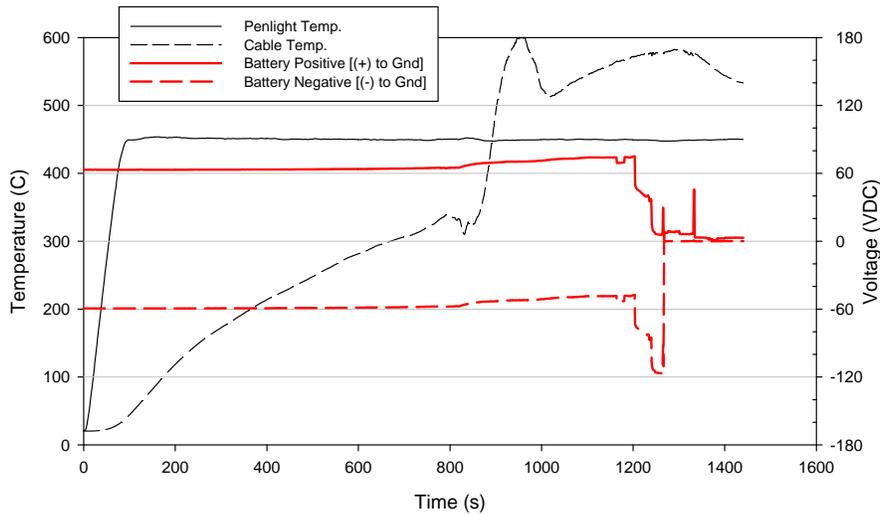
Figure 33: Voltage and temperature profile from Test 50.

The test results for Test 50 are shown in Figure 33. Test 50 used a more aggressive heating profile with the initial shroud temperature set to 450°C. Auto-ignition of the cables occurred just over 780 s (13 min) into the test. At that time, the internal temperature of the cable was about 320°C although with the aggressive heating profile the outside of the jacket would have been substantially hotter. The first discernable drift in the ground fault voltages occurs roughly 500-600 s into the test. The cable temperatures recorded during this time period were 247-283°C. At about 840s more pronounced voltage drifts on the ground fault circuit are noted. At this point the cable temperature had reached about 328°C but is considered unreliable given that the cable had already ignited. MOV2 failed approximately 1260 s (21 min) into the test with a fuse blow. MOV1 failed about 1320 s (22 min) into the test also with a fuse blow. The temperatures at this time are indeterminate given that the cable had already ignited.
