RCE REPORT

Northern States Power Company, a Minnesota corporation (NSPM), d/b/a Xcel Energy
Prairie Island Nuclear Generating Plant

Refueling Cavity Leakage
Event Date: 1988-2008

RCE 01160372-01 Revision 01(CAP 01201071)

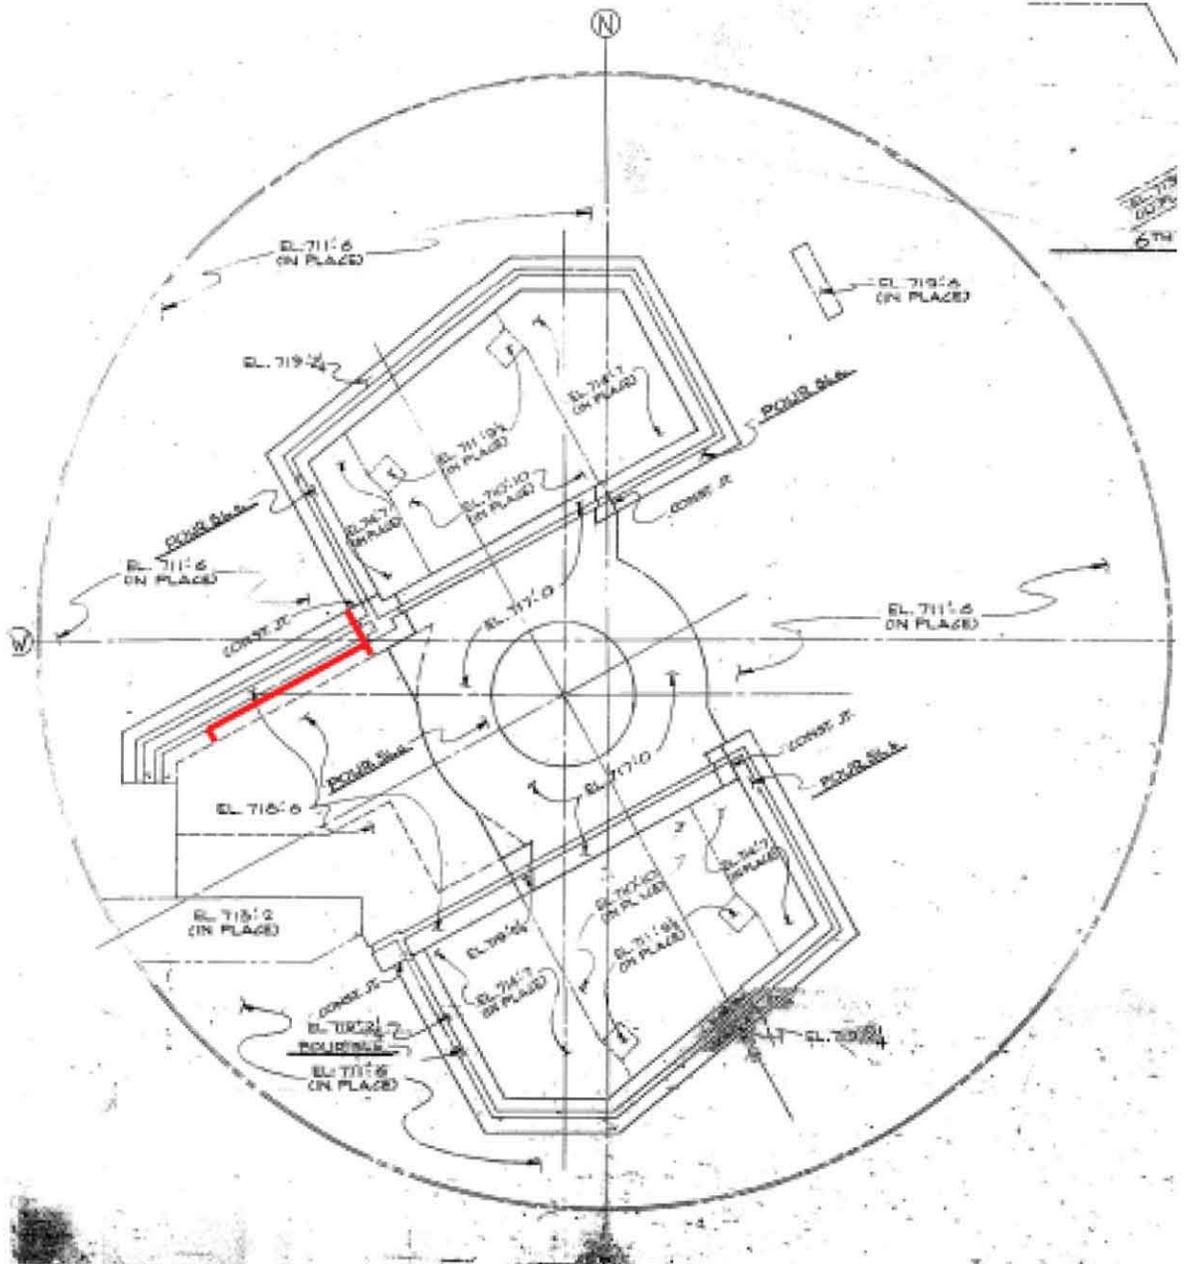
Other locations from which leakage is observed to emerge from concrete includes the El. 711'6" floor slab on the "backside" of the refueling cavity towards the stairwell, which is quite remote from the refueling pool. The path for leakage to get into this floor slab is somewhat tortuous, and demonstrates how mobile the refueling water can be once it gets into the network of joints and cracks in the concrete. See the figures that follow this section. The floor of the lower refueling cavity is at El. 718'8", this corresponds with the top of this pour and a construction joint in the refueling cavity walls. Once water has accumulated under the liner of the lower cavity, it need only flow under one of the corner embedments, an angle iron, before it would encounter the construction joint at 718'8". There are full-length keyways set into the top of each wall at each construction joint that would have the tendency to channel water lengthwise down

a joint by forming a sort of drain trough. Water has not been observed emerging from the refueling cavity wall construction joints, as would be expected since this is the shortest path for leakage to take. It is believed this may be due to the effect of the full-length keys. The effect of the keyways in this case appears to be to channel the leakage towards the 12 RCP vault until it encounters the vertical construction joint where the refueling cavity slab pour meets the RCP vault wall pour, "5La". The top of this pour is at 719'2-1/4", higher than the floor of the lower cavity, so gravity would encourage the leakage to turn down through the vertical joint. The vertical joint ends at 711'6", so the flow is forced to turn again. The construction joint at El 711'6", the mezzanine level, is continuous from the refueling cavity, through the reactor bioshield concrete, and down the steam generator vault wall. Once flow reaches the northeastern limits of the steam generator vault wall, the path is somewhat unclear, because there were no photos found of the crack through which this leakage emerges in the basement. However, drawings do show that there is a construction joint between adjacent pours of the floor slab at El 711'6". It is known that water is not seen on the surface of the floor at this location of the mezzanine level, only emerging from the underside of the slab. Leakage must flow through a path within the slab thickness itself, such as the joint between pours "3La" and "3Ld" before dripping out of a fissure. Note that this path can also explain sightings of leakage from the outside of 12 vault walls near 12 accumulator and within 12 vault on the floor at El. 710'. A similar path exists to explain leakage into 22 vault, which has been reported on Unit 2.
