Title: Evaluation of Effect of Borated Water Leaks on Concrete, Reinforcing Bars, and Carbon Steel Plate of the Containment Vessels at Prairie Island Units 1 and 2

Number: R-4448-00-01 Rev: 0 Date: 3/2009

Organization Name: Dominion Engineering, Inc PO or DIA Reference: 00026901

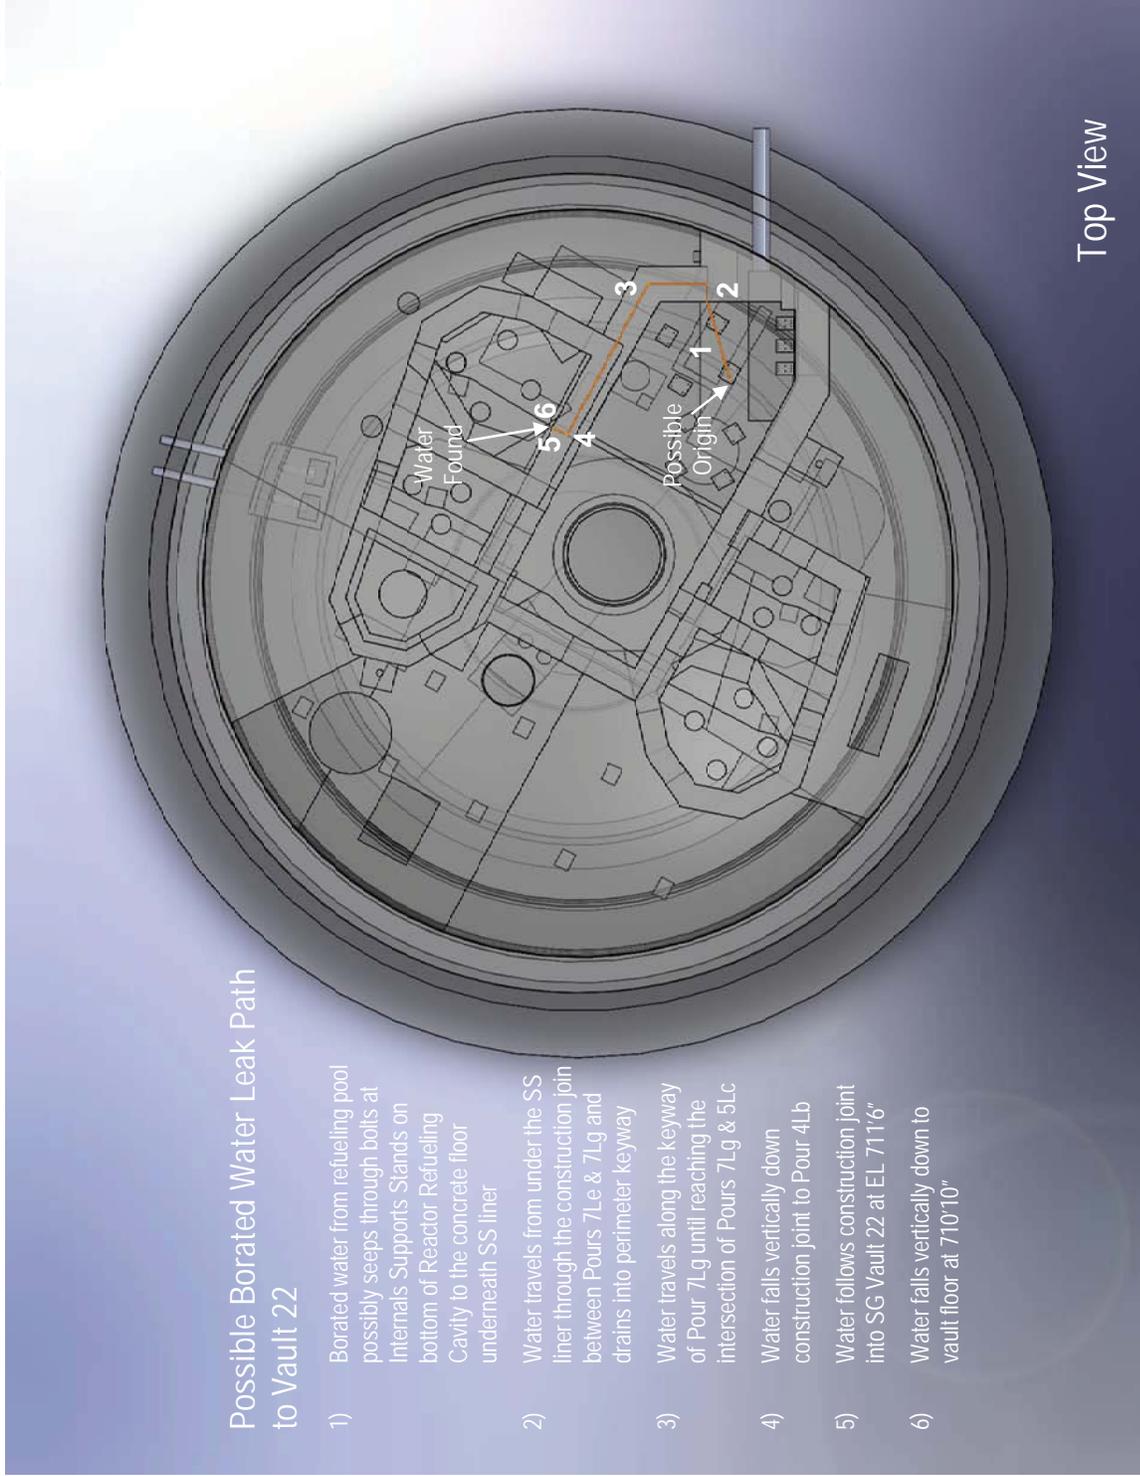
Figure A-14 Possible Borated Water Leak Path to Vault 22 – Transparent Top View

- 1) Borated water from refueling pool possibly seeps through bolts at Internals Supports Stands on bottom of Reactor Refueling Cavity to the concrete floor underneath SS liner
- 2) Water travels from under the SS liner through the construction joint between Pours 7Le & 7Lg and drains into perimeter keyway
- 3) Water travels along the keyway of Pour 7Lg until reaching the intersection of Pours 7Lg & 5Lc
- 4) Water falls vertically down construction joint to Pour 4Lb
- 5) Water follows construction joint into SG Vault 22 at EL 711'6"
- 6) Water falls vertically down to vault floor at 710'10"

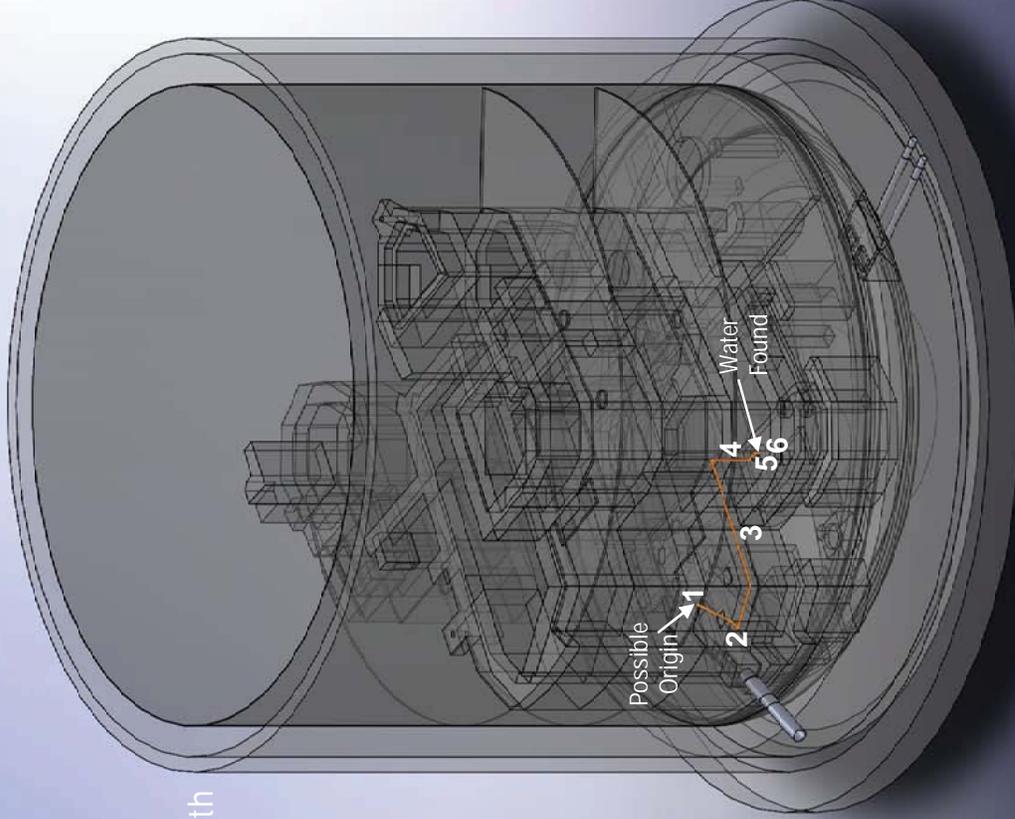
Figure A-18 Possible Borated Water Leak Path to Vault 22 – Transparent Top 3D View

- 1) Borated water from refueling pool possibly seeps through bolts at Internals Supports Stands on bottom of Reactor Refueling Cavity to the concrete floor underneath SS liner
- 2) Water travels from under the SS liner through the construction joint between Pours 7Le & 7Lg and drains into perimeter keyway
- 3) Water travels along the keyway of Pour 7Lg until reaching the intersection of Pours 7Lg & 5Lc
- 4) Water falls vertically down construction joint to Pour 4Lb
- 5) Water follows construction joint into SG Vault 22 at EL 711'6"
- 6) Water falls vertically down to vault floor at 710'10"

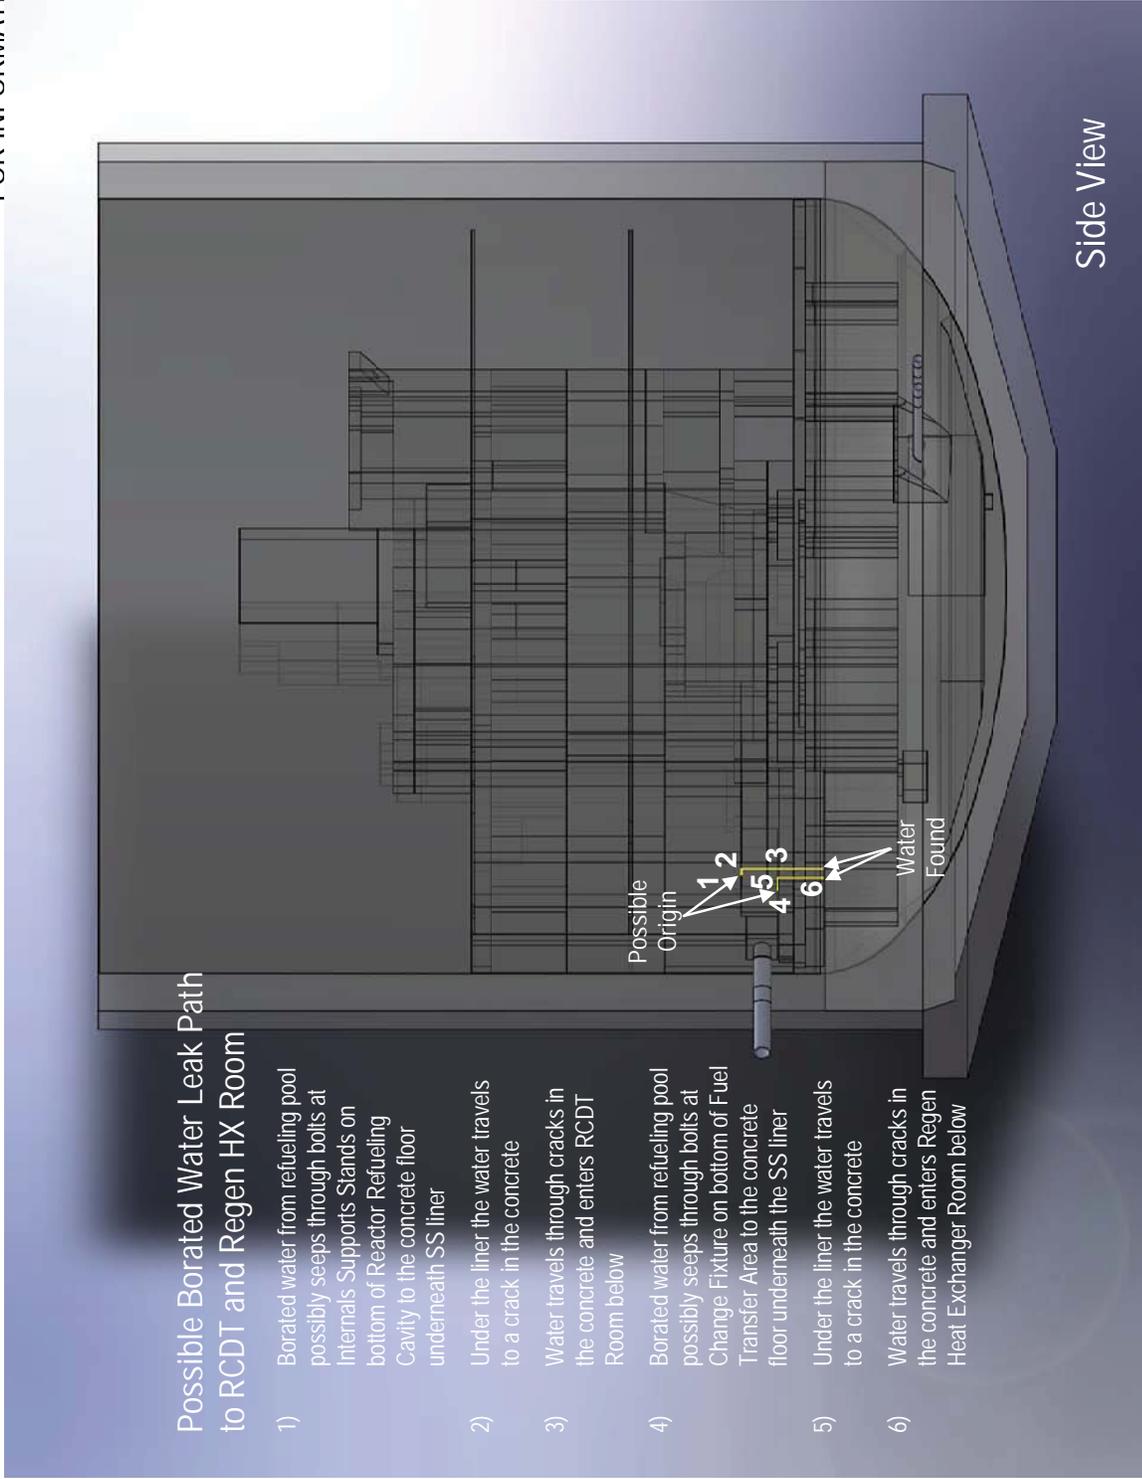
Figure A-20 Possible Borated Water Leak Path to RCDT Space and Regen HX Room in Unit 2 – Side View

- 1) Borated water from refueling pool possibly seeps through bolts at Internals Supports Stands on bottom of Reactor Refueling Cavity to the concrete floor underneath SS liner
- 2) Under the liner the water travels to a crack in the concrete
- 3) Water travels through cracks in the concrete and enters RCDT Room below
- 4) Borated water from refueling pool possibly seeps through bolts at Change Fixture on bottom of Fuel Transfer Area to the concrete floor underneath the SS liner
- 5) Under the liner the water travels to a crack in the concrete
- 6) Water travels through cracks in the concrete and enters Regen Heat Exchanger Room below
