PORC	January 24 1 pm Walnut	06- 004
Chemistry	Unplanned Environmental Tritium Releases Root Cause Report #428868 UFSAR req'd 300 ci/unit but BW does 1200000 ci/unit?	Dudek Ambler Walrath Wrigley Smith Gayheart Daly Leasure

The **Root Cause** was determined to be a lack of integrated procedural guidance to ensure proper identification, timely mitigation and evaluation of the spill events, including knowledge of local hydrology, the impact of low-level tritium leaks, and groundwater regulations.

ROOT CAUSE REPORT

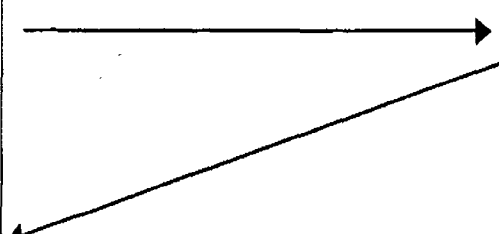
Attachment 7 - Cause & Effect Analysis

Effect / Symptom	Why	Cause / Reason
Tritium found off site

Inadequate response
Inadequate response

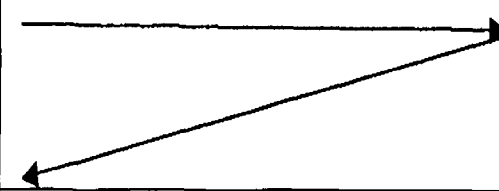
Personnel not aware of the IEPA tritium limit requirements for ground water
Personnel not aware of the IEPA tritium limit requirements for ground water

Knowledge deficiency
Knowledge deficiency

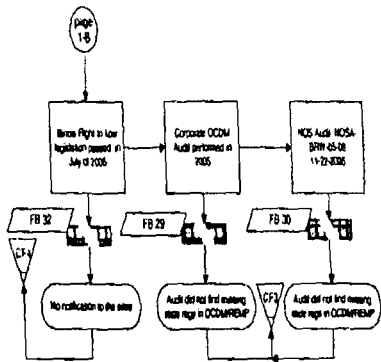
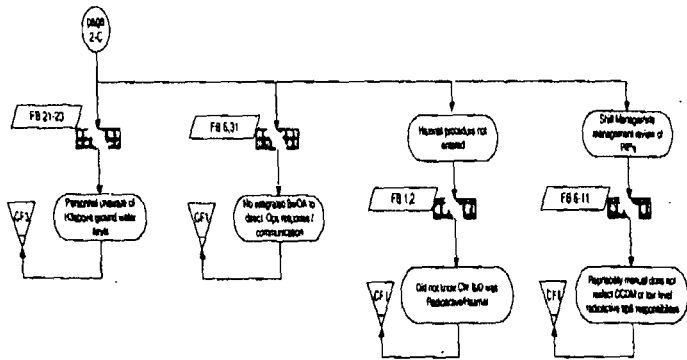
Event and Causal Factor Chart
 Tritium Event
 Root Cause Report
 WFO 00428869

Page 3 for history of blowdown vacuum breakers
