**Indian Point Unit 2
1991 Steam Generator
Inspection, Evaluation and
Repair Activities**

December, 1991

Consolidated Edison Company of New York, Inc.
4 Irving Place
New York, NY 10003

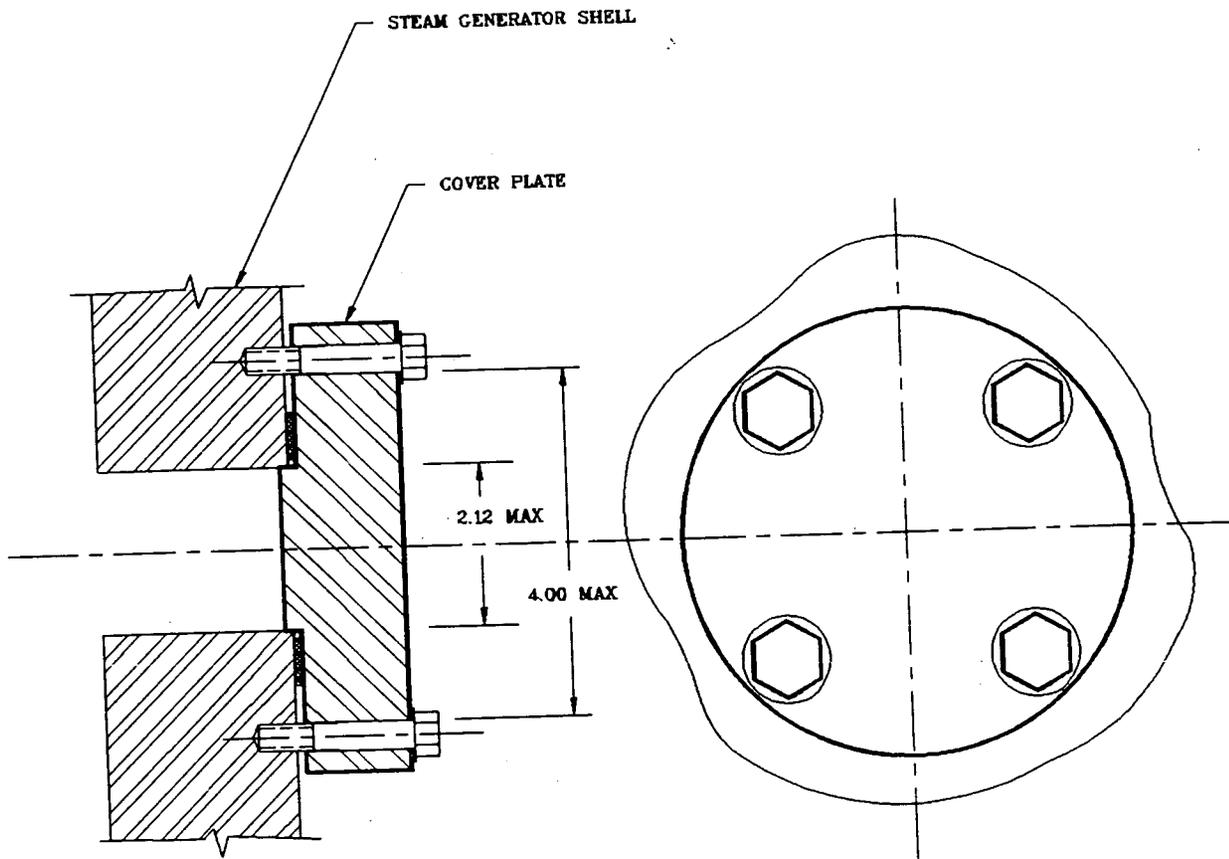
FIGURE 2.6
2 Inch Diameter Inspection Port Cover Plate Detail

The bore of the other three ports was examined by PT. No cracks were found. Figure 2.6 shows a typical 2 inch diameter inspection port.

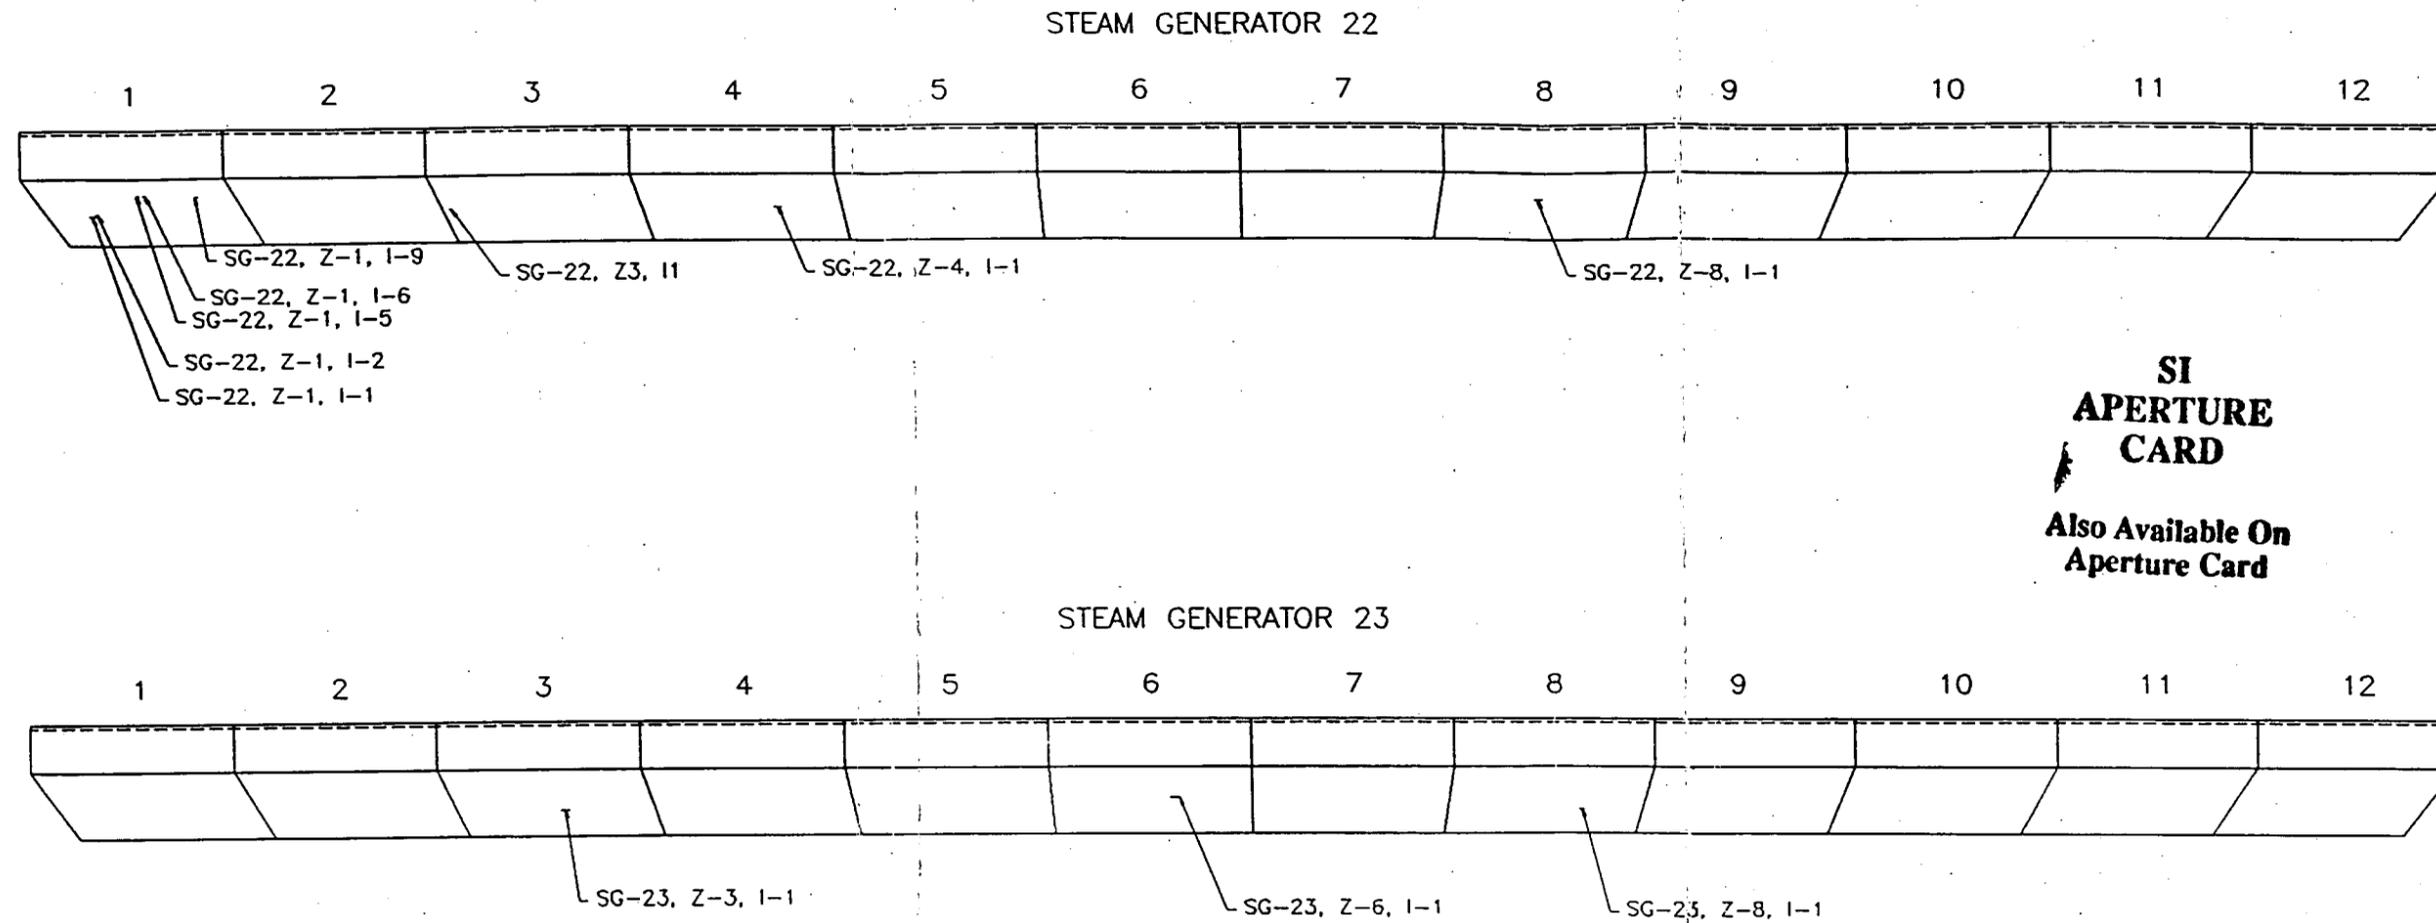
Nine boat samples containing eleven cracks were removed and analyzed. The boats were from Steam Generators 22 and 23. Two of the boat samples were from the girth weld and seven were from the region approximately 5 inches to 8 inches below the centerline of the girth weld. The location of the boat samples relative to the center line of the girth weld in Steam Generators 22 and 23 are shown in Figure 3.1. The cracks are identified by reference to the steam generator number, the zone number, and the crack number.

FIGURE 3.1
 The Location of the Boat Samples
 Relative to the Center Line of the Girth Weld
 in Steam Generators 22 and 23

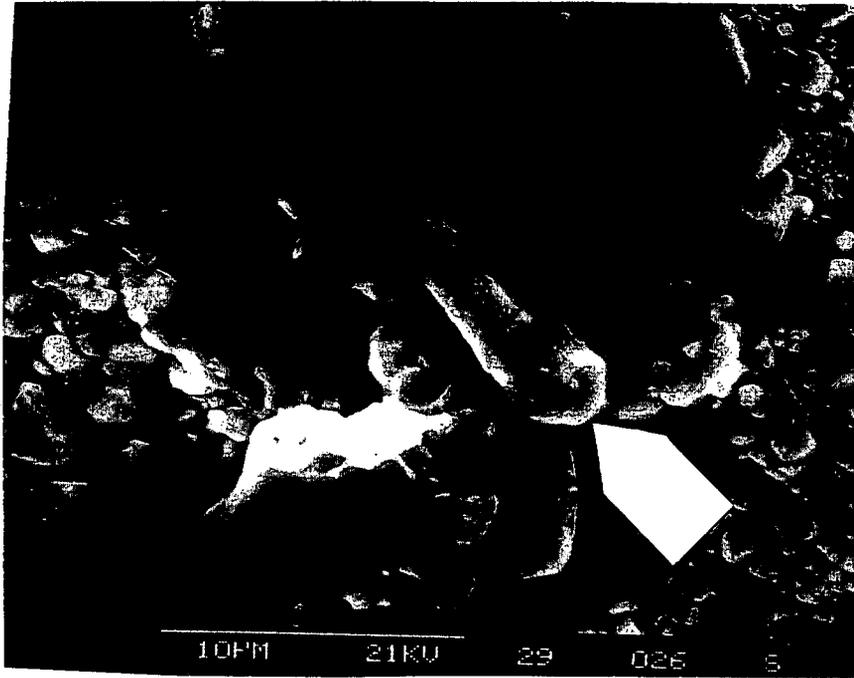
FIGURE 3.13

Fracture Showing Morphology of Copper Sulfide Particle,
 and X-Ray Spectra for the Copper Sulfide Particle
 (Boat From Steam Generator 22, Zone 1, Indications 5 & 6)

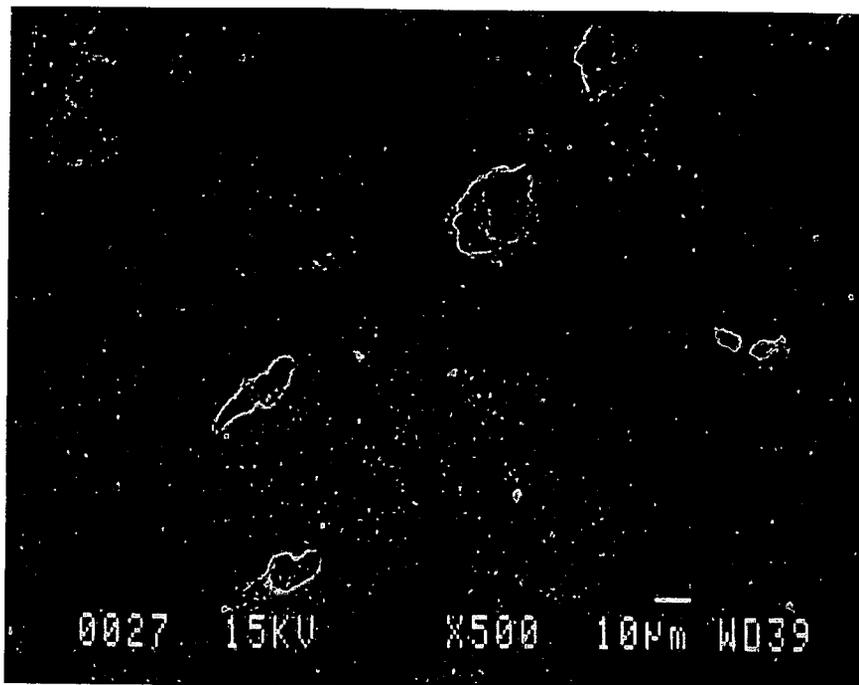
FIGURE 4.15

Figures 4.14 to 4.21 show the results of Test #HT-1 (250°C, pH 9, 300 ppb O₂). This test was typical of all of the tests with oxygen concentrations of 150 ppb or higher. Figure 4.14 shows the samples after the 50 hour exposure. Samples were suspended in the autoclave using steel wire which was sheathed with teflon tubing and shrunk on to eliminate any galvanic effects due to the connection. The specimen at the upper right is a 3 μ m finish sample while the sample immediately below is a 60 grit finish sample. The surface was characterized by a soft oxide and pits. Figure 4.15 shows an SEM micrograph of the surface that was typical of the 3 μ m samples after exposure. In general, the finer finish samples showed a lower density of pits than the coarse finish samples. The pits are evident. Figures 4.16 and 4.17 show micrographs of a sample that was sectioned normal to the exposed surface. Figure 4.16, in the unetched condition, shows the nature of the pitting. Figure 4.17 shows the same region in the etched condition.

SEM Micrograph of As-Tested HT-1 Sample Surface Showing Pits

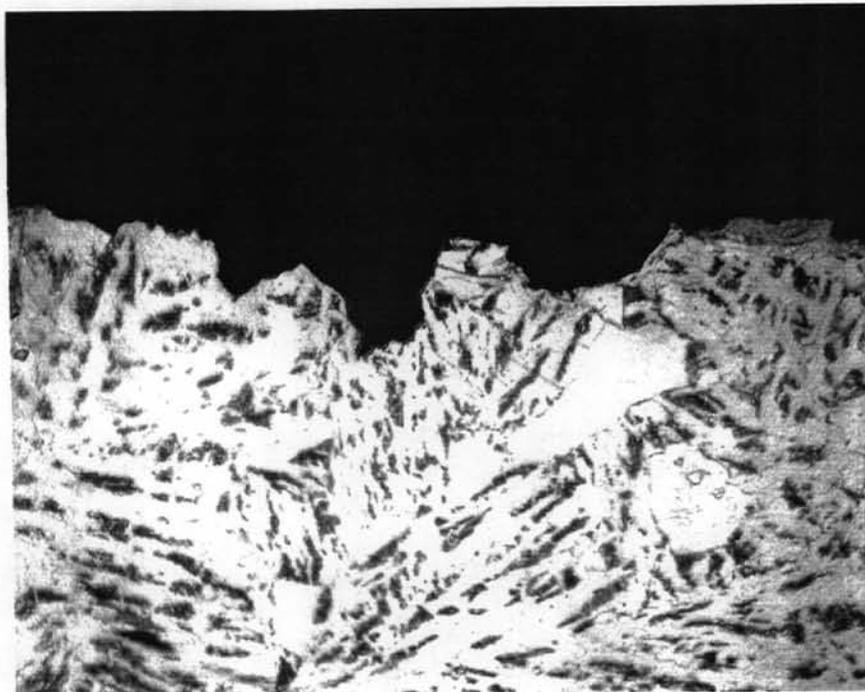
FIGURE 4.17

Optical Micrograph of HT-1 Sample Sectioned Normal to the Exposed Surface Showing Pitted Region of Figure 4.16, 500X, Etched.

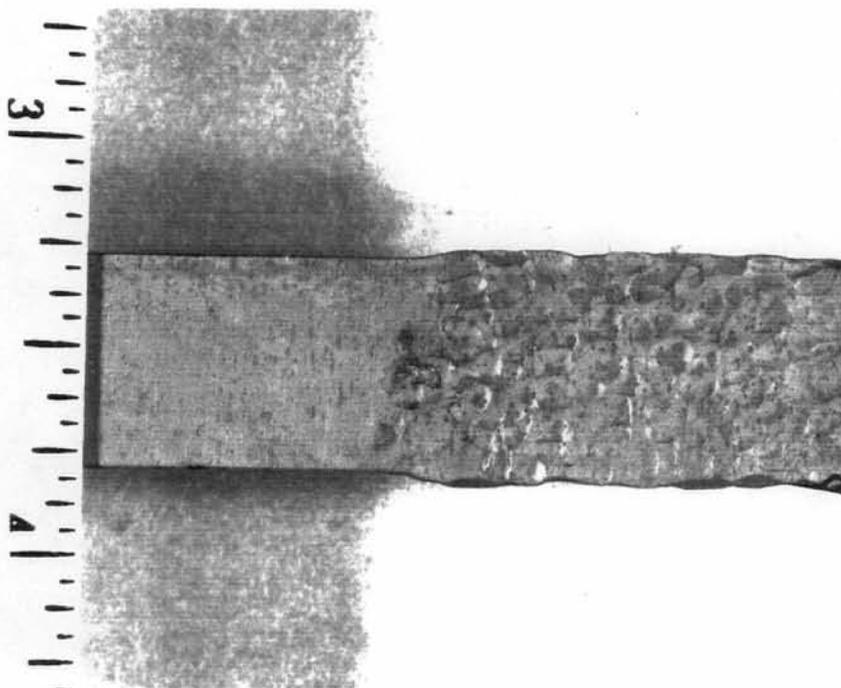
FIGURE 4.18

Figure 4.18 shows the severely peened sample, and Figure 4.19 shows the mildly peened sample. In general, the peened surfaces showed a higher density of pits than the un-peened surfaces.

Photograph of As-Tested Severe Peened Sample, HT-1.

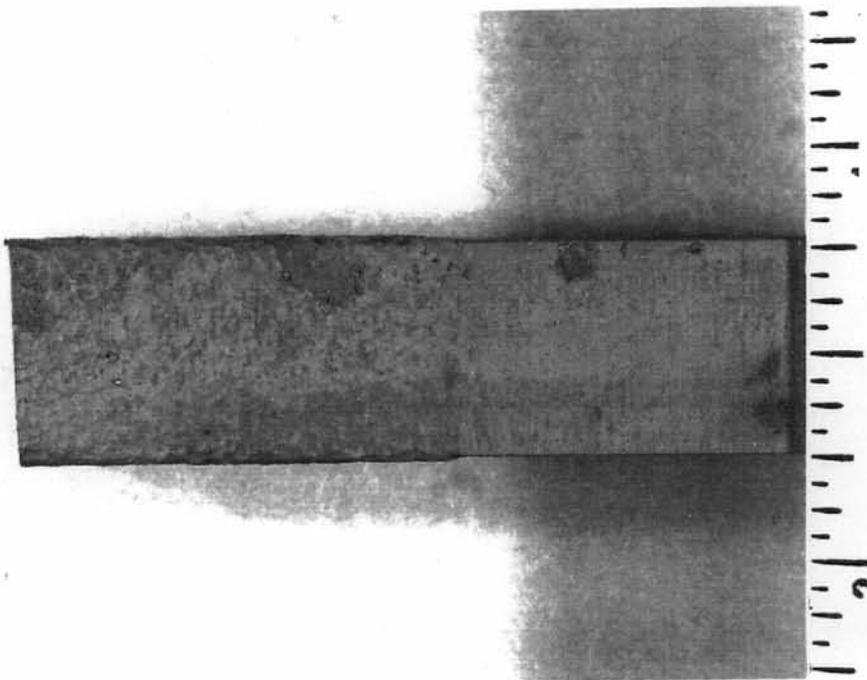
FIGURE 4.19

Photograph of As-Tested Mildly Peened Sample, HT-1.

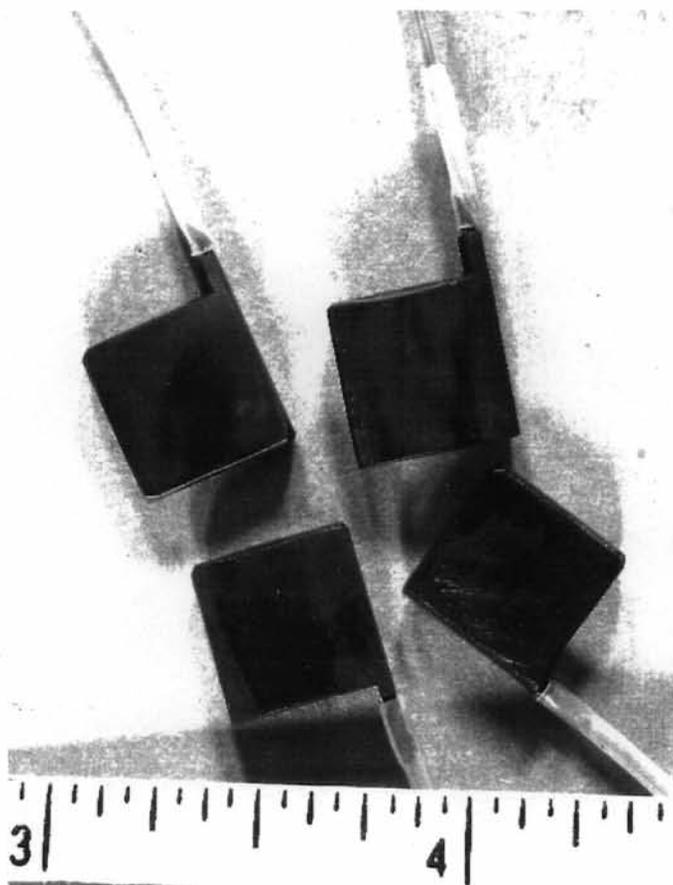
FIGURE 4.22

Figures 4.22 to 4.27 show results of Test #HT-3 (175°C, pH 9, 50 ppb O₂). This test was typical of all of the tests with oxygen concentrations below 150 ppb. There was no noticeable difference between the 250°C and the 175°C test results. Figure 4.22 shows the samples after testing. The surface was characterized by a thin dark oxide as opposed to the lighter colored and thicker oxide on the high oxygen samples. Figure 4.23 shows an SEM micrograph of a typical surface. While it was possible to find regions where inclusions had fallen, or were dissolved out of position, the density of these regions was at least a factor of 100 lower than in the high oxygen environment. There was no corrosion noted.

Photograph of As-Tested Samples for Test HT-3
Showing Dark Thin Oxide Film.

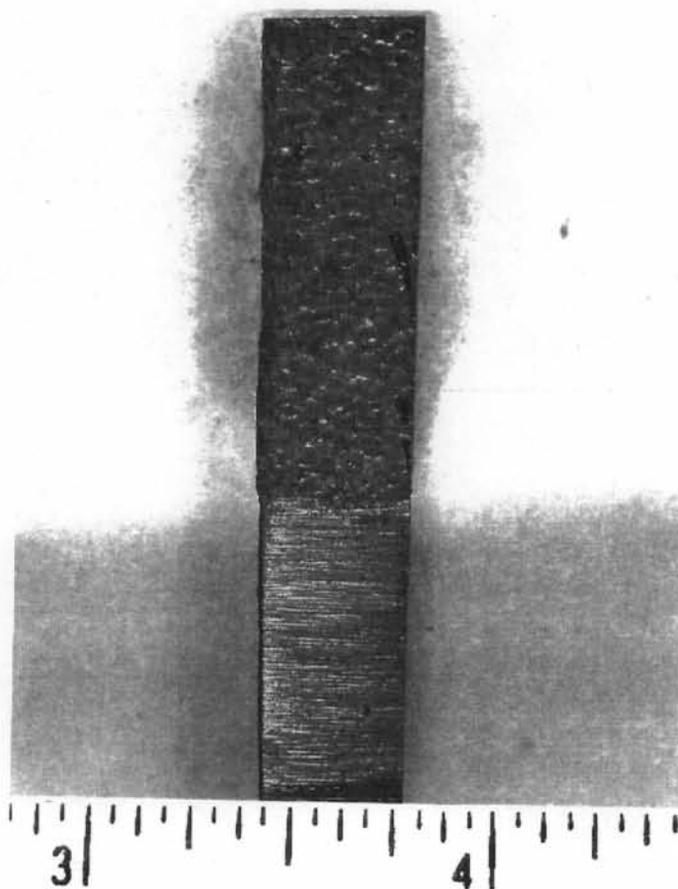
Figure 4.24

Figures 4.24 and 4.25 show the surfaces of the peened samples. As the photographs show, when compared with the high oxygen environment, the surface oxide is thin and adherent with little evidence of localized corrosion.

Photograph of Mildly Peened Sample, HT-3.
Note Lack of Visible Corrosion.

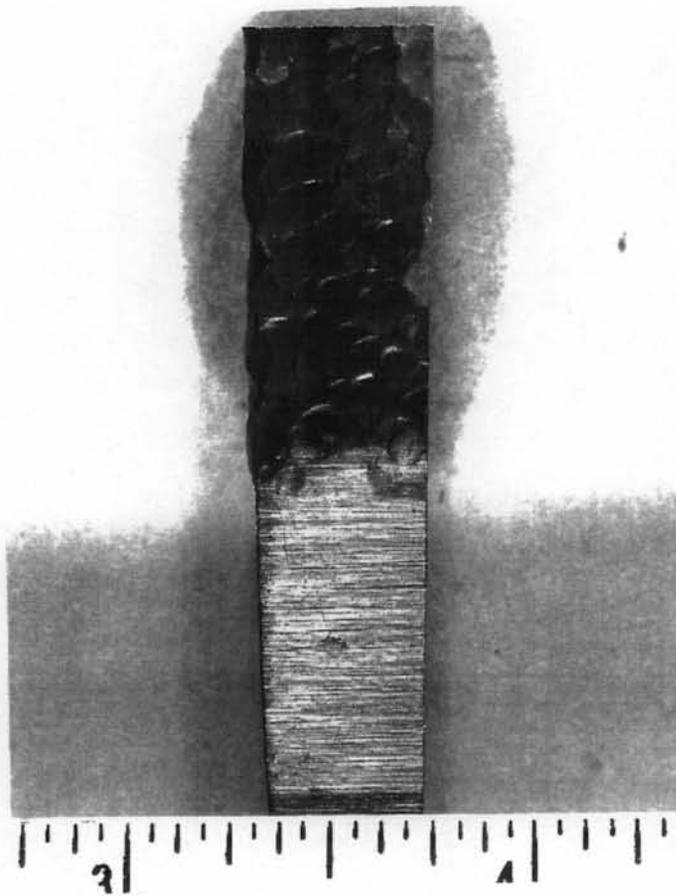
FIGURE 4.25

Photograph of Severe Peened Sample As-Tested, HT-3.

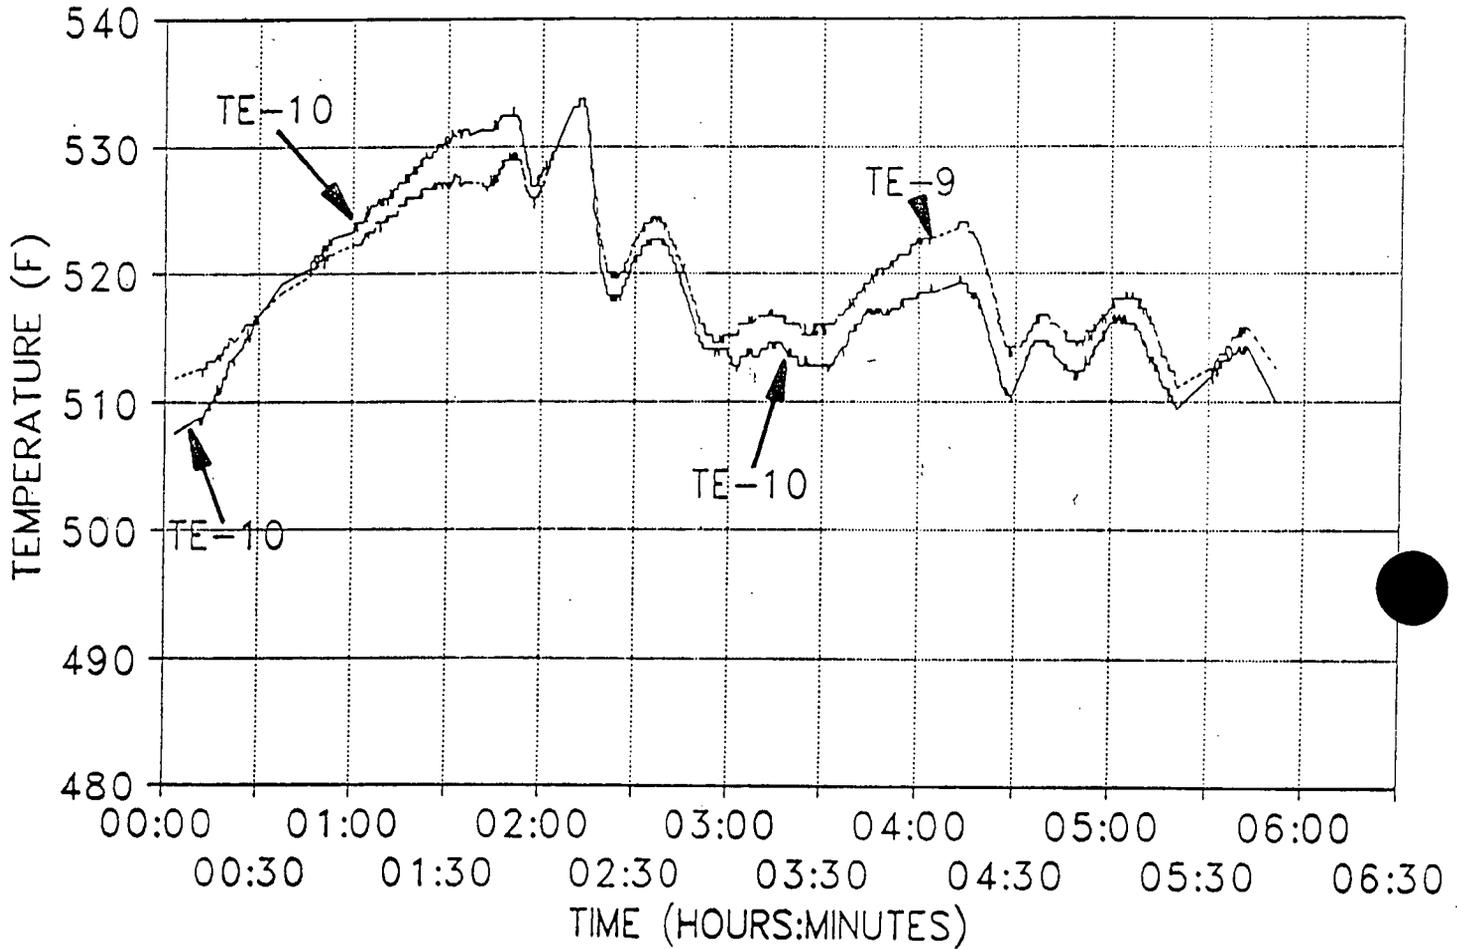
FIGURE 5.3

Temperature versus time plots were made of the girth weld thermocouple data for these two periods. Figure 5.3 shows the data from thermocouples 9 and 10 for the unit shutdown which was initiated at 22:33 on July, 27, 1990. The most rapid change in temperature occurred at approximately 02:00 and resulted in a ΔT of approximately 13°F with a period of approximately 30 minutes.

Data from Thermocouples 9 and 10 for the 7/27/90 Unit Shutdown

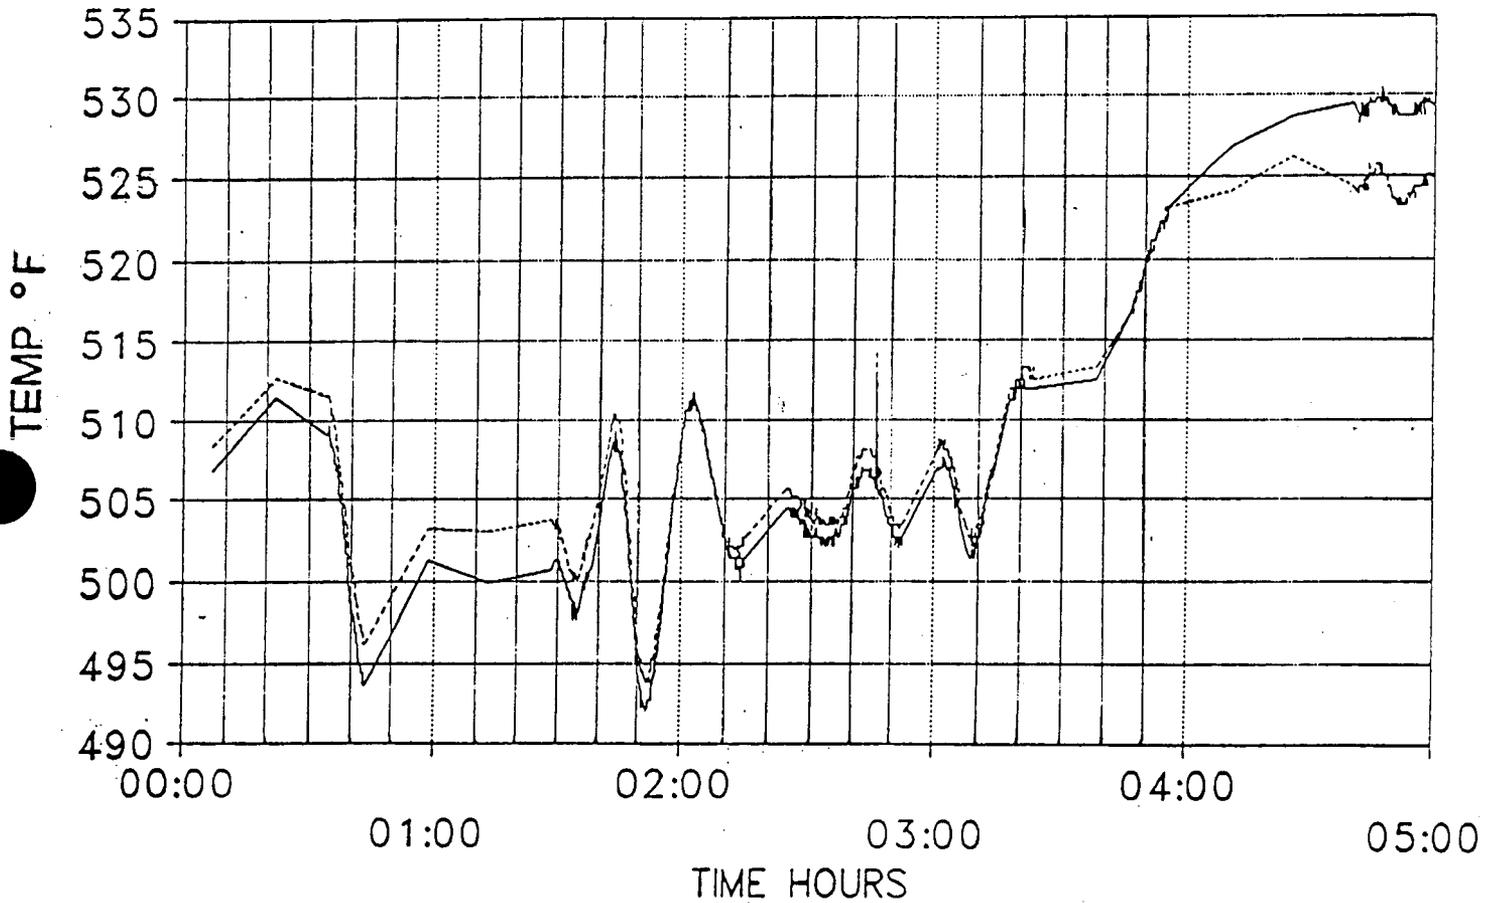
FIGURE 5.4

Figure 5.4 shows the data for these same thermocouples during the unit startup on June 23, 1990. In this event, the most rapid change in temperature occurred at approximately 02:00 and resulted in a ΔT of approximately 20°F with a period of approximately 20 minutes.

Data from Thermocouples 9 and 10 During Unit Startup on 6/23/90

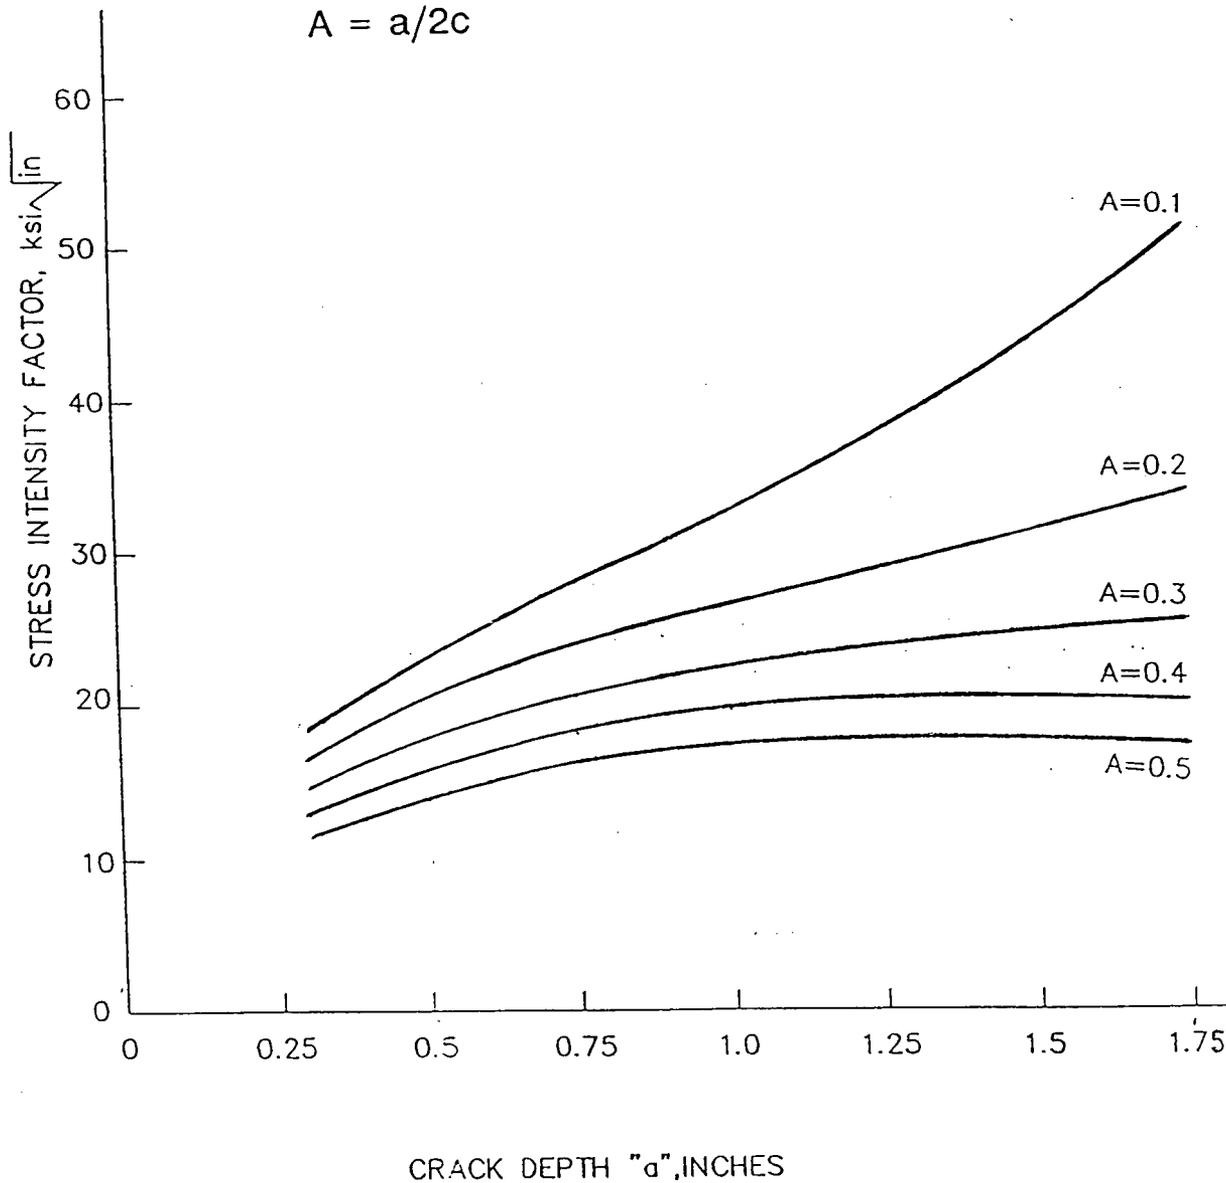
FIGURE 5.8

(a) and aspect ratios ($a/2c$) were evaluated. The stress intensity factor results are presented in Figure 5.8.

Stress Intensities for Cracks of Various Depths (a) and Aspect Ratios (a/2c) for the Pressure Axial Stress Distribution Shown in Figure 5.7

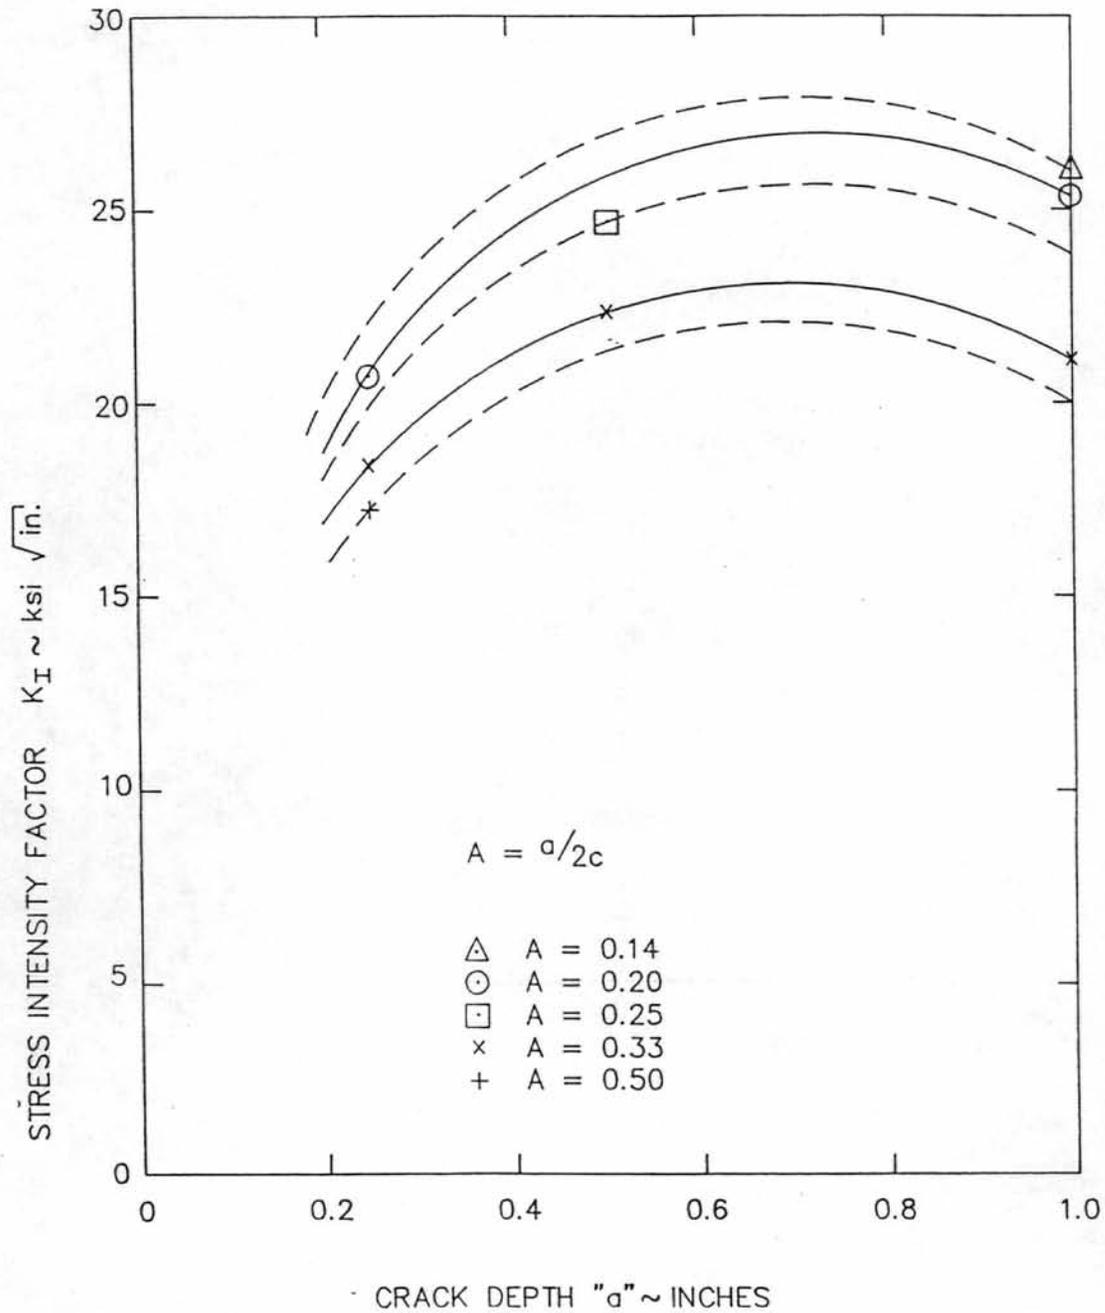
FIGURE 5.18

The through-wall stress distribution shown in Figure 5.17 was utilized to calculate stress intensity factors, K_I . Classical 2-D fracture mechanics solutions were utilized. These results are provided in Figure 5.18 and show that

Stress Intensity Factors, K_I , for the Stress
 Distribution Shown in Figure 5.17

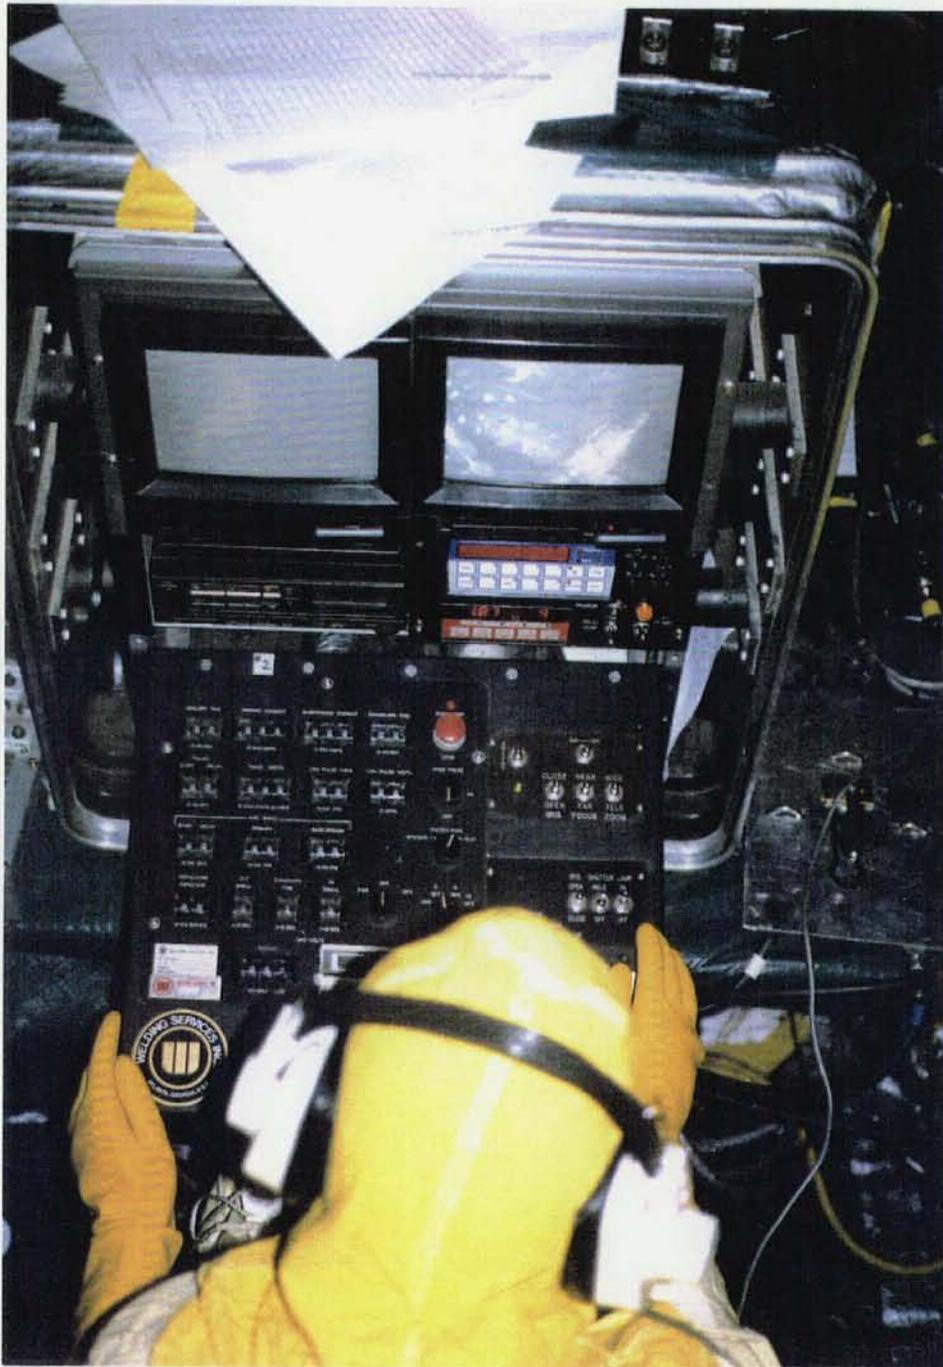
FIGURE 6.2

Operator's Control Console for Robotics

The original girth weld was removed by a robotic milling machine, producing a groove 6 inches wide and approximately 3/4 inch deep. Figure 6.1 shows the original weld, the machined groove, and the final welded contoured condition. The repair was performed remotely. Figures 6.2 through 6.4 show the operator's console for the girth weld repair robotics, the robotic milling machine and the milled welding groove, respectively. The weld metal used for the repairs was a Thyssen ER80S-G wire, specified to a sulfur content of less than 0.010%. The actual weld material sulfur content was verified to be below the specification. The chemical analysis of the filler metal is provided in Table 6.1. All of the filler metal used was manufactured from the same heat of material. The low sulfur filler metal reduces the quantity of sulfide inclusions that can be formed in the weldment. Laboratory tests have shown that sulfide inclusions in steel can develop into preferential pitting and corrosion sites. By reducing the available constituents for inclusion formation, the number of inclusions and hence, pit locations, are reduced.

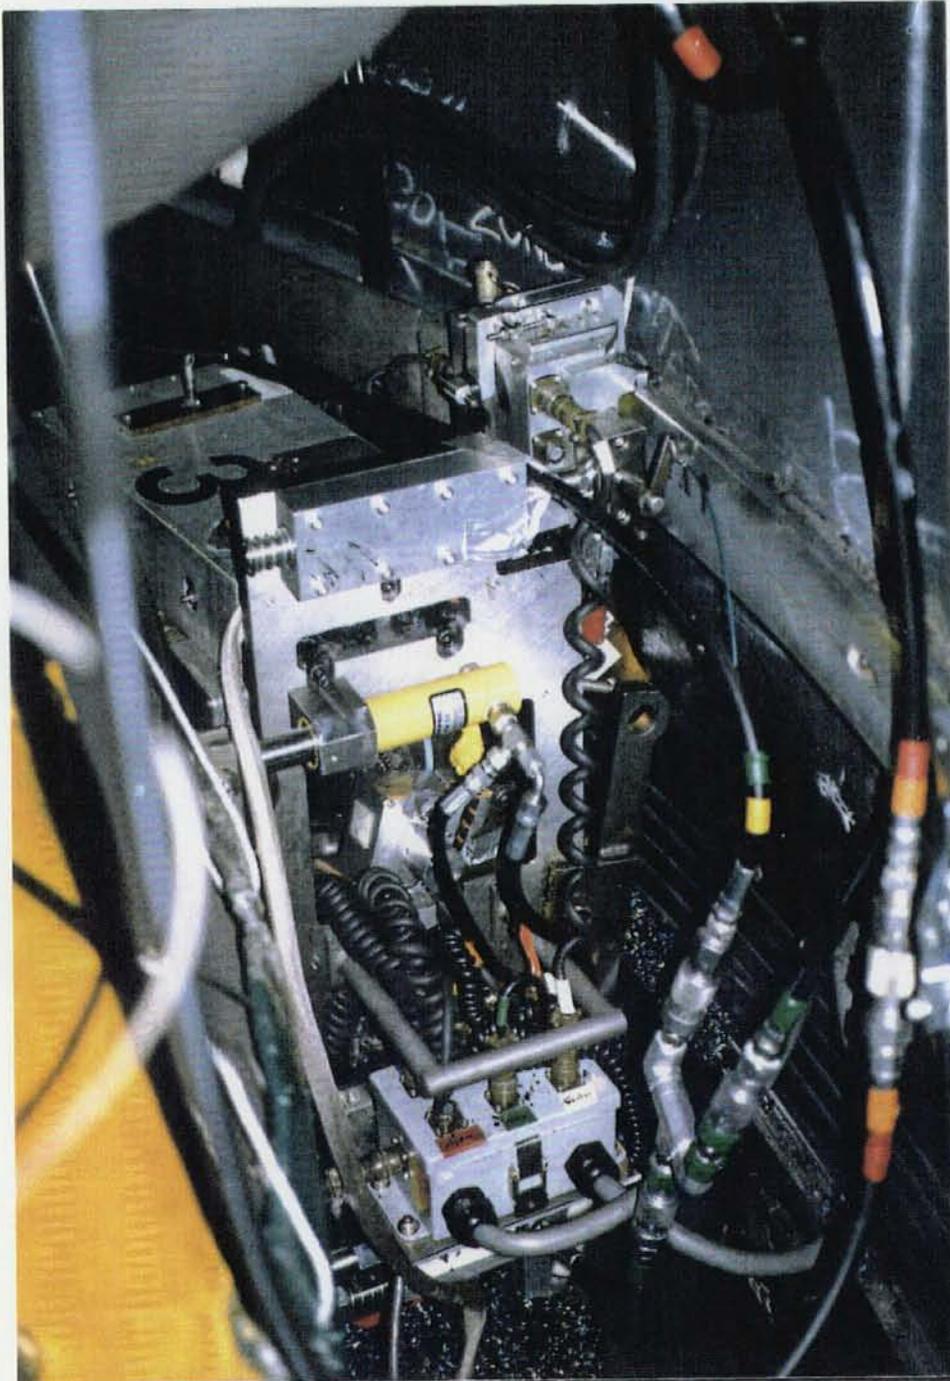
FIGURE 6.3
Robotic Milling Machine

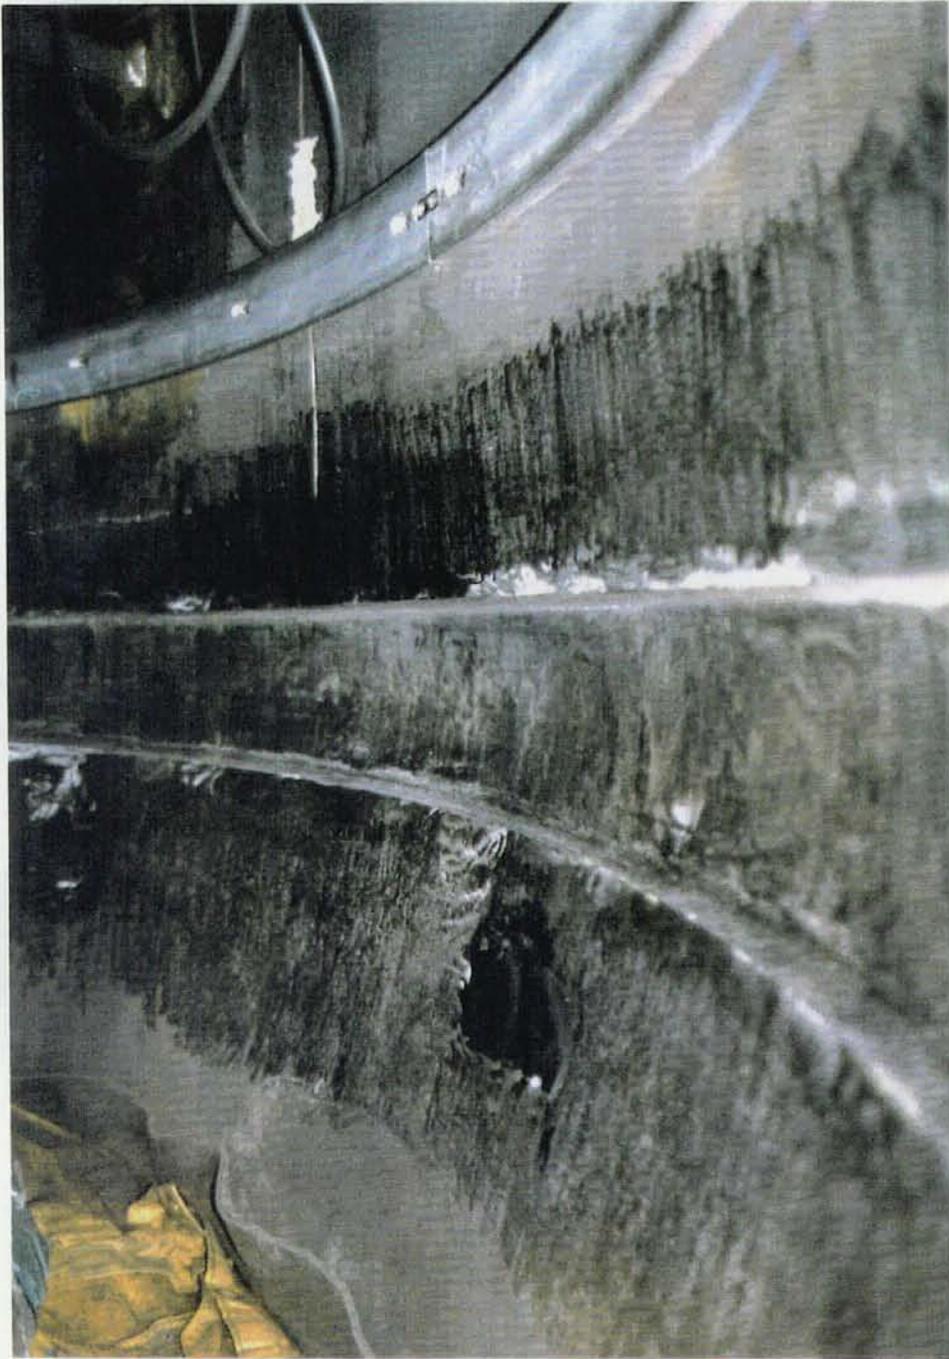
FIGURE 6.4
Milled Welding Groove

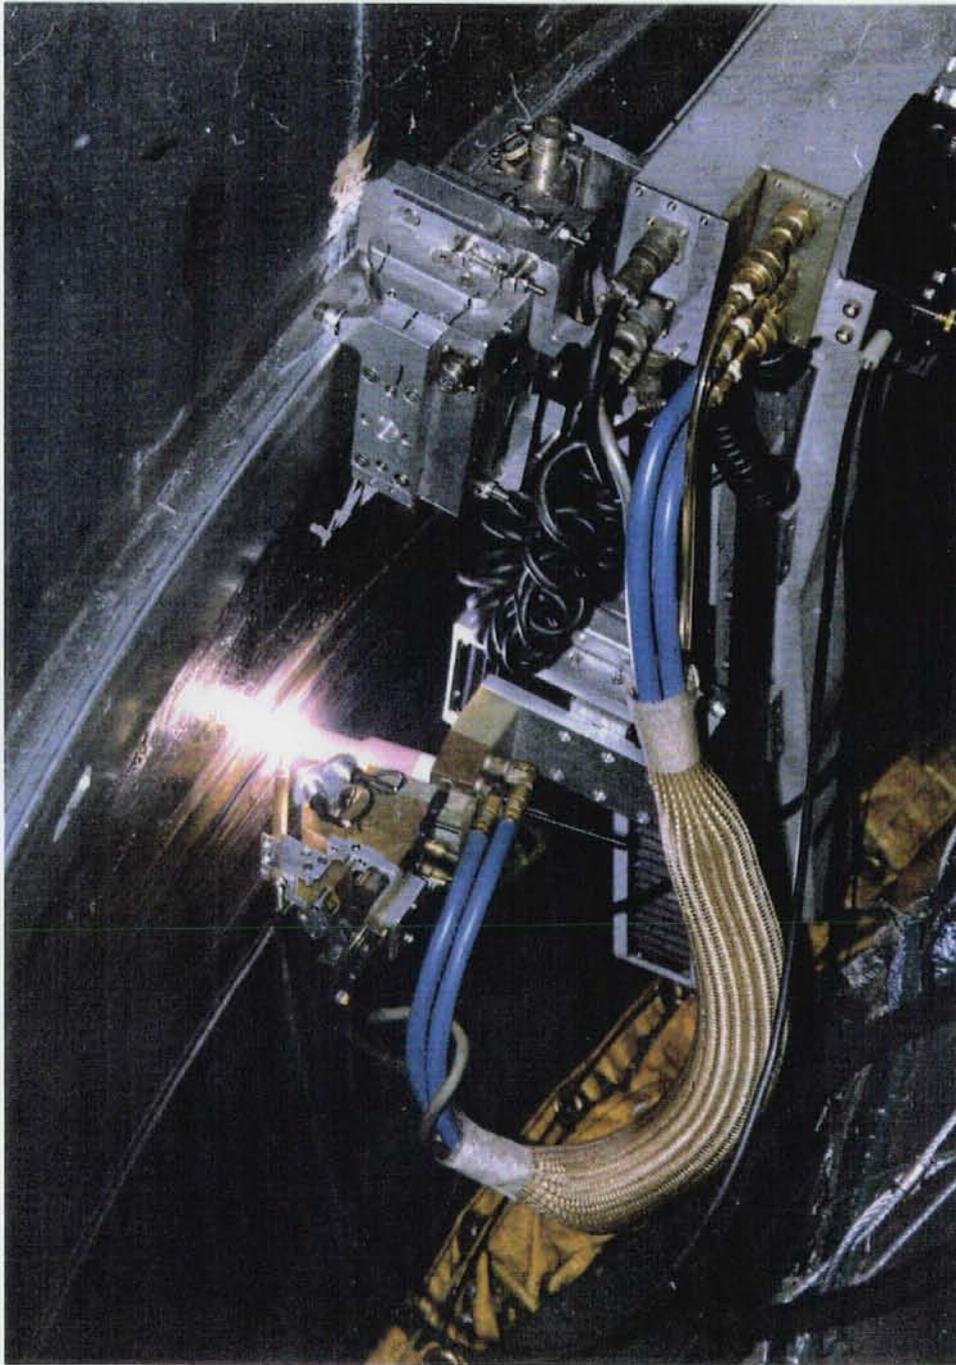
FIGURE 6.5
Robotic Welding Machine

The welding was performed by automatic Gas Tungsten Arc Welding, utilizing robotic welding machines. The completed welds were contoured and smoothed to provide a minimum 20 inch radius and an approximate 64 RMS finish. The radius provides a smoothly contoured transition between the upper barrel and the transition cone, thereby minimizing the geometry stress concentration effect. The radius is a significant improvement over the original condition in which the crown of the weld was readily apparent. Figures 6.5 through 6.8 show the robotic welding machine, the as-welded surfaces, and the contoured

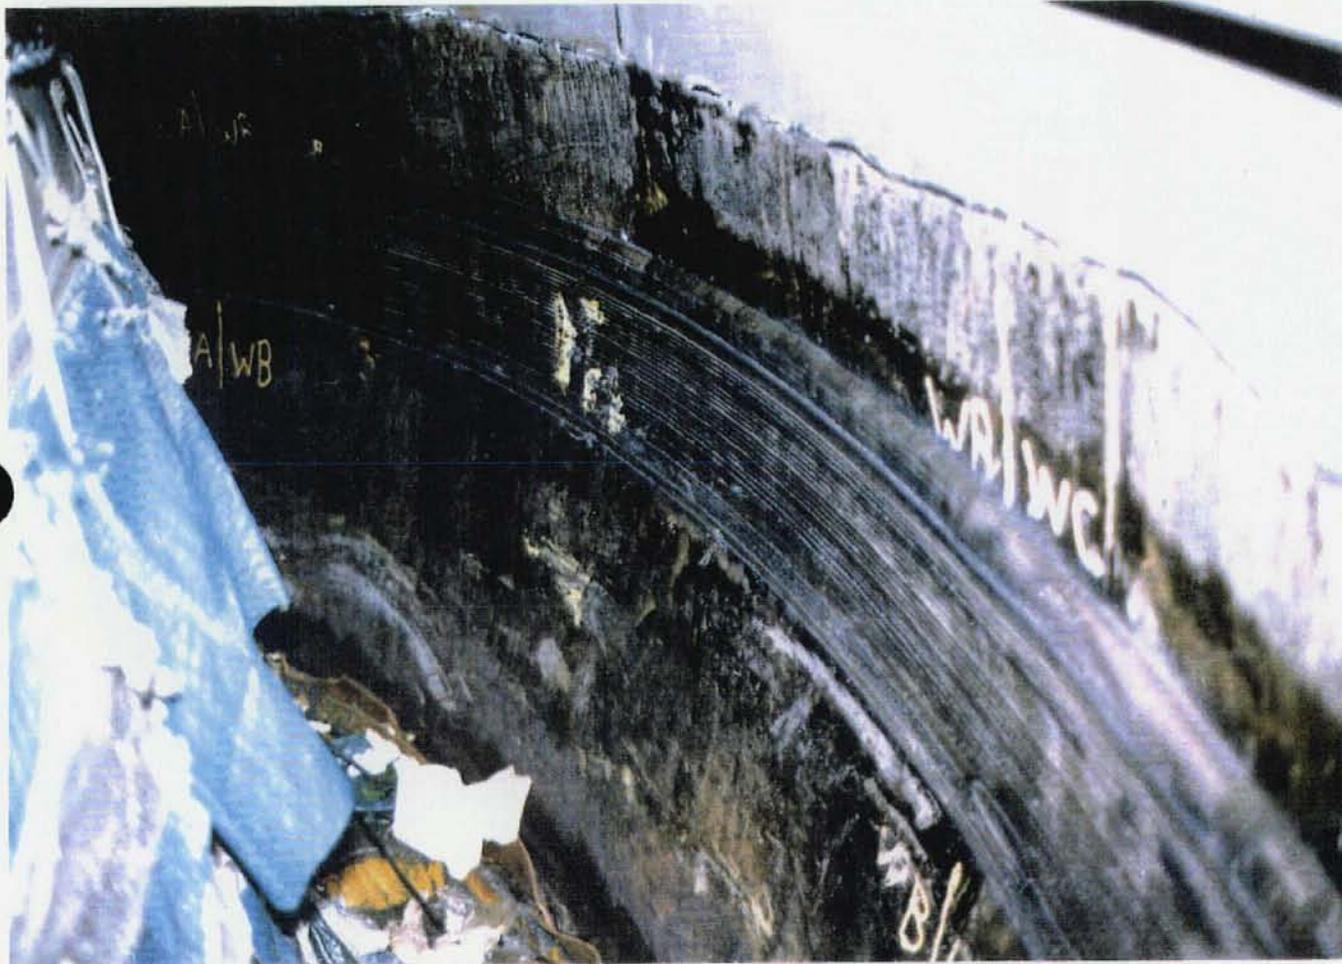
FIGURE 6.6

Girth Weld As-Welded Surface
