**Indian Point Unit 2
1991 Steam Generator
Inspection, Evaluation and
Repair Activities**

December, 1991

Consolidated Edison Company of New York, Inc.
4 Irving Place
New York, NY 10003

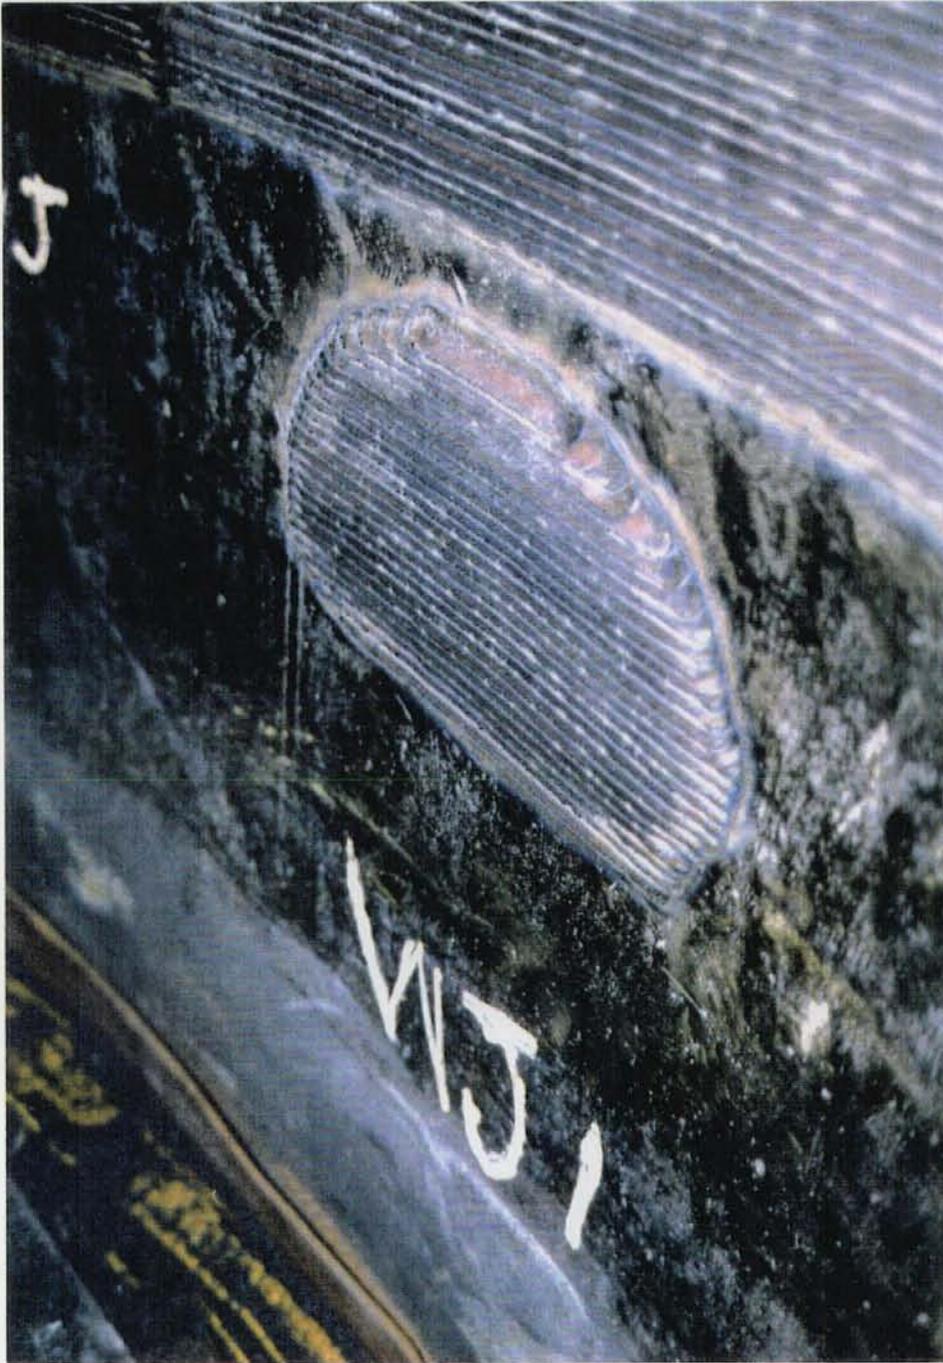
FIGURE 6.7
Below Girth Weld As-Welded Surface

The welding was performed by automatic Gas Tungsten Arc Welding, utilizing robotic welding machines. The completed welds were contoured and smoothed to provide a minimum 20 inch radius and an approximate 64 RMS finish. The radius provides a smoothly contoured transition between the upper barrel and the transition cone, thereby minimizing the geometry stress concentration effect. The radius is a significant improvement over the original condition in which the crown of the weld was readily apparent. Figures 6.5 through 6.8 show the robotic welding machine, the as-welded surfaces, and the contoured

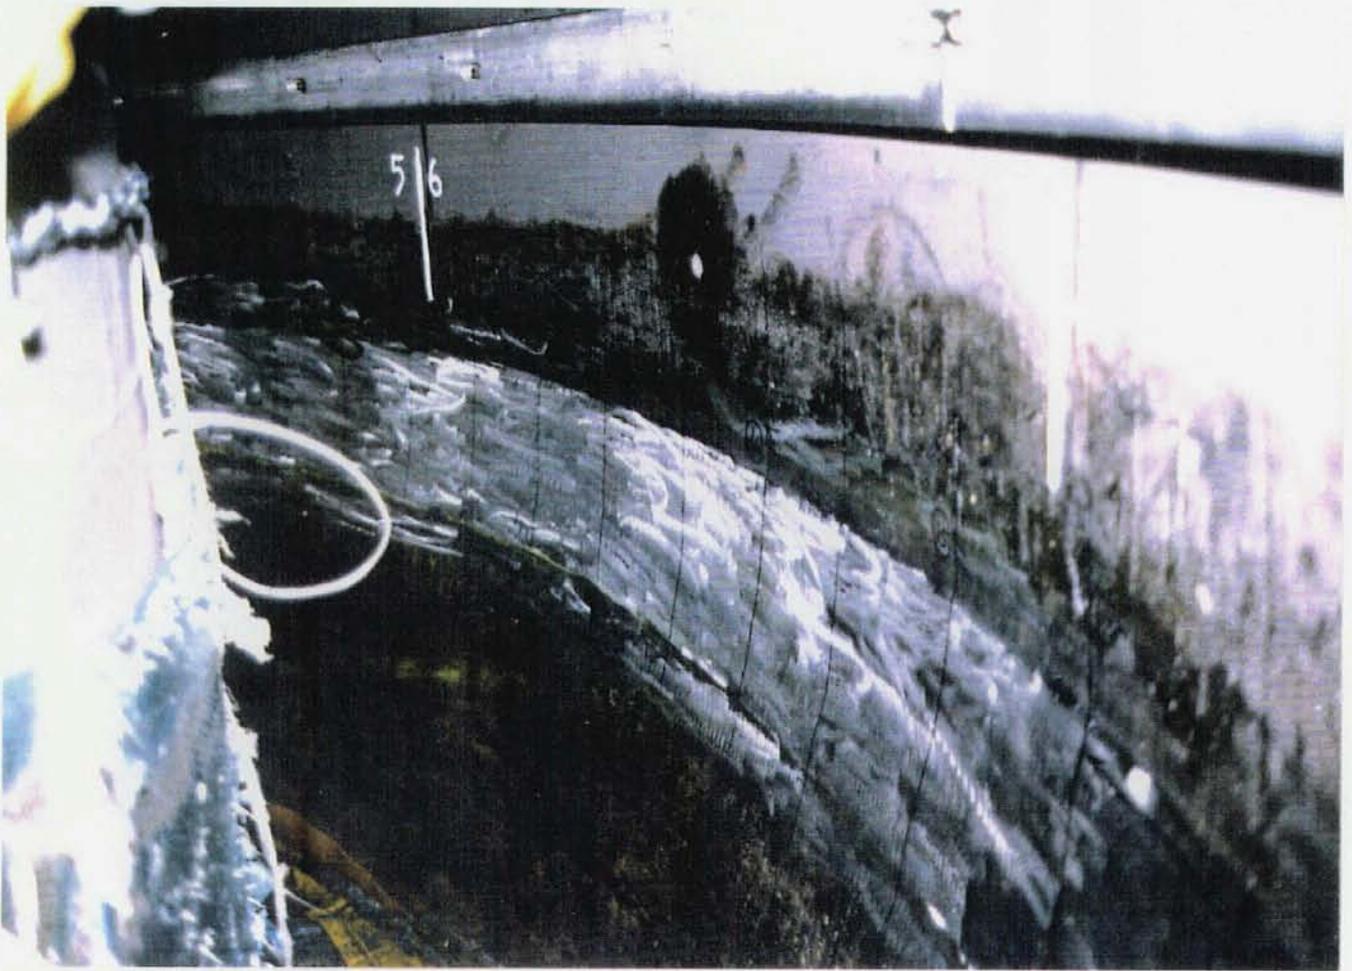
FIGURE 6.8
Girth Weld Surface After Contouring

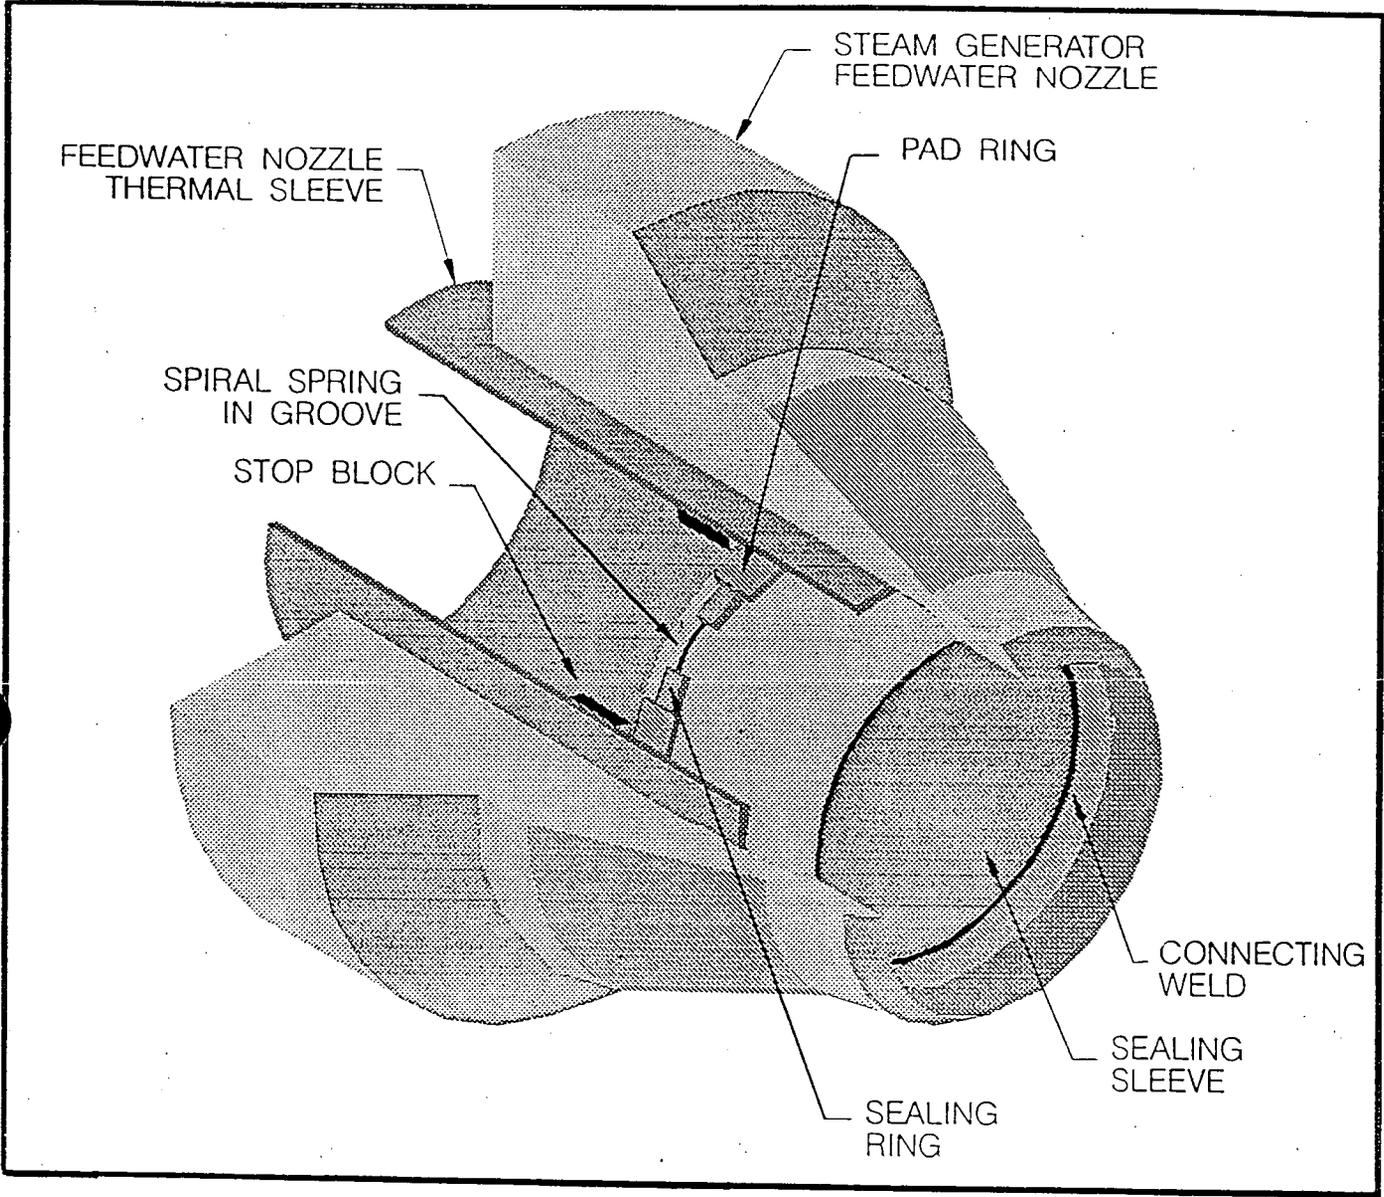
FIGURE 6.9

A feedwater nozzle sealing sleeve assembly was installed to reduce the amount of feedwater which leaks past the existing thermal sleeve into the feedwater nozzle bore. Leakage of cold feedwater has resulted in thermal fatigue of the feedwater nozzle under the thermal sleeve during periods of cold feedwater or auxiliary feedwater injection.

Feedwater Nozzle Sealing Sleeve

The sealing sleeve, Figure 6.9, was installed in all four steam generator feedwater nozzles after the feedwater pipe at the feedwater nozzles were cut for the girth weld post weld heat treatment.

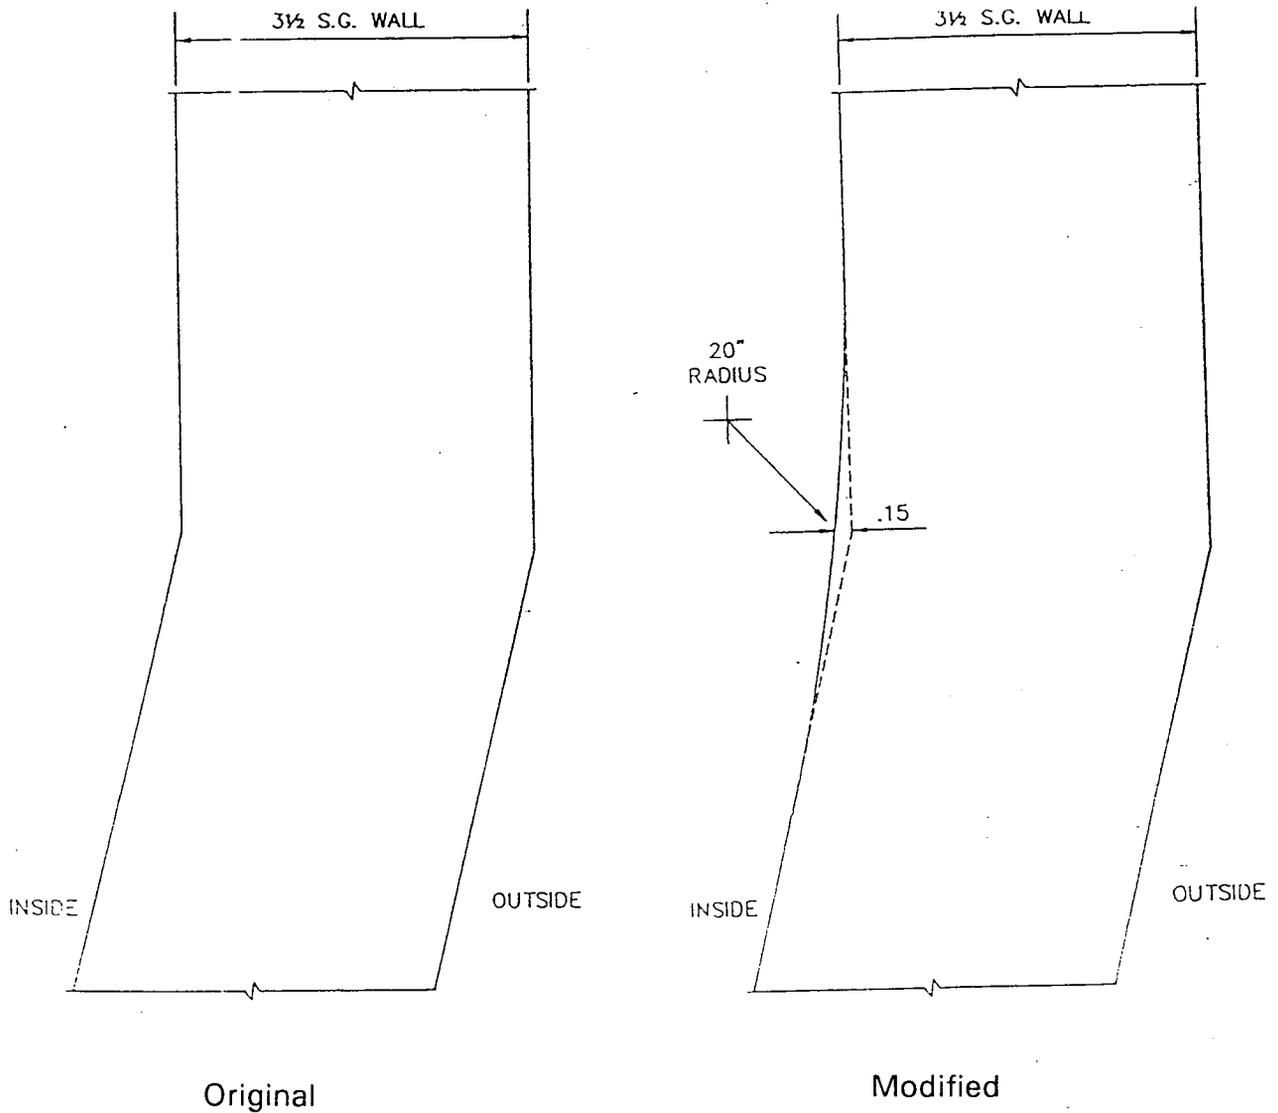
A finite element model of the steam generator girth weld was prepared. The model represented the repaired condition including the 20 inch blend radius as shown in Figure 7.1. The ANSYS computer code was utilized. The model is an axisymmetric finite element model of the steam generator shell. The model extends in the axial direction 48 inches above the girth weld and 75 inches below the girth weld. The number of elements through the thickness is greater at the region of the girth weld where additional detail is required. Eight elements are provided through the thickness at the girth weld. Figure 7.2 shows the cross-section of the model with the repaired girth weld geometry, and Figure 7.3 shows the finite element mesh at the region close to the girth weld.

FIGURE 7.1
 Cross-Section of Original Girth Weld and Modified Girth Weld
