**Indian Point Unit 2
1991 Steam Generator
Inspection, Evaluation and
Repair Activities**

December, 1991

Consolidated Edison Company of New York, Inc.
4 Irving Place
New York, NY 10003

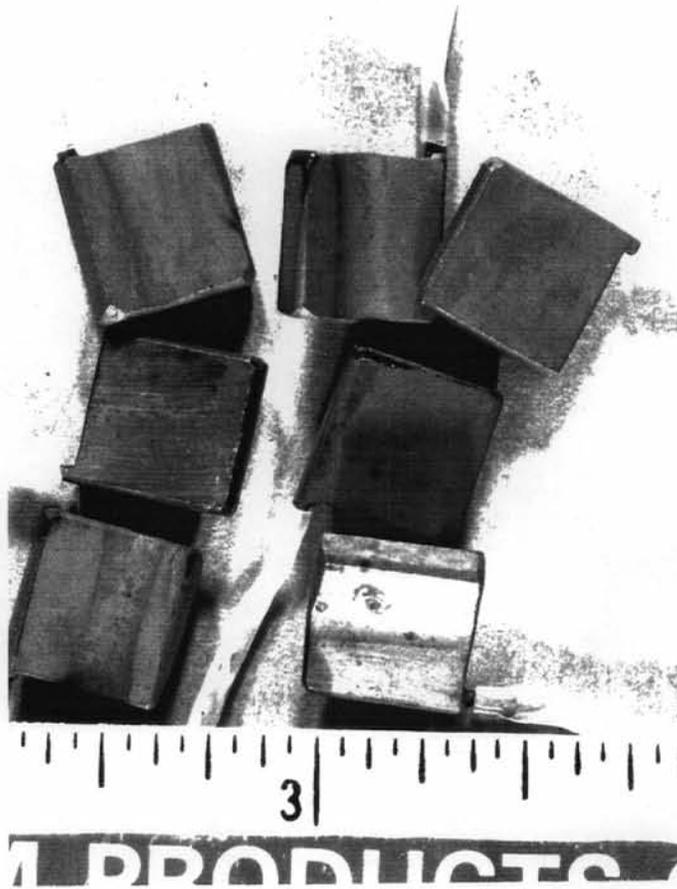
FIGURE 4.14

Figures 4.14 to 4.21 show the results of Test #HT-1 (250°C, pH 9, 300 ppb O₂). This test was typical of all of the tests with oxygen concentrations of 150 ppb or higher. Figure 4.14 shows the samples after the 50 hour exposure. Samples were suspended in the autoclave using steel wire which was sheathed with teflon tubing and shrunk on to eliminate any galvanic effects due to the connection. The specimen at the upper right is a 3 μ m finish sample while the sample immediately below is a 60 grit finish sample. The surface was characterized by a soft oxide and pits. Figure 4.15 shows an SEM micrograph of the surface that was typical of the 3 μ m samples after exposure. In general, the finer finish samples showed a lower density of pits than the coarse finish samples. The pits are evident. Figures 4.16 and 4.17 show micrographs of a sample that was sectioned normal to the exposed surface. Figure 4.16, in the unetched condition, shows the nature of the pitting. Figure 4.17 shows the same region in the etched condition.

Photograph of As-Tested Samples for Test HT-1.

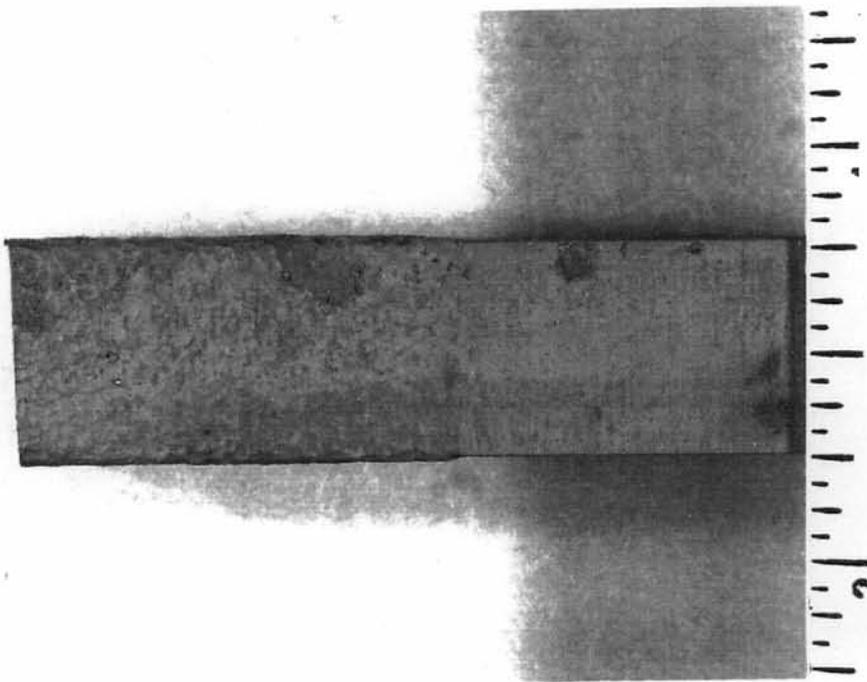
FIGURE 4.19

Figure 4.18 shows the severely peened sample, and Figure 4.19 shows the mildly peened sample. In general, the peened surfaces showed a higher density of pits than the un-peened surfaces.

Photograph of As-Tested Mildly Peened Sample, HT-1.

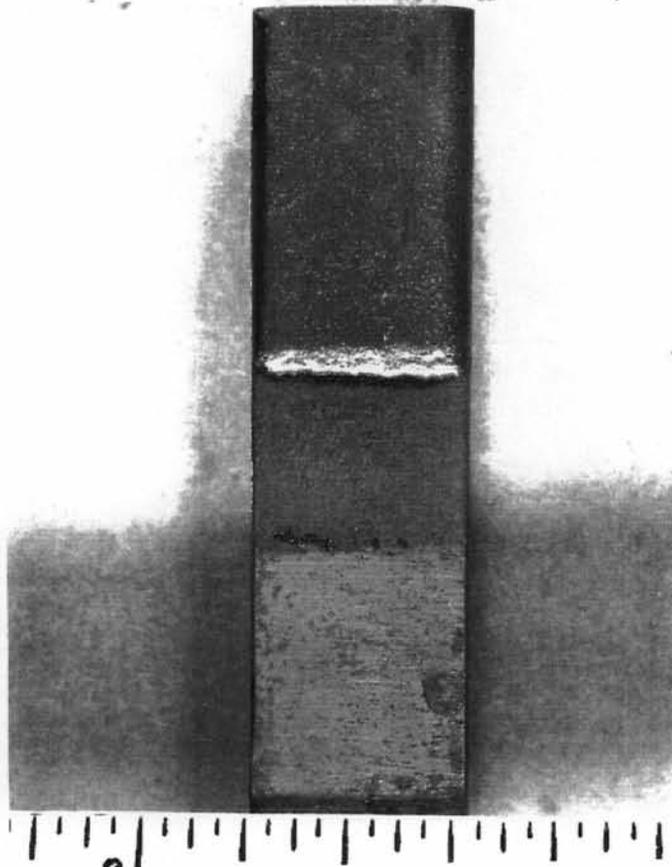
FIGURE 4.20

Figures 4.20 and 4.21 show a "coated surface" sample. Figure 4.20 shows a macro-photo of the as-tested sample. The upper half of the sample had been plasma sprayed while the lower half had not. Figure 4.21 shows a higher

Photograph of As-Tested Coated Sample, HT-1.

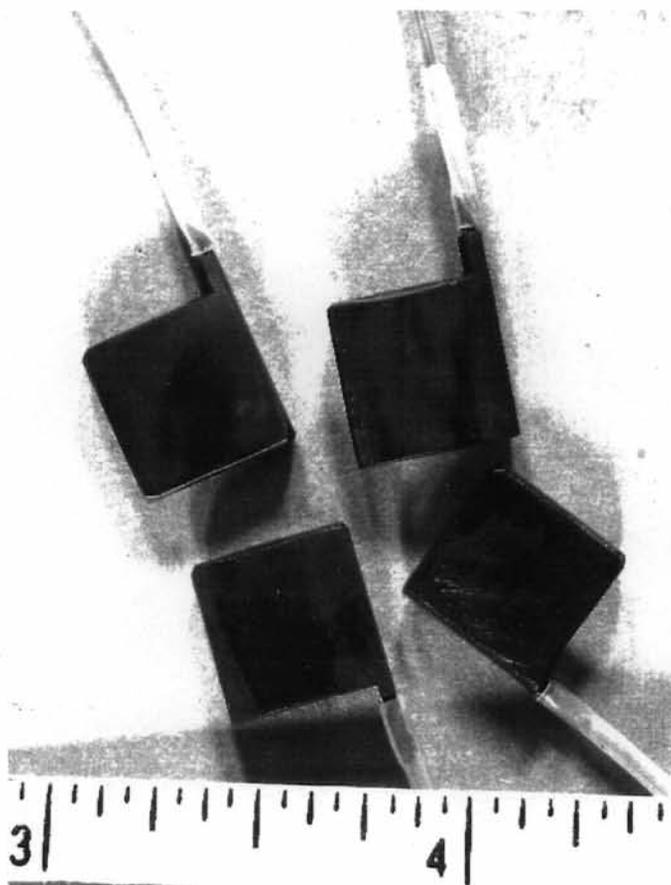
FIGURE 4.22

Photograph of As-Tested Samples for Test HT-3
Showing Dark Thin Oxide Film.

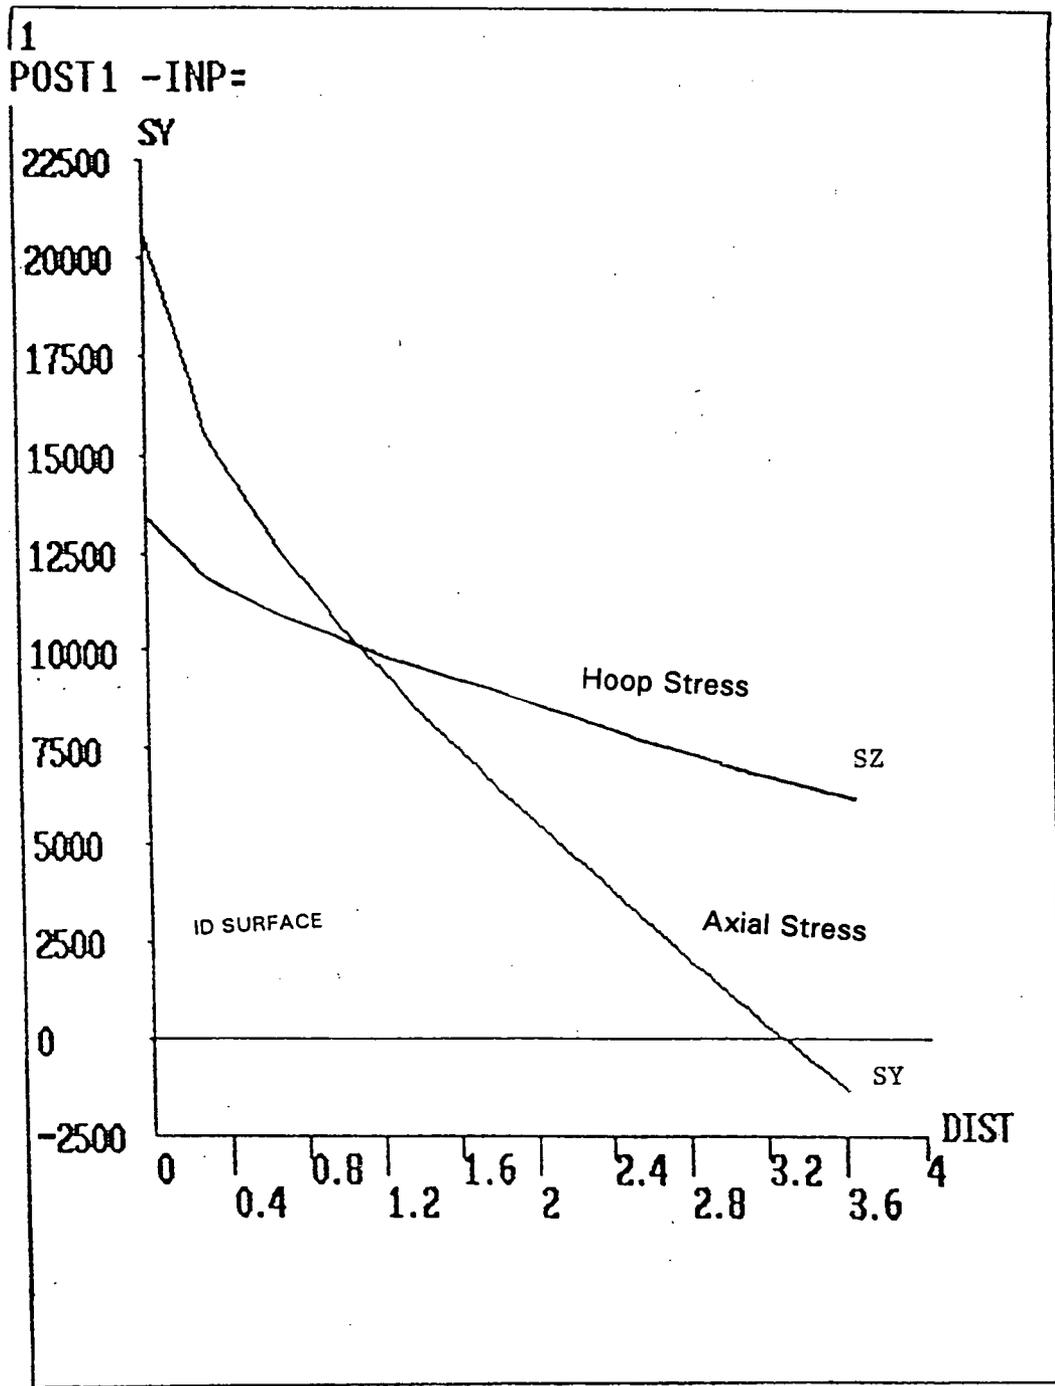
FIGURE 5.7

Figure 5.7 shows the through-wall distribution of the axial stress and the hoop stress at the center of the girth weld. This shows that at the inside surface of the girth weld the axial stress is approximately 50% larger than the hoop stress. These analyses also indicate that at a depth of approximately 1 inch from the inside surface of the shell, the axial stress value is reduced to a level below the hoop stress value.

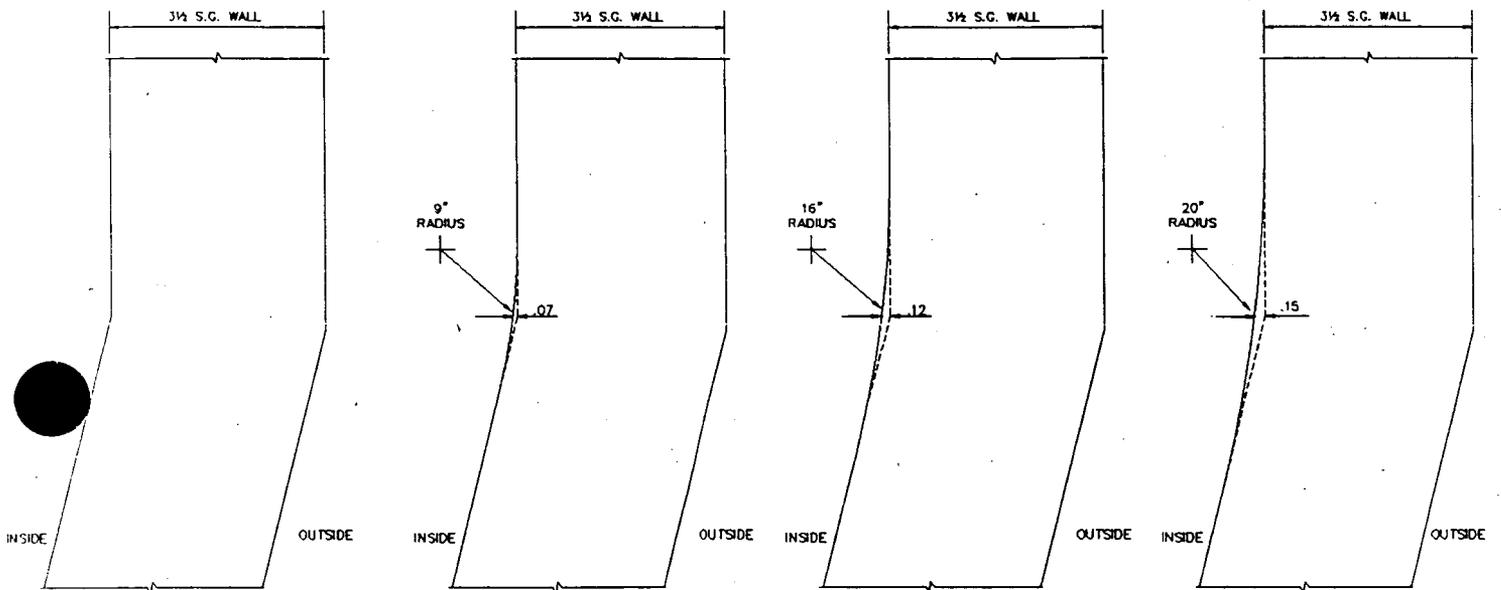
The effects of the repair weld contour radius was evaluated. Various weld radii were considered as shown in Figure 7.4. The use of the 20 inch radius increased the thickness of the shell by 0.15 inch. The pressure stress and the thermal stress for these different cases were evaluated. Figure 7.5 shows the comparison of the pressure stress for the original configuration and the 20 inch radius configuration. This is a plot of the axial surface stress variation in the axial direction with the centerline of the girth weld at the 3 inch location. Note that the maximum pressure stress, which occurs at the centerline of the girth weld, is 20,600 psi for the original configuration and 16,200 psi for the 20 inch radius repaired configuration. This reduction in the stress is largely due to the greater thickness and the reduced stress concentration.

FIGURE 7.4
Variation in Girth Weld Contour Radius

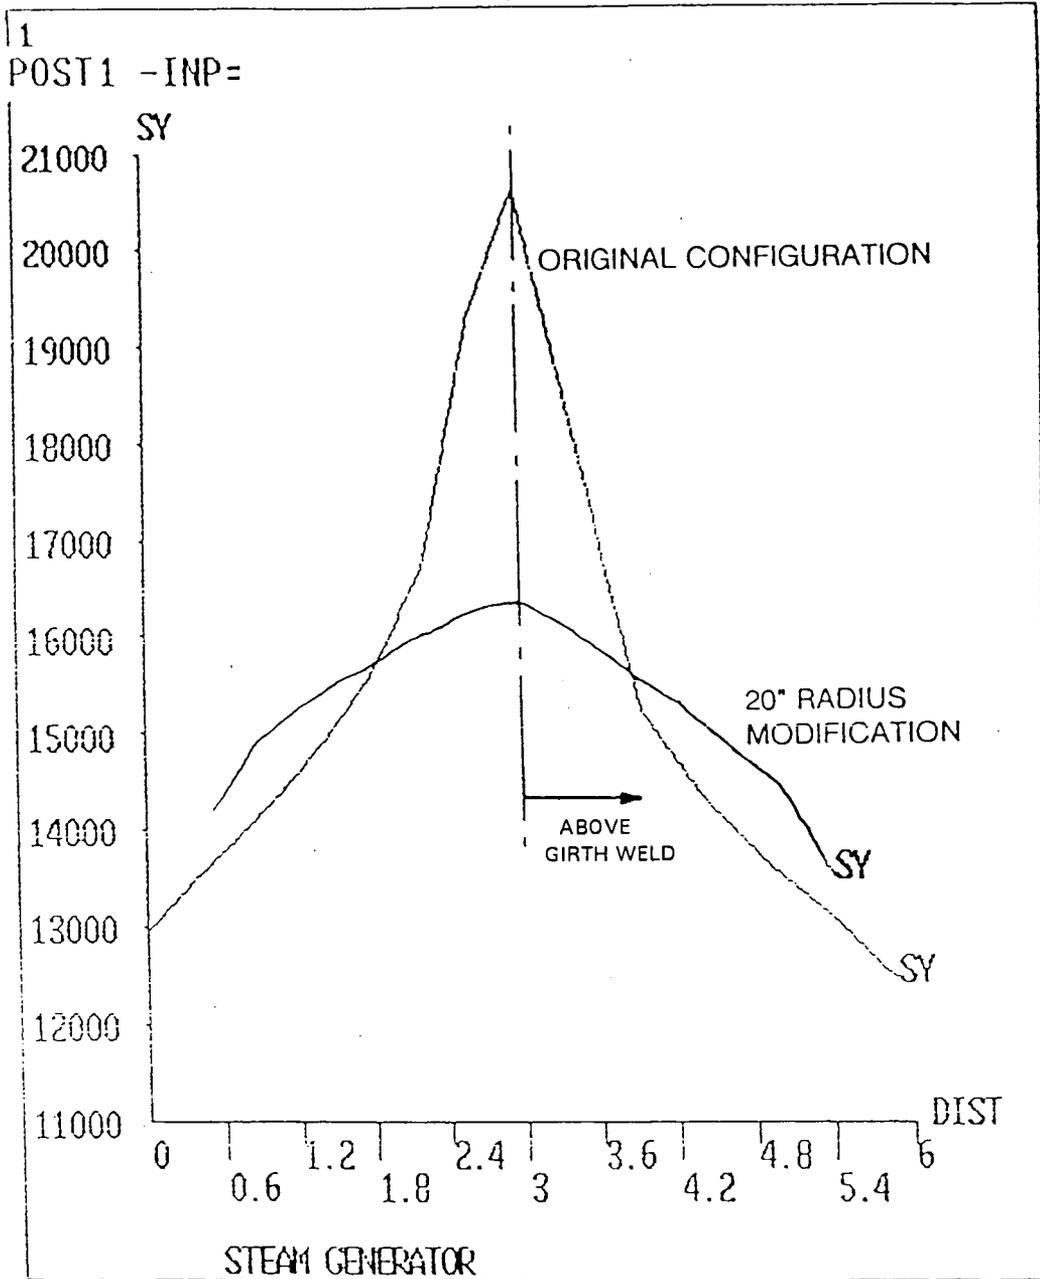
FIGURE 7.5

Comparison of these analyses shows that the stresses due to pressure and thermal transients are lower for the repaired weld than for the original design.

Effect of Girth Weld Contour Radius on
Pressure Stresses

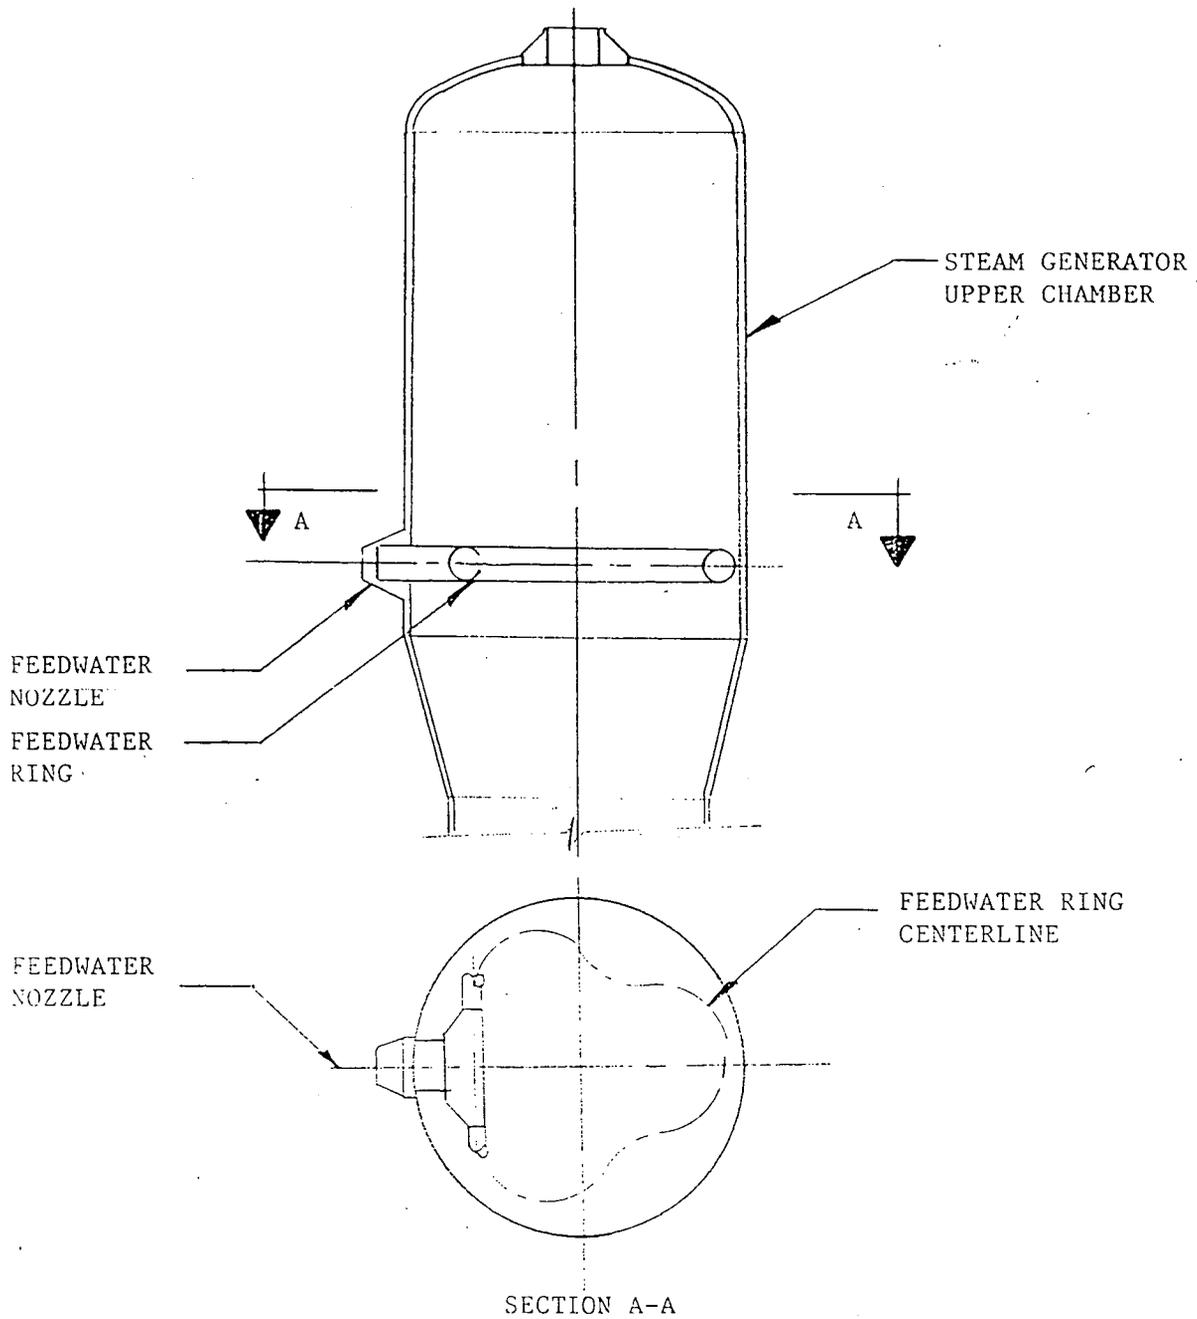
FIGURE 8.1

Following an inspection of the feedwater nozzle surfaces with the thermal sleeve removed, indication of nozzle cracking had been observed beneath the thermal sleeve in the 1990 outage. The location and schematic of the present feedwater nozzle arrangement is as shown in Figure 8.1. The cause of the nozzle cracking has been attributed to cold feedwater leaking past the existing thermal sleeve. This leakage flow path is schematically shown in Figure 8.2.

Series 44 Steam Generator &
Feedwater Nozzle Arrangement

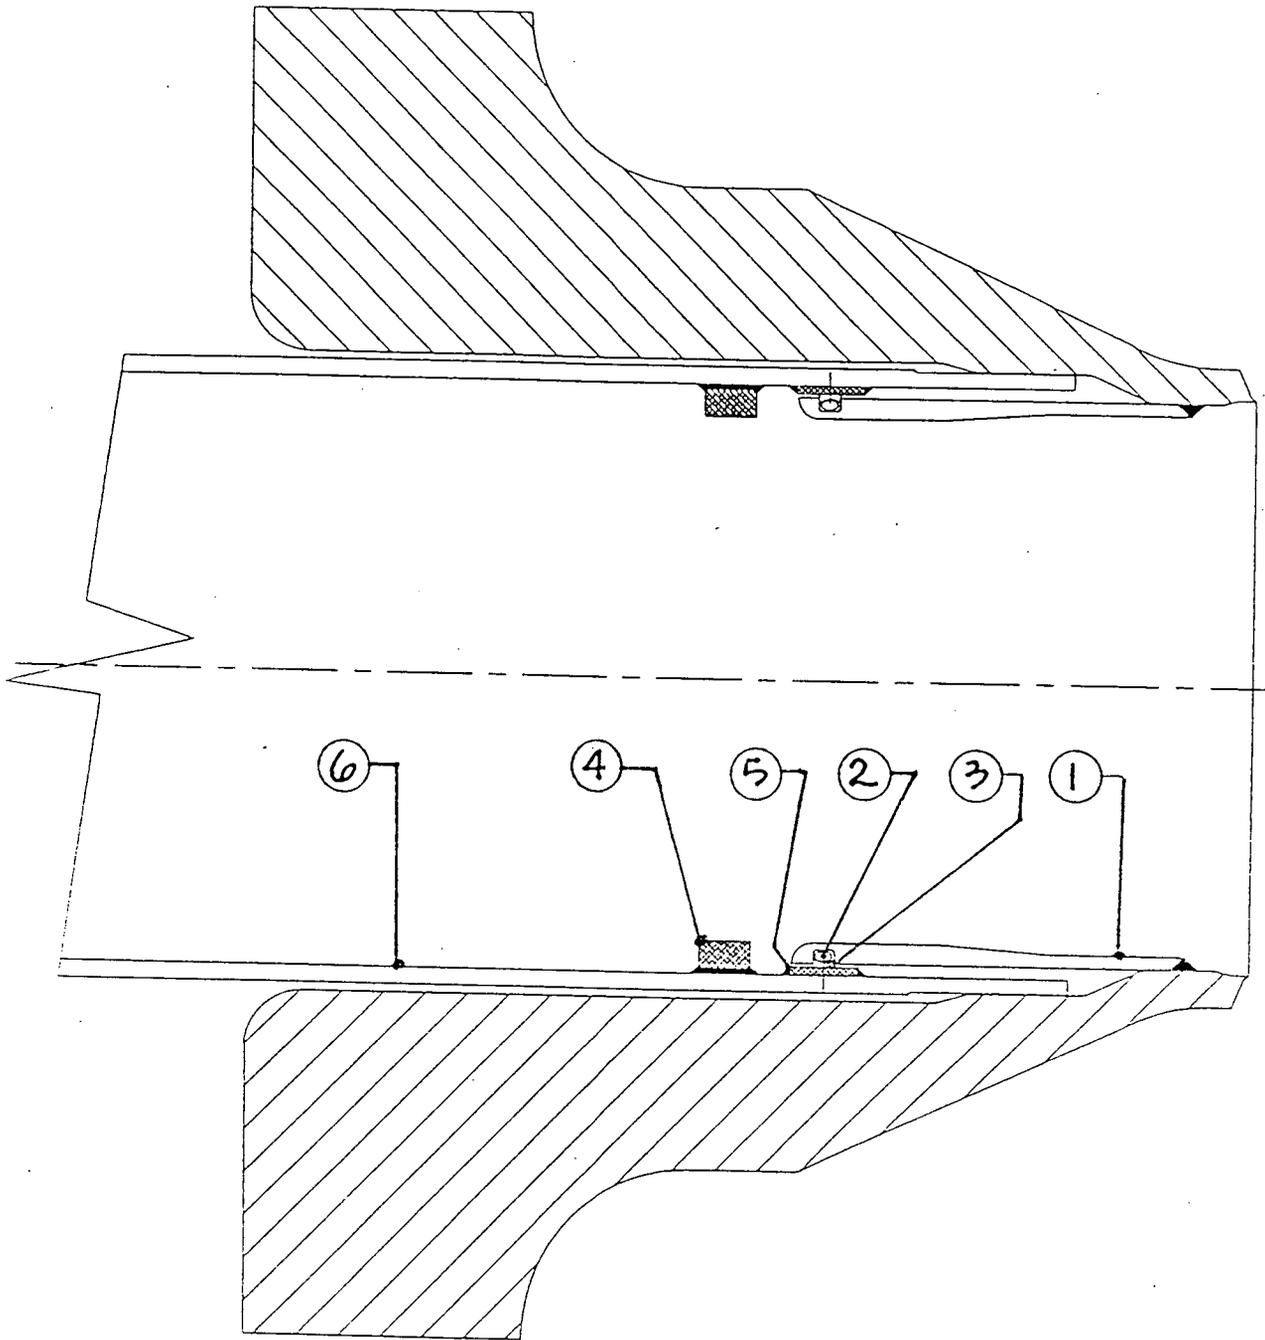
Feedwater flow enters the steam generator feedwater nozzle, flows into the thermal sleeve, through the feedwater ring and enters the upper steam generator chamber via J tubes. The existing thermal sleeve is a push fit into the feedwater nozzle. The sealing sleeve provides a protective barrier to leakage flow. A schematic of the sealing sleeve is presented in Figure 8.3.

FIGURE 8.3
Feedwater Nozzle Sealing Sleeve

A feedwater nozzle sealing sleeve assembly was installed to reduce the amount of feedwater which leaks past the existing thermal sleeve into the feedwater nozzle bore. Leakage of cold feedwater has resulted in thermal fatigue of the feedwater nozzle under the thermal sleeve during periods of cold feedwater or auxiliary feedwater injection.
