ROOT CAUSE REPORT

3 **TITLE:** Inadequate response to unplanned environmental tritium releases from Braidwood Station due to weak managerial oversight and the lack of integrated procedural guidance.

Unit(s): Braidwood Units 1 and 2

Event Date: 11/30/2005

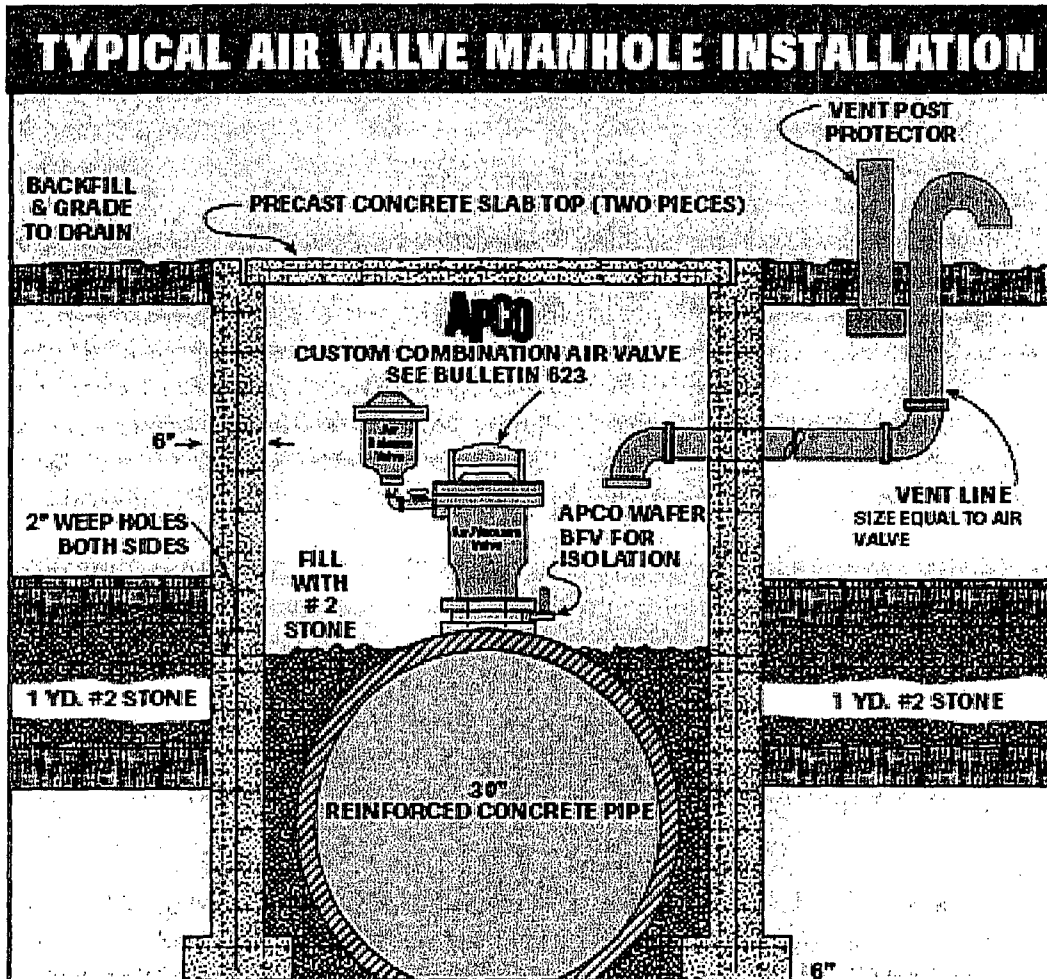
1980's. To allow air release from the piping on start-up and to allow air introduction to protect against vacuum damage to the piping, vacuum breakers are installed.

NOTE: Above is typical. Braidwood has 48" reinforced concrete pipe. Other differences may apply.

System control was transferred to the upstream motor operator isolation valves located in the turbine building. This modification caused the blowdown line to operate in a partially voided condition in various locations, depending on elevation which allowed column separation water hammer events to occur when flow rates were changed significantly, i.e.; during system start-up or shut down. Events were not initially seen because blowdown was essentially in service all the time. As a result of this change in operational methodology, the blowdown system would no longer be maintained full and pressurized upon shutdown. Minimal technical review was performed on the hydraulic transient effects on the vacuum breakers from this method of operation.

The failure of the VB-2 float assembly was discussed with the vendor. Based on the failure description, the vendor indicated that it appeared to be consistent with the effects of a pressure surge (i.e. water hammer). The vendor indicated that surge protection check valves should be considered for a vacuum breaker when pipe flows exceed 6 ft/s and are required when flow velocities exceed 10 ft/s. The vendor also recommended a 7-10 year PM frequency to address valve elastomer degradation. The condition was addressed by revising the operating procedure BwOP CW-12 to manually open and close the valves to slowly initiate or terminate blowdown flow.

A more rigorous technical review may have initiated the installation of surge protected check valves (which eventually occurred in 2001) before the majority of the leaks described in this report occurred. This is a missed opportunity.
