# **The MacArthur Maze and Newhall Pass Fires and their Implications for Spent Fuel Transport**

**Christopher S. Bajwa**

**Earl P. Easton**

## **ABSTRACT**

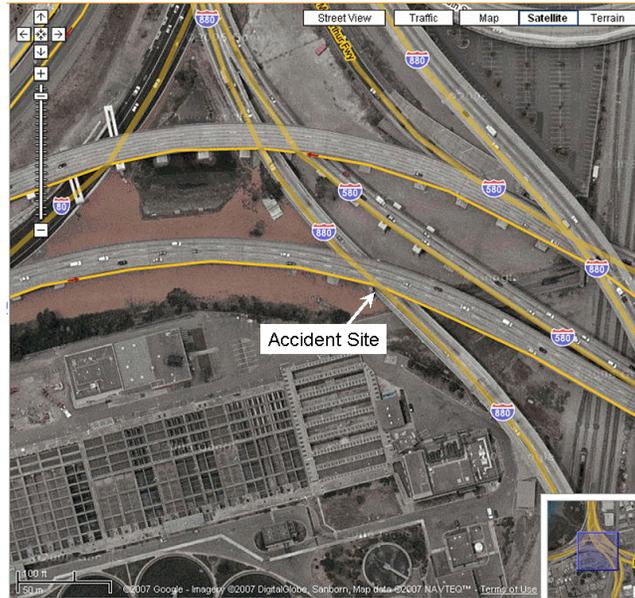
**Fig. 1. Aerial photograph of I-880 and I-580 Interchange**

The main portion of the fire, fueled by gasoline leaking from the tanker, spread along a section of the I-880 roadway, and encompassed an area of roughly 30 m [100 ft] in length by 10 m [33 ft] in width. Some of the gasoline went through the scupper drain on I-880 and burned on the ground around an I-880 roadway support pillar. The fire on the I-880 roadway heated the steel girders on the underside of the I-580 overpass to temperatures at which the steel strength was reduced and was insufficient to support the weight of the elevated roadway. A portion of the I-580 overpass (between Bents 19 and 20) completely collapsed onto the I-880 roadway about 17 minutes after the fire started, based on surveillance video taken from a water treatment plant adjacent to the highway interchange. A second portion of the I-580 overpass (between Bents 18 and 19) began to sag heavily and eventually partially collapsed approximately 40 minutes after the fire began. The fire was determined to have burned intensely for about 40 minutes, but for the remaining 60 minutes of the fire, it was significantly reduced in size, due to the collapse of the two I-580 spans. A photograph of the scene after the fire was extinguished is shown in Figure 2<sup>1</sup> [3].

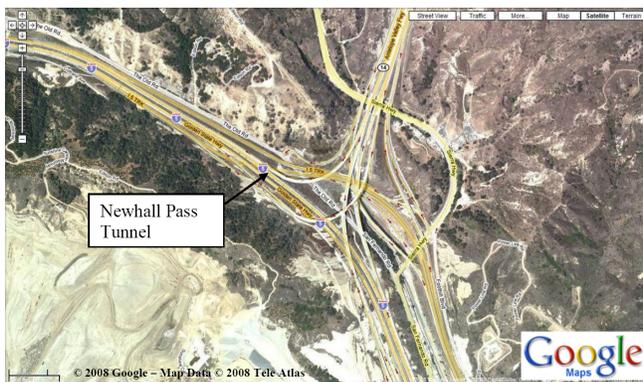
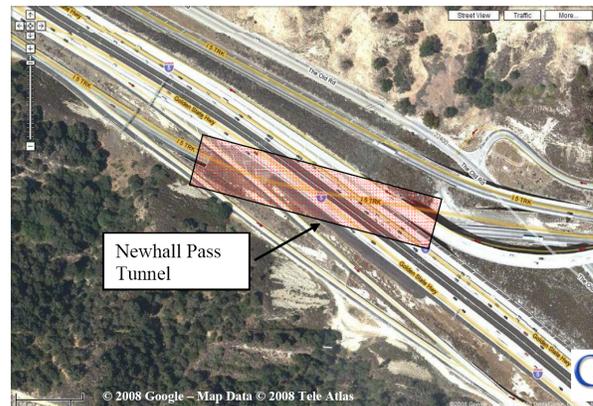
**Fig. 4. California Interstate 5 and Highway 14 Interchange**

Smaller local fires continued to burn for the next 12 hours, while debris from the tunnel was removed. All fires were completely extinguished within 30 hours. An aerial map of the Newhall Pass tunnel is shown in Figure 4.
