Attached is the draft presentation that Garry gave me last night. He cautioned me that there may be changes before the public meeting on Friday. Note that they have already identified that there has been a change in the repair they are considering. The PNSC met yesterday and recommended that the repair consist of the delamination removal and replacement.

# Crystal River Unit #3 Containment Delamination Evaluate

November 17, 2009

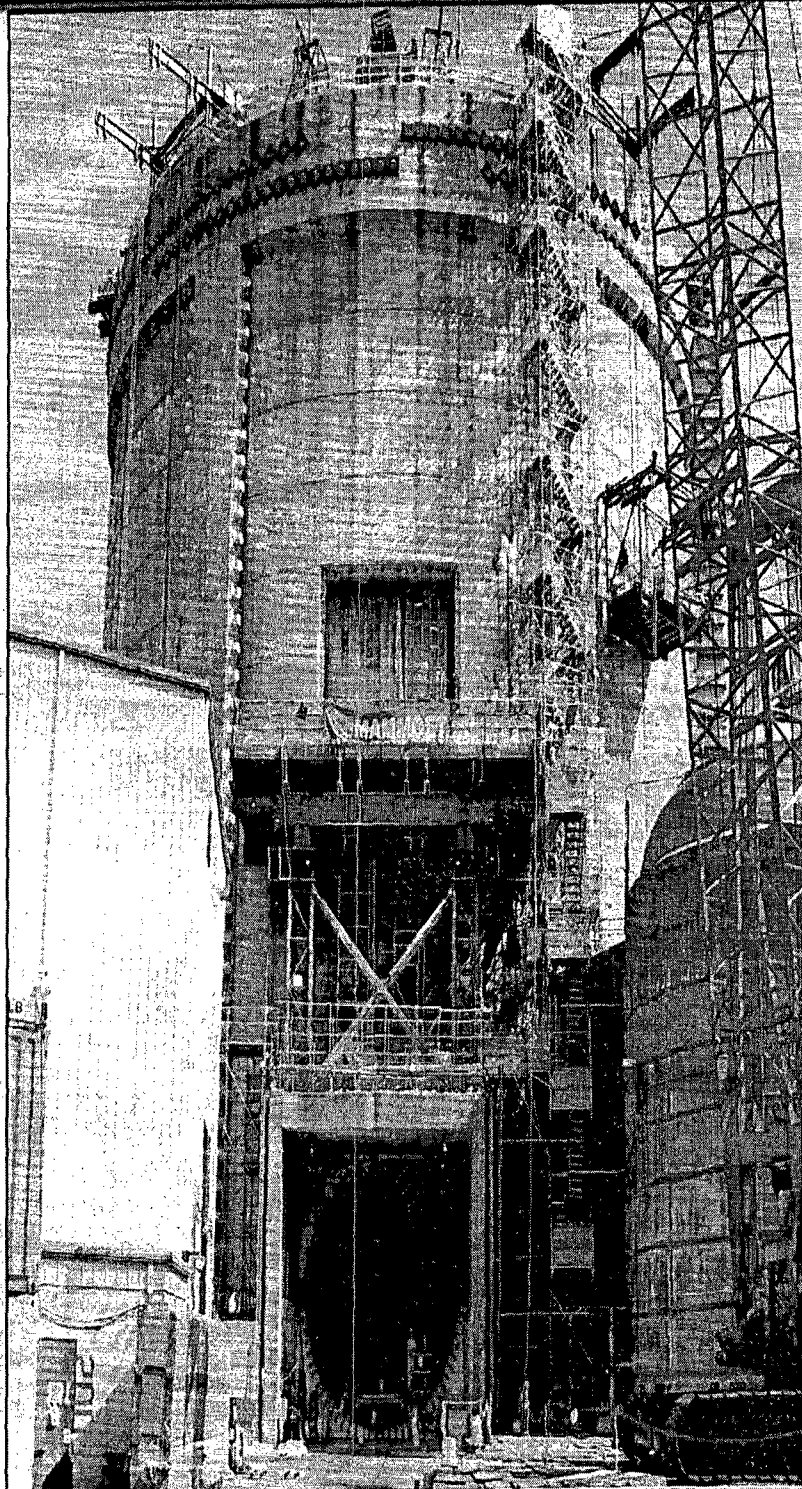
# Steam Generator Replacement (SGR) Opening (between Buttresses 3 and 4)

## SGR Opening Dimensions

@ Liner  
23' 6" x 24' 9"

@ Concrete Opening  
25' 0" x 27' 0"

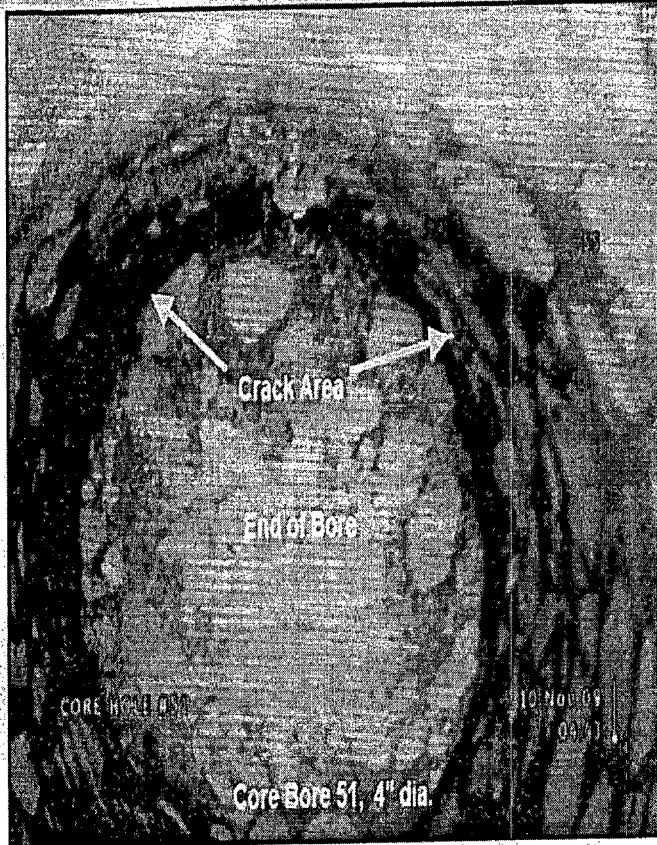
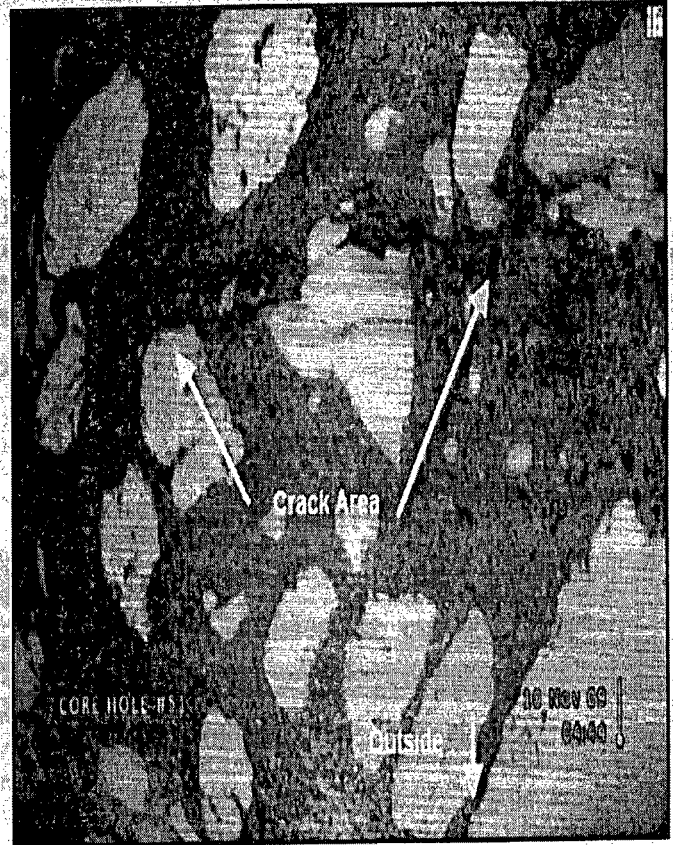
## Core Bores & Boroscopic Examination

Examination – Inward View

Examination – Side View

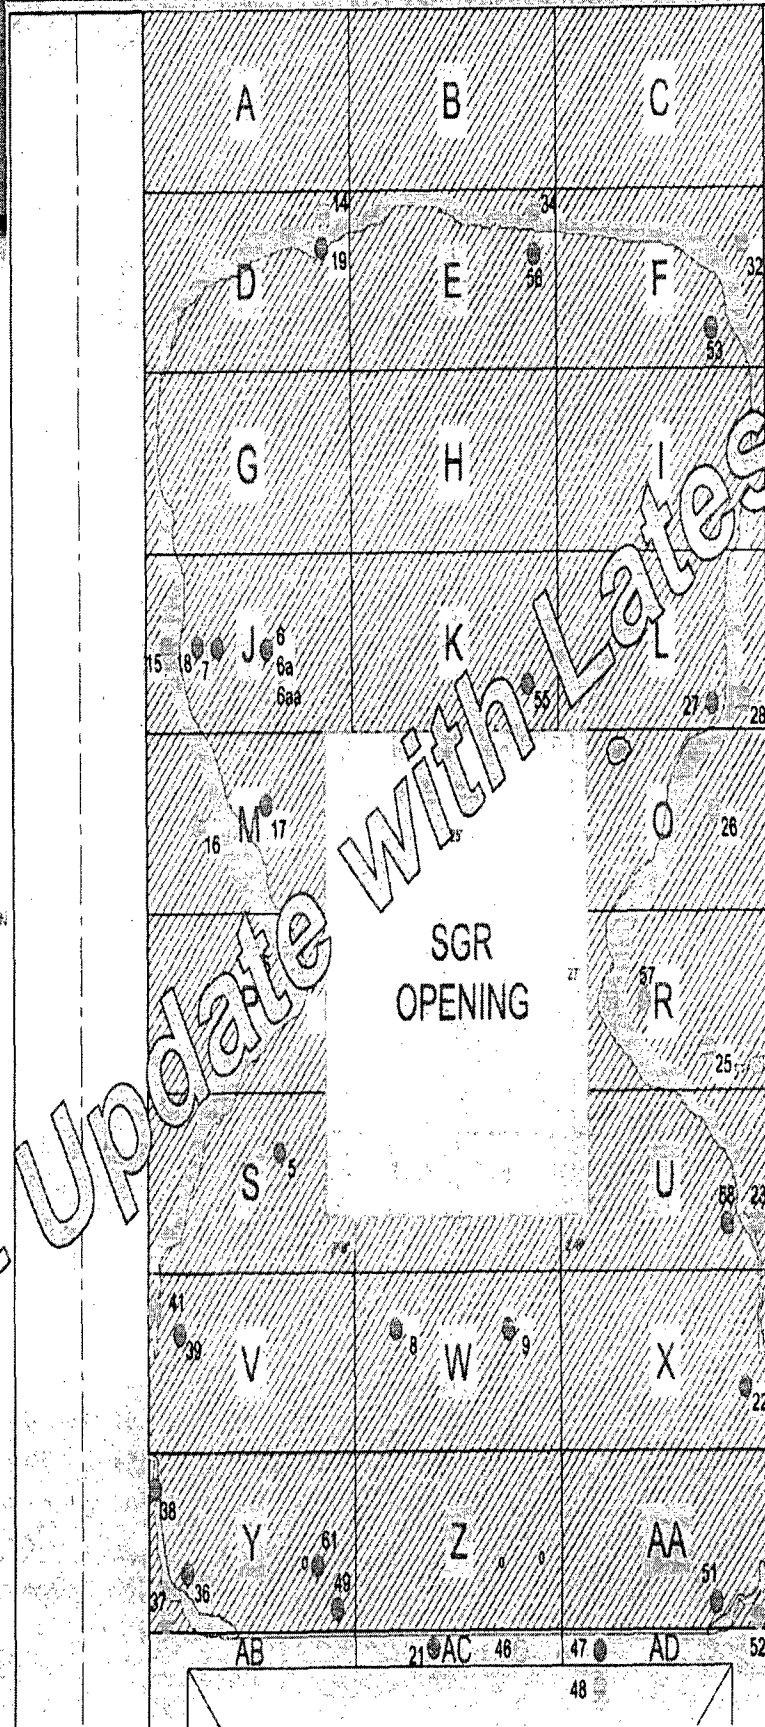
# Core Borings

- CORE BORE WITH DELAMINATION
- CORE BORE NOT DELAMINATED
- TO BE CORE BORED
- CORE BORE DRILLED

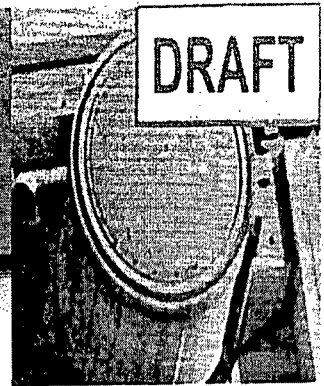
# 1976 Dome Delamination Cause

- Compression - tension interaction failure occurred
- Contributing Effects
  - Radial tension due to prestressing
  - Thermal effects
  - Tendon alignment
  - Stress concentrations
  - Shrinkage
- Combined with biaxial compressive stresses and lower than normal direct tensile strength of concrete
