CR-3 WORK REQUEST FORM

TAG DESC : PRESTRESSING SYSTEM TENDONS

SIXTH TENDON SURVEILLANCE PER SP-182 TO BE PERFORMED BY PRE

The sixth tendon surveillance for the Crystal River Unit 3 (CR-3) Reactor Building post tensioning system was performed between October 20, 1997 and January 16, 1998. The surveillance was performed to demonstrate the integrity of the containment prestressing system, including containment tendons, tendon end anchorage hardware, general and adjacent concrete integrity, and corrosion protection system. The tendon surveillance was performed in accordance with the CR-3 Improved Technical Specifications (ITS). This surveillance occurred during the twenty-second year after the CR-3 structural integrity test, which took place in November, 1976. The tendon surveillance was completed while the plant was shut down.

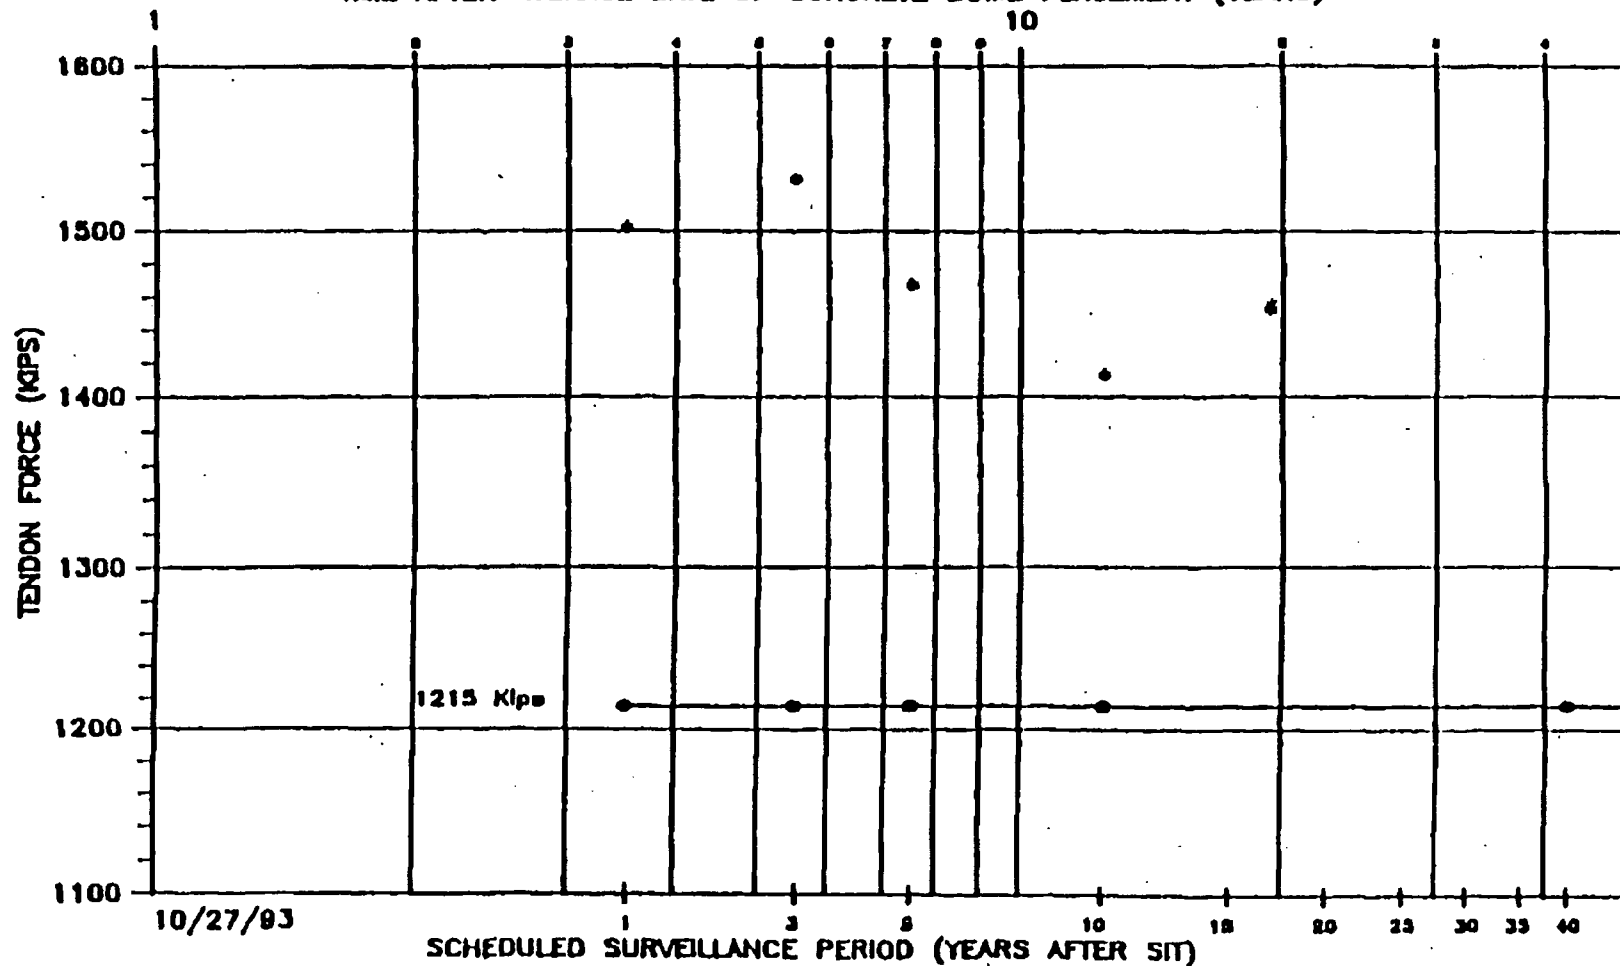
TENDON HISTORICAL TRENDS
DOMT TENDONS

FPC - Crystal River Unit #3
Tendon Surveillance Program
Dome Group Trend of Losses

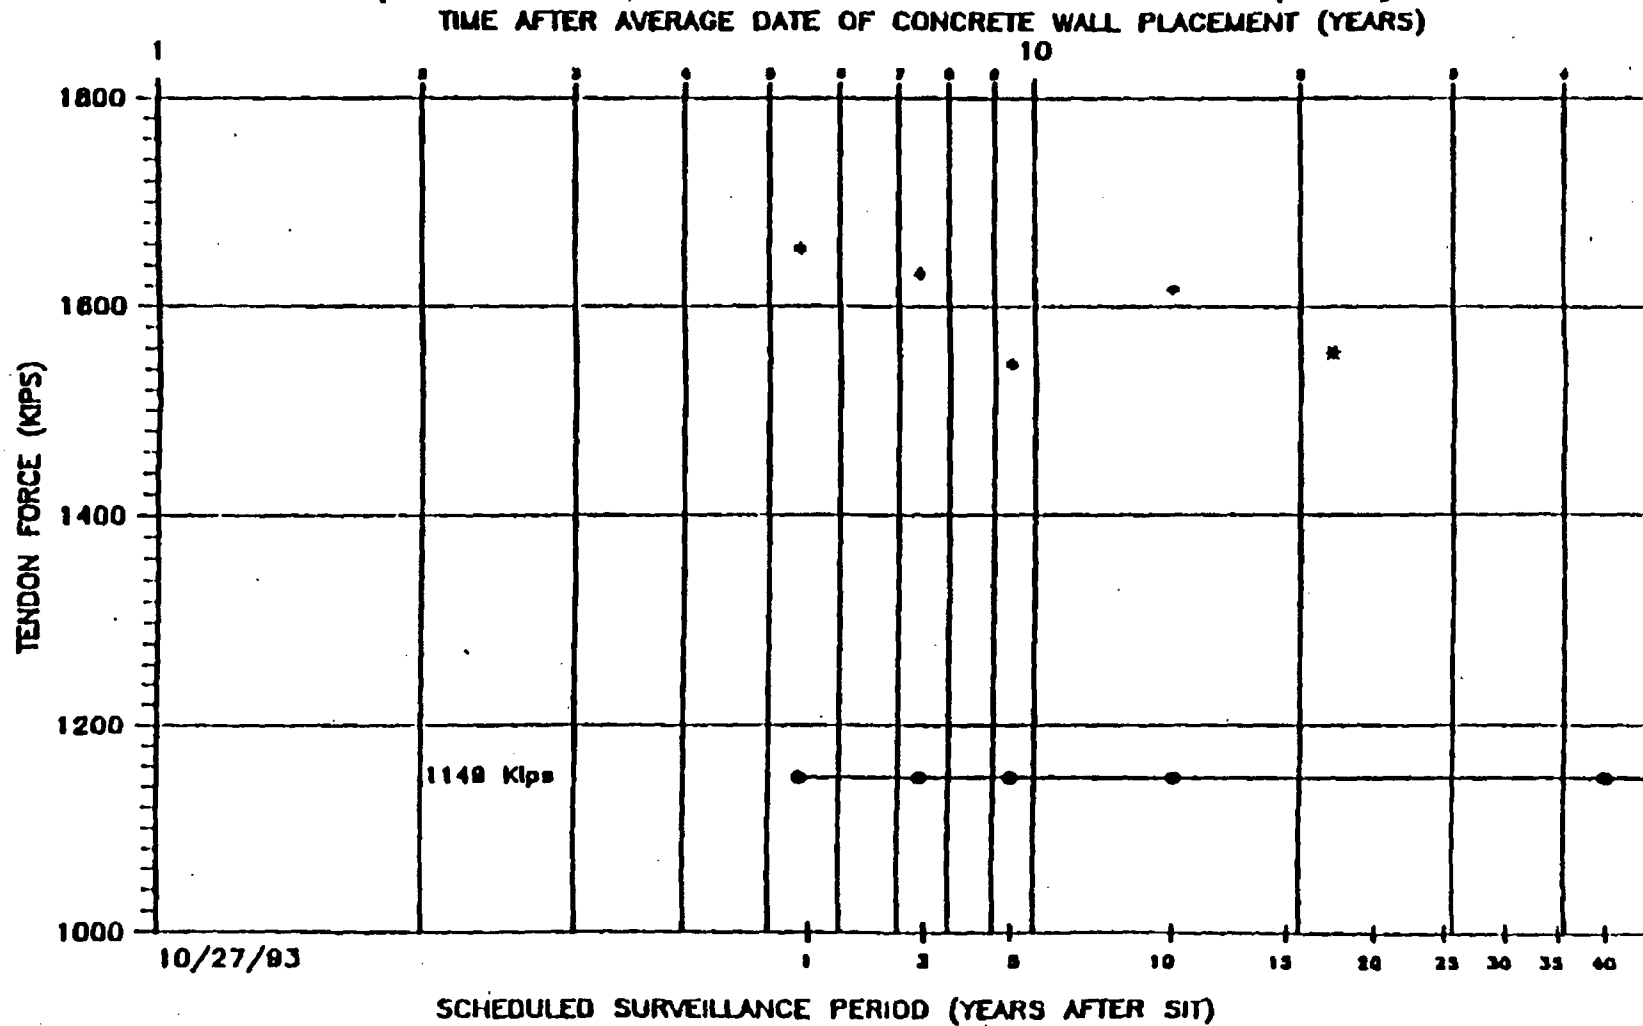
TENDON HISTORICAL TRENDS
VERTICAL TENDONS

FPC - Crystal River Unit #3
Tendon Surveillance Program
Vertical Group Trend of Losses

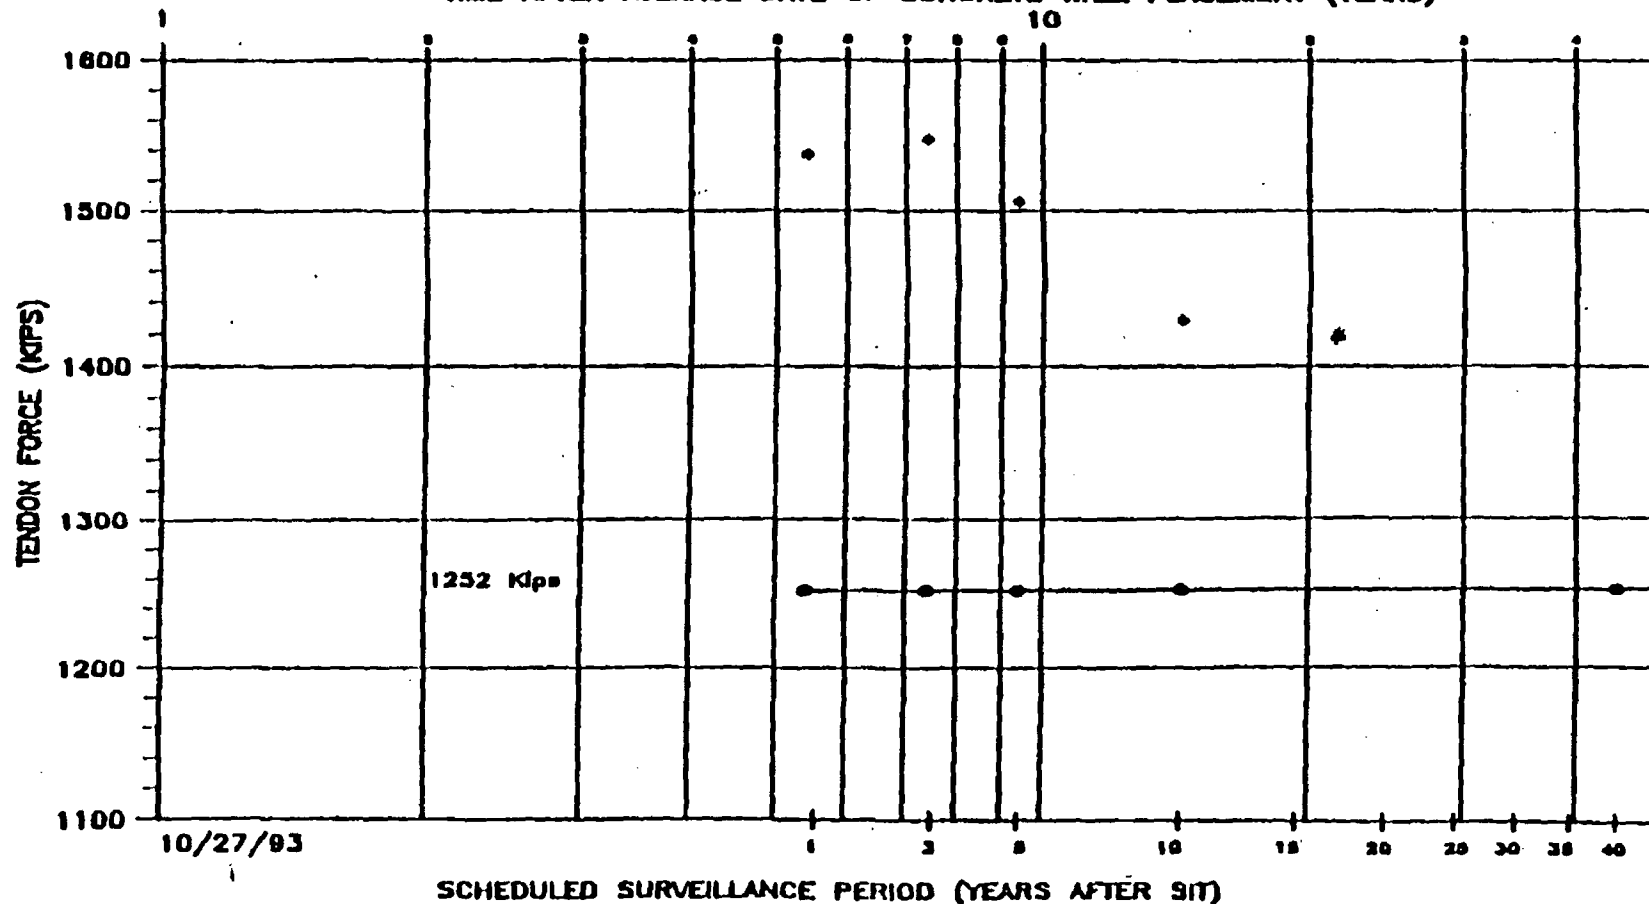
TENDON HISTORICAL TRENDS
HOOP TENDONS

FPC - Crystal River Unit #3
Tendon Surveillance Program
Hoop Group Trend of Losses
