F6m
DPSPU 81-11-4

HISTORY OF WASTE TANK 6 1954 THROUGH 1974

C. J. THOMAS
Waste Management Technology

March 1981

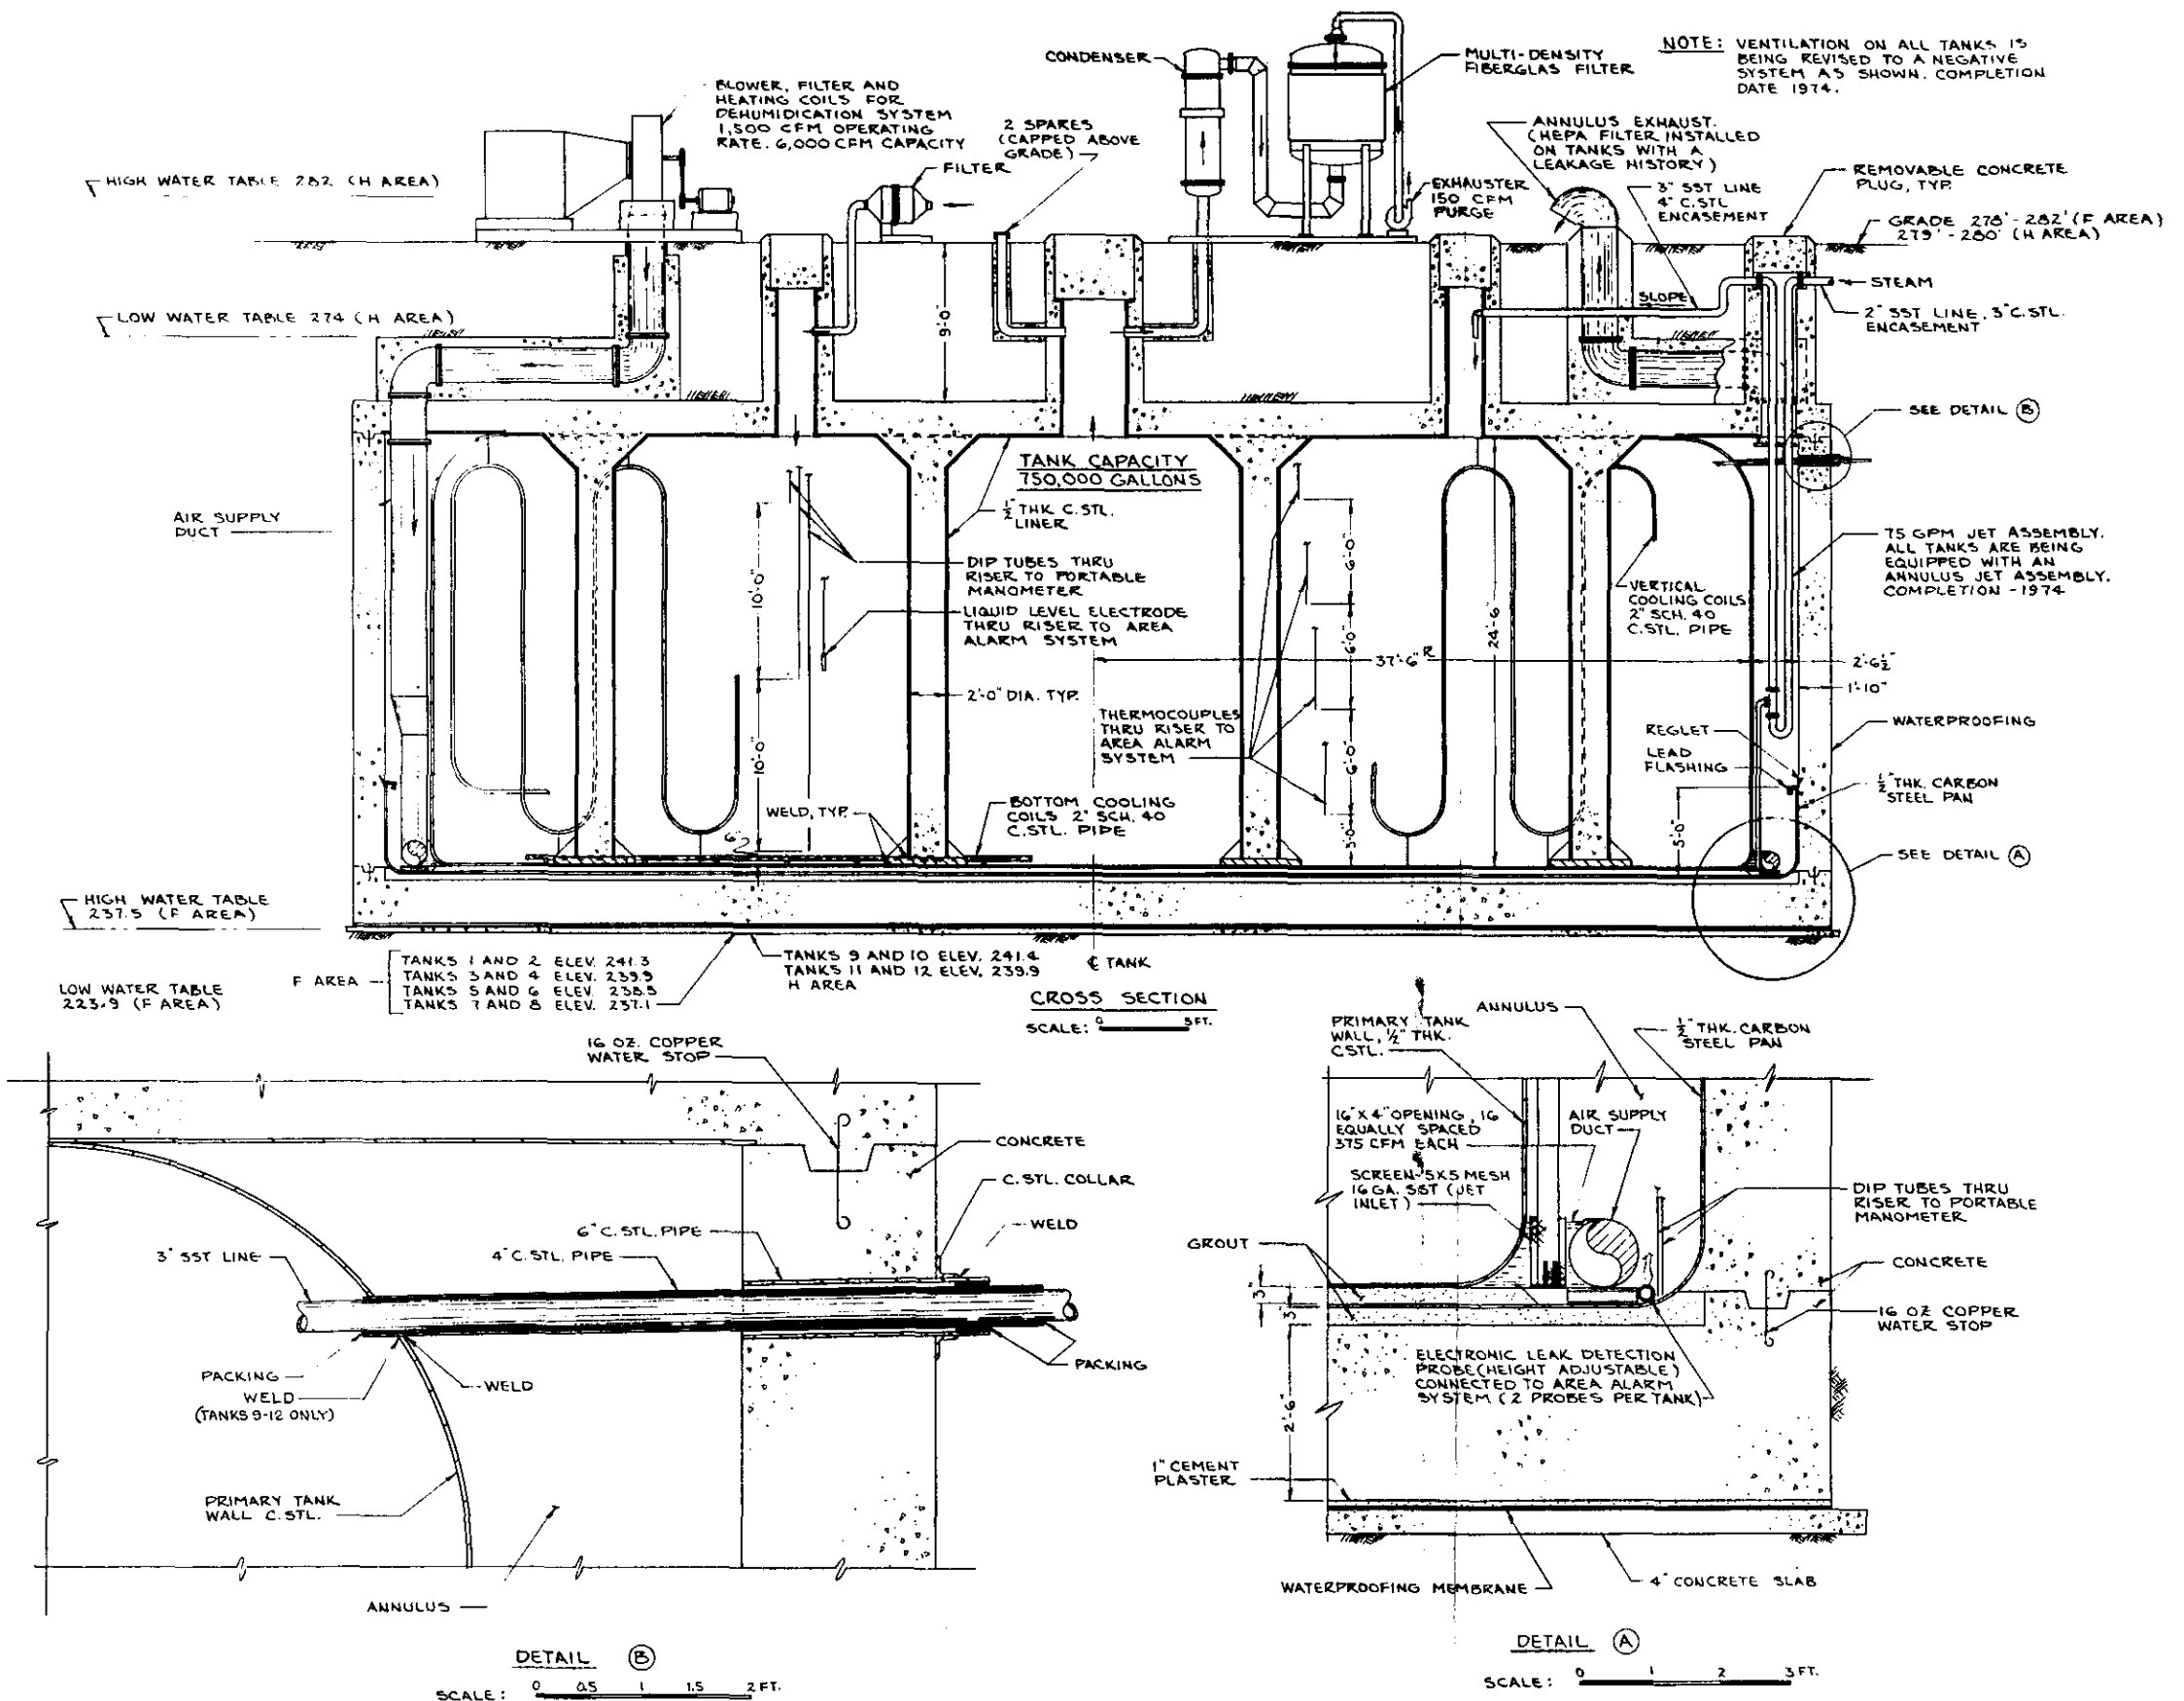
FIGURE 1. WASTE STORAGE TANK 6

Tank 6 is a 750,000 gal, type I tank that is located in F Area and used for the storage of high heat waste (figure 1). It is 75 ft in diameter, 24-1/2 ft high, and has 34 vertical cooling coils distributed throughout the tank. There are two horizontal coils at the bottom, where the sludge and most of the fission products concentrate. The tank is constructed from type ASTM A-285-B steel with non-stress-relieved welds, and it is inside a concrete vault with an annular space surrounding the tank. Lining the bottom of the vault is a 5-ft-high steel annulus pan (secondary container) to collect leakage from the primary tank. There are eight risers providing access to the tank interior and four risers to the annulus.

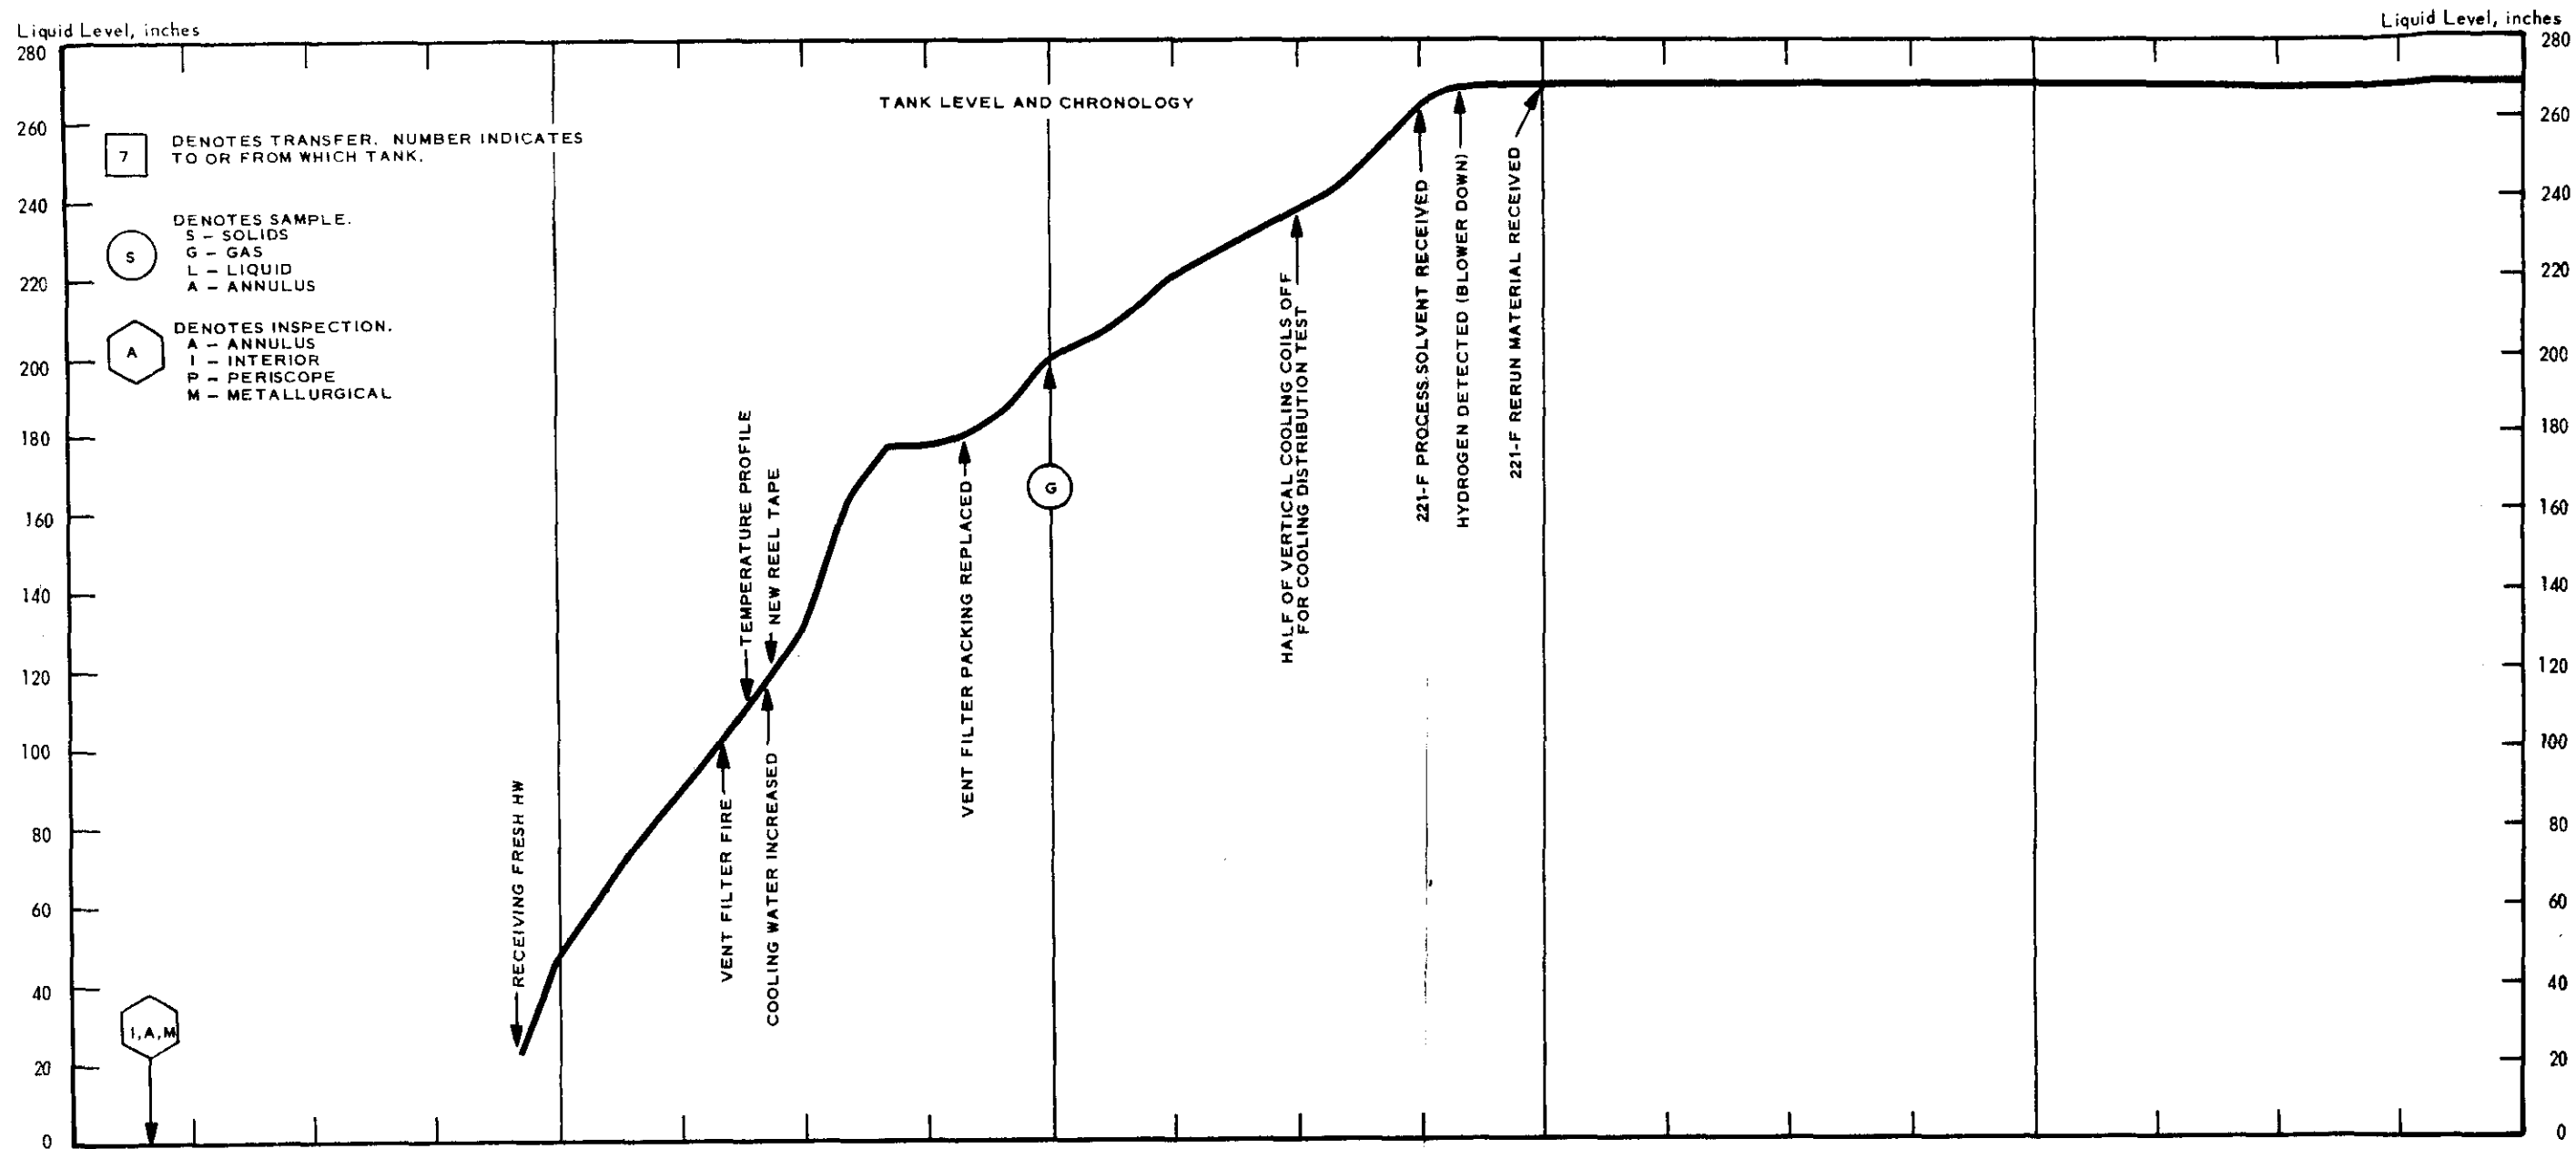
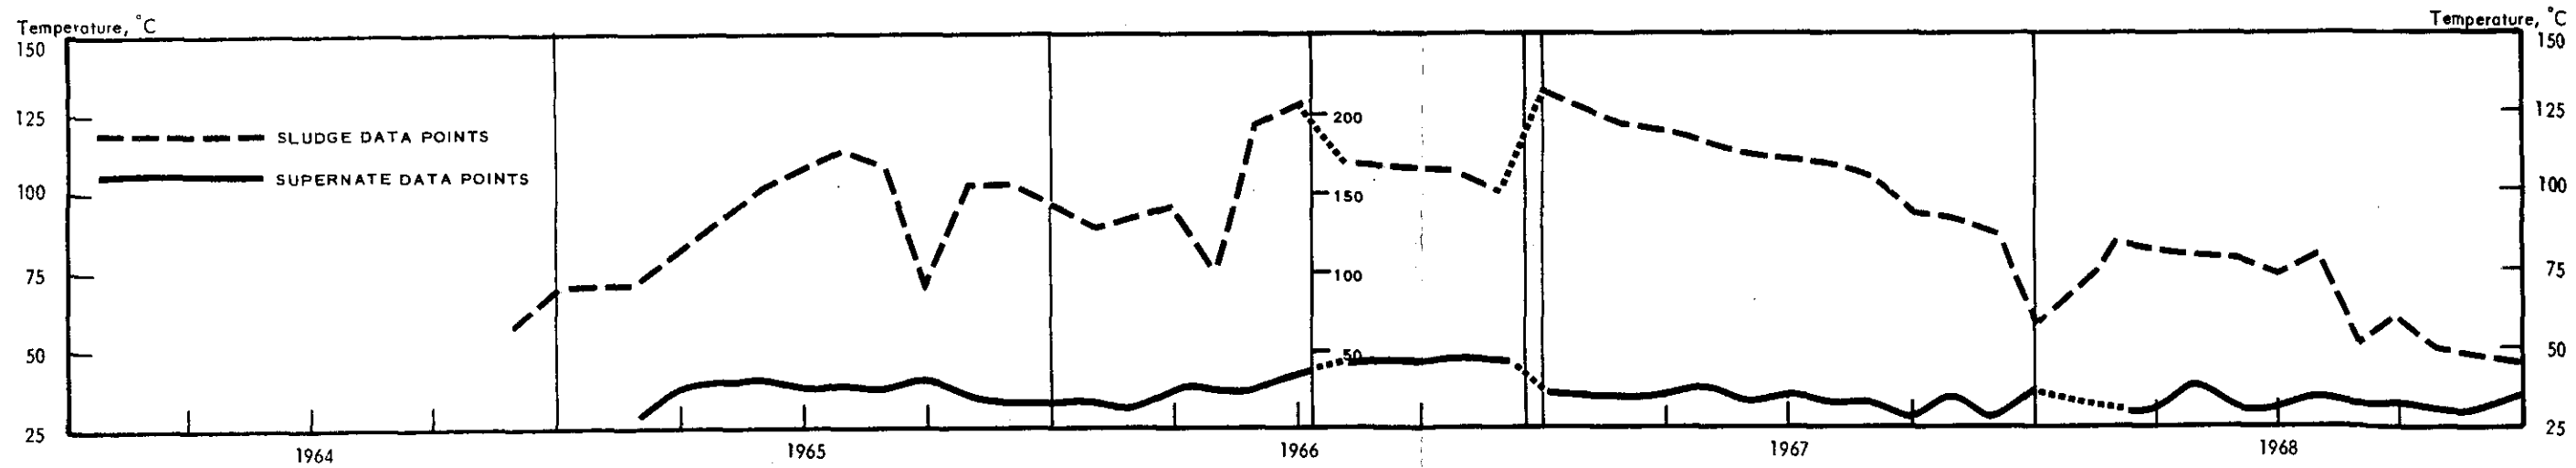
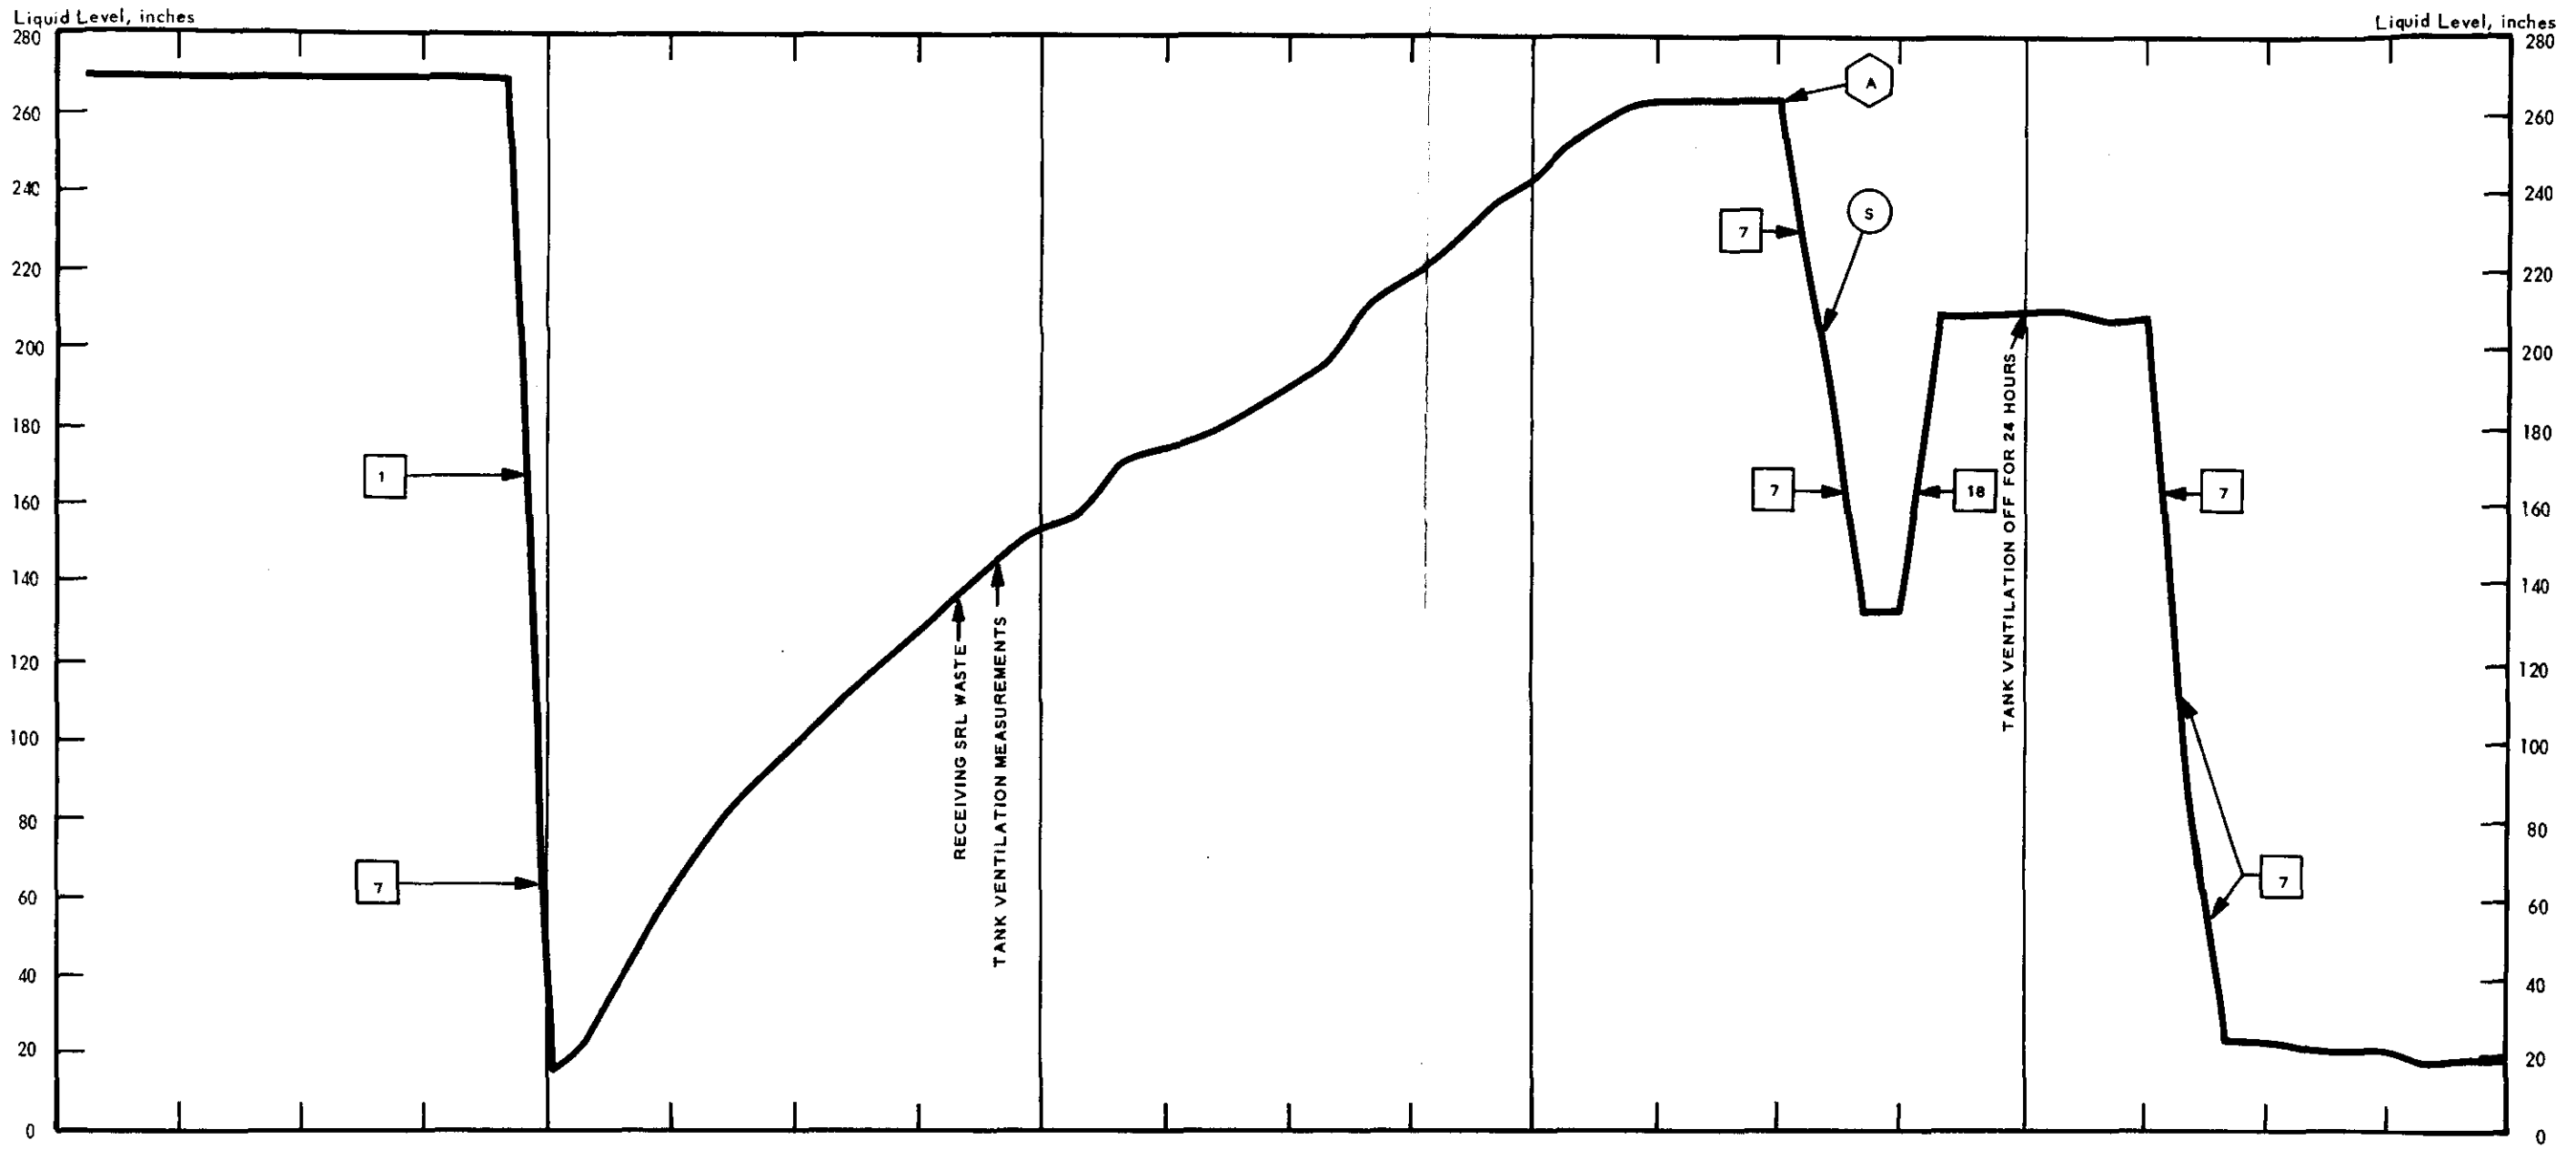
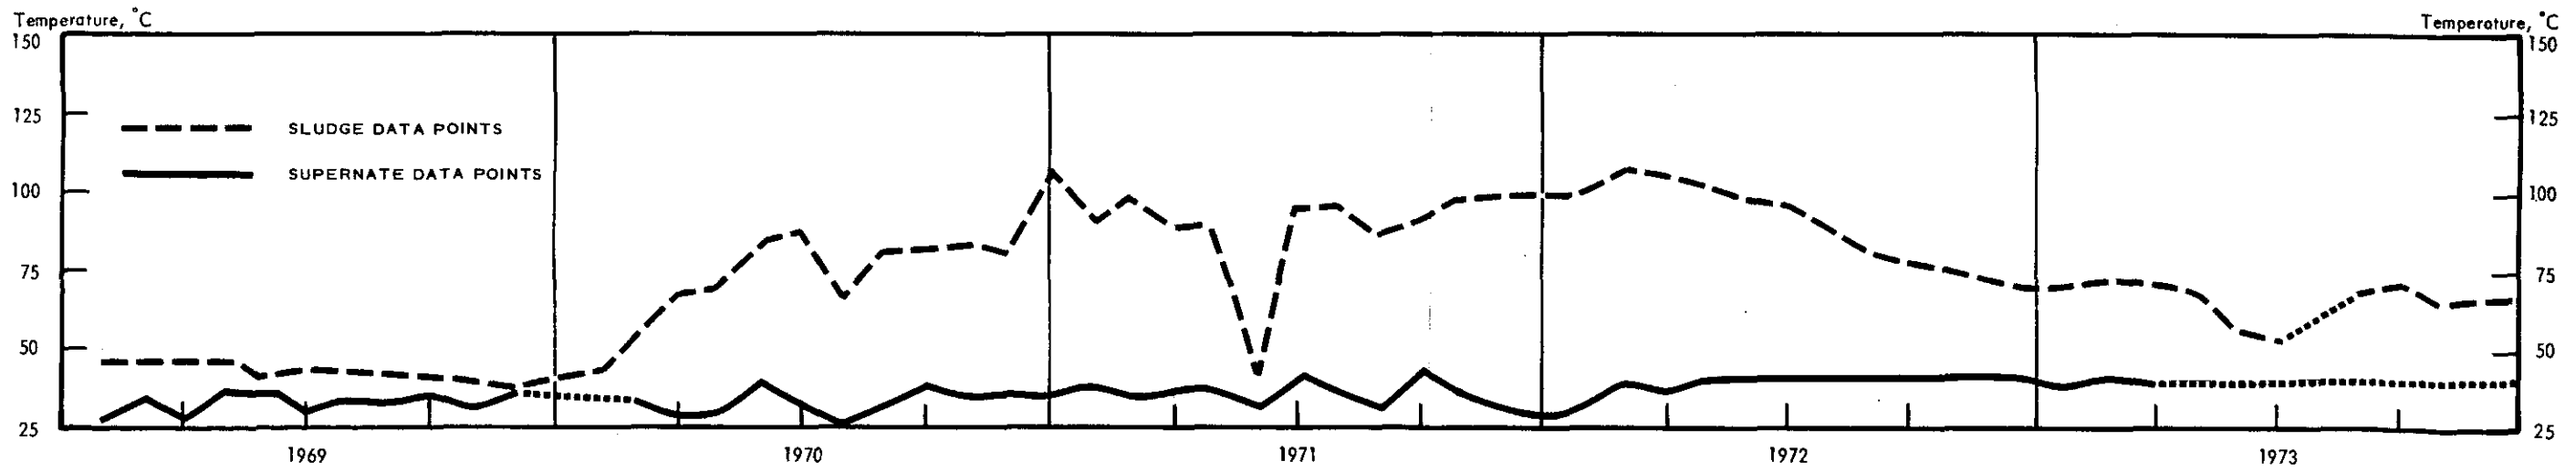
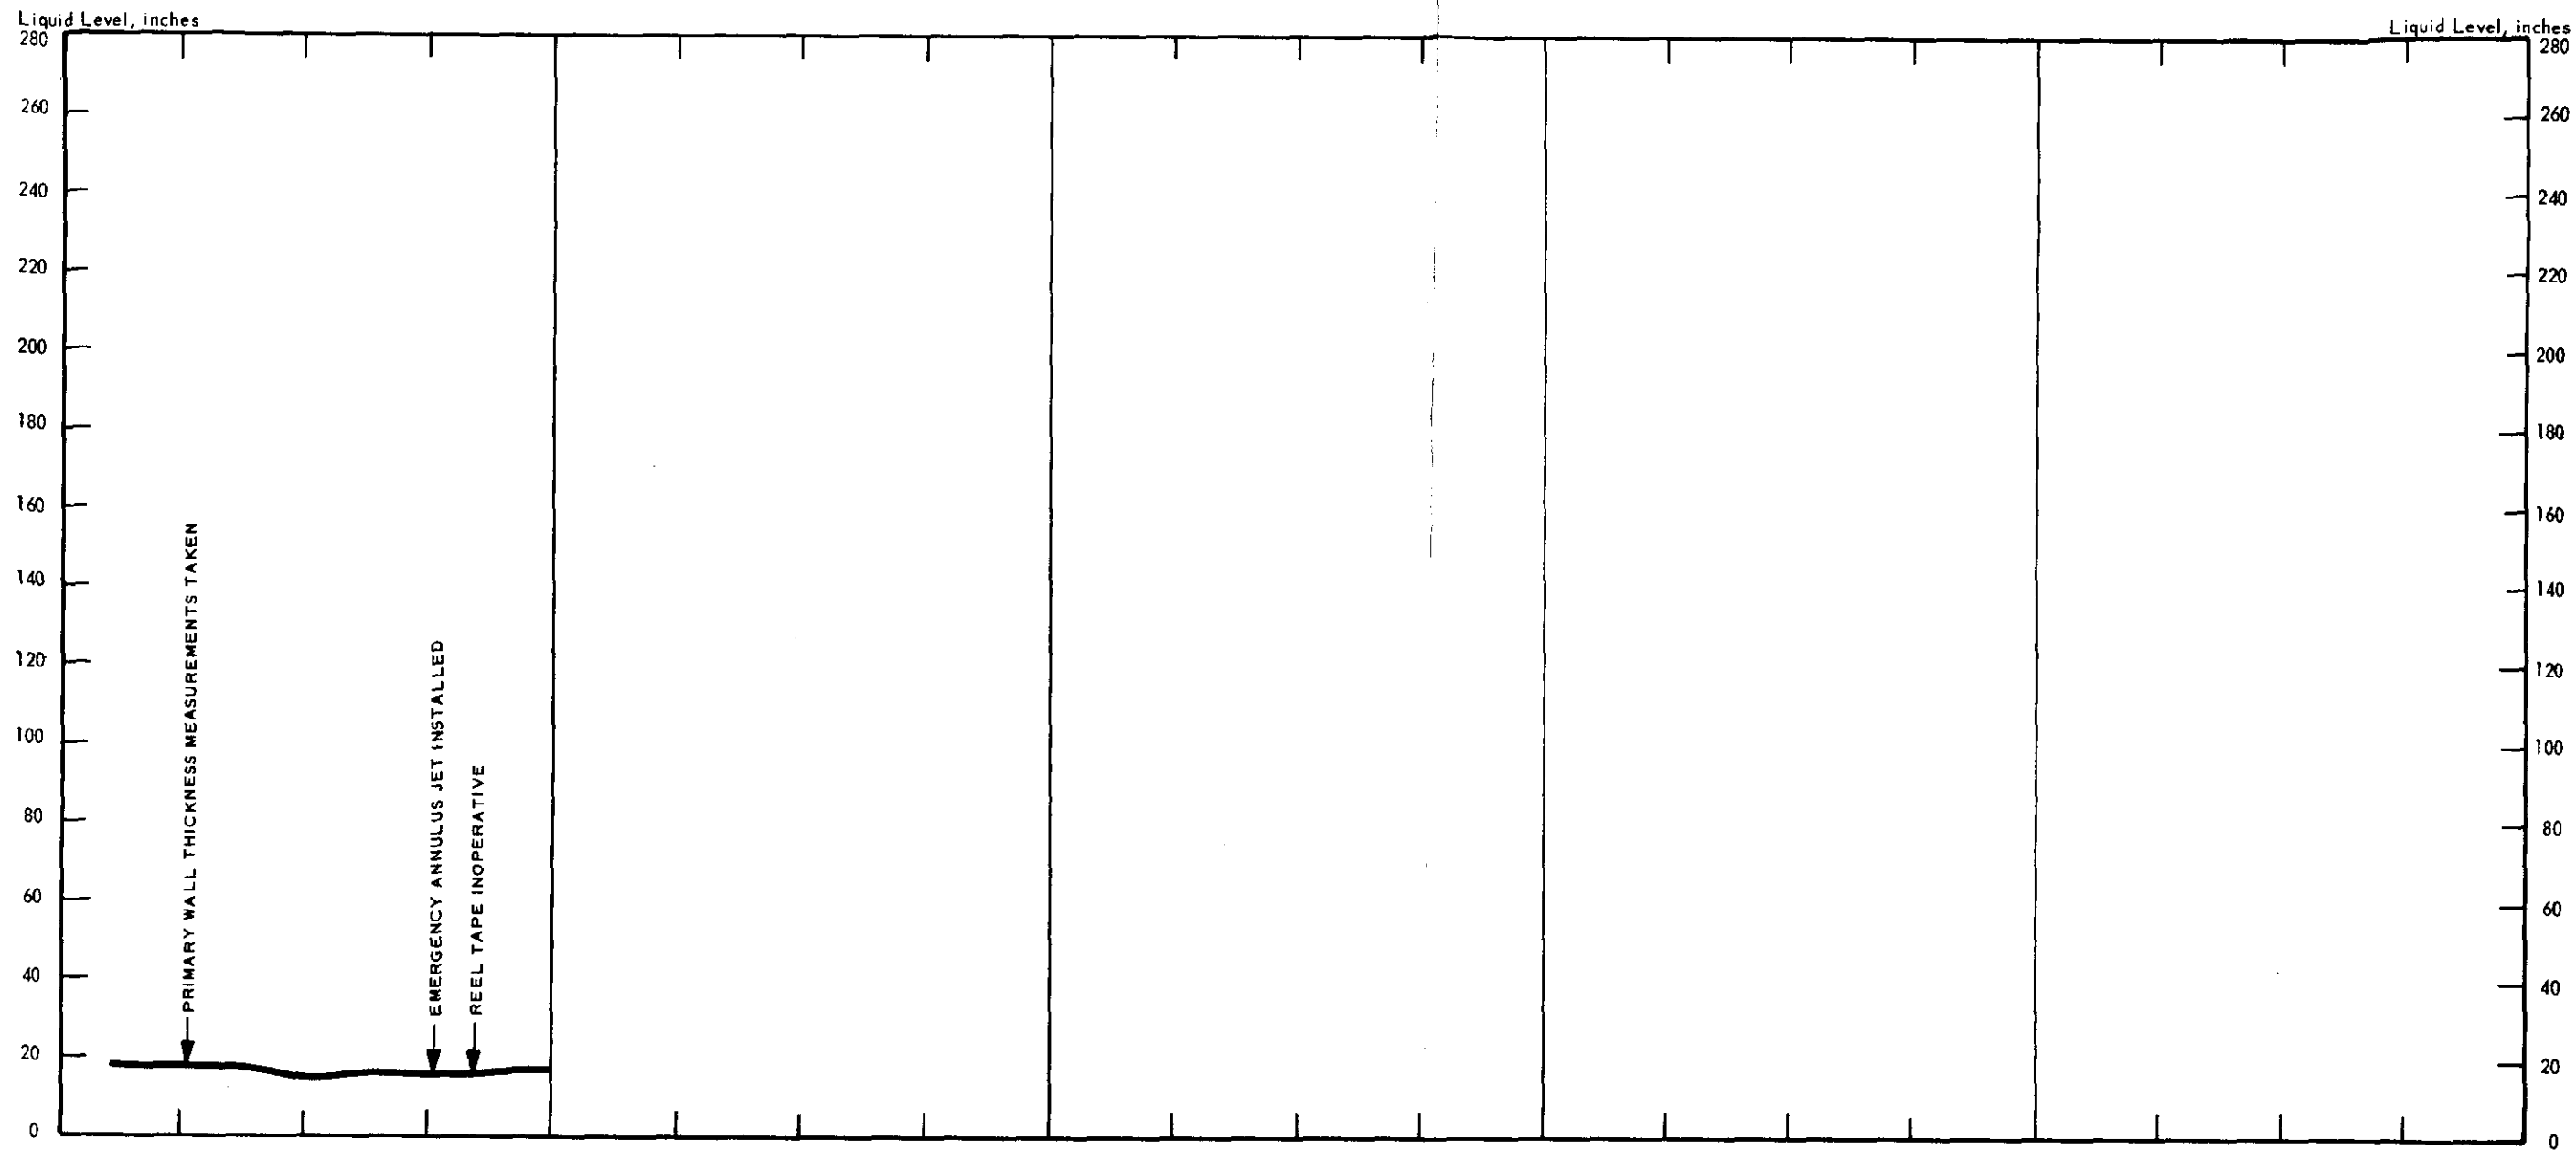
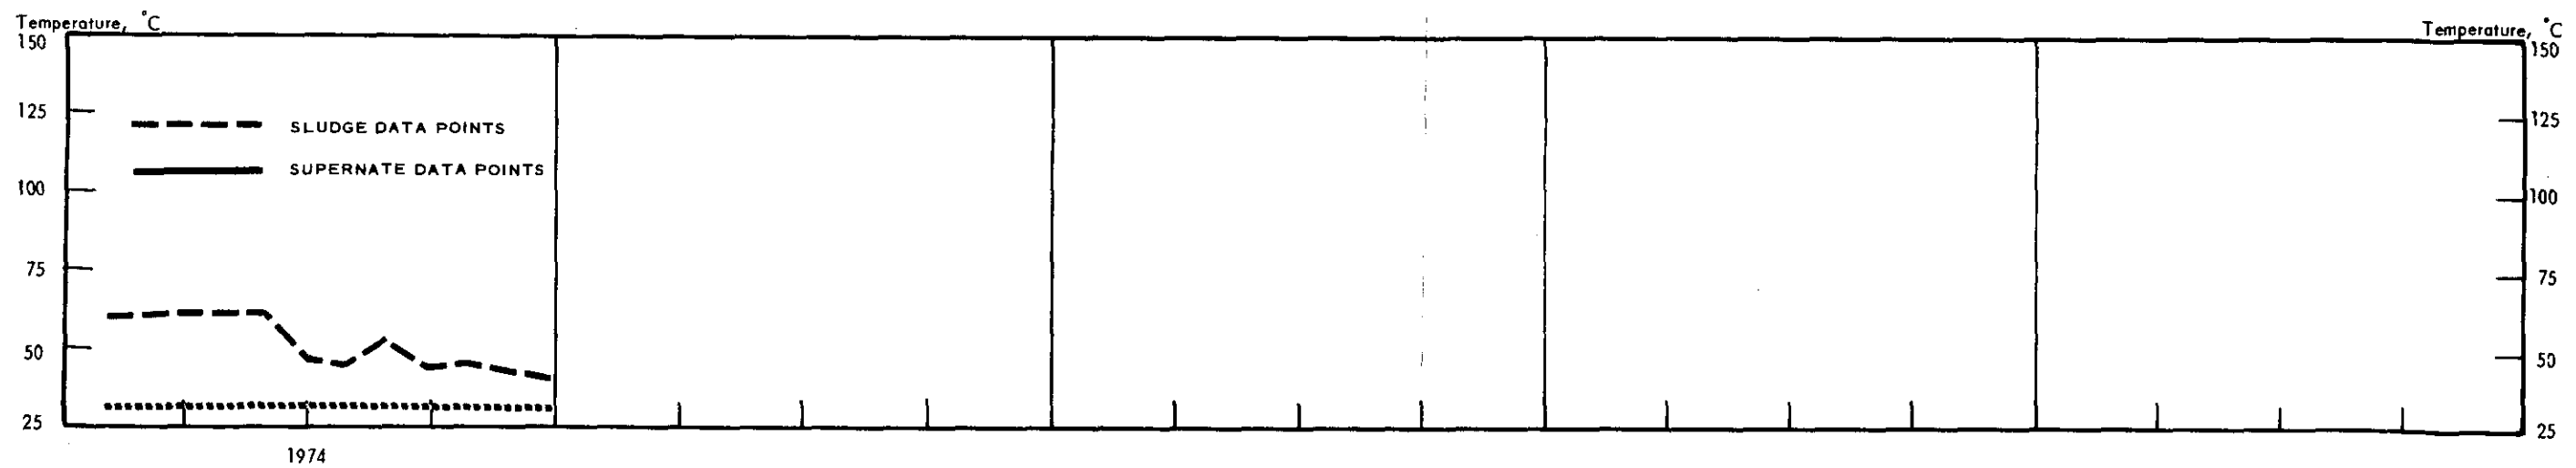
FIGURE 2. TANK 6 LIQUID LEVELS AND TEMPERATURES

Events in the history of tank 6 are listed chronologically in figure 2 and discussed briefly in this report. Listing of a date by month and year at any place in this report serves as a reference to the Works Technical Report for that month. The history covers a period from November 1954 through December 1974.

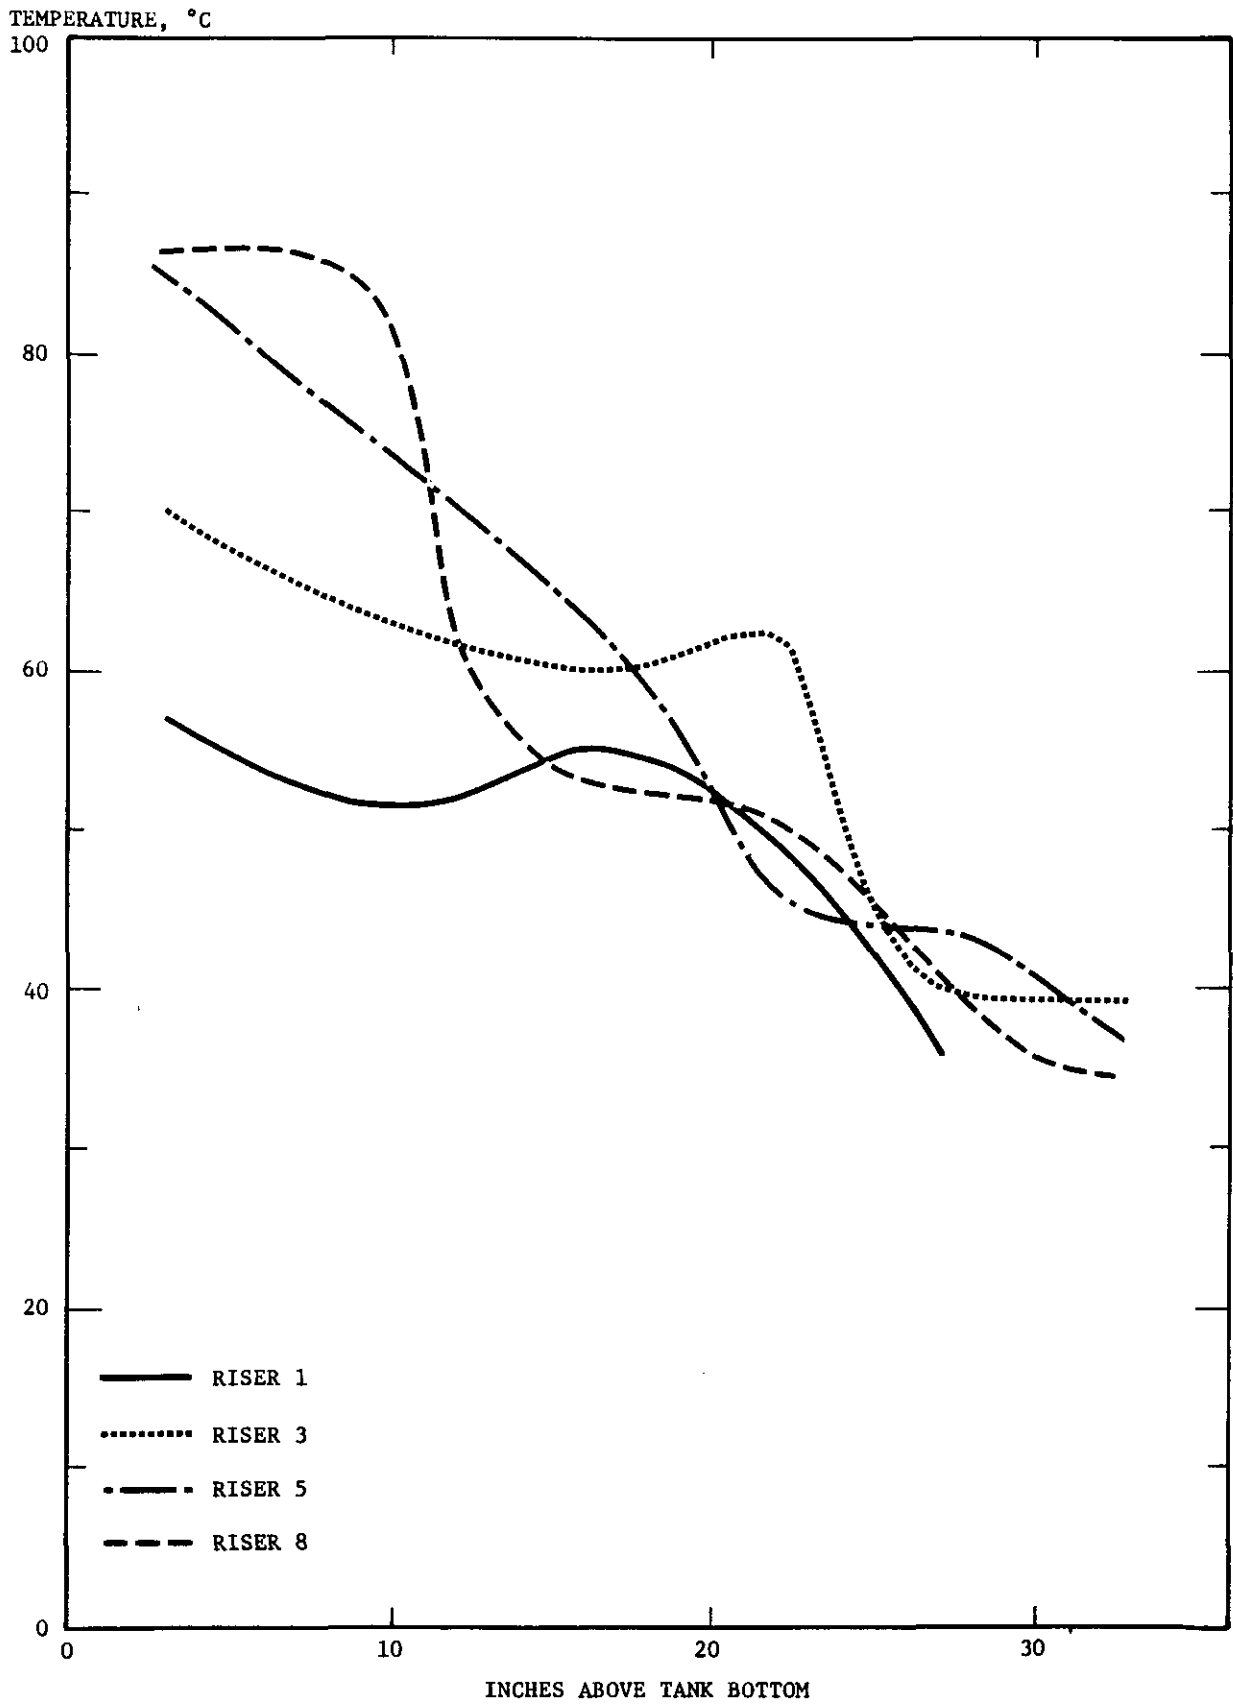
FIGURE 5. SLUDGE TEMPERATURES IN TANK 6 ON APRIL 29, 1965

Vertical temperature profiles of the tank interior were taken through the thermowells in risers 1, 3, 5, and 8 in April 1965. The profiles were taken by incrementally lowering a 40-ft thermocouple into the existing thermowells. The temperature profiles are shown in figure 2. Vapor space measurements were taken in November 1970. Primary wall thicknesses under the east and west annulus risers were checked and found to be within specifications. The wall thickness measurements are shown in figures 6 and 7.
