**SUBJECT: CRYSTAL RIVER NUCLEAR PLANT - SPECIAL INSPECTION REPORT
05000302/2009007**

The purpose of this inspection was to examine activities associated with the delamination identified in the Unit 3 containment. The inspection was conducted in accordance with the Special Inspection charter issued by the Region II Administrator on October 13, 2009. As part of the inspection, the NRC examined your evaluation of extent of condition, your evaluation of root cause, and your planned corrective action for continued operability. The inspectors interviewed personnel and conducted plant walk downs, including visual examination of accessible portions of the outside and inside surfaces of the containment.

ROOT CAUSE ASSESSMENT CRYSTAL RIVER UNIT 3 CONTAINMENT CONCRETE DELAMINATION

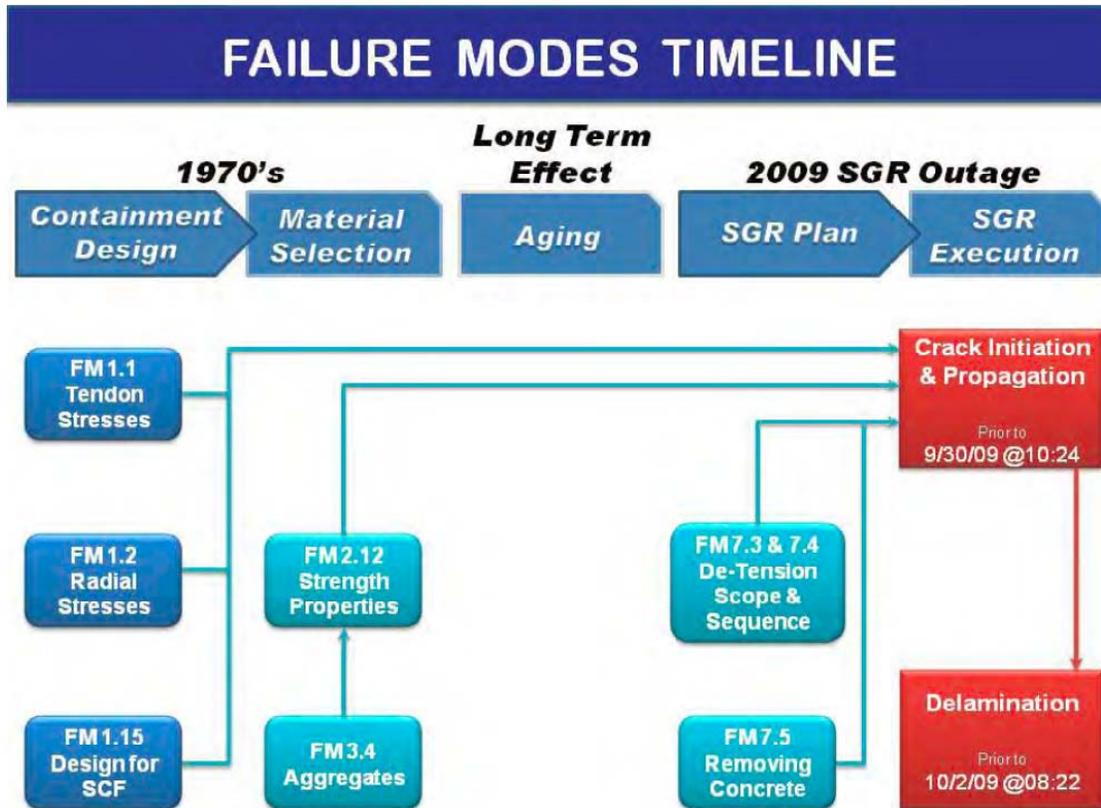
Figure 5.2.3 Failure Modes Timeline

Following the analysis of failure modes, the licensee determined the timing of the contribution of each causal failure mode to the wall delamination event in the Failure Modes Timeline, as shown in Figure 5.2.3. The licensee's root cause analysis and computer simulation determined that the large-scale delamination observed did not exist prior to the SGR opening operations but occurred during construction activities for creation of the SGR construction opening, while the unit was shut down. This determination was supported by the following evidence: (1) the condition assessment confirmed that the delamination was present only in Bay 3-4, the panel where the SGR opening operations were performed, and not in any of the other five bays; (2) the shape of the delaminated area of Bay 3-4 corresponds exactly to the region of detensioned horizontal and vertical tendons (see Figure 5.2.1), indicating that the detensioning process influenced the delamination process, which could not happen if the delamination occurred prior to the detensioning; and (3) traditional petrographic analyses did not detect the presence of pre-existing defects (general lack of significant carbonation and mineral growth on the fracture surface).

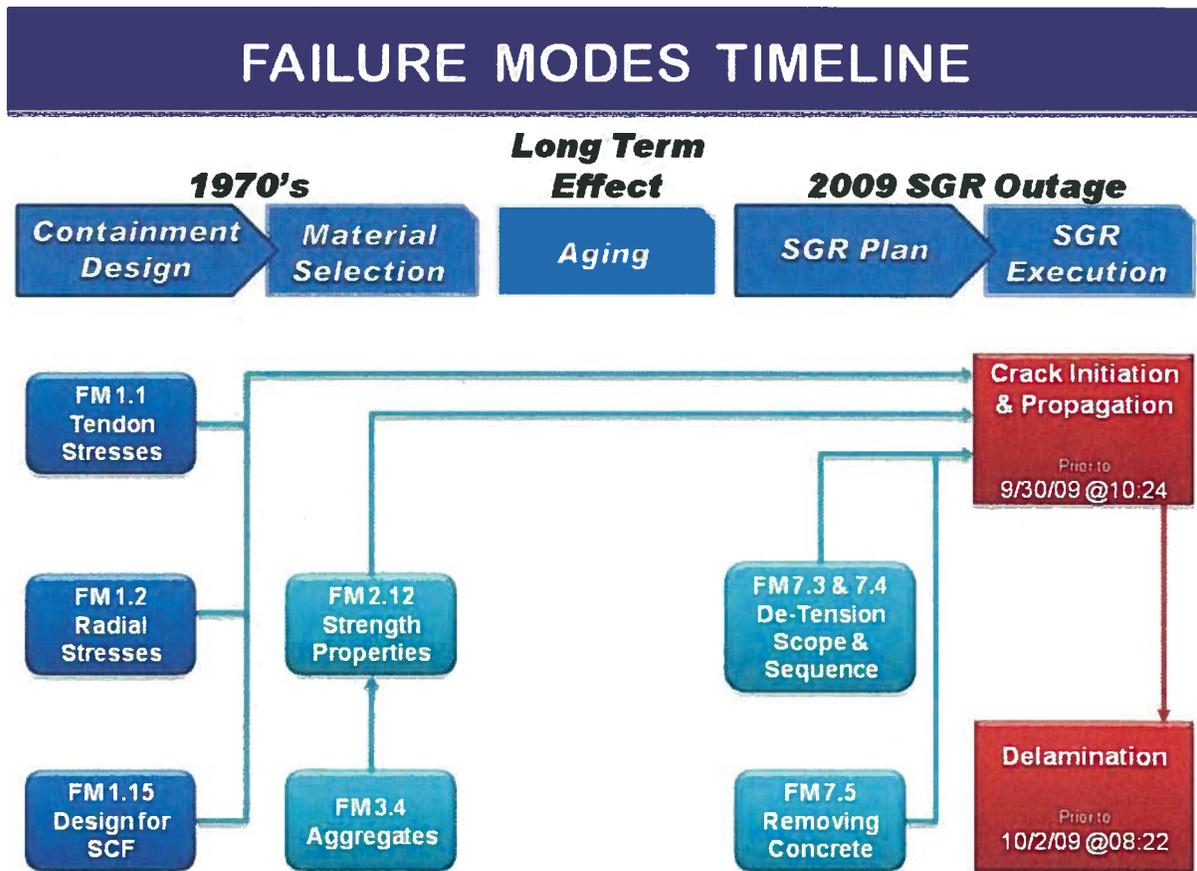
Figure 2.1 Failure Mode Timeline

Once the analysis of Failure Modes was complete, a Failure Modes Timeline was generated to identify when the issue arose and how it contributed to the event. This timeline is shown in [Figure 2.1](#).

The information in the next few sections will cover several topics related to the delamination event. The timeline in Figure 2.1 identifies how these topics converged to create the delamination. Section 7 provides a computer simulation of the delamination event. Section 8 integrates the individual elements and clarifies the overall process by which the root cause was determined.

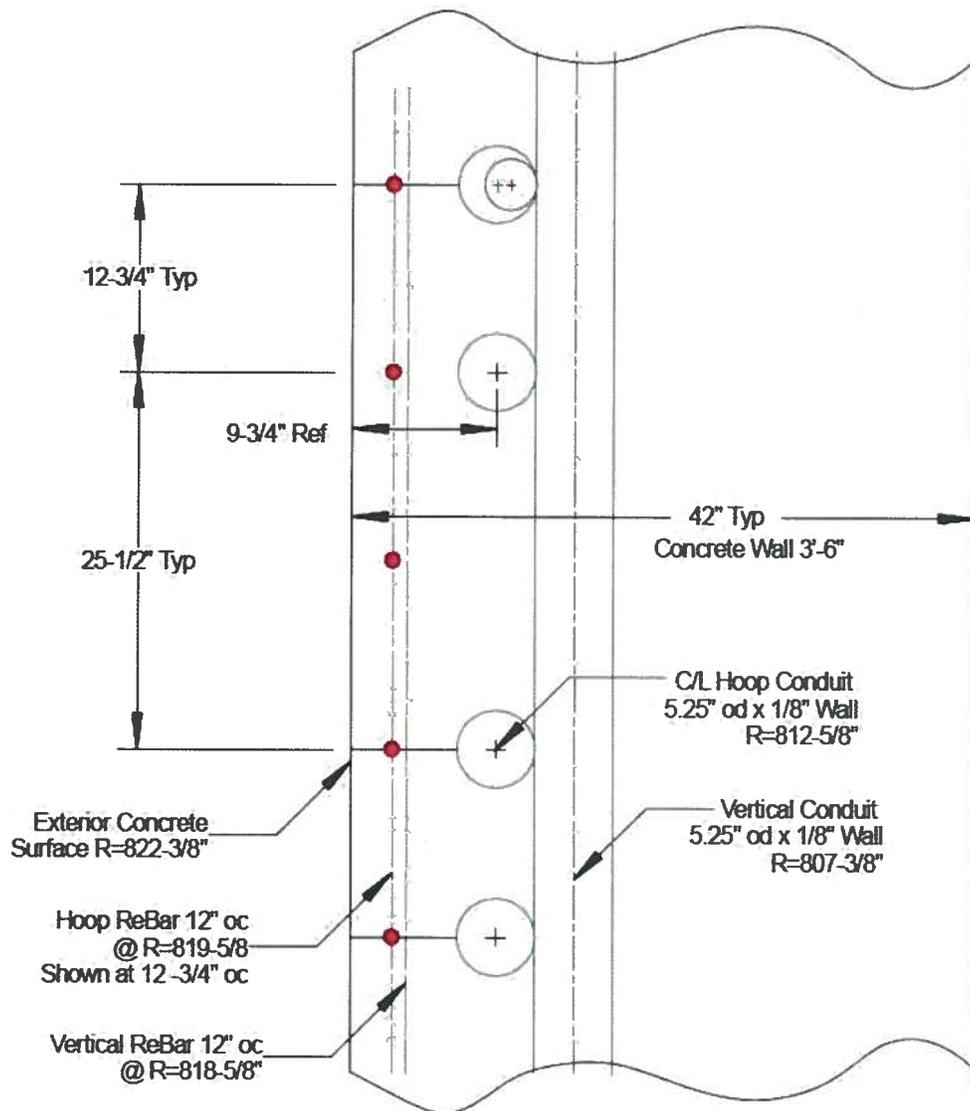
Figure 3.2 Layout of horizontal tendon sleeves in the CR3 containment wall (R is the containment inner radius in inches)

Figure 3.2 shows that there is no radial reinforcement provided beyond the horizontal tendons which results in the outermost 10 inches of concrete being radially un-reinforced while being subjected to tensile stresses.

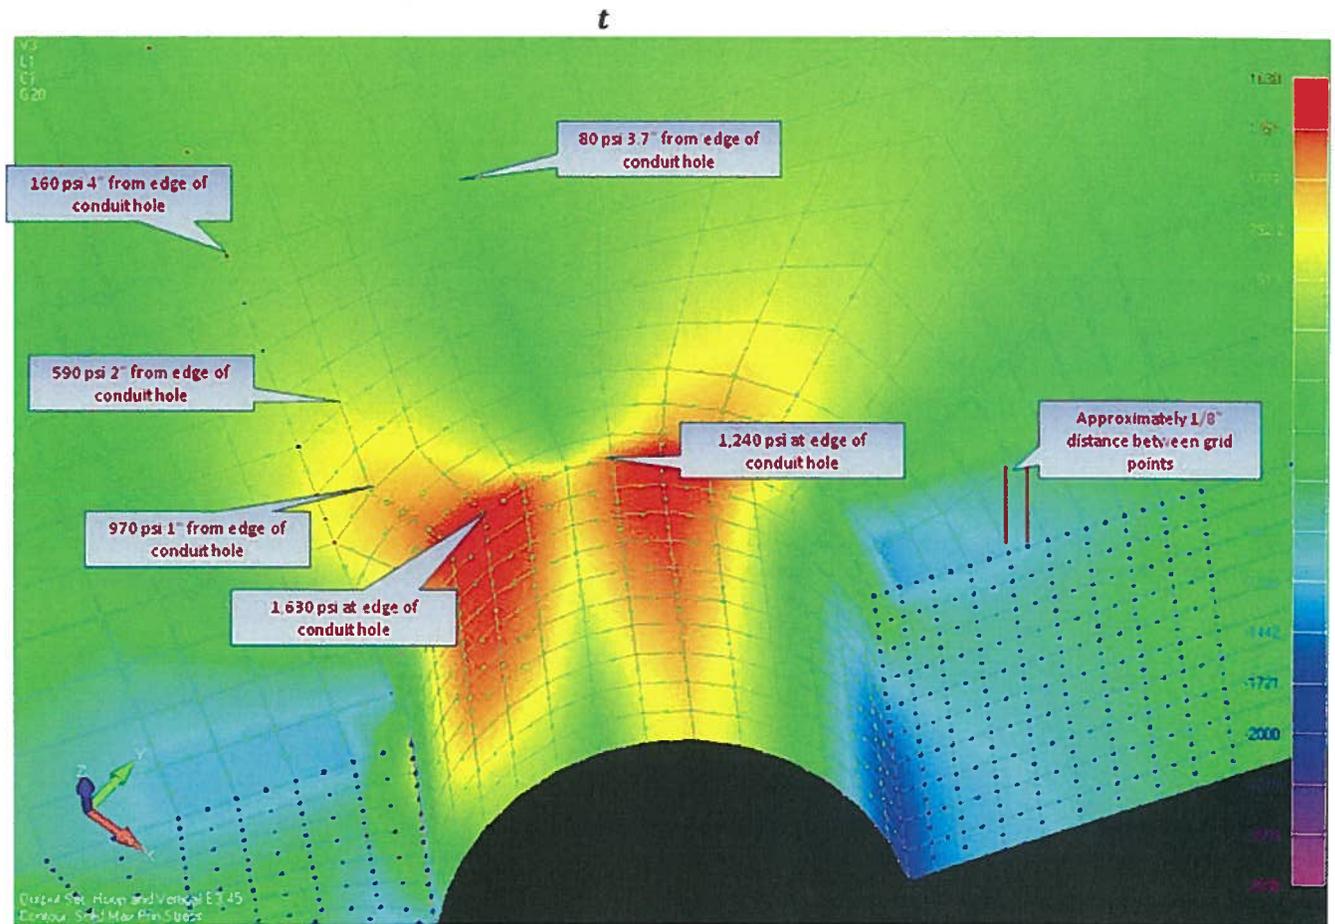
Figure 3.4 Stress contours for normally tensioned conditions at the intersection of a vertical and horizontal tendon.(3 Dimensional Effect Looking Through a Hoop Tendon Hole)

The tensile stress peaks at a very high value right at the edge of the horizontal tendon hole at the intersection with a vertical tendon due to the vertical and horizontal tendons. It reaches 1630 psi at the hole and drops off rapidly by a factor of 2 about every inch away. More generally, tensile stress peaks at about 510 psi on the edge of a horizontal tendon away from the vertical tendons and drops off about a factor of 2 every inch away. Figures 3.3 to 3.6 show a general display of stress variations along various directions in the containment concrete assuming no cracking in the concrete. For exact values refer to the specific calculations of design parameters found in the applicable FMs and the figures in Section 7 of this report.

The area around a representative horizontal tendon is shown in Figure 3.4. This is a critical area due to the high stresses and displacement of concrete by the tendon sleeves. This is the location along which the delamination propagated from the top and bottom of the holes to the next hole vertically or propagated circumferentially (azimuthally) around a segment of the building. Notice that the peak tensile stress at the edge of the horizontal tendon hole near a vertical tendon (Figure 3.4) is well in excess of the tensile capacity of the CR3 concrete. It is likely that small cracks formed at these intersections but then stopped propagating when they reached a location where the stress was too low to continue.

FM 1.1 determines that CR3's containment design results in a somewhat higher potential for delamination than other similar designs on the basis of Compressive-Tensile Stress Interaction. FM 1.2 finds that radial tensile stresses are high (refer to Figure 3.4) and there is no radial reinforcement. Large tendons lead to high peak stresses. FM 1.15 identified that stress concentration factors were not explicitly considered in the original design of the containment building. As with all the confirmed failure modes, they conclude that these issues did not individually cause the delamination but contributed to the conditions that resulted in delamination.

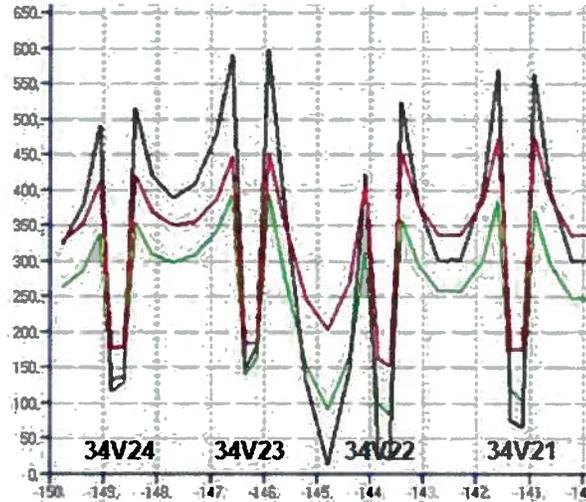
Figure 3.6 Plot of maximum principal stress as a function of distance around the containment circumference. (Black is pre-SGR, Green is Post SGR de-tensioning, Red is post SGR concrete removal.)

Figure 3.6 shows stresses in the containment structure going around its circumference. Local stress peaks are caused by the vertical tendons spaced evenly around the containment at about 3 foot intervals. The three graphs show pre-SGR conditions, post SGR de-tensioning, and post SGR concrete removal. It is intended to simply show the changing stress seen traveling from one vertical tendon to the next.

While the vertical tendons also displace concrete they are located inside the horizontal tendons in the area where the radial forces are compressive so the effect of displacement of concrete is not significant to the cause of cracking because concrete is strong in compression. Figure 3.6 is similar to Figures 3.4 and 3.5 showing the sharp stress changes near vertical tendons.

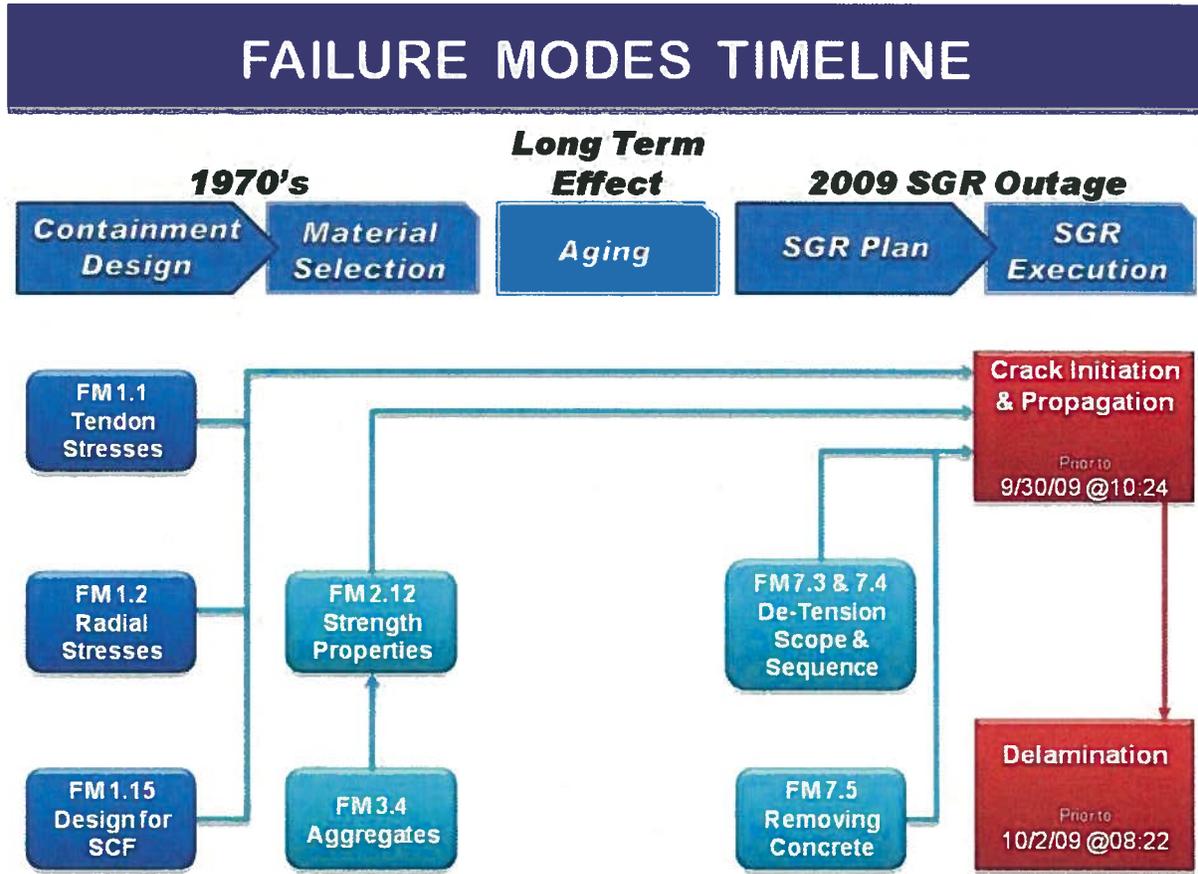
Figure 7.1 Failure Modes flow chart

The first step in the timeline was the original design of the containment building. That design specified the tendon sizes, locations, and no radial reinforcement for radial stress which ultimately played a part in the delamination four decades later.

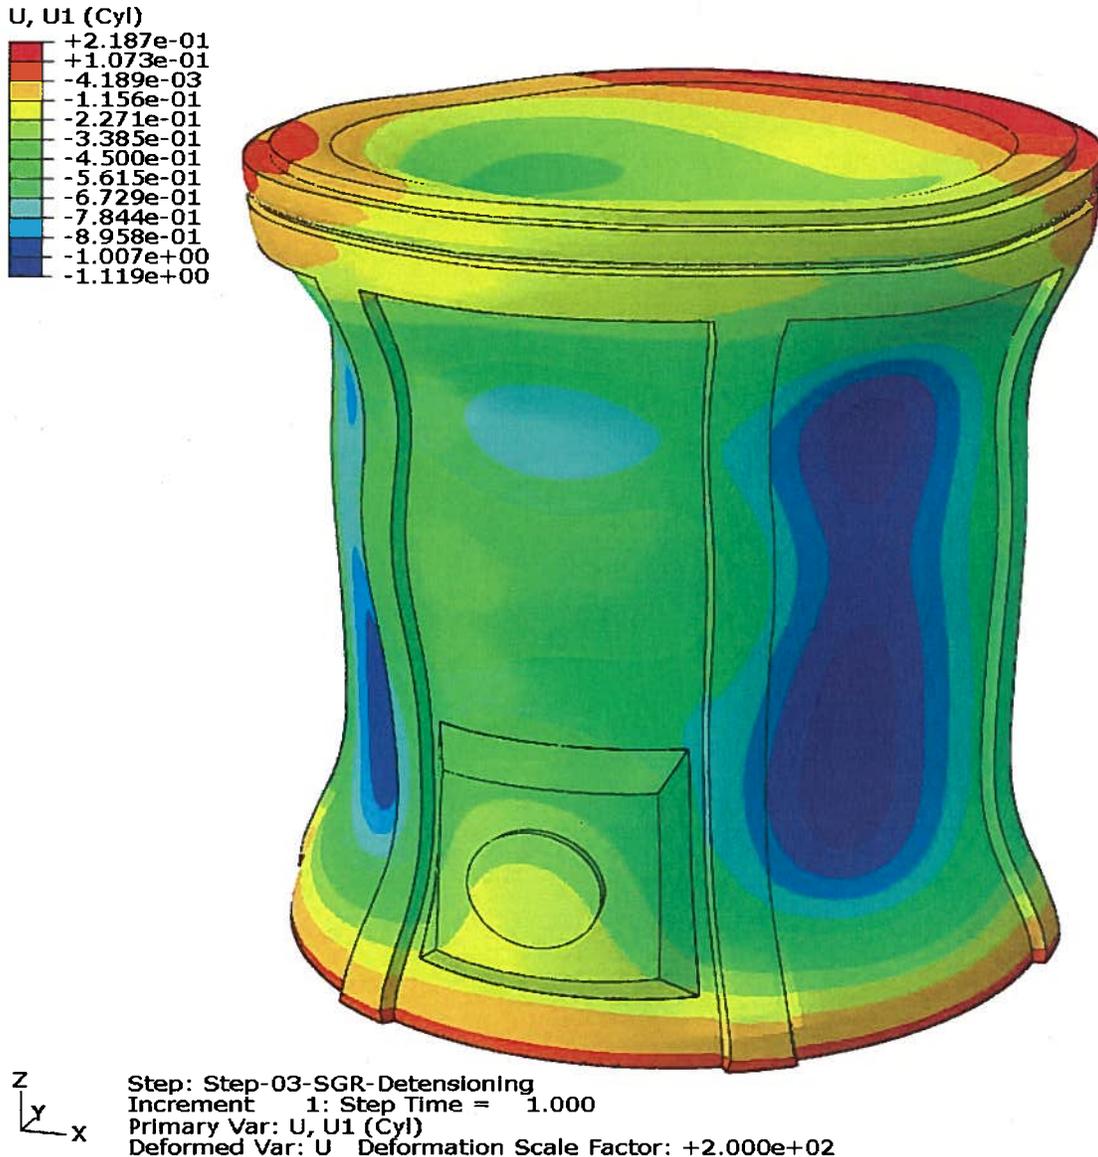
Figure 7.5 CR3 containment radial displacement post-SGR de-tensioning

The next milestone is the completion of the SGR de-tensioning in 2009. This consisted of de-tensioning 17 horizontal and 10 vertical tendons. The de-tensioned zone extends from about elevation 183' to 210' with a maximum effect at elevation 197'.

The shape of buttress 3 in profile has changed from a gradual C curve into an S curve because of the development of a bulge in the center of bay 34. The blue spot indicating radial contraction is now missing from bay 34 and is somewhat reduced in bay 45 (which experienced a reduction of nine tendons (due to tendons extending across two bays)). Bay 23 is not visible but also sees a reduced effect due to eight of its tendons being de-tensioned.

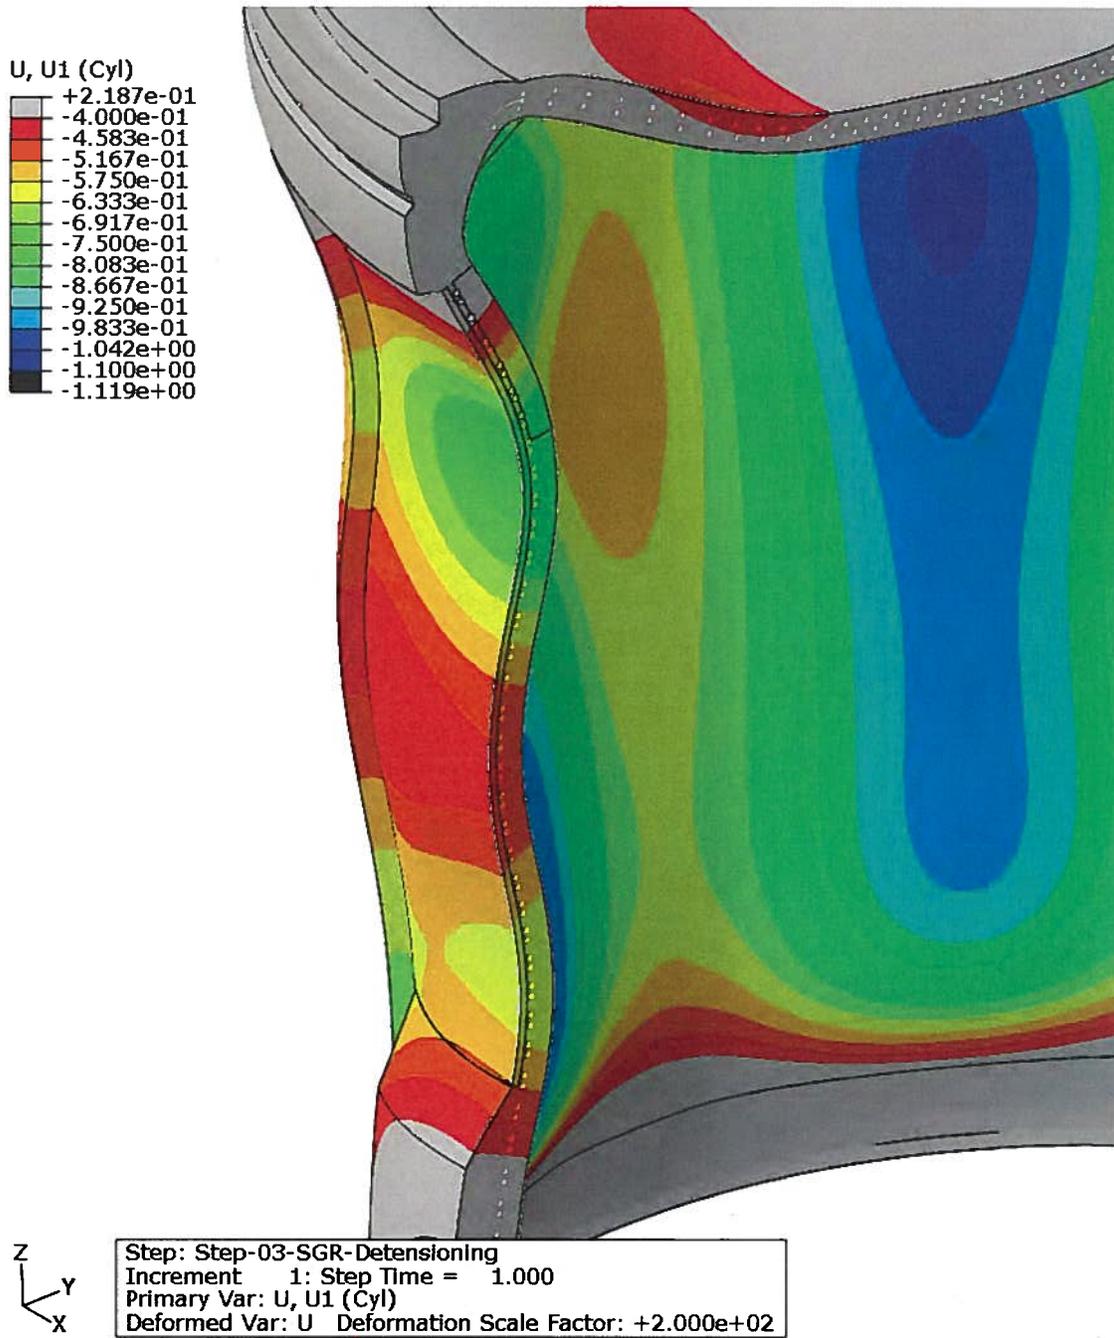
Figure 7.10 CR3 containment wall cut-away profile of radial displacement following the SGR

Here, an S curve has developed in the wall. Delamination stems more from the rate of change in the profile than from the magnitude of the change in profile. The inward displacement of the wall was greater prior to SGR de-tensioning than after de-tensioning, but its margin to delamination was greater because the contraction was smooth. In this plot, the maximum curvatures are at elevations 173' and 220'. The maximum delamination gap widths measured were centered around 175' and 216' (See Figure 7.14) which is good agreement.

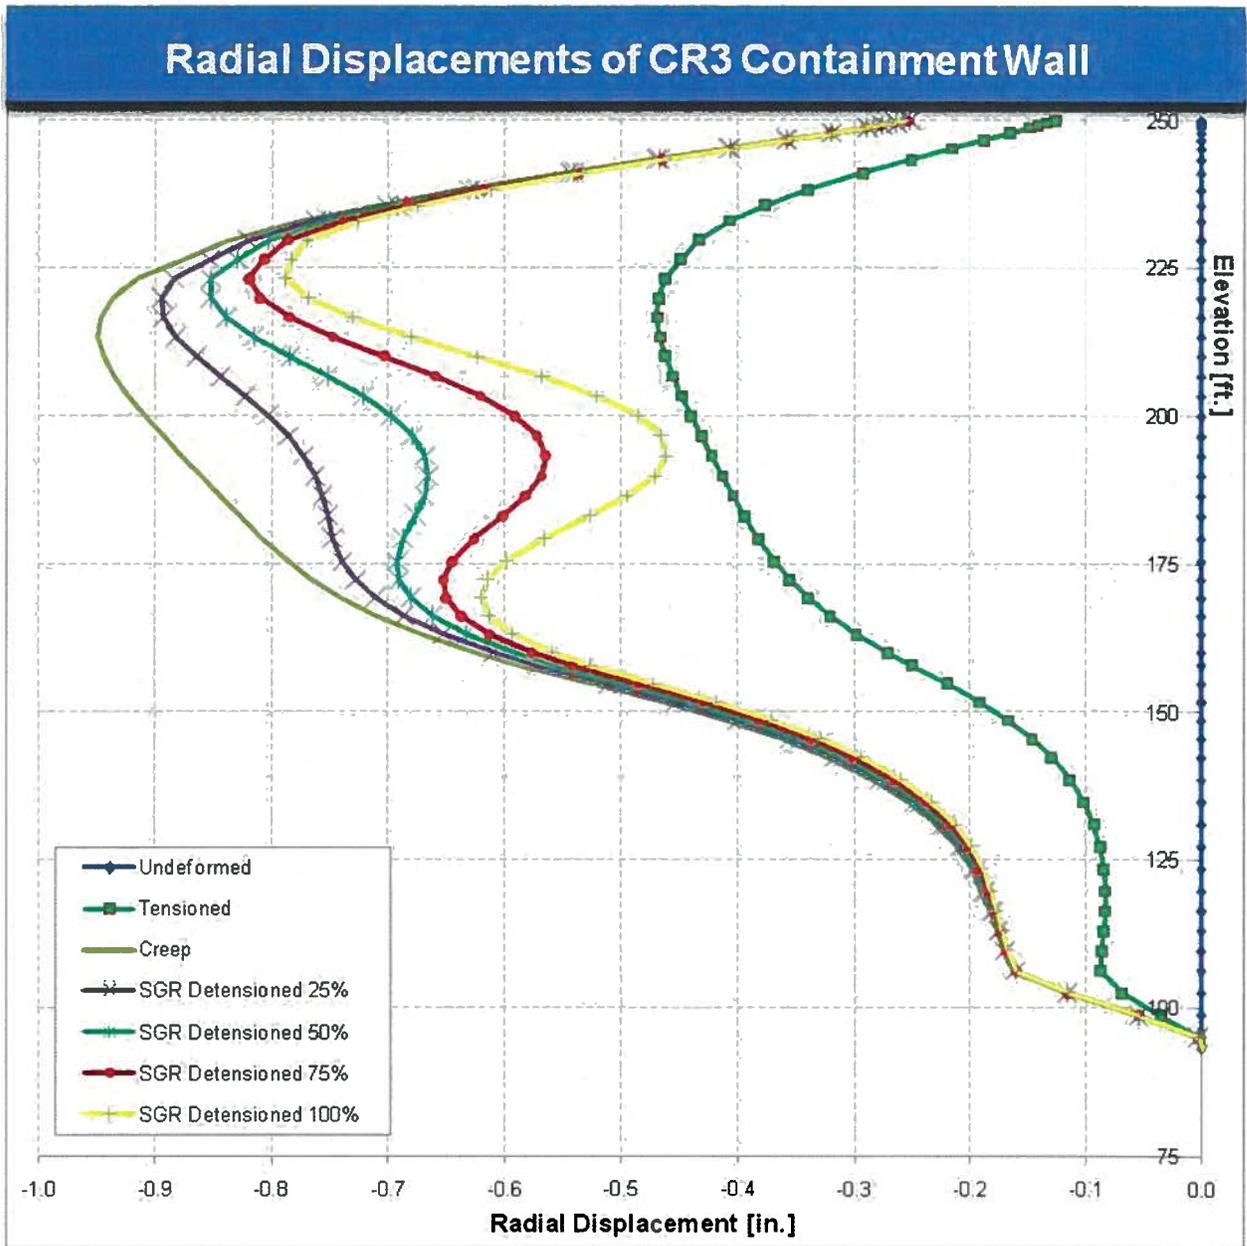
Figure 7.11 Bay 34 midline profile for progressive SGR de-tensioning

Figure 7.11 shows the radial displacement that occurred during the SGR de-tensioning. Delamination occurs where radial stress is high. That occurs at sharp bends in the wall. The de-tensioned region ran horizontally from elevation 183' to 210' for a span of 27'. Horizontally the bulge extended across the bay for span of about 60' so there was a smoother transition in that direction. Note in Figure 7.11 that the radial displacement associated with de-tensioning is linear. This means that the stress that develops is monotonically increasing and other sequences of de-tensioning the same number of tendons would not change the end-point which is the highest stress condition.

As expected, the un-tensioned case shows no radial displacement. The 1976 tensioned case shows uniform displacement of 0.5” inward. Creep increases that displacement to 1” inward by 2009. The SGR de-tensioning shows the impact of de-tensioning 10 vertical and 17 horizontal tendons in creating a double peaked profile with a much sharper curvature than was experienced previously. The intermediate lines are partial de-tensioning points going from fully tensioned to de-tensioned for SGR. The model did not remove each tendon sequentially. Instead, it de-tensioned all the selected tendons incrementally. While that is not the exact sequence used, the model gives a realistic view of the transition felt by the bay 34 wall. In the fully tensioned case (Creep), the curvature is approximately 0.05” over a 25’ span or 170 $\mu\text{in/in}$. De-tensioning 10

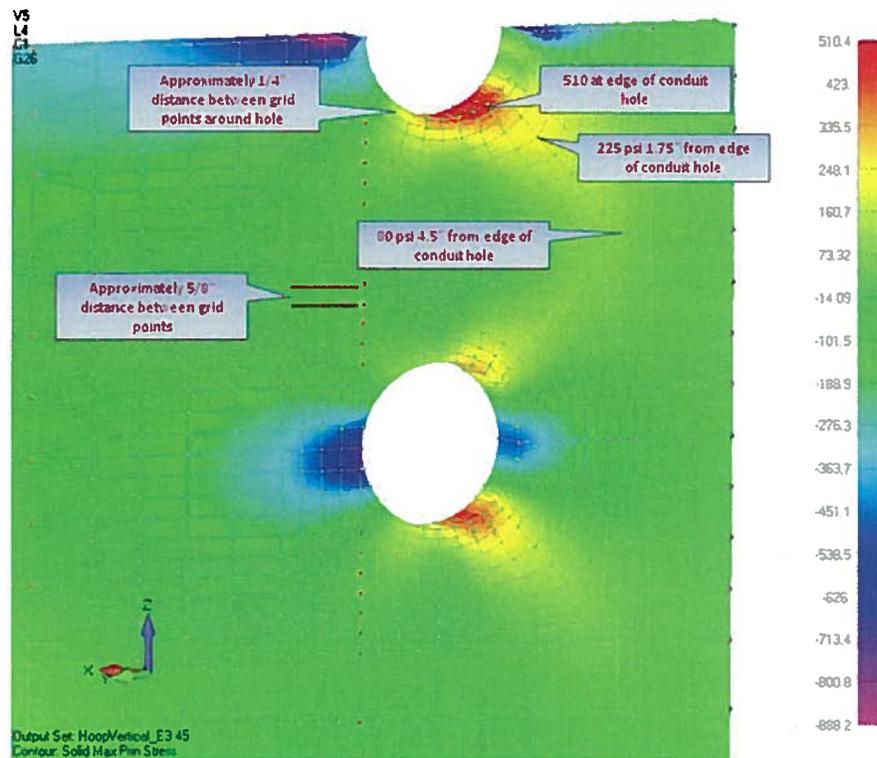
Figure 7.15 Stress contours for normally tensioned conditions in between intersections of a horizontal tendon with vertical tendons. (Section View)

the concrete. Figure 7.15 shows the stress distribution around the horizontal tendons. Note the high compressive and tensile peaks on the edges of the horizontal tendons.

The peak tensile stress in Figure 7.15 is about 500 psi in the area immediately next to the horizontal tendons near the top and bottom positions. In the absence of outside influences, the peak stress is just at the tensile capacity of the concrete and may indicate very small cracks at the top and bottom of each horizontal tendon sleeve hole. Figures 7.16 to 7.23 show the maximum principal stress added as a result of the bending of the containment wall.

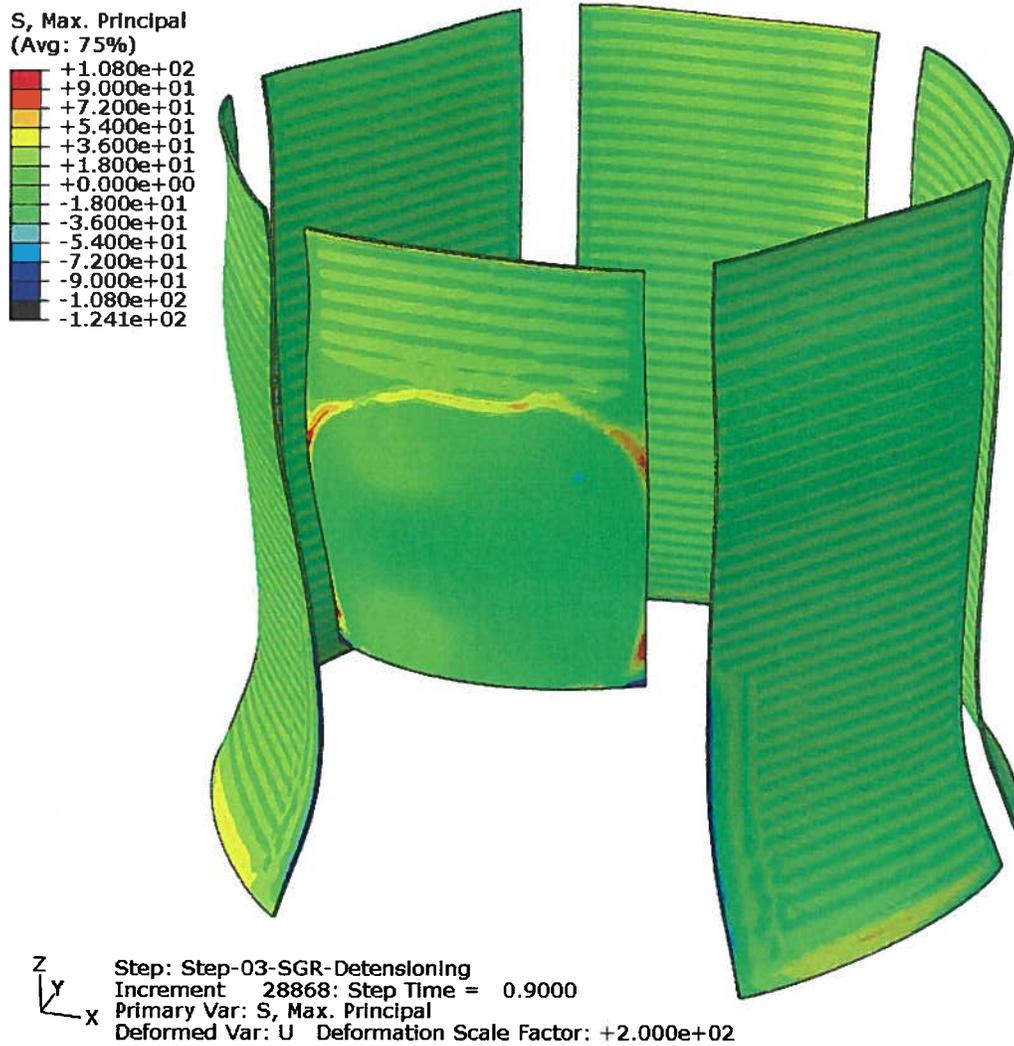
Figure 7.21 Step 18 of 20 in simulating the SGR de-tensioning.
Maximum principle stress (psi)

Note that at this step delamination has occurred and the stress has been relieved which can appear to be a relaxation of stress.

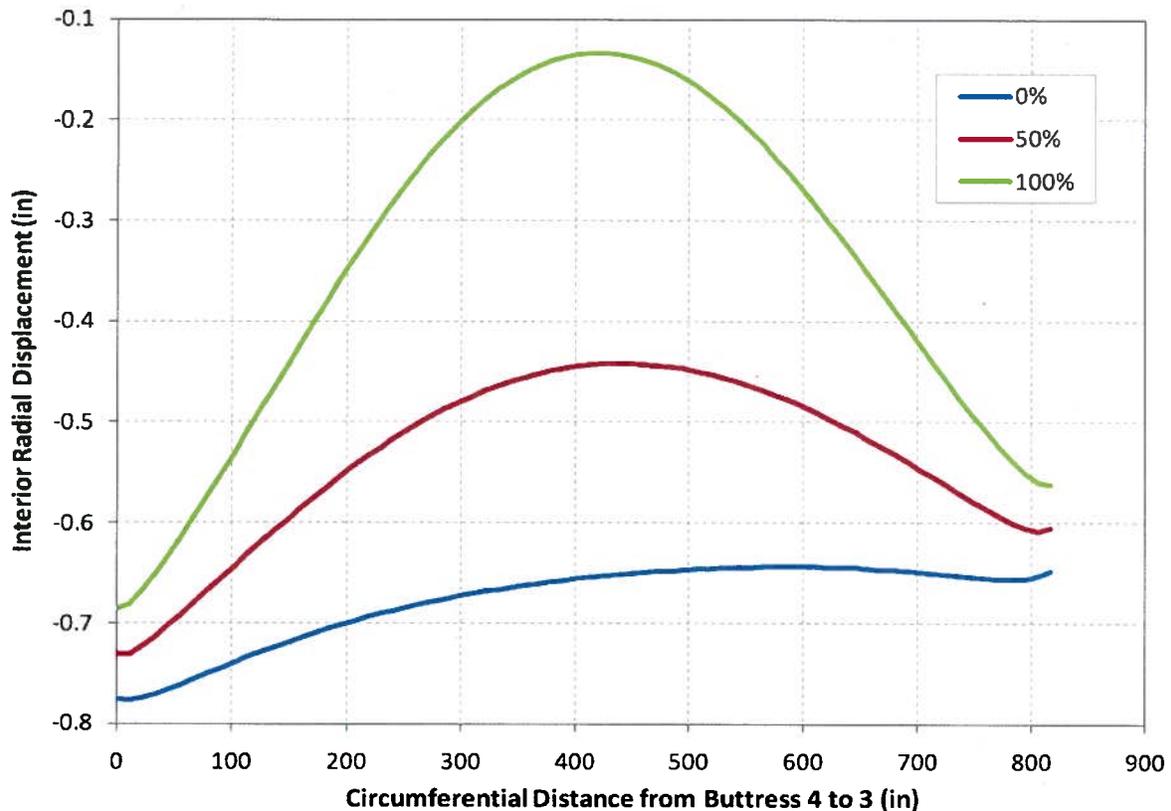
Figure 7.24 Azimuthal dependence of Bay 34 post SGR de-tensioning.

The asymmetric response in Figure 7.24 is due to an asymmetry in the dome tendon attachment arrangement that was correctly reflected in the model.

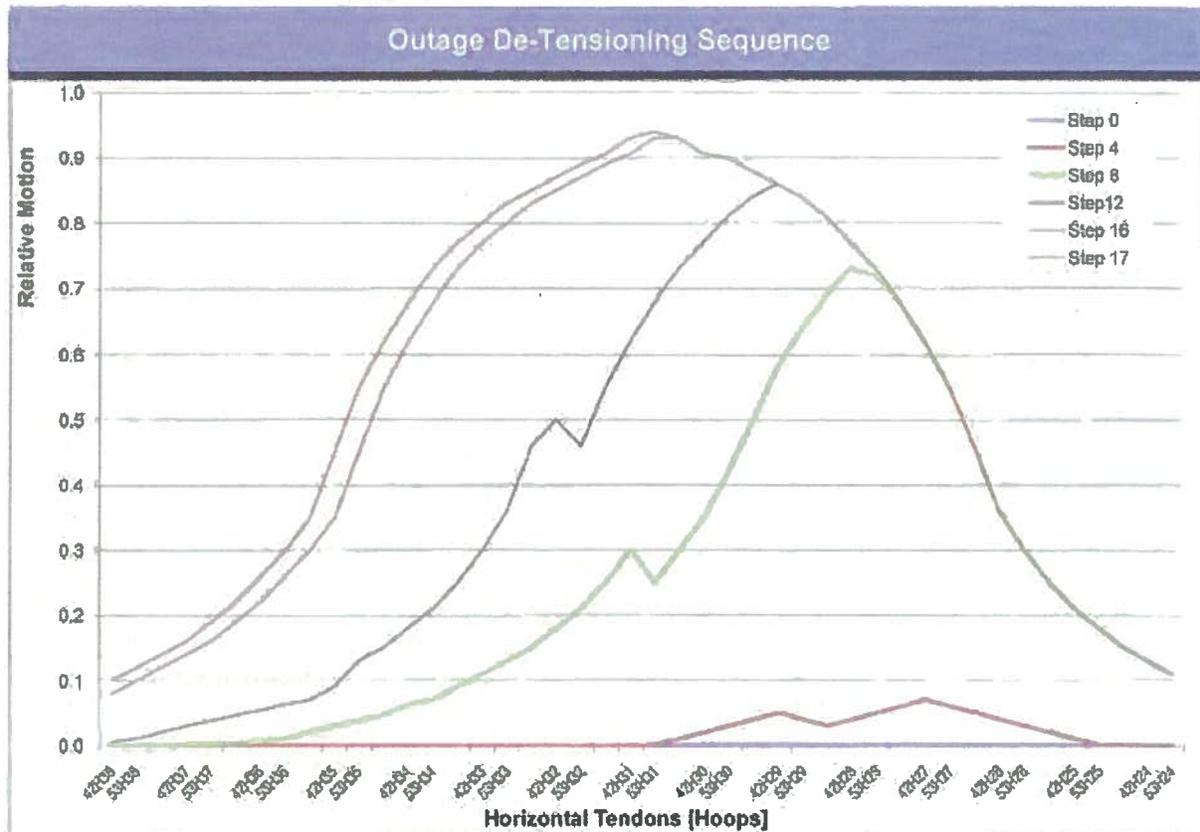
Figure 7.25 A Plot of the radial displacement in Bay 34 as SGR tendon de-tensioning progressed. The full displacement was 0.5”.

Cracking occurred in the area of the SGR opening. The cracks then propagated to form the unique hour glass shape in bay 34. Figure 7.25 shows a vertical slice through the bulge that formed in bay 34. The total deformation increases sharply as the total number of de-tensioned tendons increases. The absence of this transition in a de-tensioned environment is what prevented cracking in the neck of the hour glass.

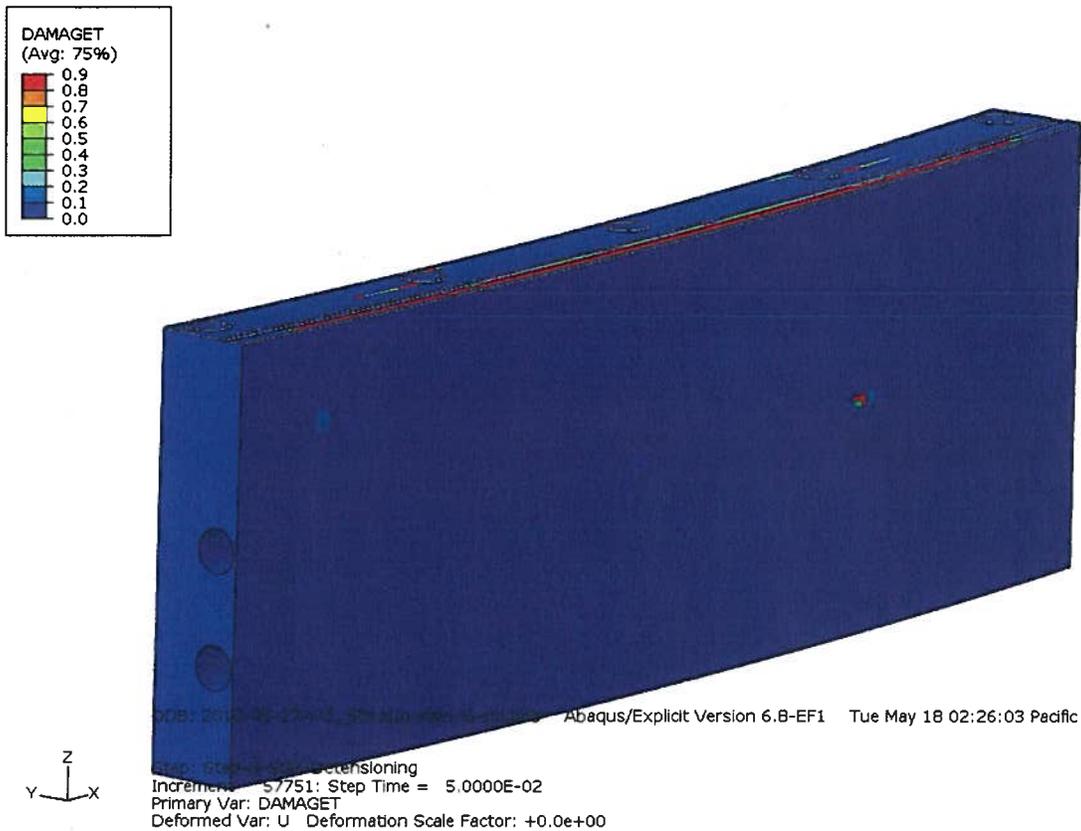
Cracking and then delamination began at some point in the de-tensioning and concrete removal process. Figures 7.26 to 7.29 show the results of the detailed Abaqus sub-model assuming tensile capacity of 360 psi. DAMAGET is a damage scale, a numerical measure of the ability of the concrete to pass load. The range is 0 to 1.0 where pristine material is 0 and fully fractured material is 1.0 and can pass no load.

Figure 7.26 A Plot of a bay 34 wall segment approaching delamination.

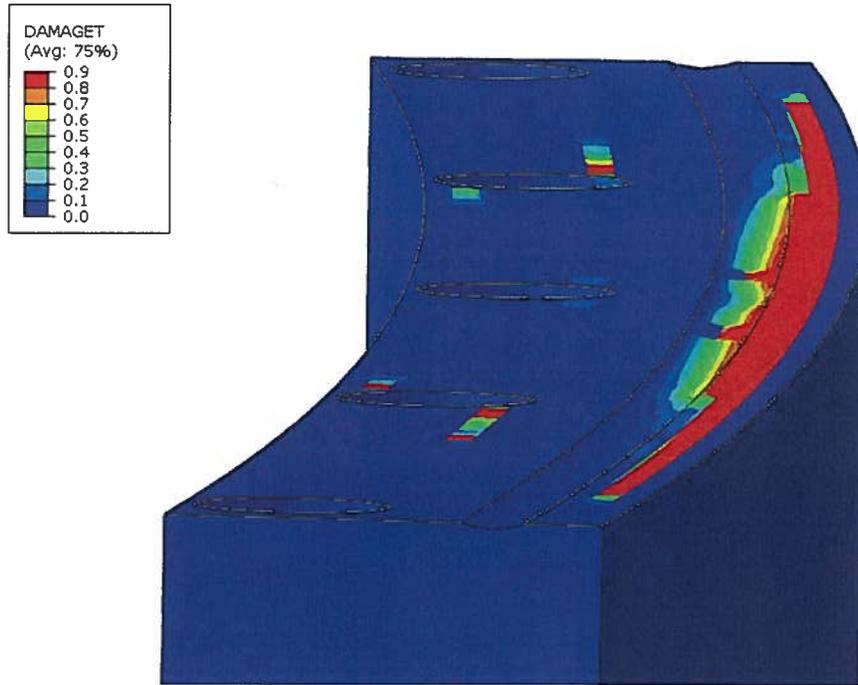
Figure 7.27 A Plot of a bay 34 wall segment delaminating

Figures 7.27 and 7.28 shows the Abaqus Detailed model prediction of delamination assuming tensile capacity of 360 psi. The peak stress locations on the top and bottom of the horizontal tendons extend out under the high radial tension conditions until they connect with the next tendon hole.

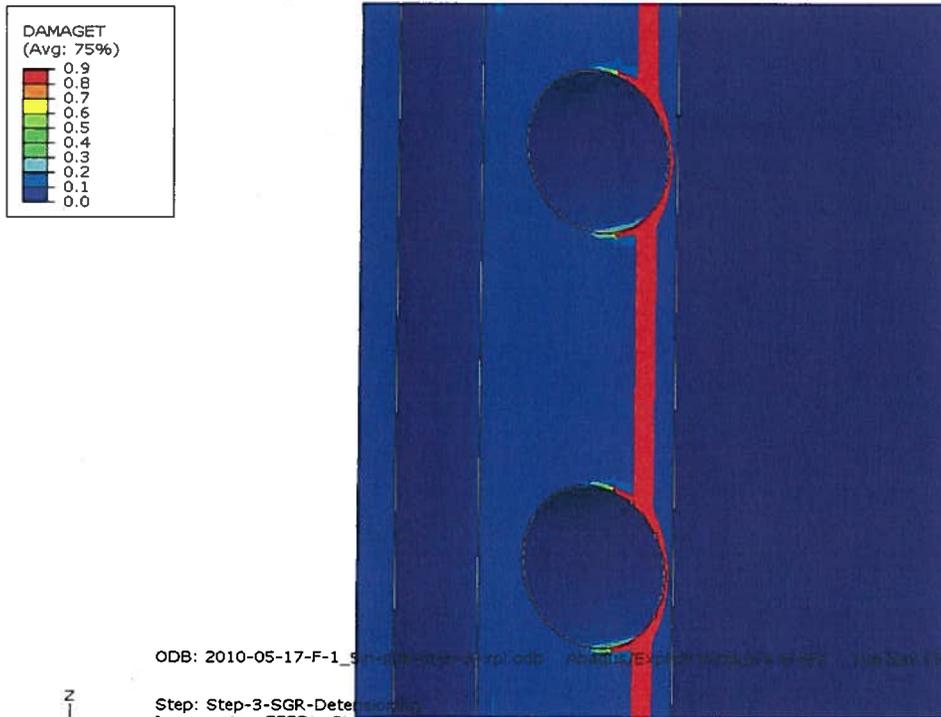
Figure 7.28 A Plot of a bay 34 wall segment delaminating $F't= 360$ psi

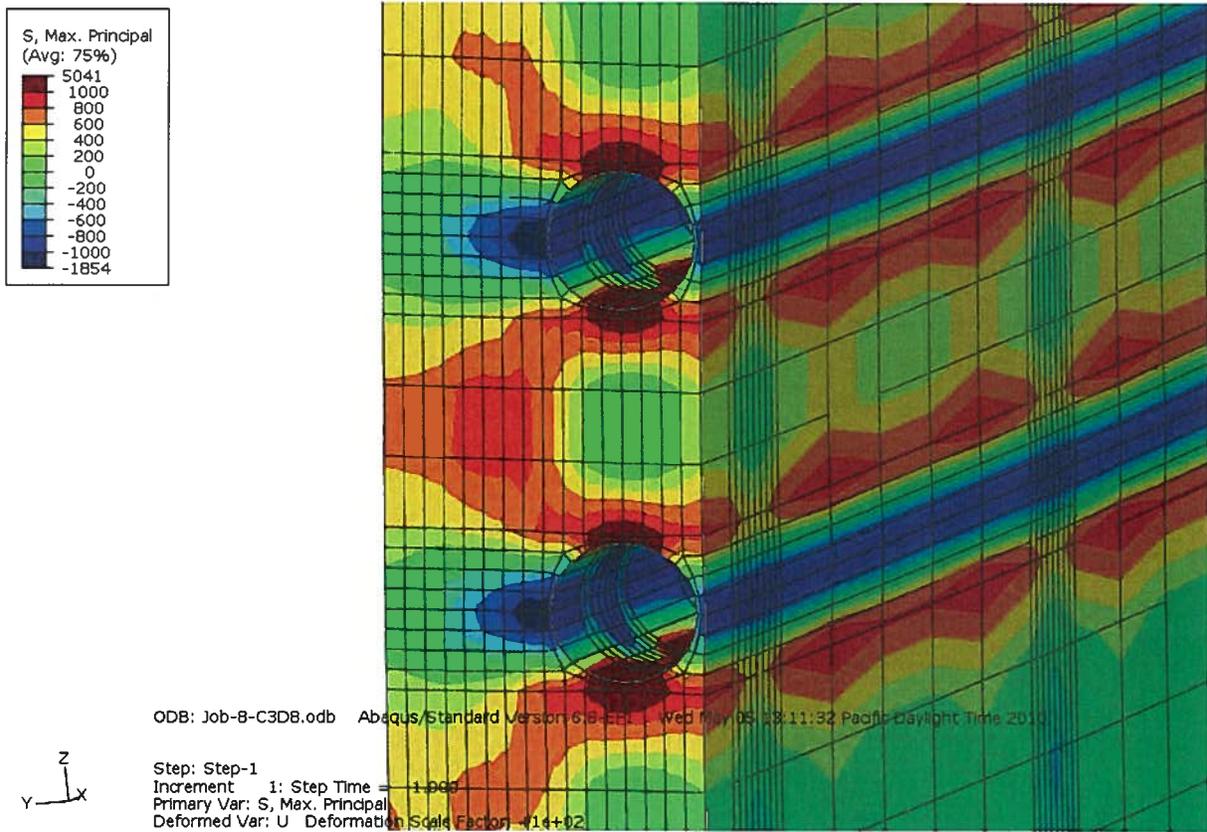
Figure 7.29 A Plot of maximum principal stresses in delamination. F't =360 psi

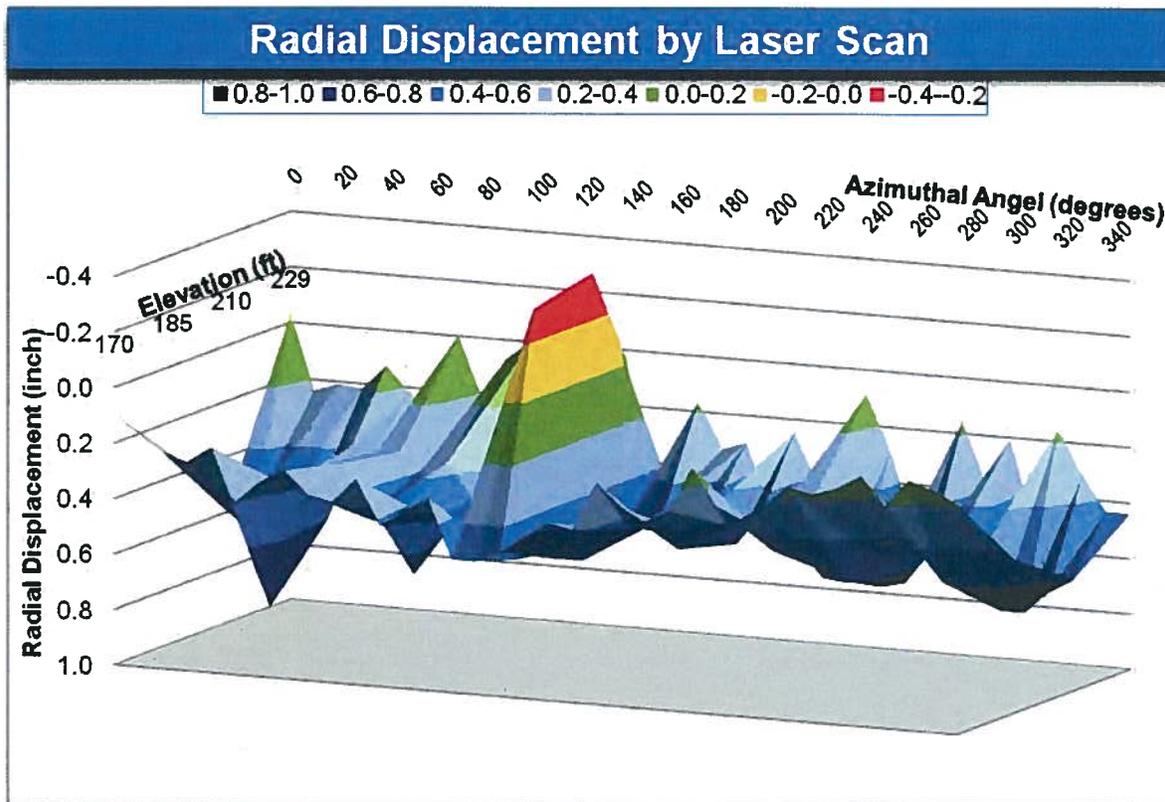
Figure 7.30 Three dimensional representation of radial displacement as a function of azimuthal angle and elevation.

In a sense, it is a snapshot of the conditions that existed at the end of the SGR opening project. The most prominent feature in figure 7.30 is the bulge at azimuthal angle 150 degrees. In addition each of the six bays is recognizable with its edges relatively fixed and its center sections bowed inward under tendon tension. Please note that these data indicate a change in displacement rather than an absolute displacement. Almost all points moved outward as the containment was de-tensioned in March, 2010. The notable exception was the area immediately around the SGR opening.

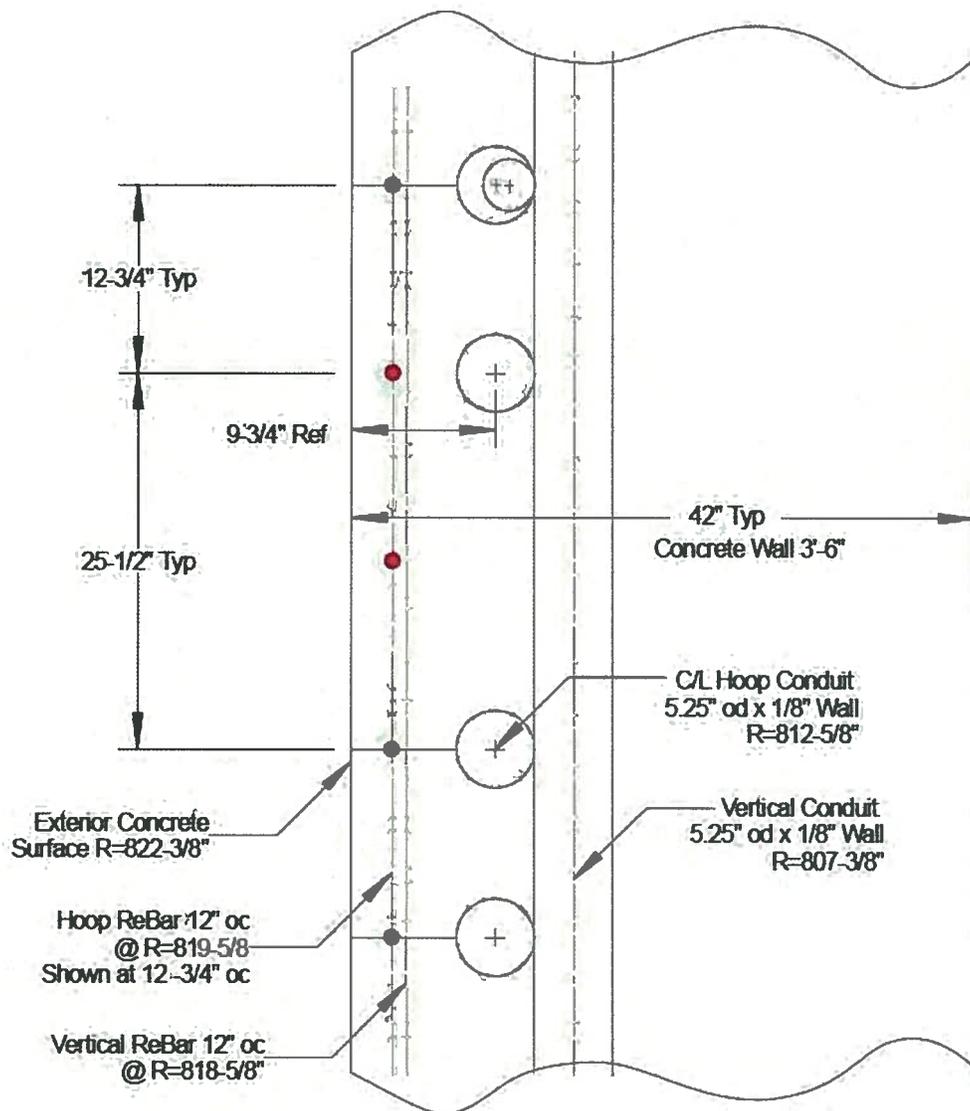
Figure 3.2 shows that there is no radial reinforcement provided beyond the horizontal tendons which results in the outermost 10 inches of concrete being radially un-reinforced while being subjected to tensile stresses.

Figure 3.2 Layout of horizontal tendon sleeves in the CR3 containment wall (R is the containment inner radius in inches)
