**SUBJECT: CRYSTAL RIVER NUCLEAR PLANT - SPECIAL INSPECTION REPORT
05000302/2009007**

The purpose of this inspection was to examine activities associated with the delamination identified in the Unit 3 containment. The inspection was conducted in accordance with the Special Inspection charter issued by the Region II Administrator on October 13, 2009. As part of the inspection, the NRC examined your evaluation of extent of condition, your evaluation of root cause, and your planned corrective action for continued operability. The inspectors interviewed personnel and conducted plant walk downs, including visual examination of accessible portions of the outside and inside surfaces of the containment.

ROOT CAUSE ASSESSMENT CRYSTAL RIVER UNIT 3 CONTAINMENT CONCRETE DELAMINATION

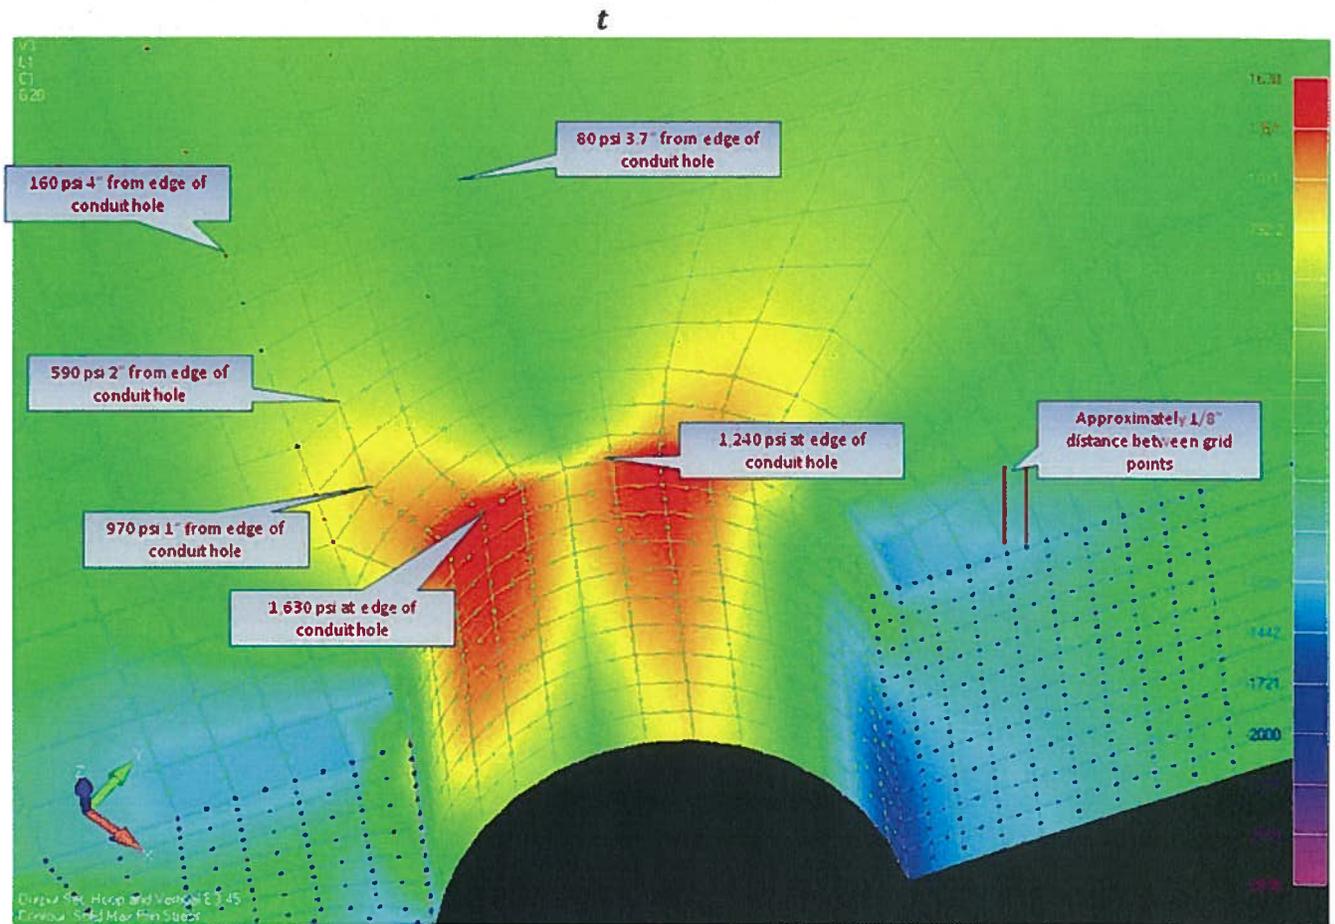
The area around a representative horizontal tendon is shown in Figure 3.4. This is a critical area due to the high stresses and displacement of concrete by the tendon sleeves. This is the location along which the delamination propagated from the top and bottom of the holes to the next hole vertically or propagated circumferentially (azimuthally) around a segment of the building. Notice that the peak tensile stress at the edge of the horizontal tendon hole near a vertical tendon (Figure 3.4) is well in excess of the tensile capacity of the CR3 concrete. It is likely that small cracks formed at these intersections but then stopped propagating when they reached a location where the stress was too low to continue.

Figure 3.4 Stress contours for normally tensioned conditions at the intersection of a vertical and horizontal tendon.(3 Dimensional Effect Looking Through a Hoop Tendon Hole)

FM 1.1 determines that CR3's containment design results in a somewhat higher potential for delamination than other similar designs on the basis of Compressive-Tensile Stress Interaction. FM 1.2 finds that radial tensile stresses are high (refer to Figure 3.4) and there is no radial reinforcement. Large tendons lead to high peak stresses. FM 1.15 identified that stress concentration factors were not explicitly considered in the original design of the containment building. As with all the confirmed failure modes, they conclude that these issues did not individually cause the delamination but contributed to the conditions that resulted in delamination.

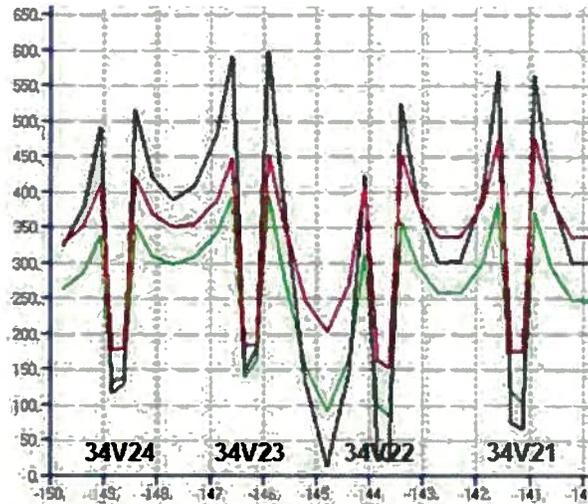
Figure 3.6 shows stresses in the containment structure going around its circumference. Local stress peaks are caused by the vertical tendons spaced evenly around the containment at about 3 foot intervals. The three graphs show pre-SGR conditions, post SGR de-tensioning, and post SGR concrete removal. It is intended to simply show the changing stress seen traveling from one vertical tendon to the next.

Figure 3.6 Plot of maximum principal stress as a function of distance around the containment circumference. (Black is pre-SGR, Green is Post SGR de-tensioning, Red is post SGR concrete removal.)

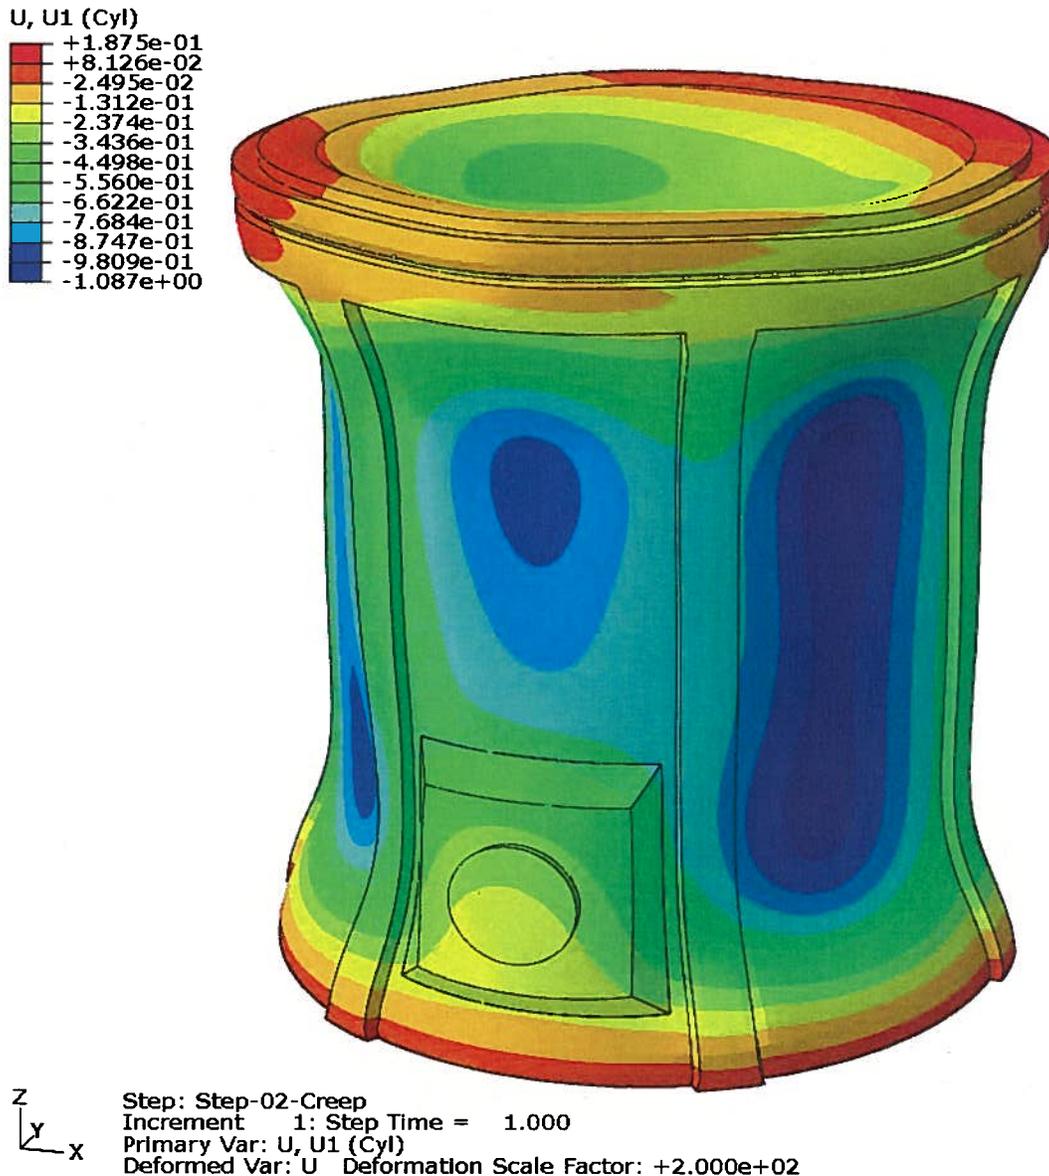
Figure 7.4 CR3 containment radial displacement after 30 years of creep.

Creep is the gradual displacement of concrete under long term stress so one would expect additional radial displacement over time. The effect of creep is visible in the depth of the dome, the narrowing of the waist of the building, and the displacement of the equipment hatch.

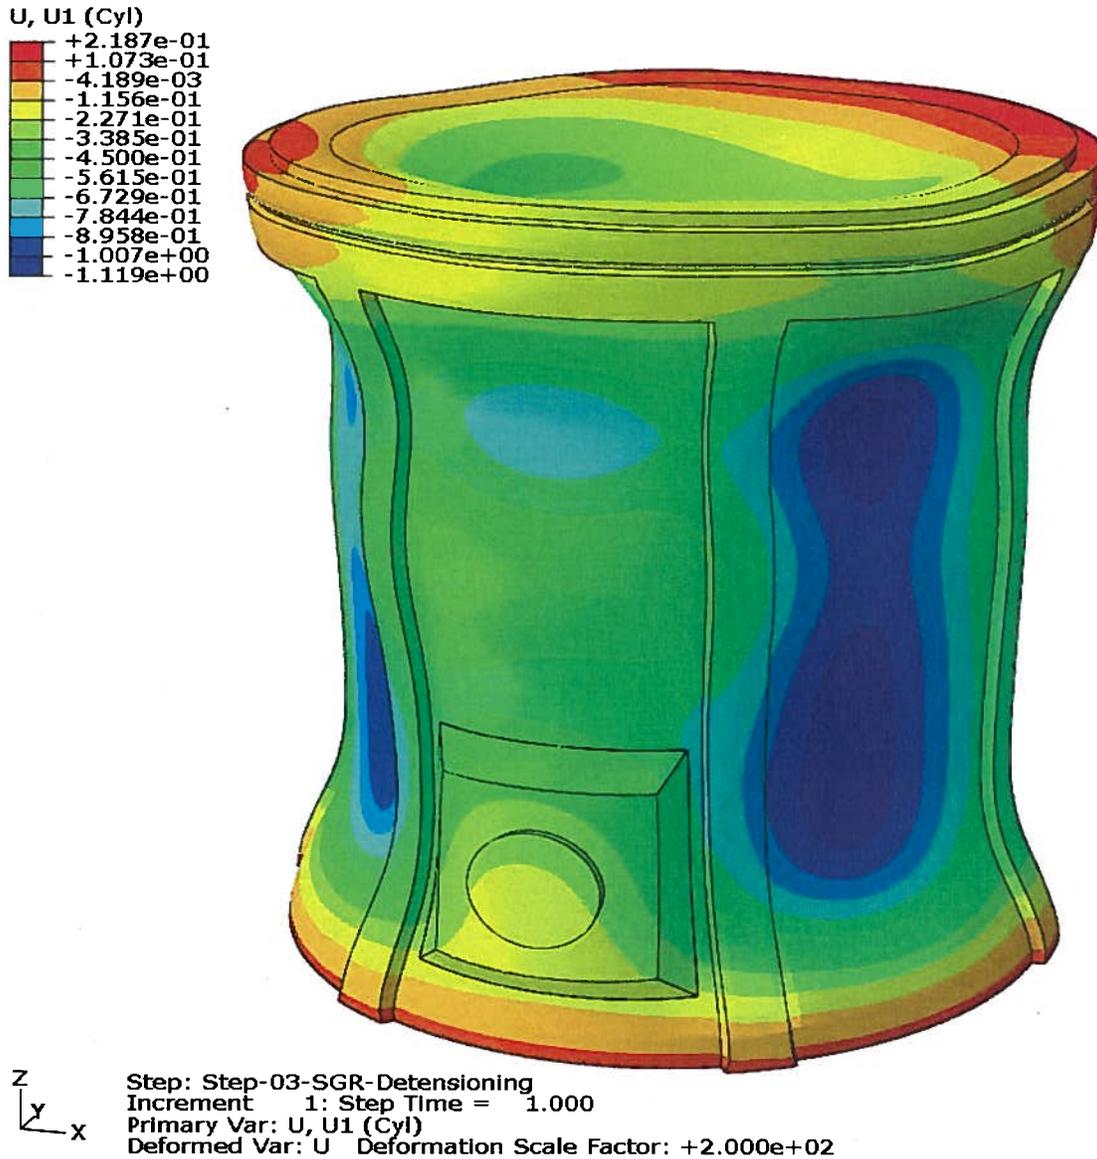
Figure 7.5 CR3 containment radial displacement post-SGR de-tensioning

The shape of buttress 3 in profile has changed from a gradual C curve into an S curve because of the development of a bulge in the center of bay 34. The blue spot indicating radial contraction is now missing from bay 34 and is somewhat reduced in bay 45 (which experienced a reduction of nine tendons (due to tendons extending across two bays)). Bay 23 is not visible but also sees a reduced effect due to eight of its tendons being de-tensioned.

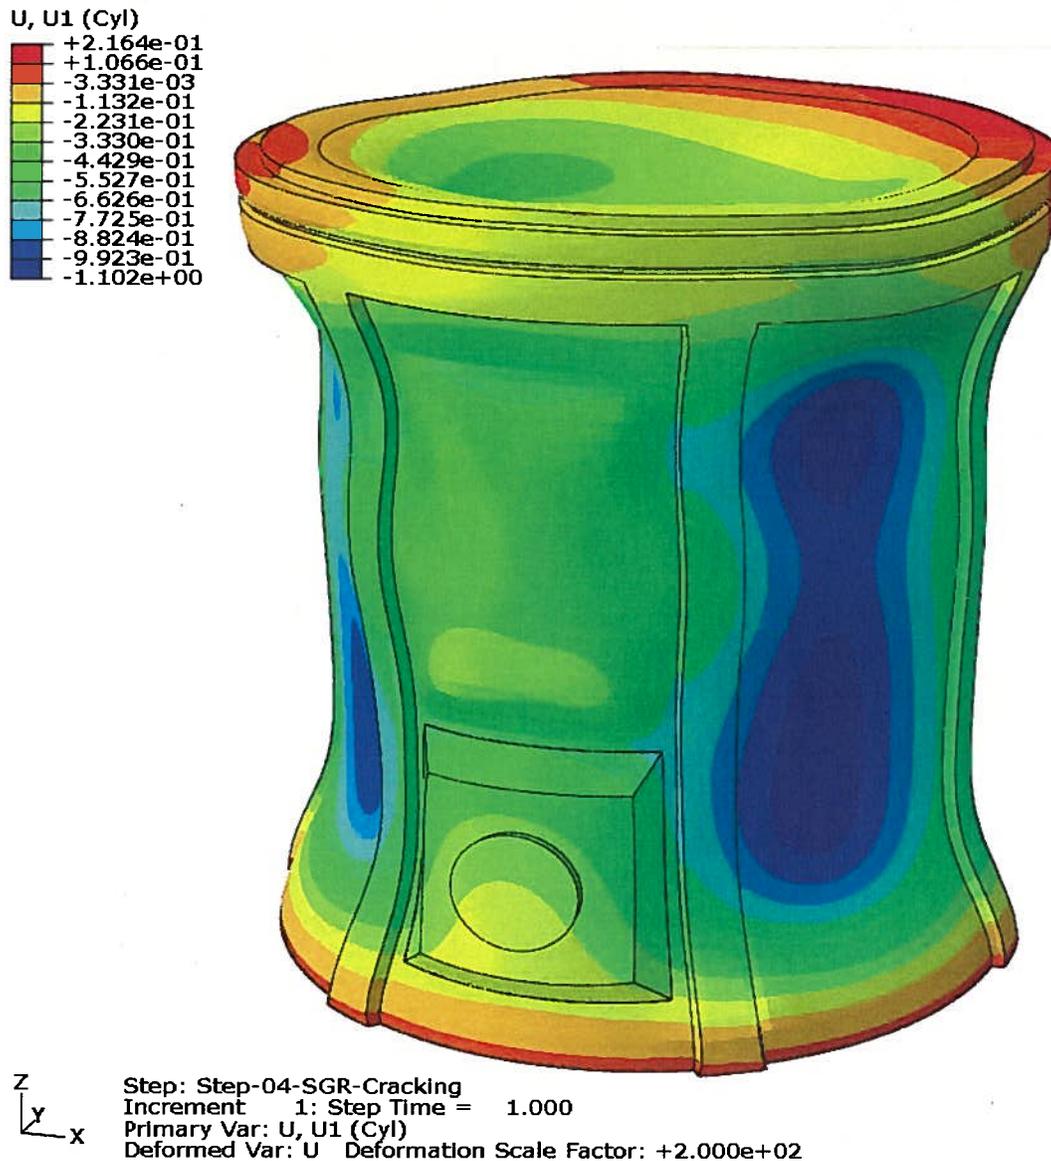
Figure 7.6 is a special case. The containment wide Global Abaqus model is not designed to handle the consequences of concrete cracking. The additional complexity involved with handling crack propagation and load distribution in a cracked environment would be prohibitive for the full containment model. That analysis is performed in the sub-models. In Figure 7.6 the analysis was stopped at Figure 7.5 and the ties between the inner and outer layers were manually broken to determine what the containment-wide response would be. The result is that an hourglass shape has developed in the bulged area of bay 34, matching the actual delamination pattern, and is caused by the interaction of the building causing the center of bay 34 to bulge outward. The de-tensioned zone at the sides of the SGR opening reduces the propensity to crack. The result is an hour glass shape with the peak displacement in the fully tensioned area just above and below the bulge in the middle of the bay.

Figure 7.6 CR3 containment radial displacement post SGR de-tensioning

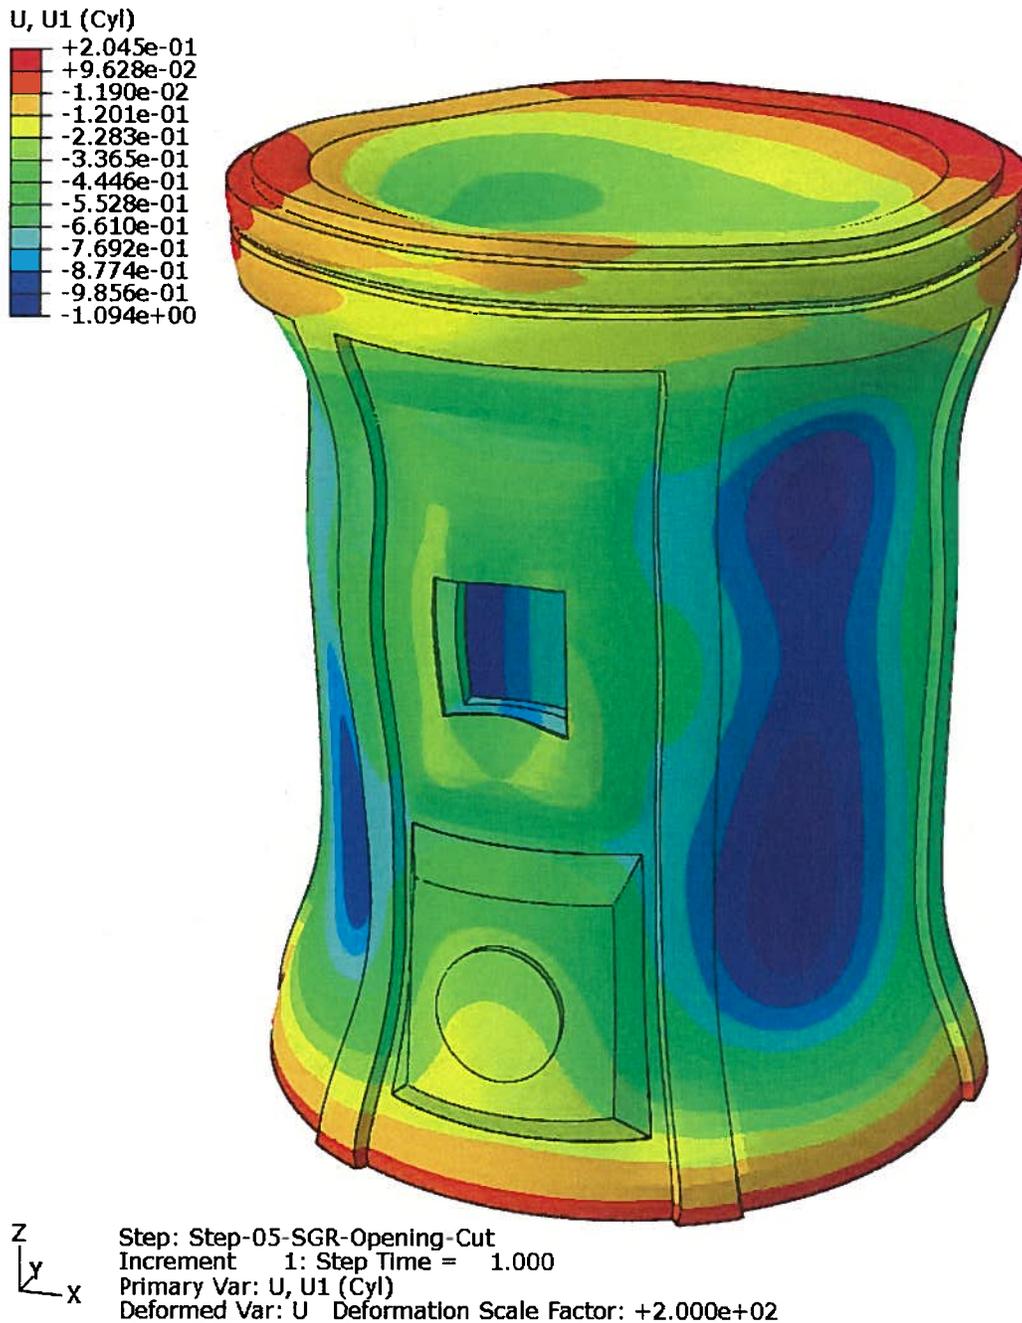
Figure 7.7 CR3 containment radial displacement after SGR opening completion.

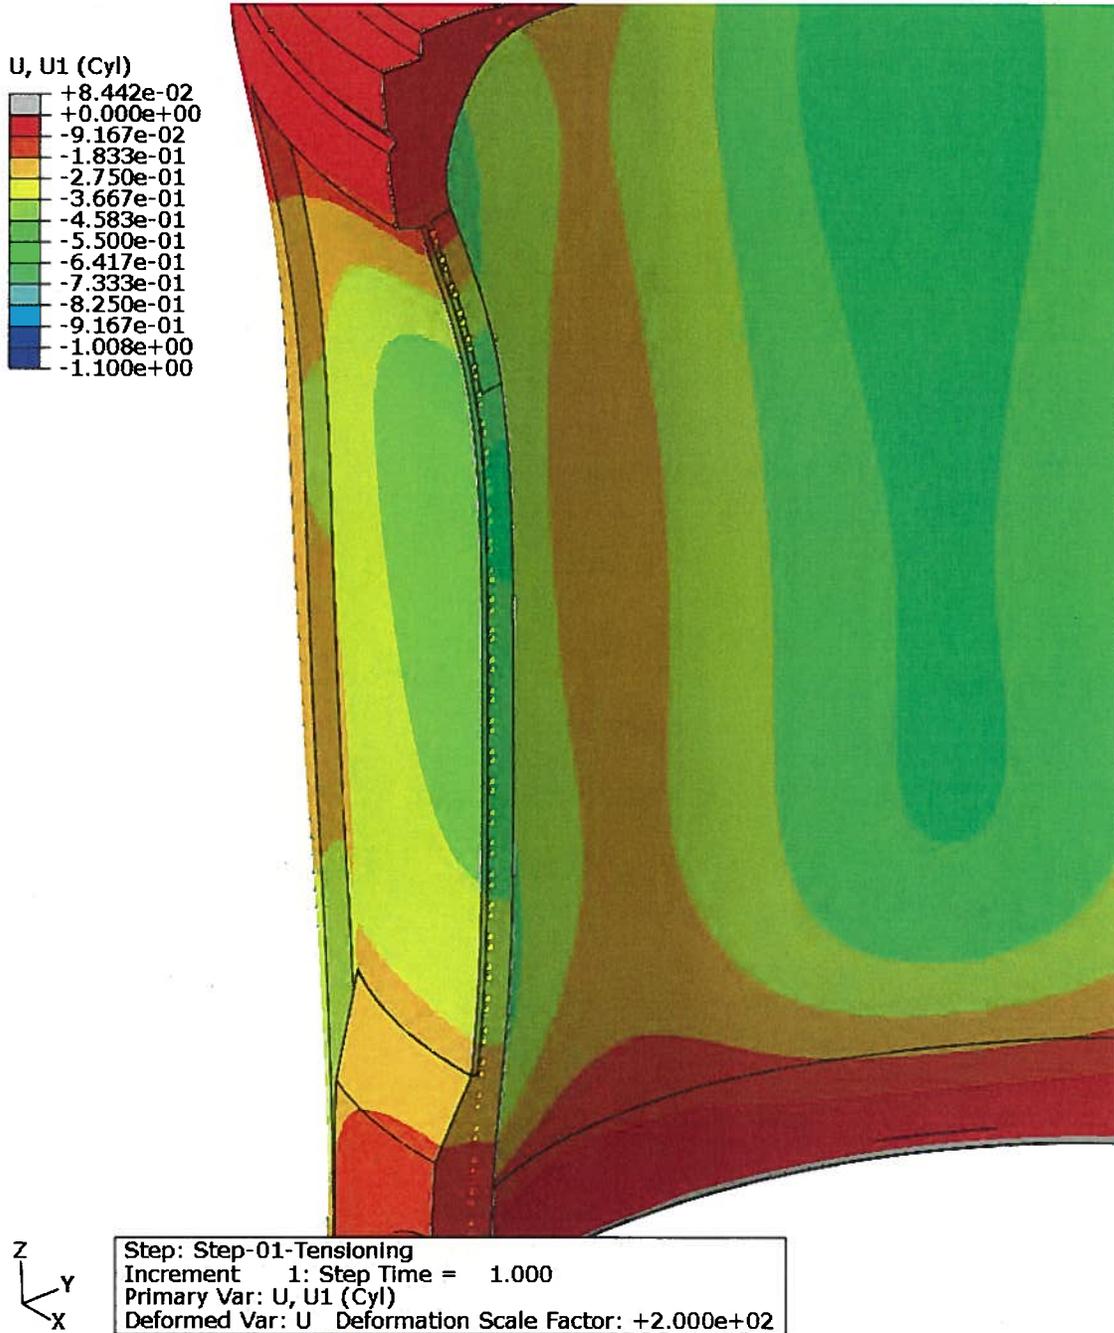
Up until this point the entire containment has been displayed, which is useful to understanding the overall forces at work but it does not explain the local conditions that ultimately result in delamination. Figure 7.8 is a cut-away profile of the bay 34 wall showing radial displacement as it was immediately after tensioning in 1976.

Figure 7.8 CR3 Bay 34 wall profile radial displacement post initial tensioning in 1975. The next milestone is in 2009 after 30 years of creep.

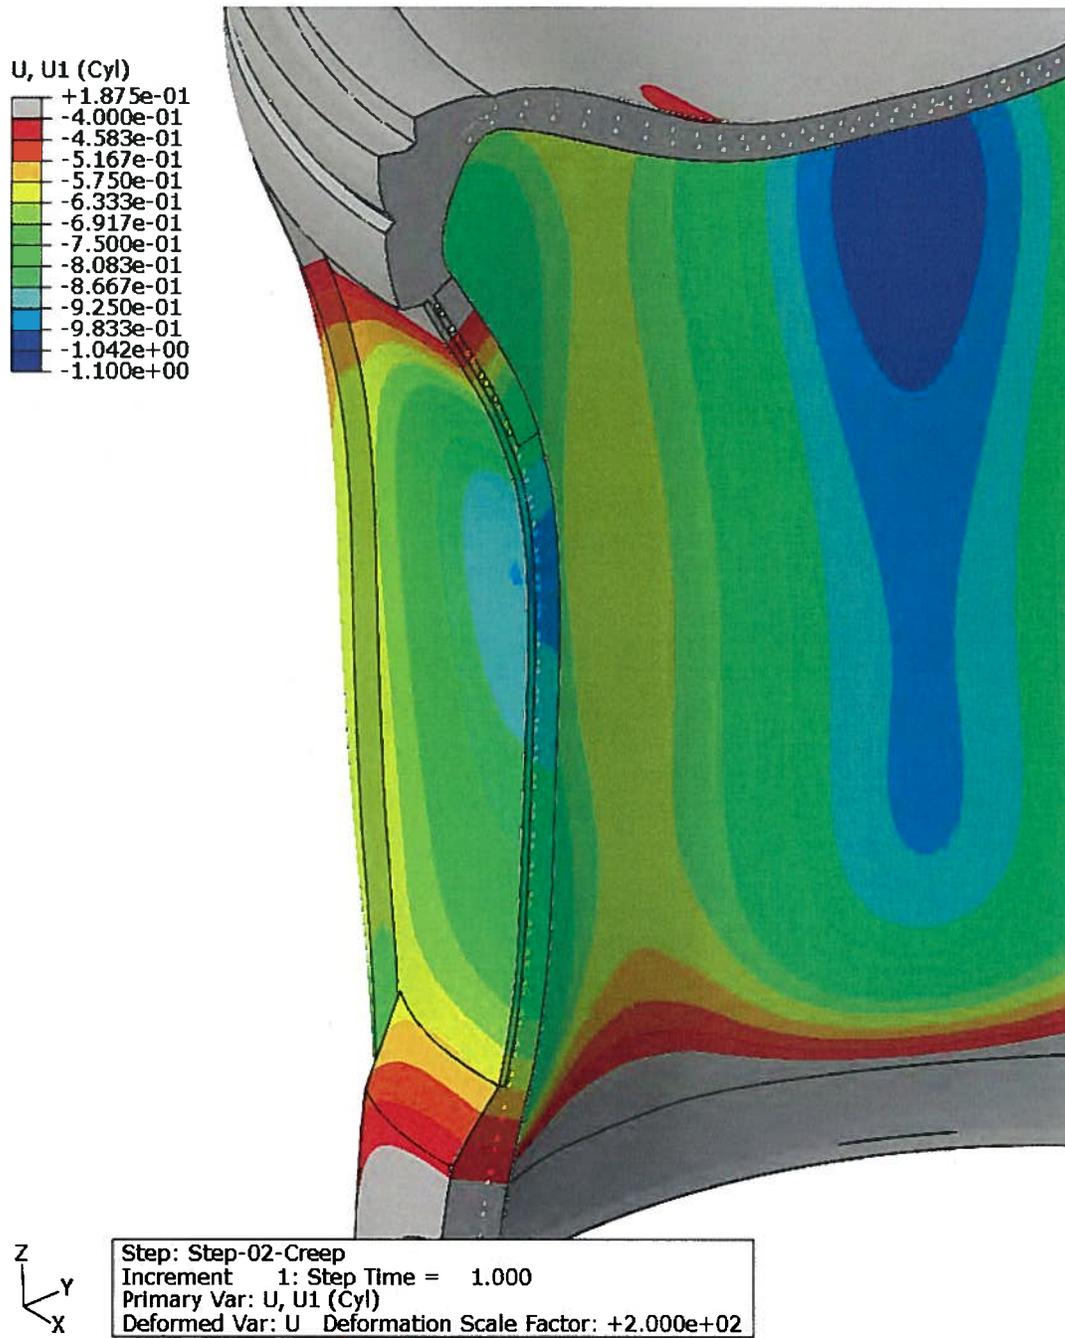
Figure 7.9 CR3 containment cut-away profile showing radial displacement after 30 years of creep.

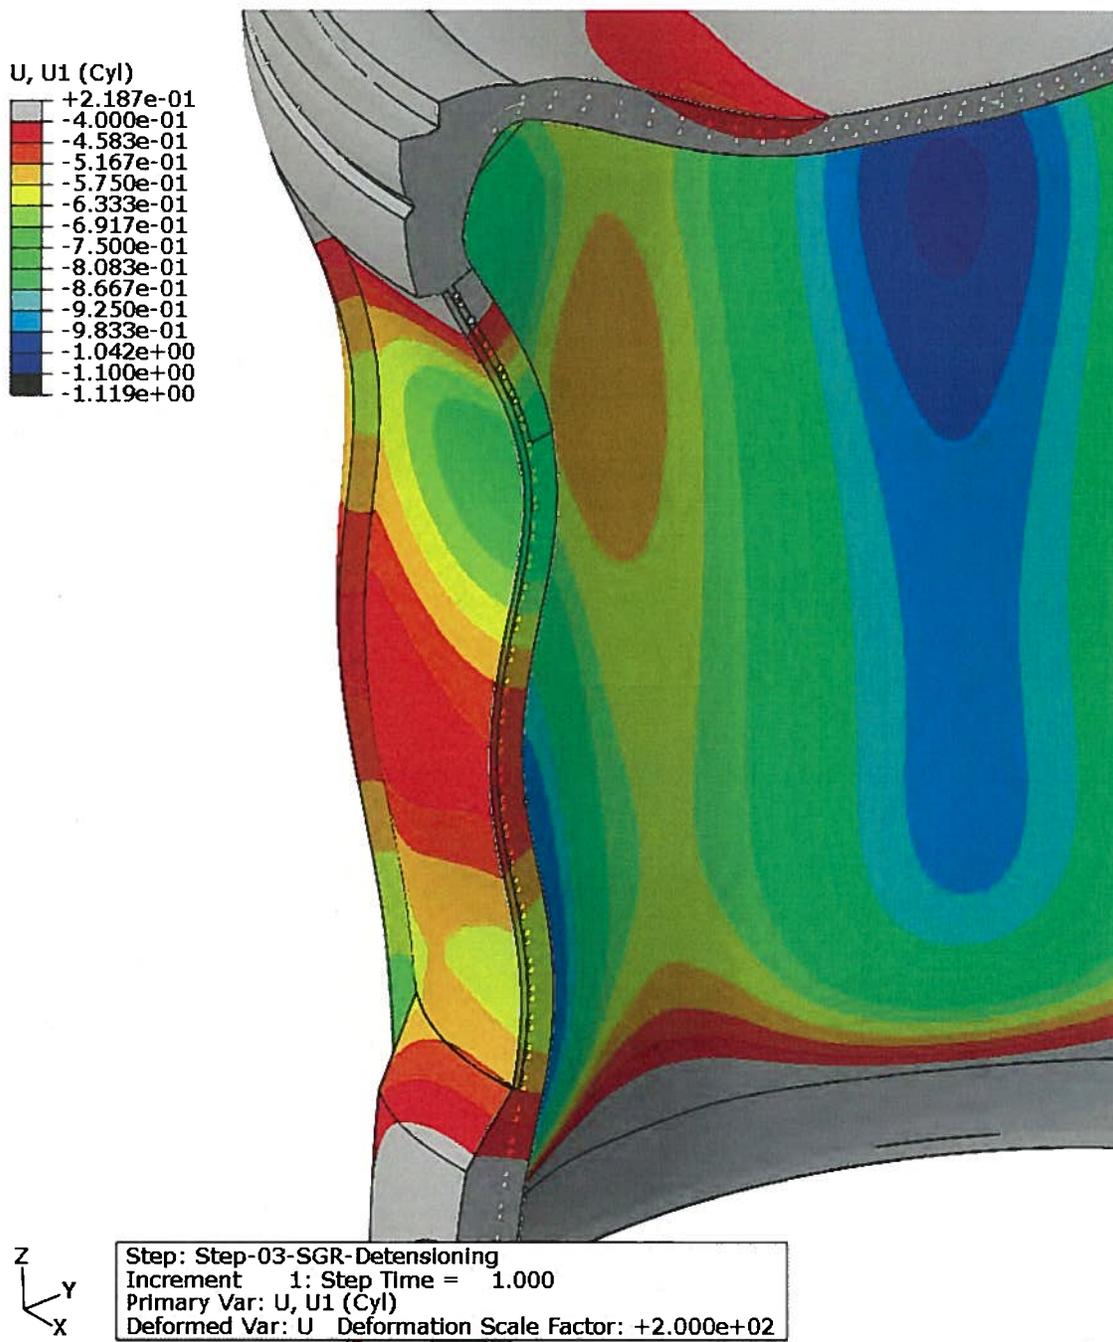
Figure 7.10 CR3 containment wall cut-away profile of radial displacement following the SGR

Here, an S curve has developed in the wall. Delamination stems more from the rate of change in the profile than from the magnitude of the change in profile. The inward displacement of the wall was greater prior to SGR de-tensioning than after de-tensioning, but its margin to delamination was greater because the contraction was smooth. In this plot, the maximum curvatures are at elevations 173' and 220'. The maximum delamination gap widths measured were centered around 175' and 216' (See Figure 7.14) which is good agreement.

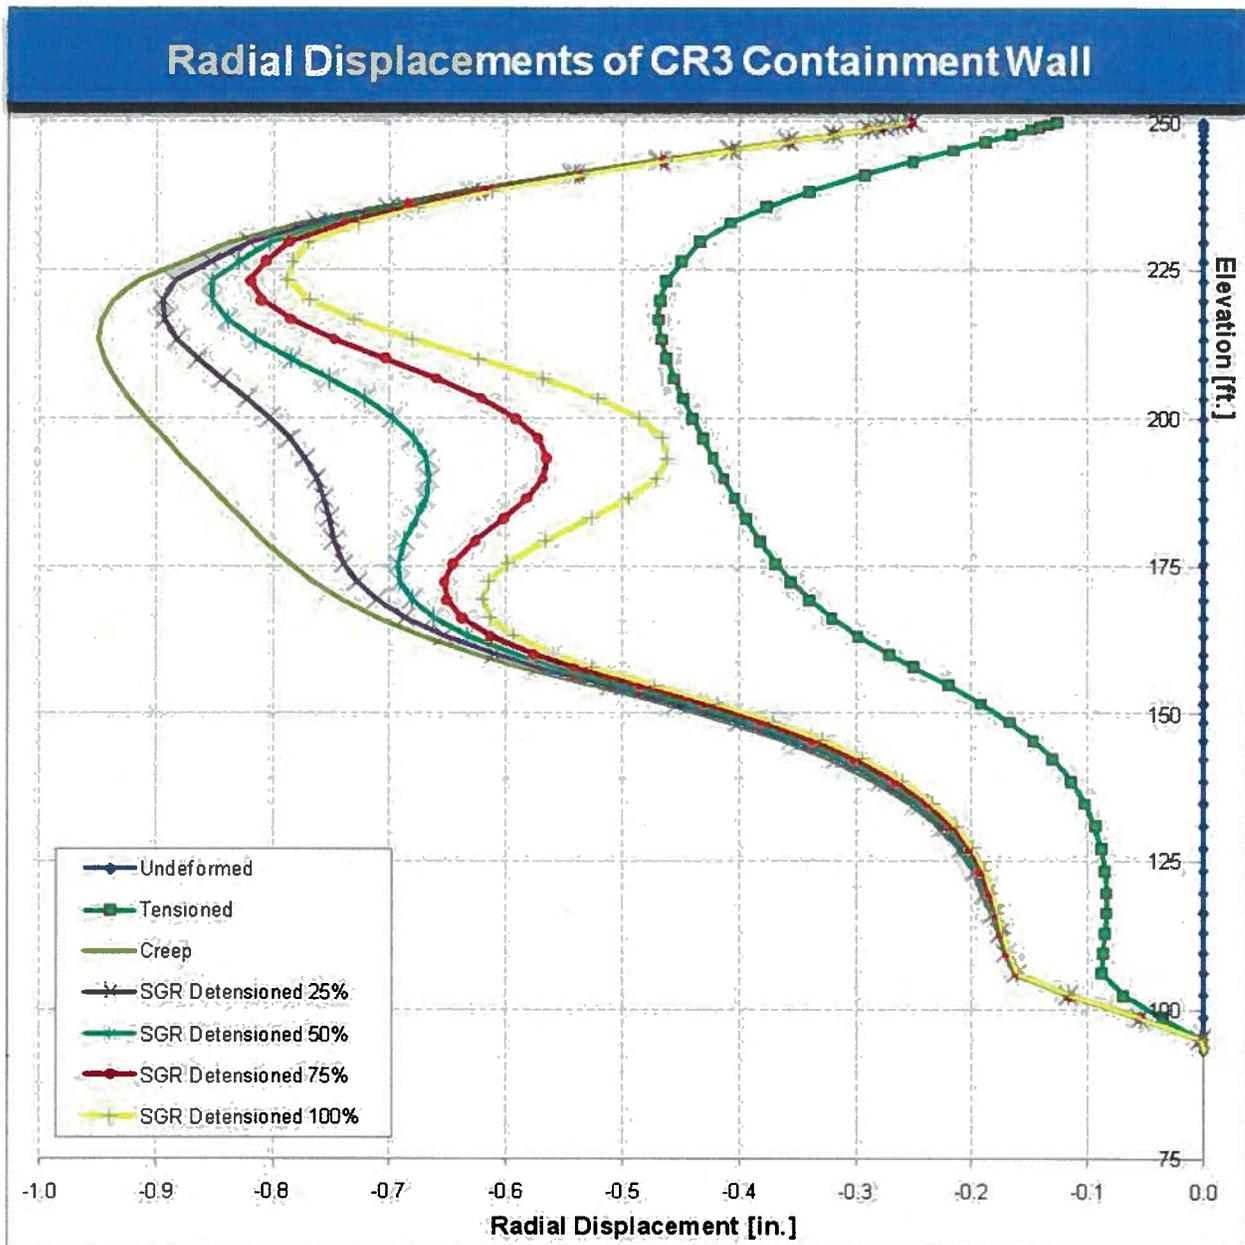
Figure 7.11 Bay 34 midline profile for progressive SGR de-tensioning

As expected, the un-tensioned case shows no radial displacement. The 1976 tensioned case shows uniform displacement of 0.5" inward. Creep increases that displacement to 1" inward by 2009. The SGR de-tensioning shows the impact of de-tensioning 10 vertical and 17 horizontal tendons in creating a double peaked profile with a much sharper curvature than was experienced previously. The intermediate lines are partial de-tensioning points going from fully tensioned to de-tensioned for SGR. The model did not remove each tendon sequentially. Instead, it de-tensioned all the selected tendons incrementally. While that is not the exact sequence used, the model gives a realistic view of the transition felt by the bay 34 wall. In the fully tensioned case (Creep), the curvature is approximately 0.05" over a 25' span or 170 $\mu\text{in/in}$. De-tensioning 10

vertical tendons and then 17 horizontal tendons in a row created two sharp peaks with a curvature of 0.15" in 40' or 310 $\mu\text{in/in}$ and 0.3" in 50' or 500 $\mu\text{in/in}$, indicating that there should be more severe damage above the opening (centered at 225') and less severe damage below the opening (centered at 170'). However, the actual de-tensioning sequence de-tensioned the higher tendons last, which indicates that the lower peak was accentuated during most of the de-tensioning sequence, so the curves presented here may not exactly match the transient peaks seen until de-tensioning was complete. In Figure 7.14 the two centers of damage are at 216' and 175', and the damage appears similar above and below the opening. Overall there was good agreement between the predictions of the computer model and the delamination observed. Looking at bay 34 from the outside, at the end of de-tensioning the wall has two concave curves and one convex curve. It is worth noting that the peak concave curvature occurred in tensioned areas, so the concrete exposed to the peak curvature still had the tensile peak due to normal tendon force on the area around the horizontal tendons.

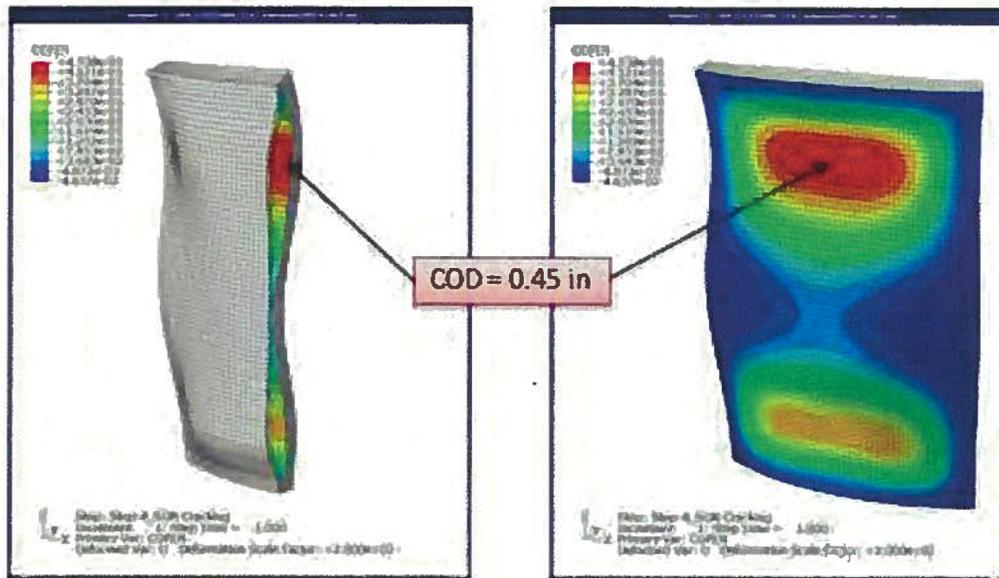
Figure 7.12 shows the predicted effect of delamination. The wall separates into an inner section and an outer section. The separation is not uniform because the bulge area tends to close the gap in the center. The center area is de-tensioned so the force separating the two sections is reduced.

The Abaqus bay sub-model was used to calculate the response of bay 34 to the SGR de-tensioning sequence. The results are shown in Figures 7.12 and 7.13. The delamination event alone is shown in Figure 7.12. Figure 7.13 shows the bay response to removing the concrete after delamination. Notice the size of the crack that develops is not uniform and it is not greatest in the middle of the bay. It is greatest above and below the middle of the bay. This makes sense if the non-delaminated concrete on the outside of the neck of the hour-glass is restraining the crack opening. It also makes sense in terms of the area in which the tendons are de-tensioned. Note the similarity between the computer predictions in Figures 7.12 and 7.13 and the actual crack width data taken by core bore and Impulse Response monitoring. Also note that the crack opening does not significantly change due to removing the concrete. That explains the lack of change in the cracks visible at the edges of the opening when compared between 10/3/09 and 10/28/09. The depth of concrete removed on 10/3/09 was about 15" and on 10/28/09 it was 100%. It is recognized, however, that the model predicts about 0.5" for the crack and the peak cracking was about 2.5" so the relative dimensions should be considered rather than the absolute values.

Figure 7.12 The Dimensional response to delamination – Step 4 SGR Cracking Crack Opening Distance (COD) is the width of the crack that develops. Note the similarity of the pattern in this Figure to that in Figure 7.14.

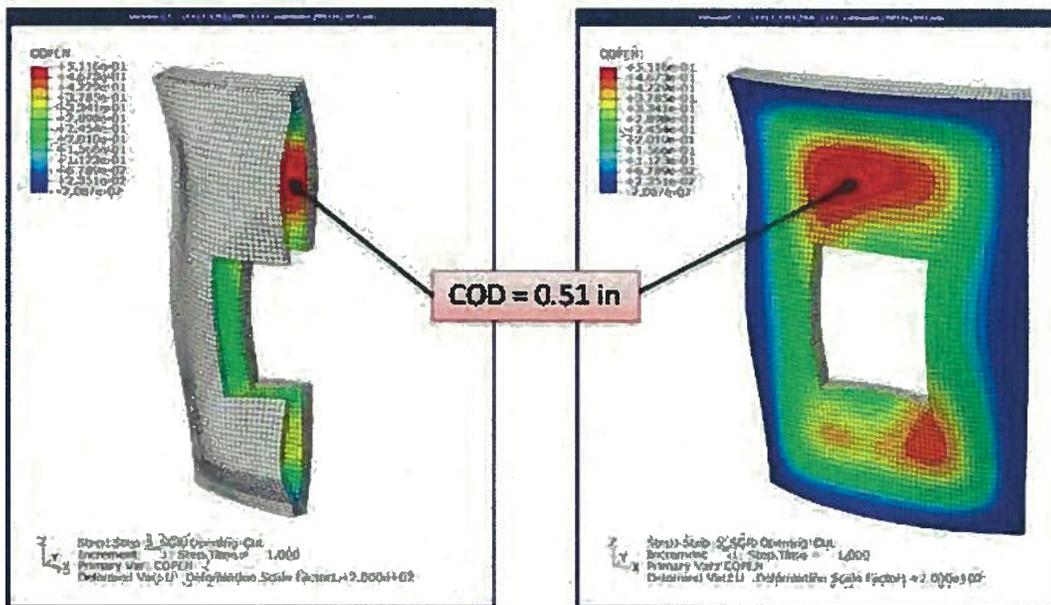
Figure 7.13 Crack Opening Distance (COD) after Concrete Removal – Step 5. Note the width of the crack increased by about 10% due to concrete removal. Concrete removal does cause an increase but not a significant one.

Figure 7.14 displays the amount of separation due to delamination that was measured in bay 34. Compared with the radial displacement shown in Figure 7.13, the general agreement of the shape over the entire bay is an indication of the accuracy of the computer mode.

For completeness the effect of cutting out the concrete in the opening is also included in Figure 7.13, which increases the gap between with a mesh size of 1 square inch rather than the 1 square foot mesh of Abaqus Global.

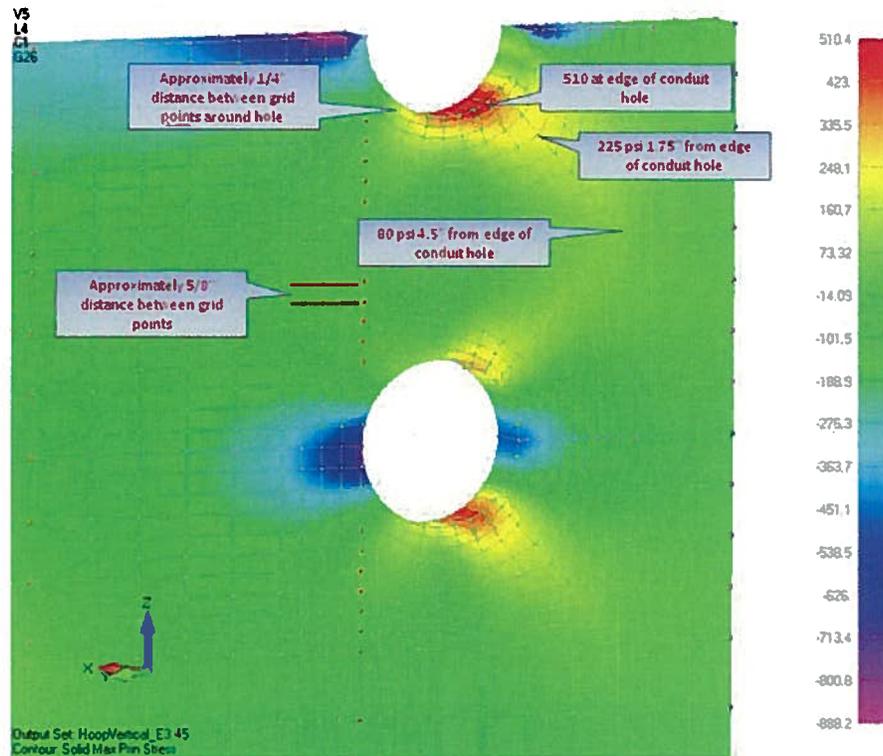
Figure 7.15 *Stress contours for normally tensioned conditions in between intersections of a horizontal tendon with vertical tendons. (Section View)*

The peak tensile stress in Figure 7.15 is about 500 psi in the area immediately next to the horizontal tendons near the top and bottom positions. In the absence of outside influences, the peak stress is just at the tensile capacity of the concrete and may indicate very small cracks at the top and bottom of each horizontal tendon sleeve hole. Figures 7.16 to 7.23 show the maximum principal stress added as a result of the bending of the containment wall.

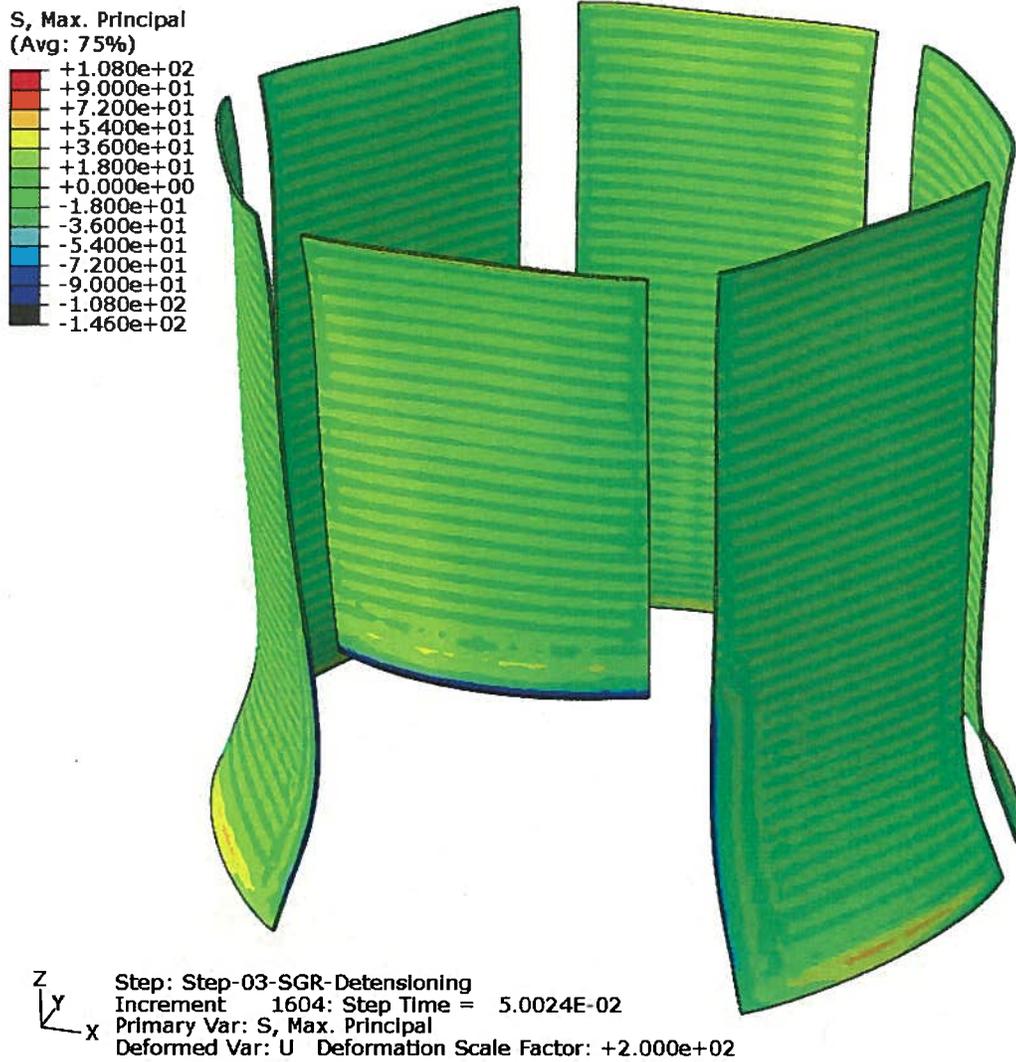
Figure 7.16 Step 1 of 20 time-steps in simulating the SGR de-tensioning.
Maximum principle stress (psi)

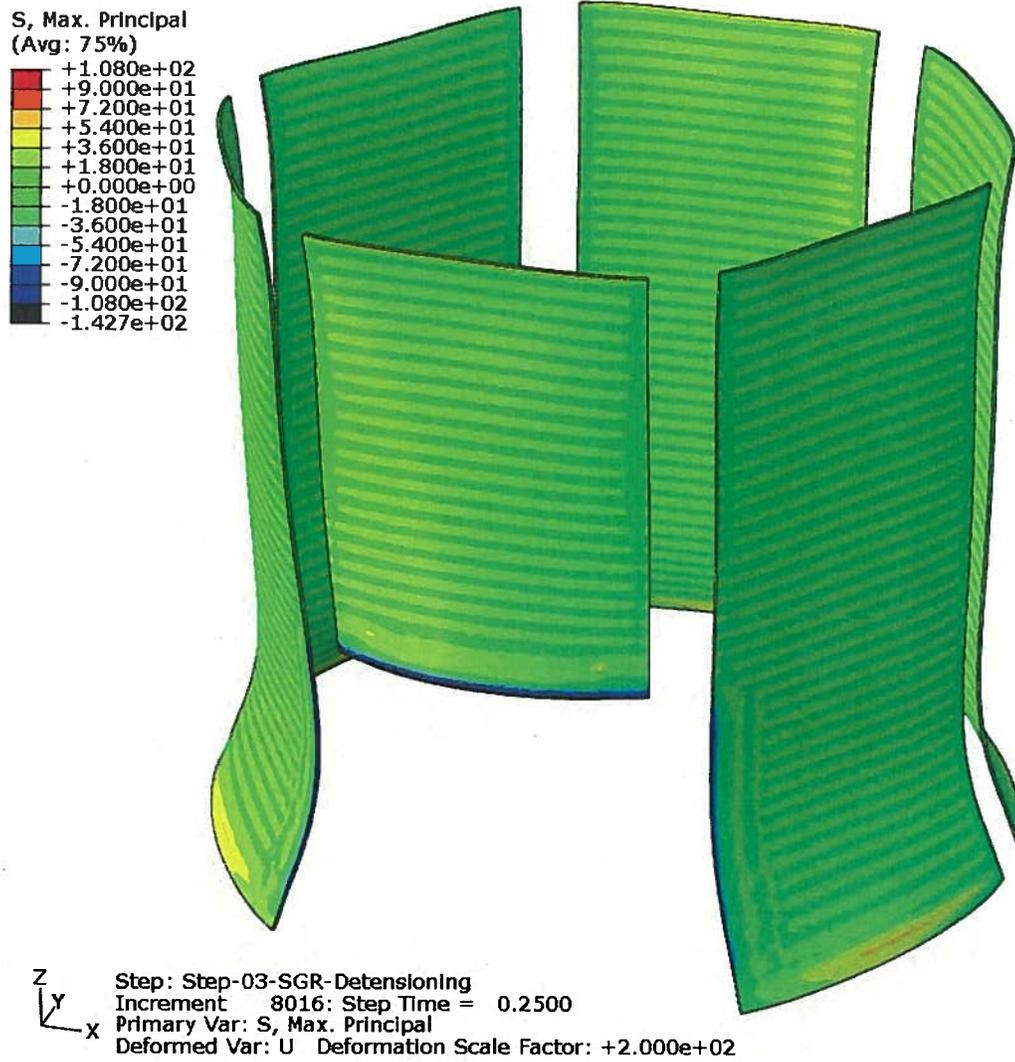
Figure 7.17 Step 5 of 20 in simulating the SGR de-tensioning.
Maximum principle stress (psi)

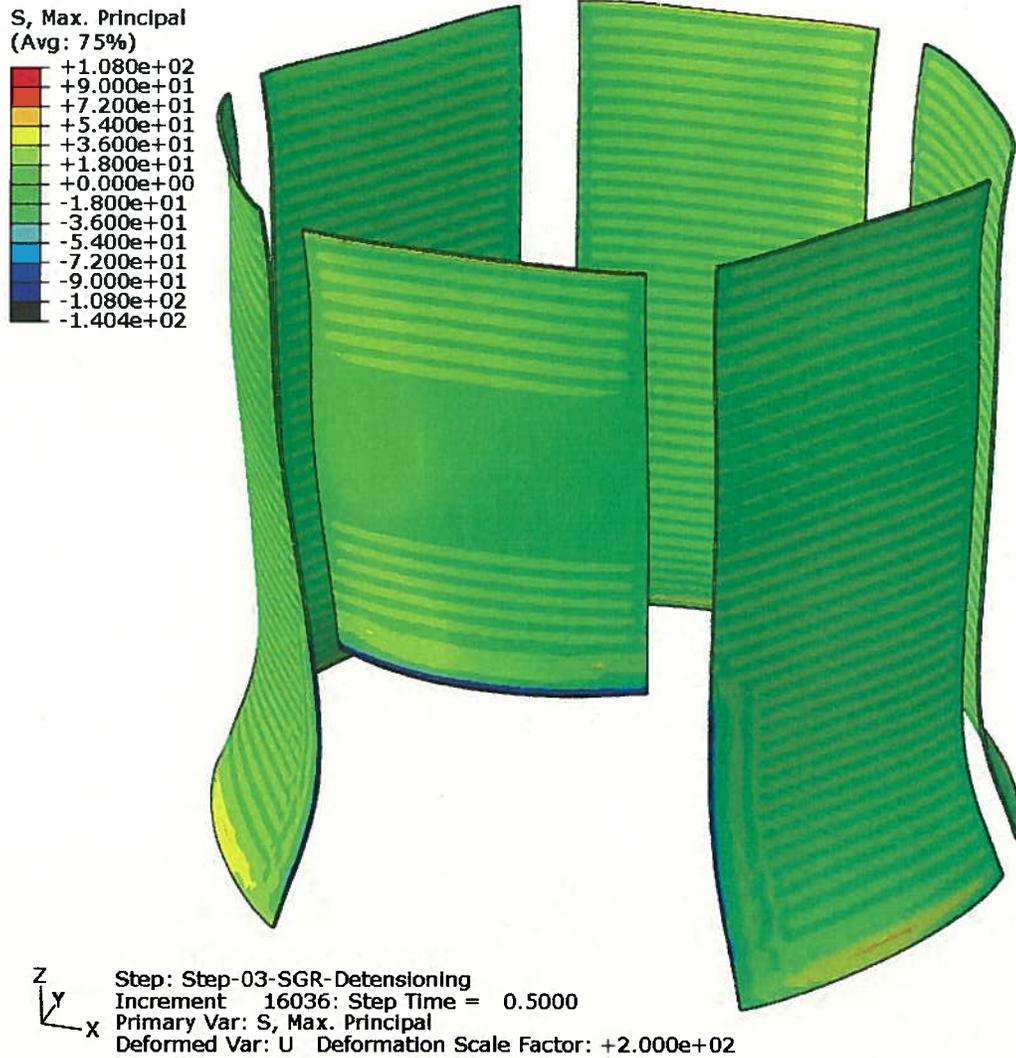
Figure 7.18 Step 10 of 20 in simulating the SGR de-tensioning.
Maximum principle stress (psi)

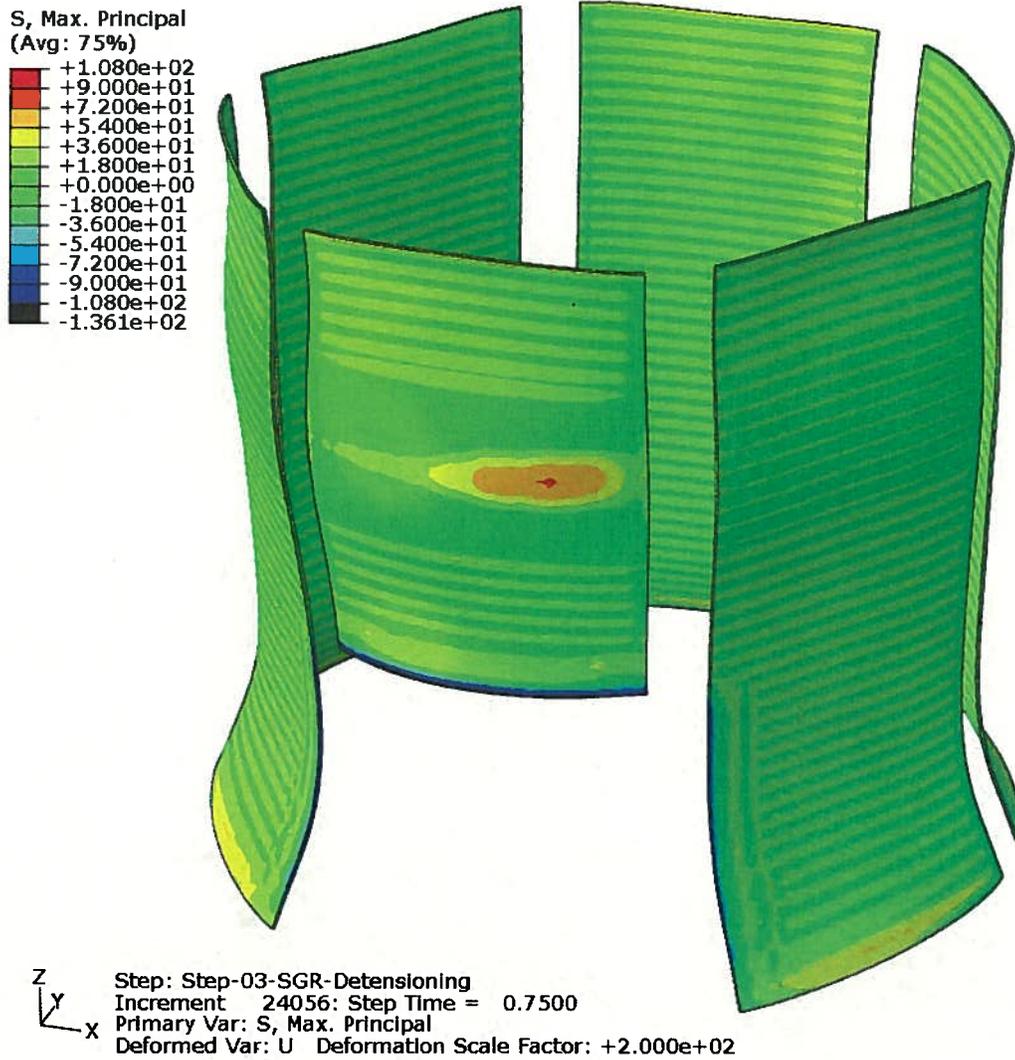
Figure 7.19 Step 15 of 20 in simulating the SGR de-tensioning.
Maximum principle stress (psi)

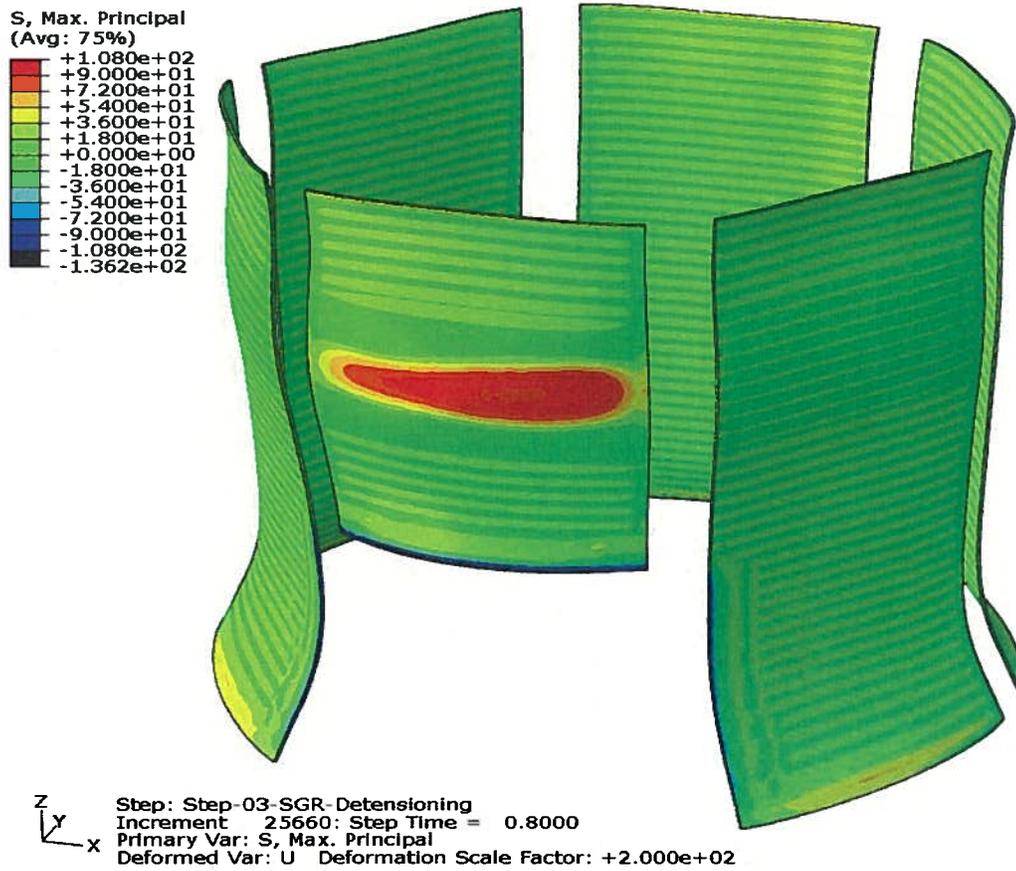
Figure 7.20 Step 16 of 20 in simulating the SGR de-tensioning.
Maximum principle stress (psi)
