**SUBJECT: CRYSTAL RIVER NUCLEAR PLANT - SPECIAL INSPECTION REPORT
05000302/2009007**

The purpose of this inspection was to examine activities associated with the delamination identified in the Unit 3 containment. The inspection was conducted in accordance with the Special Inspection charter issued by the Region II Administrator on October 13, 2009. As part of the inspection, the NRC examined your evaluation of extent of condition, your evaluation of root cause, and your planned corrective action for continued operability. The inspectors interviewed personnel and conducted plant walk downs, including visual examination of accessible portions of the outside and inside surfaces of the containment.

ROOT CAUSE ASSESSMENT CRYSTAL RIVER UNIT 3 CONTAINMENT CONCRETE DELAMINATION

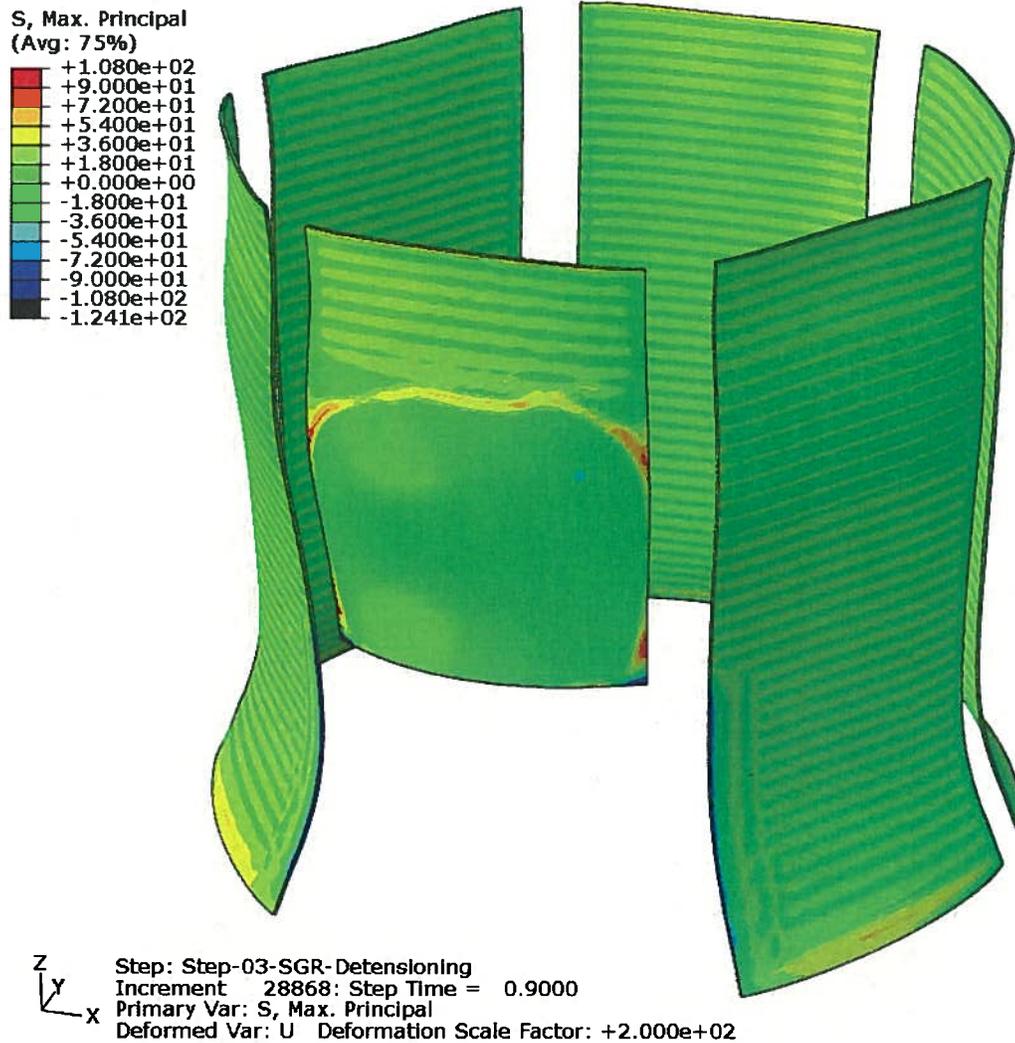
Figure 7.21 Step 18 of 20 in simulating the SGR de-tensioning.
Maximum principle stress (psi)

Note that at this step delamination has occurred and the stress has been relieved which can appear to be a relaxation of stress.

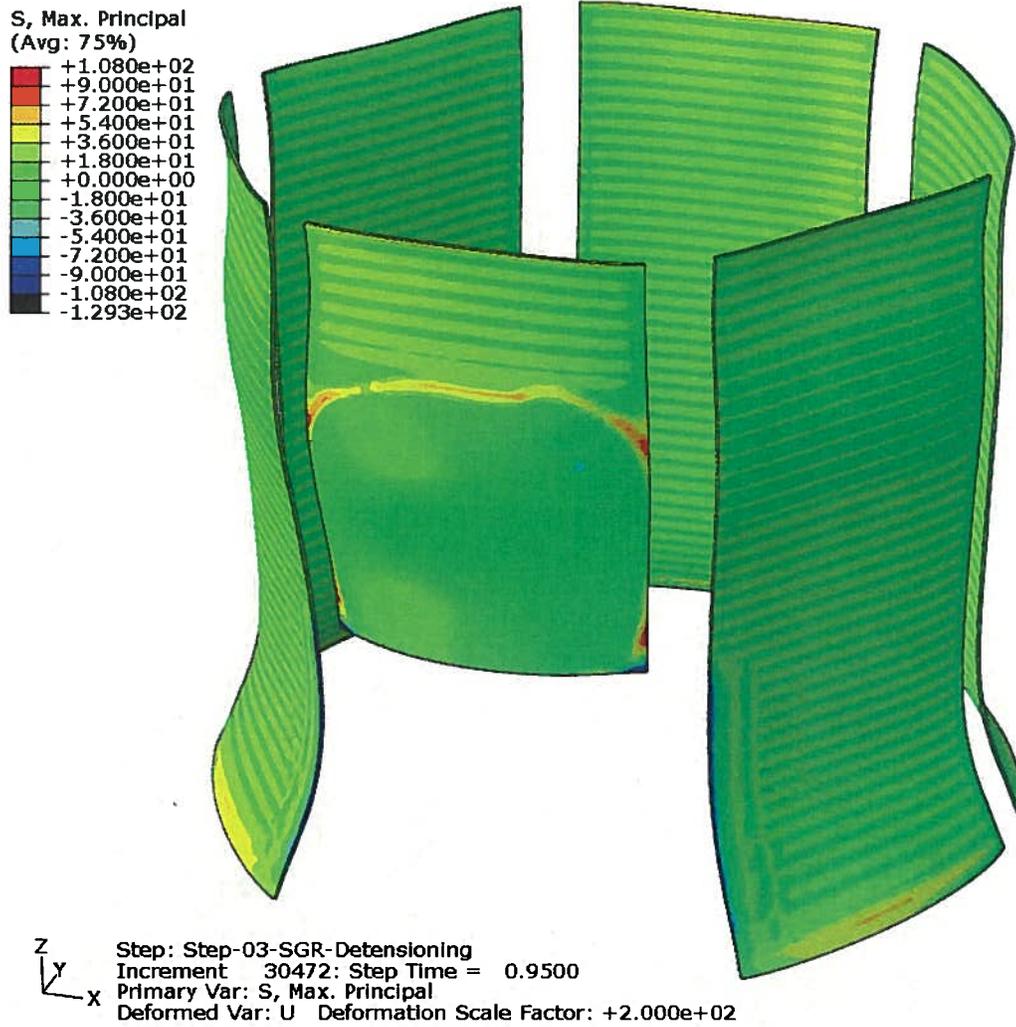
Figure 7.22 Step 19 of 20 in simulating the SGR de-tensioning.
Maximum principle stress (psi)

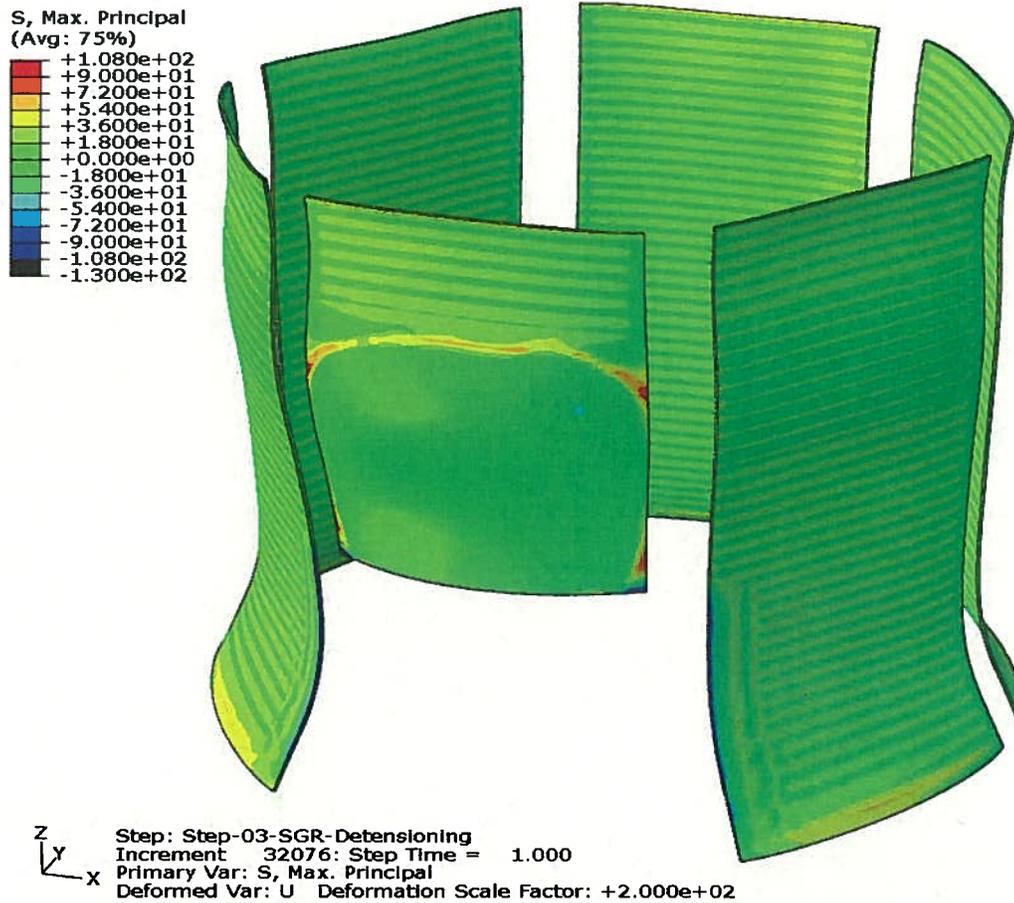
Figure 7.23 Step 20 of 20 in simulating the SGR de-tensioning. Simulation Complete.
Maximum principle stress (psi)

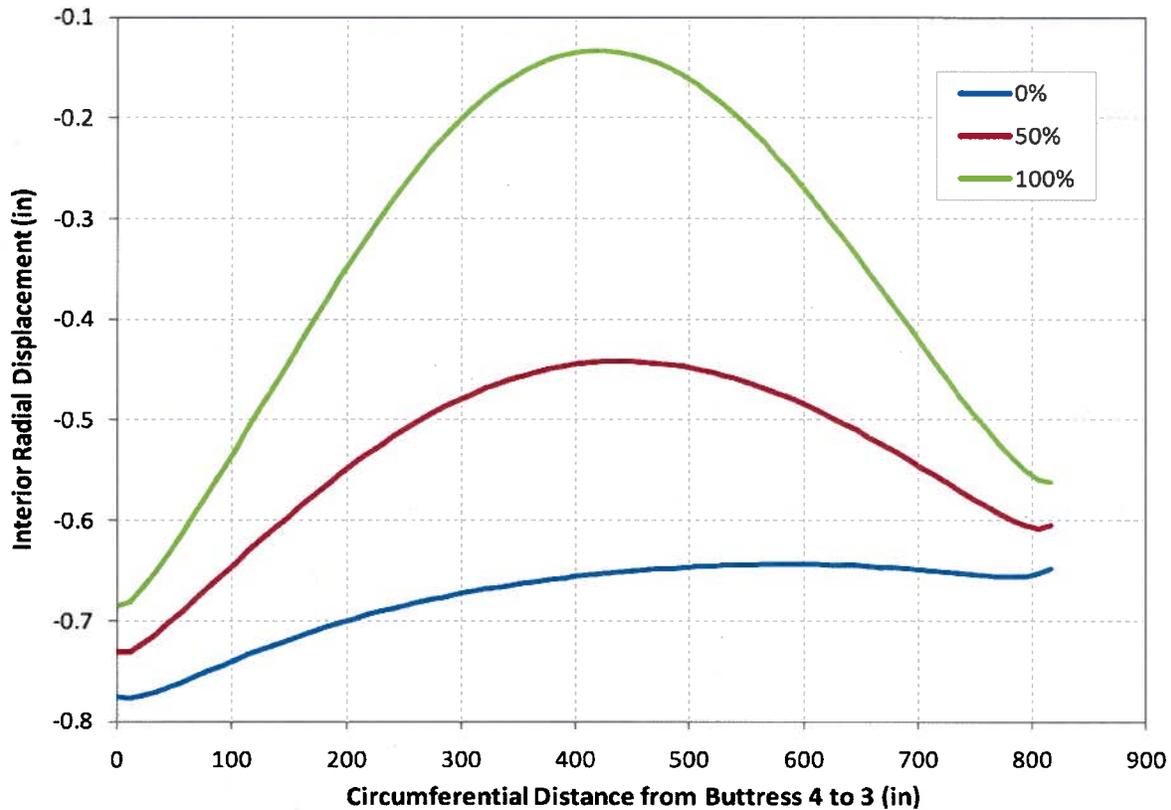
Figures 7.24 and 7.25 show the azimuthal shape and the vertical shape of the bulge. Figure 7.24 is a profile of bay 34 taken along its circumference at elevation 196'. Figure 7.11 was a profile taken at the middle of bay 34 going vertically so that between them both cross-sections are illustrated.

Figure 7.24 Azimuthal dependence of Bay 34 post SGR de-tensioning.

The asymmetric response in Figure 7.24 is due to an asymmetry in the dome tendon attachment arrangement that was correctly reflected in the model.

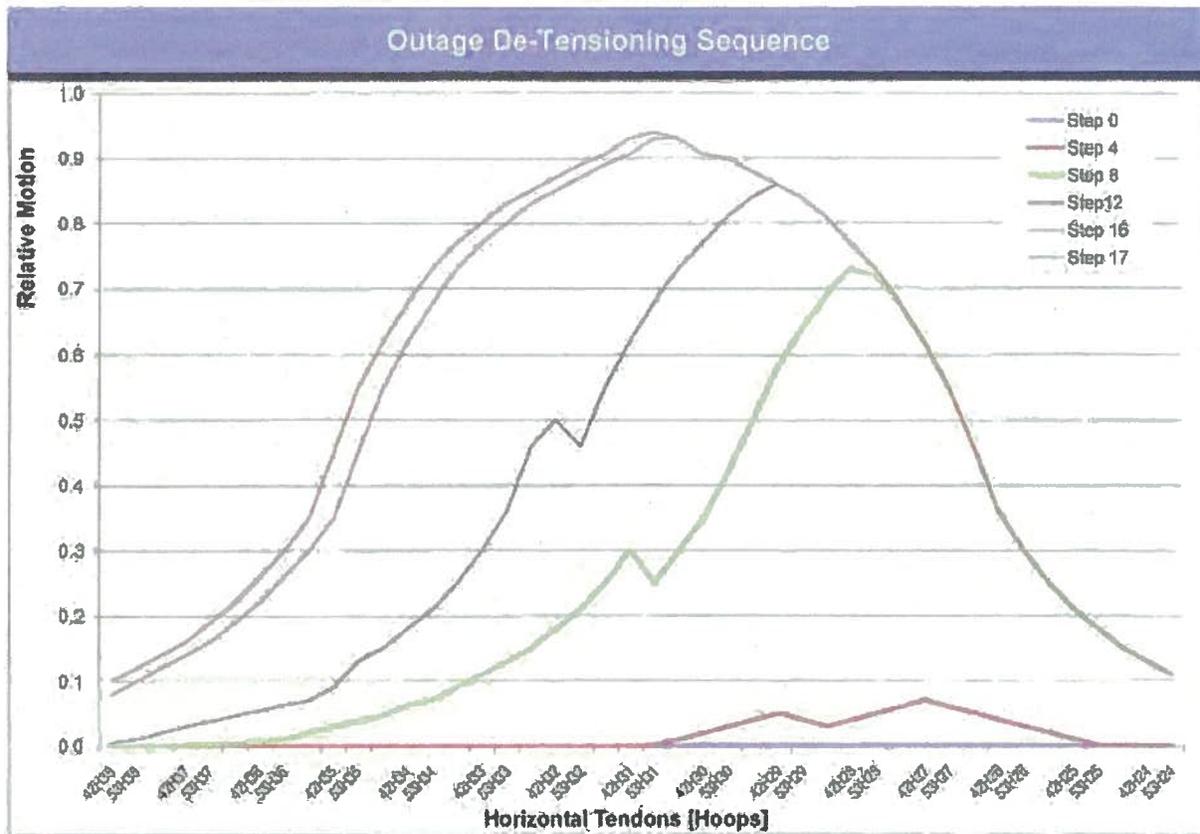
Figure 7.25 is a different version of the radial displacement as a function of elevation. It is a relative plot of displacement (0 is fully tensioned and 1 is fully un-tensioned) showing the displacement of one location to the next if there were no curvature prior to de-tensioning. It is idealized to show the relative displacement due only to de-tensioning tendons and the various plots are based upon the actual SGR de-tensioning sequence. Step 8 and step 12 both show an irregularity which is caused by skipping tendons so that a tendon remains tensioned after those around it have been de-tensioned.

Figure 7.25 A Plot of the radial displacement in Bay 34 as SGR tendon de-tensioning progressed. The full displacement was 0.5”.

Cracking occurred in the area of the SGR opening. The cracks then propagated to form the unique hour glass shape in bay 34. Figure 7.25 shows a vertical slice through the bulge that formed in bay 34. The total deformation increases sharply as the total number of de-tensioned tendons increases. The absence of this transition in a de-tensioned environment is what prevented cracking in the neck of the hour glass.

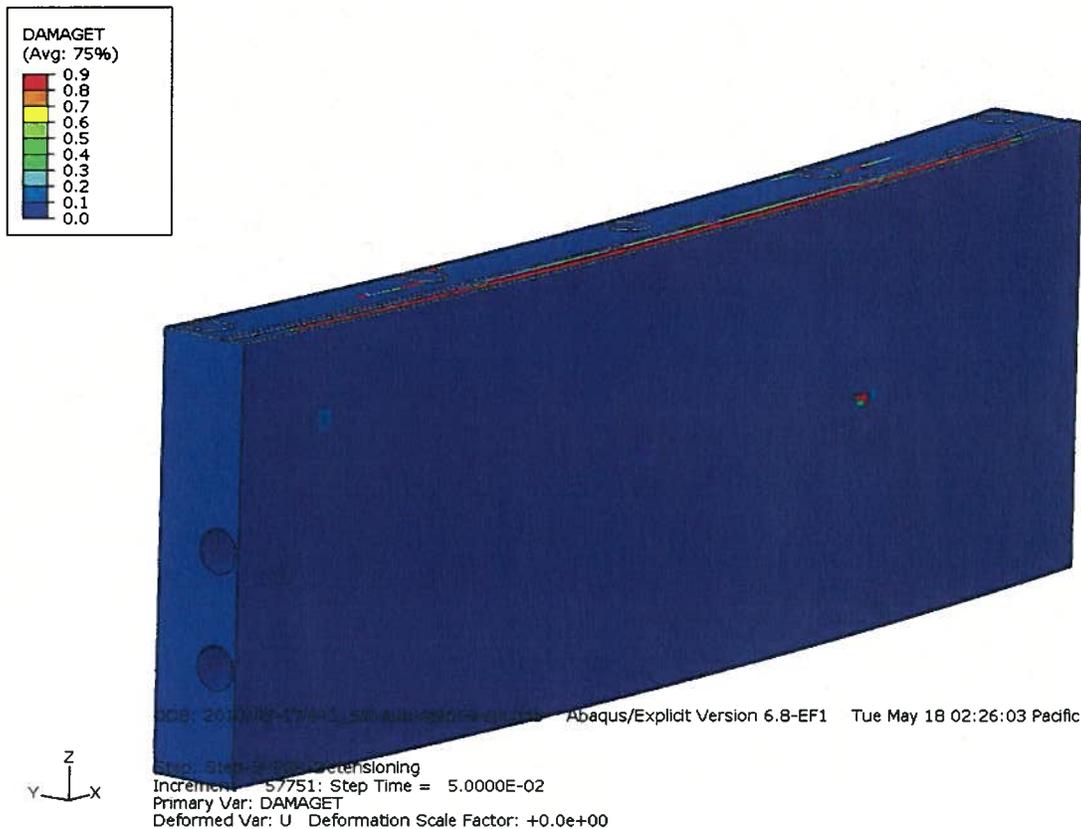
Cracking and then delamination began at some point in the de-tensioning and concrete removal process. Figures 7.26 to 7.29 show the results of the detailed Abaqus sub-model assuming tensile capacity of 360 psi. DAMAGET is a damage scale, a numerical measure of the ability of the concrete to pass load. The range is 0 to 1.0 where pristine material is 0 and fully fractured material is 1.0 and can pass no load.

Figure 7.26 A Plot of a bay 34 wall segment approaching delamination.

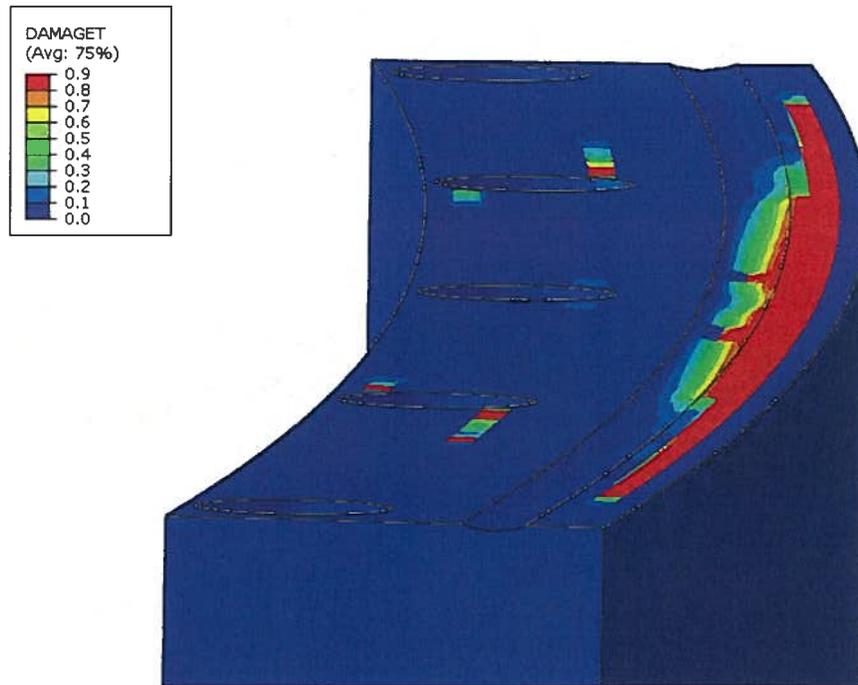
Figure 7.27 A Plot of a bay 34 wall segment delaminating

Figures 7.27 and 7.28 shows the Abaqus Detailed model prediction of delamination assuming tensile capacity of 360 psi. The peak stress locations on the top and bottom of the horizontal tendons extend out under the high radial tension conditions until they connect with the next tendon hole.

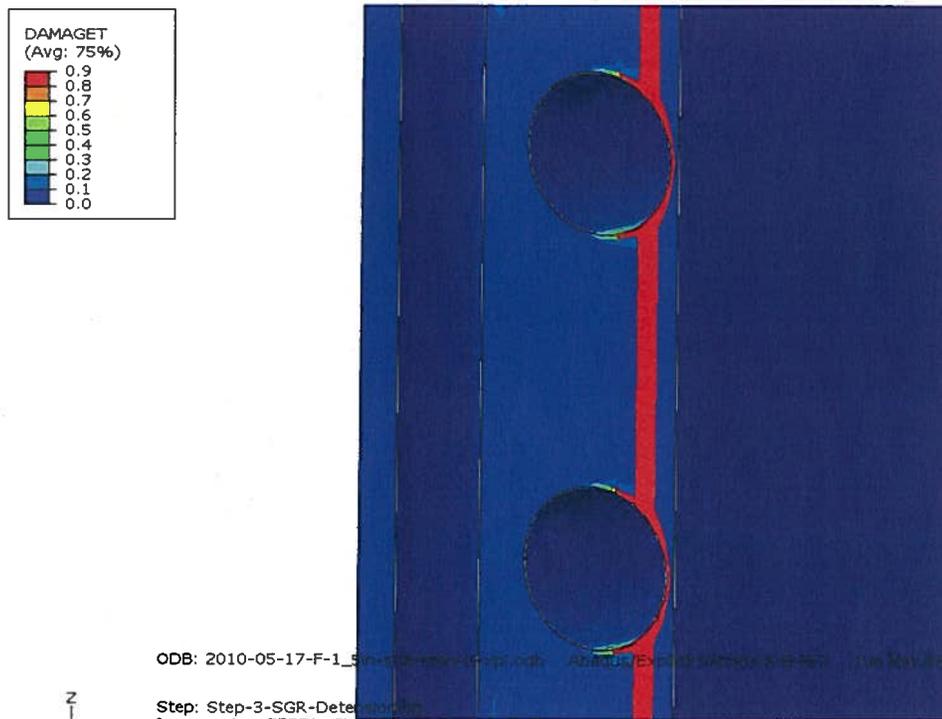
Figure 7.28 A Plot of a bay 34 wall segment delaminating $F't= 360$ psi

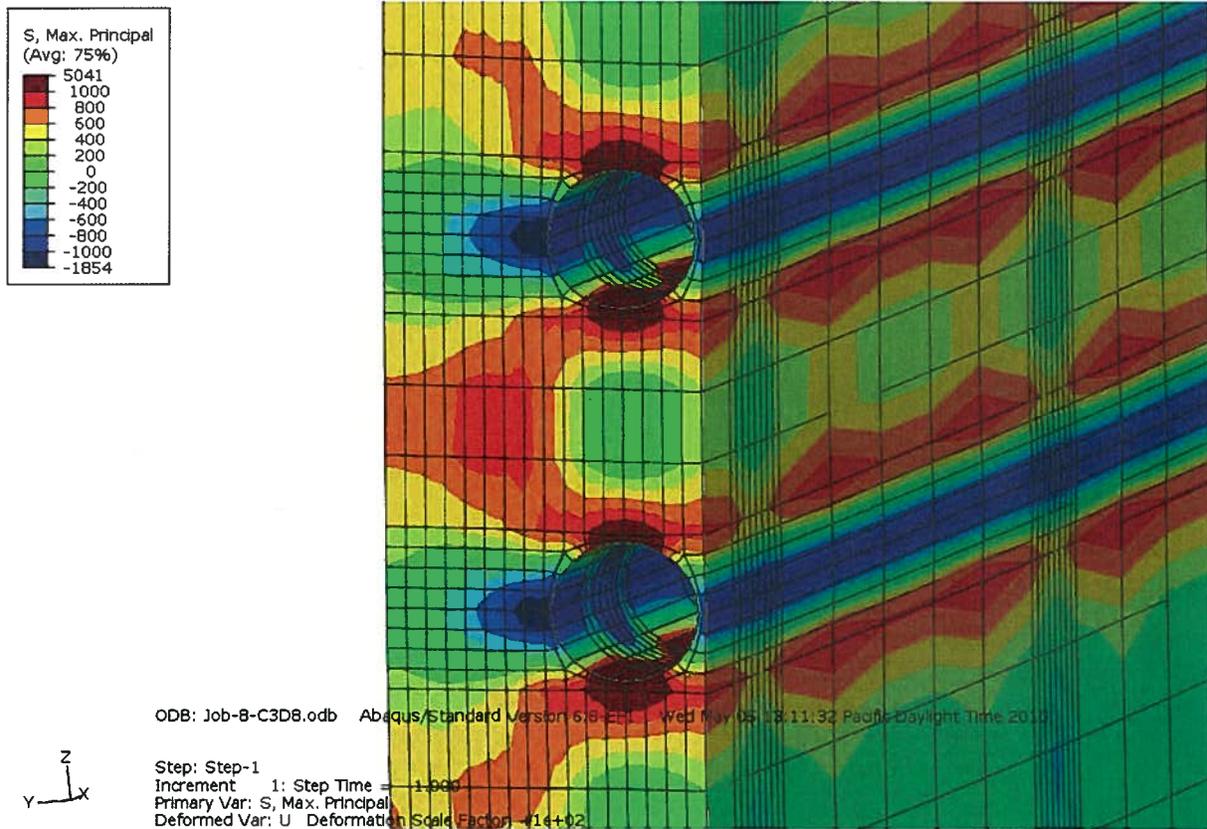
Figure 7.29 A Plot of maximum principal stresses in delamination. $F't = 360$ psi

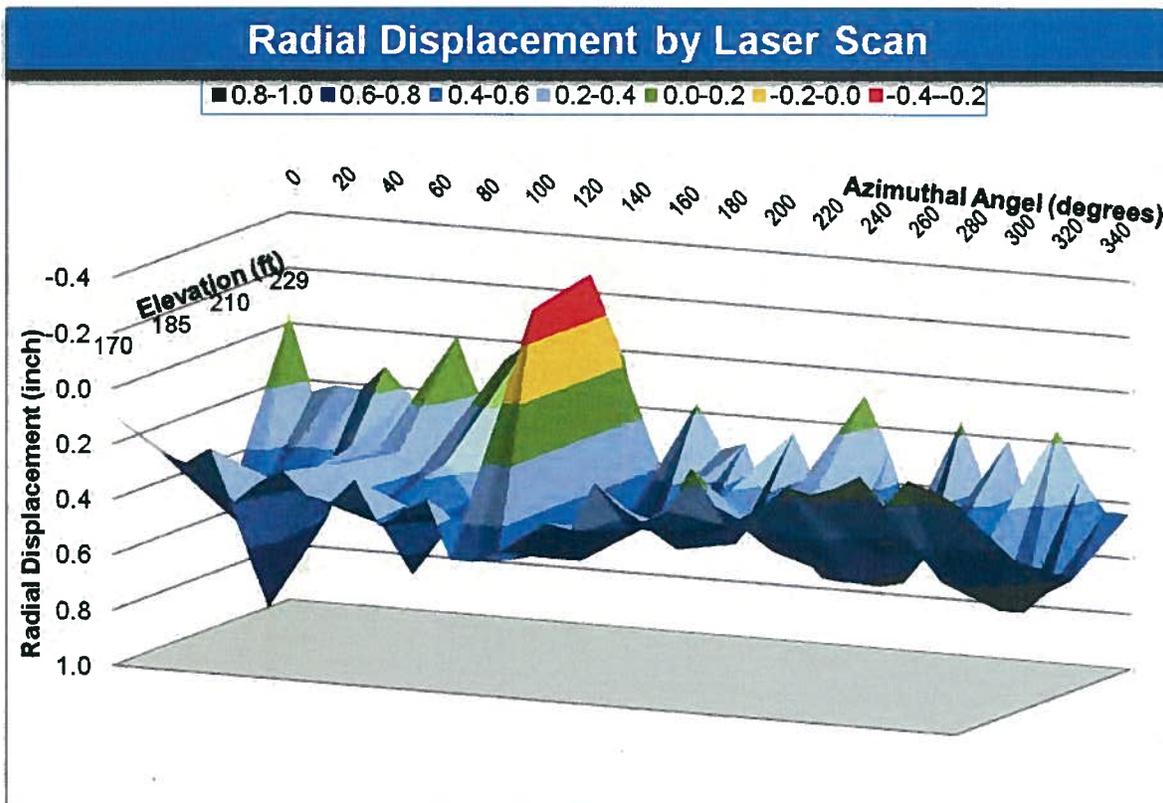
Figure 7.30 Three dimensional representation of radial displacement as a function of azimuthal angle and elevation.

In a sense, it is a snapshot of the conditions that existed at the end of the SGR opening project. The most prominent feature in figure 7.30 is the bulge at azimuthal angle 150 degrees. In addition each of the six bays is recognizable with its edges relatively fixed and its center sections bowed inward under tendon tension. Please note that these data indicate a change in displacement rather than an absolute displacement. Almost all points moved outward as the containment was de-tensioned in March, 2010. The notable exception was the area immediately around the SGR opening.

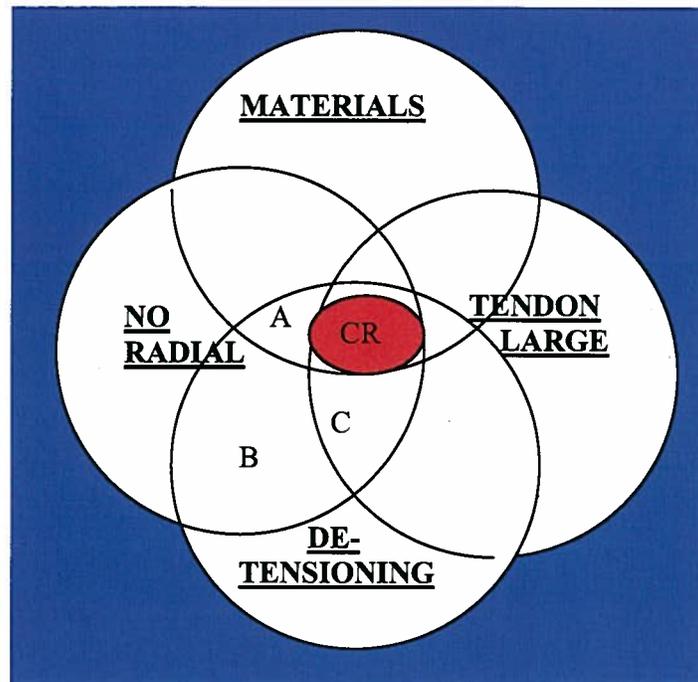
- ◆ Lack of radial reinforcement (No Radial)
- ◆ High stress peaks due to large tendons and wall design (Tendon Large)
- ◆ Certain material characteristics (Materials)
- ◆ Large tensile stress - typically associated with the interface between several tensioned tendons and several de-tensioned tendons (typically during SGR) (De-tensioning)

Of the peer plants considered only CR3 had all four factors.

Figure 8.1 Venn diagram of plants with critical characteristics. A, B, and C are similar plants.

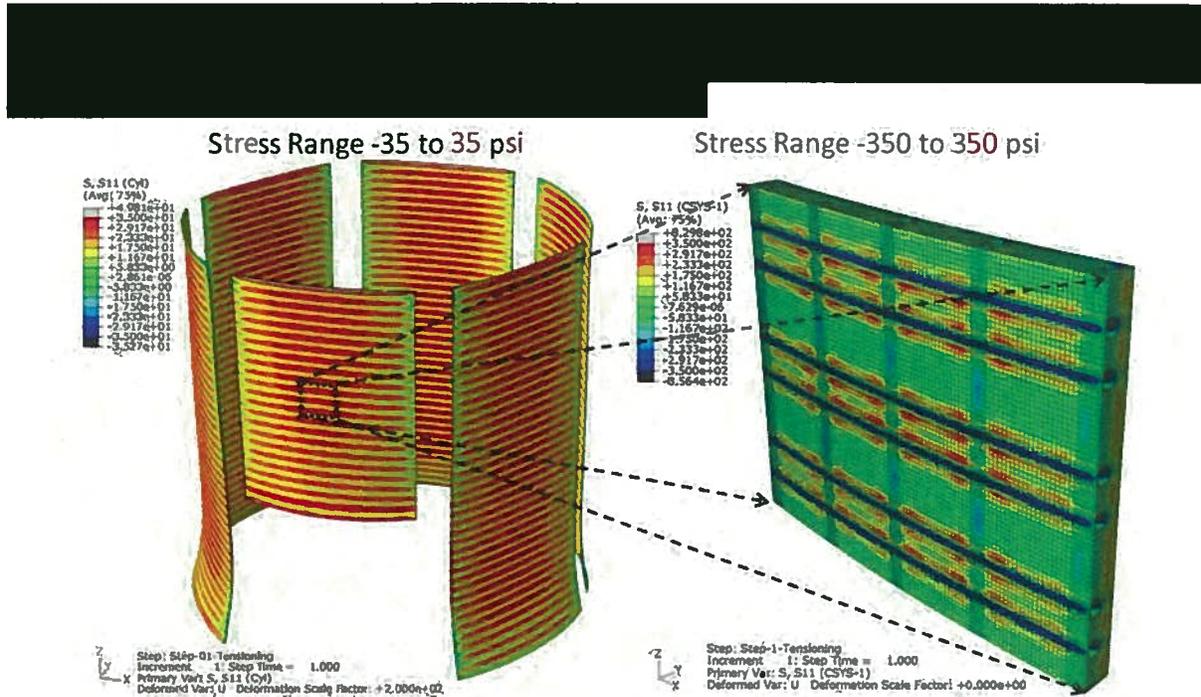
Figure A1.9 Comparison of indicated peak stress between the Abaqus sub-model and the detailed model - Step 1: Tensioned.

Approximately a factor of 10 difference in peak radial stress on outside of the hoop layer

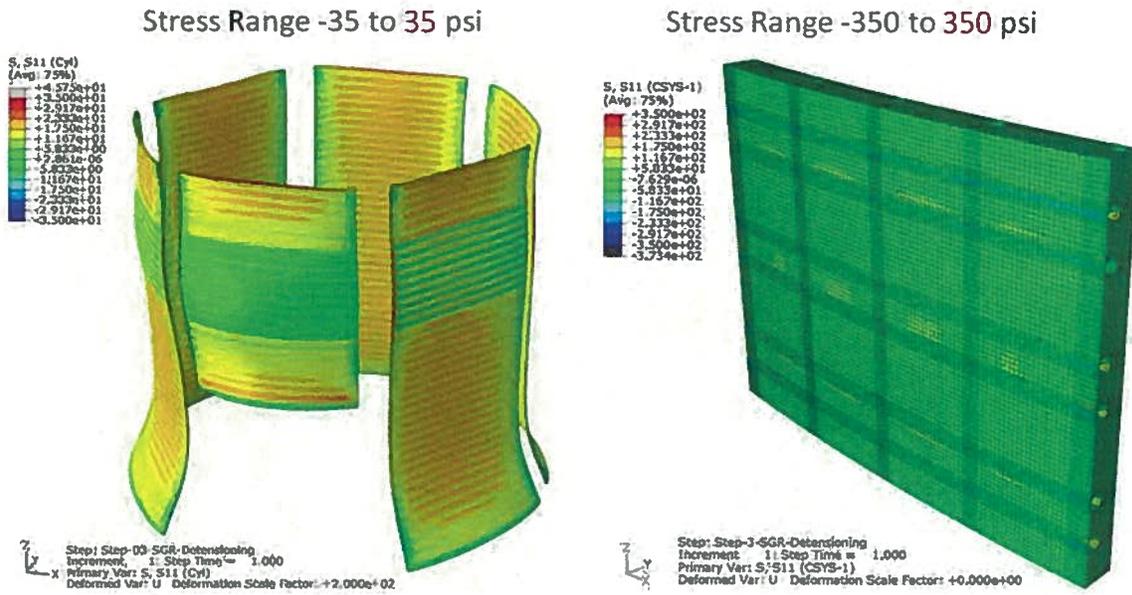
Figure A1.10 Comparison of indicated peak stress between the Abaqus sub-model and the detailed model - Step 3: SGR de-tensioning

The radial tensile stress concentrations is reduced during the SGR de-tensioning

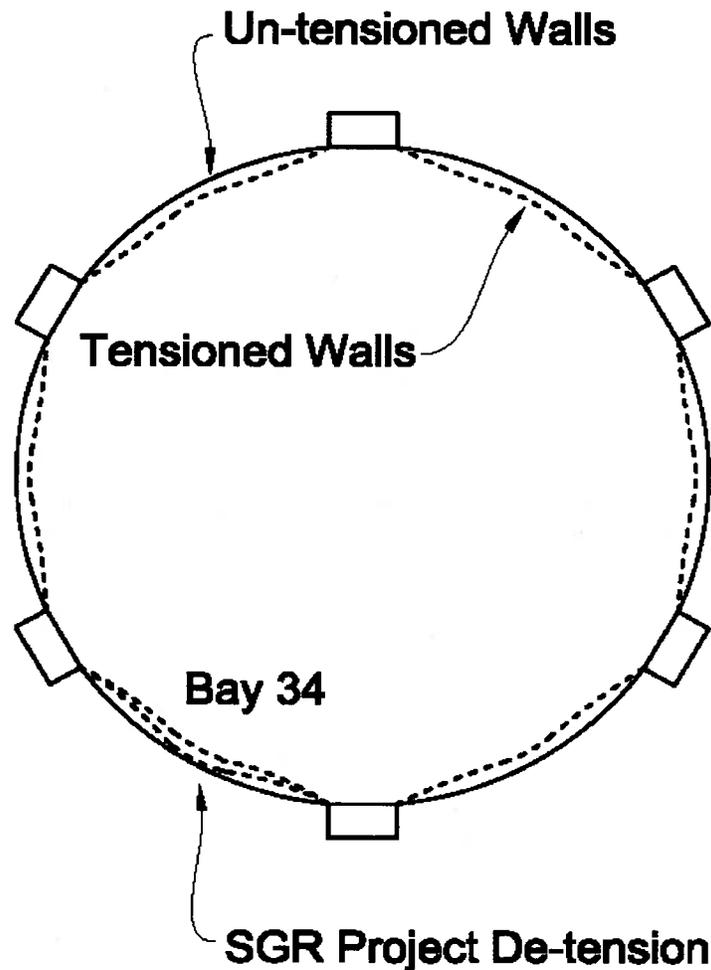
Figure A2.1 The effect of tensioning on containment walls

The containment building was constructed as a cylinder, but when the tendons were tensioned, they modified the shape of the bays. The figure below shows this using an exaggerated degree of change to illustrate the point. The amount of radial displacement is actually about 0.5" immediately after tensioning and about 1" after 30 years of creep are added in.

Figure A2.1 shows a simplified drawing of the building response to tensioning its tendons. It also shows the bulge that developed as a result of the SGR partial de-tensioning.

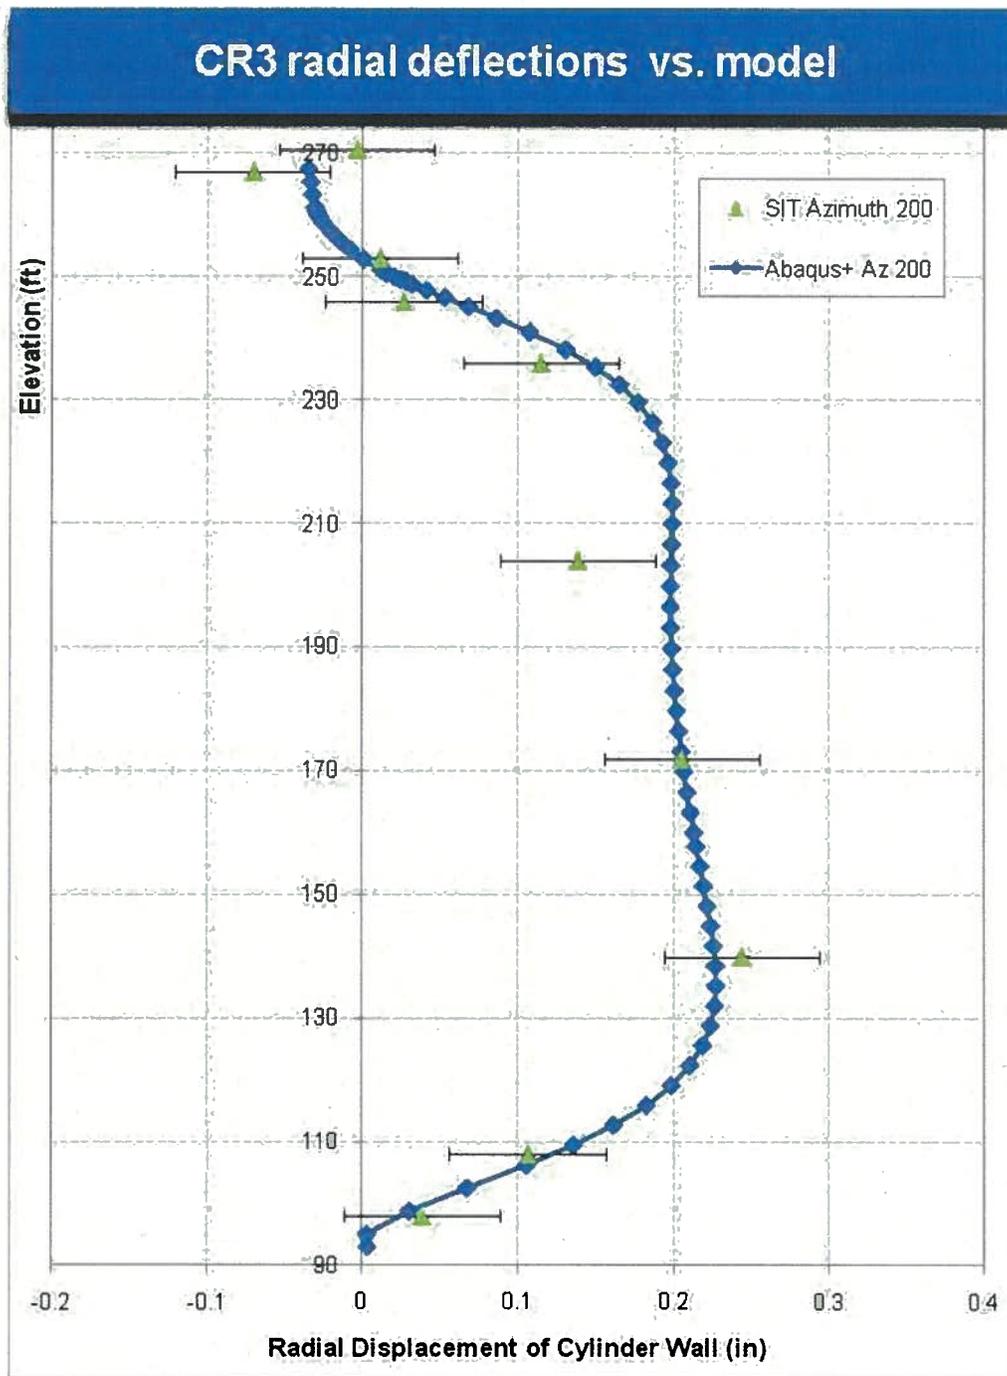
Figure A2.2 Comparison of measured radial deflections during the 1976 CR3 SIT taken at azimuth 200 degrees (Az 200) with PII computer model predictions

In 1976 CR3 performed a Structural Integrity Test (Reference 10) which involved pressurizing containment. The building was instrumented and dimensional changes were recorded which offer an opportunity to benchmark computer model predictions. Figure A2.2 shows a comparison between the PII computer model to the building's actual response in the SIT.

Overall the agreement between the computer models and the plant data is good. There is a slight discrepancy in radial displacement around elevation 220'. One would expect to see good agreement on a benchmark like this because it is a uniform application of pressure to all parts of containment.

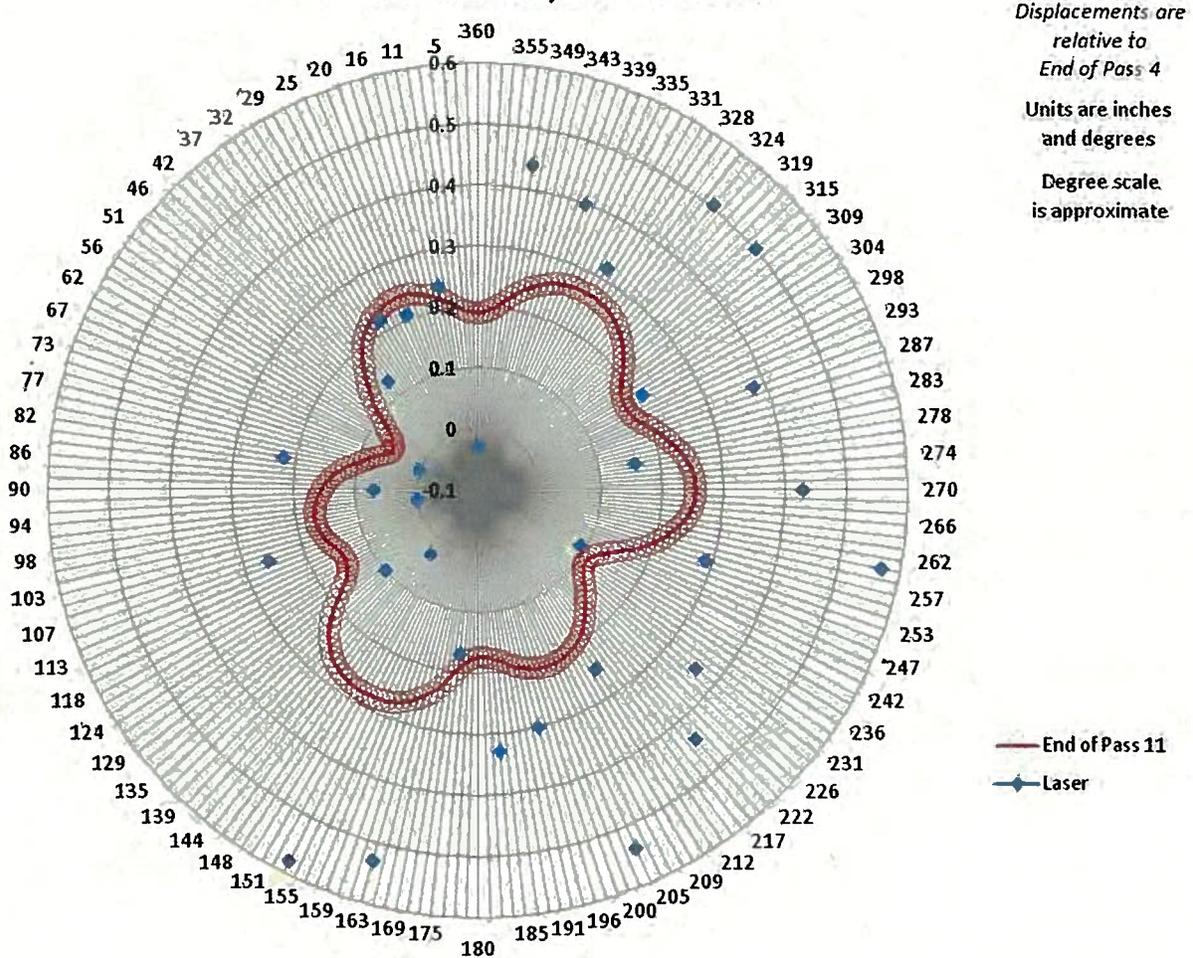
Figure A2.3 Comparison of PII computer model predictions for radial displacement from pass 4 through pass 11 at elevation 229' to the laser scanning data.

Primarily, the computer predictions show features that are expected. The six buttresses (at 0 degrees, 60 degrees, et cetera) show some movement but less than the bay midlines. However, the level and distribution of correlation between the model and the laser data is more difficult to explain. On elevation 229' there is considerable scatter in the laser data. Generally the laser data agree with the model predictions from 0 to 180 degrees (with the exception of immediately around the SGR opening at 150 degrees). Interestingly, in 1976 the agreement was better at 270 degrees than at 90 degrees. In 2010 the laser data from 180 degrees to 360 degrees is scattered and generally larger than the computer model predictions.

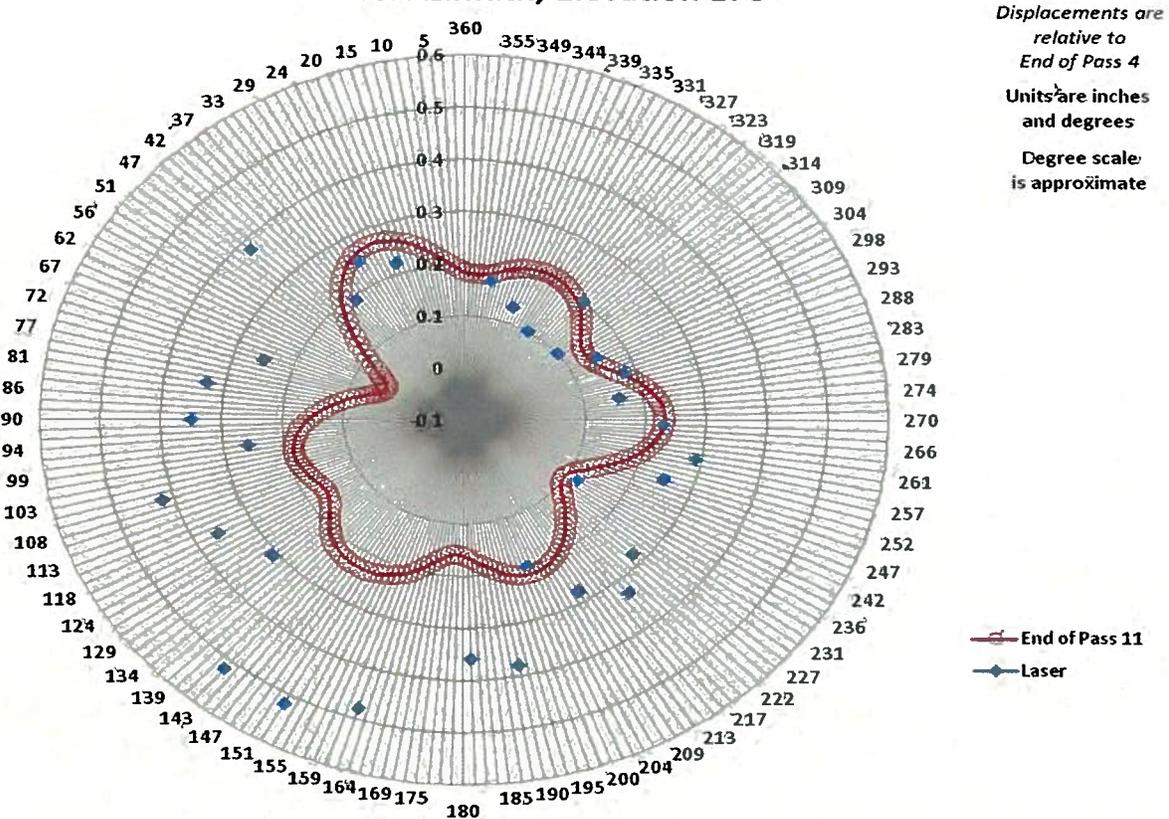
Figure A2.6 Benchmark comparison of PII computer models with laser scanning data for elevation 170'.

Elevation 170' is similar to elevation 229'. The laser data agree well with the model from 260 degrees to 45 degrees and then the laser data is scattered and larger than the computer model predictions for the rest of the circle. Figure A2.7 shows the containment surface surveyed by the laser scanning equipment.

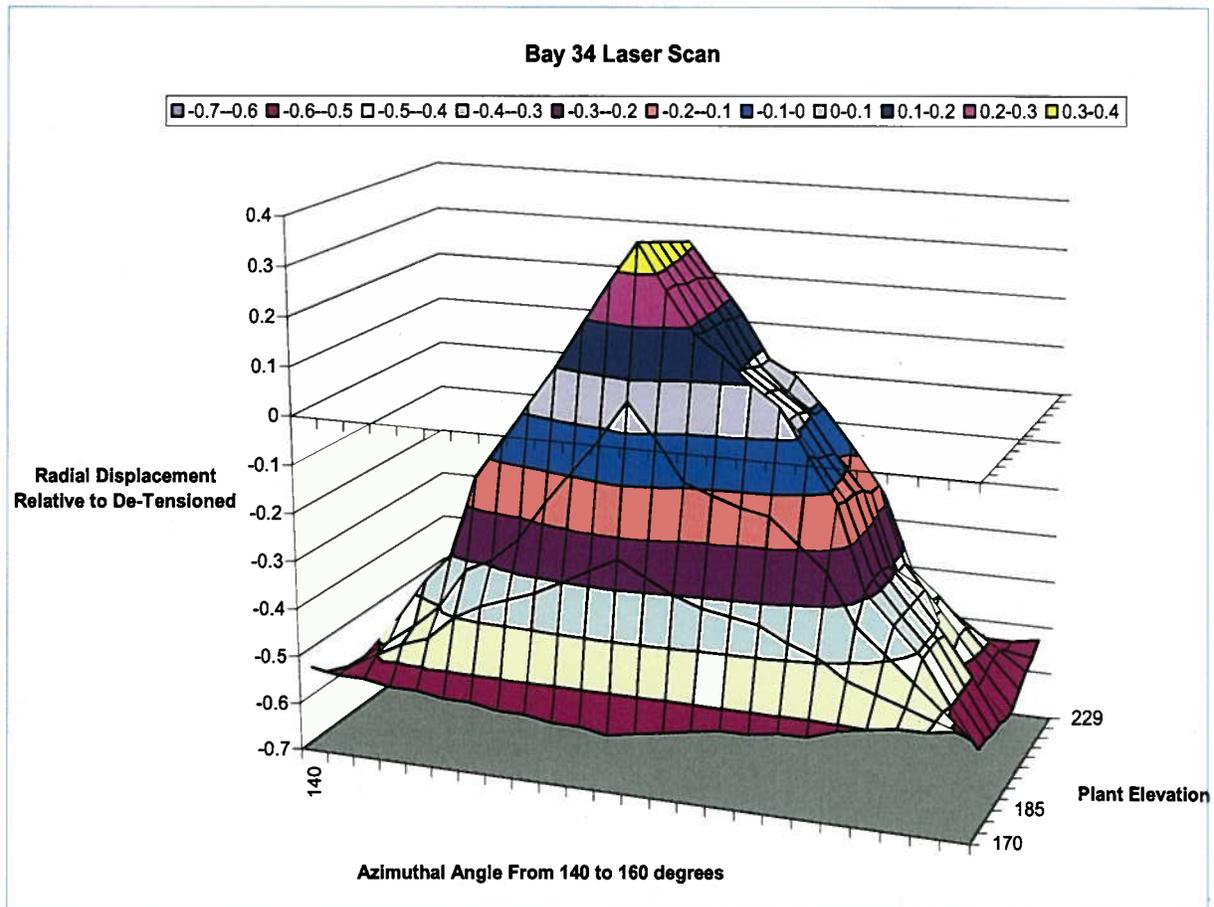
Figure A2.8 Three dimensional laser scan results for Bay 34.

Figure A2.8 shows the results of the laser scan illustrated in three dimensions, displaying a very detailed image of the changes in radial deflection from the middle of the March, 2010 de-tensioning sequence to the end of that sequence.

The data demonstrating the bulge area in the center of bay 34, as shown in Figure A2.6, exhibit how, while every other part of the containment moved outwards during the de-tensioning in March, 2010, the area around azimuth 150 degrees from elevation 180' to 210' moved inwards. This is the reaction that would be expected had a bulge existed at the start and been deflated by the de-tensioning evolution. The laser would estimate the height of the bulge at 0.4" (based upon the partial evolution monitored) and the computer model would estimate it at 0.4" based on the information in Figure 7.12.

Figure A2.8 is another method to display the laser scan data in the center of bay 34. The above comparison indicates that laser scanning confirms the salient points in the delamination scenario relative to radial displacement of bay 34.

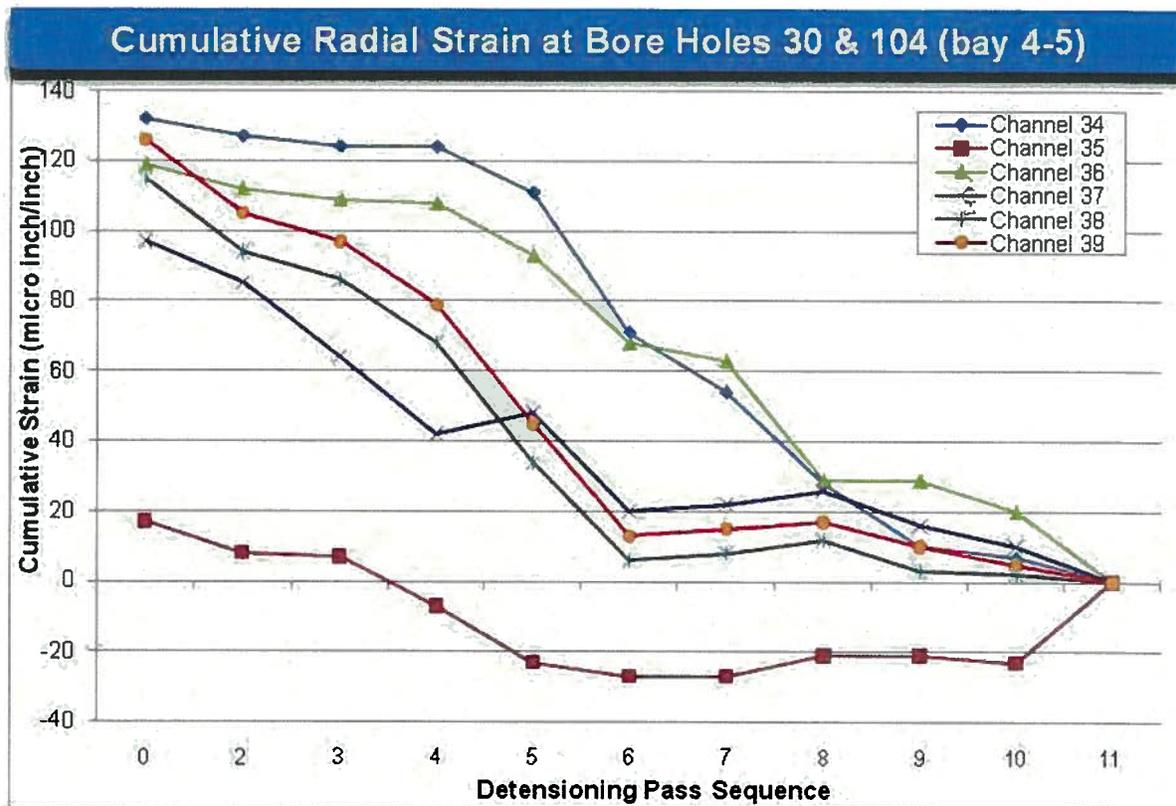
Figure A2.10 Cumulative radial strain readings as the containment was de-tensioned in March, 2010

Note that the readings are normalized to zero in the de-tensioned state. The two deepest sensors (#34 at 14" and #36 at 13") behave similarly. Sensor #35, at 10" deep, was located in a section of the bay that underwent a lesser total strain change than deeper in the concrete or at the other sensor, which indicates that the containment at elevation 215' in Bay 45 straightened out during the de-tensioning. This is confirmed in the computer model. The computer model also indicates that the most extreme displacement occurs at pass 6 and that the cumulative data shows a distinct change at that pass in sensors 37, 38, and 39.

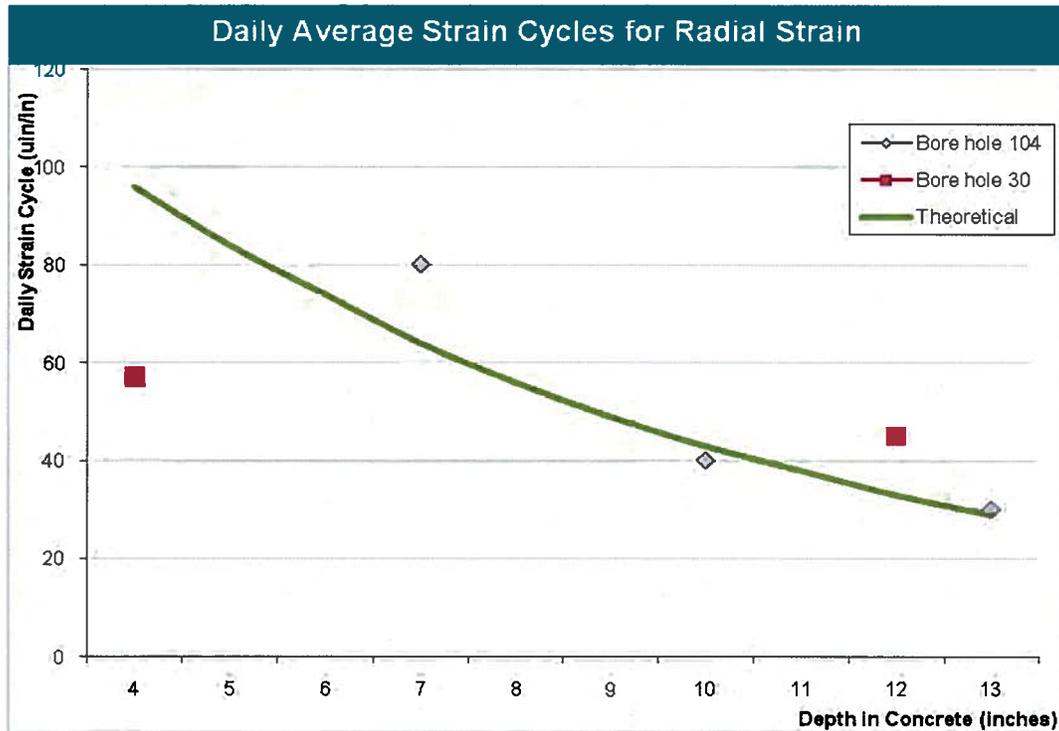
Figure A3.1 Plot of average daily radial strain cycles as a function of depth in concrete

These cycles are driven by the temperature variation due to solar heating and have been directly correlated to the equivalent temperature readings as a function of depth in the concrete. This shows the concrete sees a strain of about 40 µin/in at the critical depth of 10 inches.

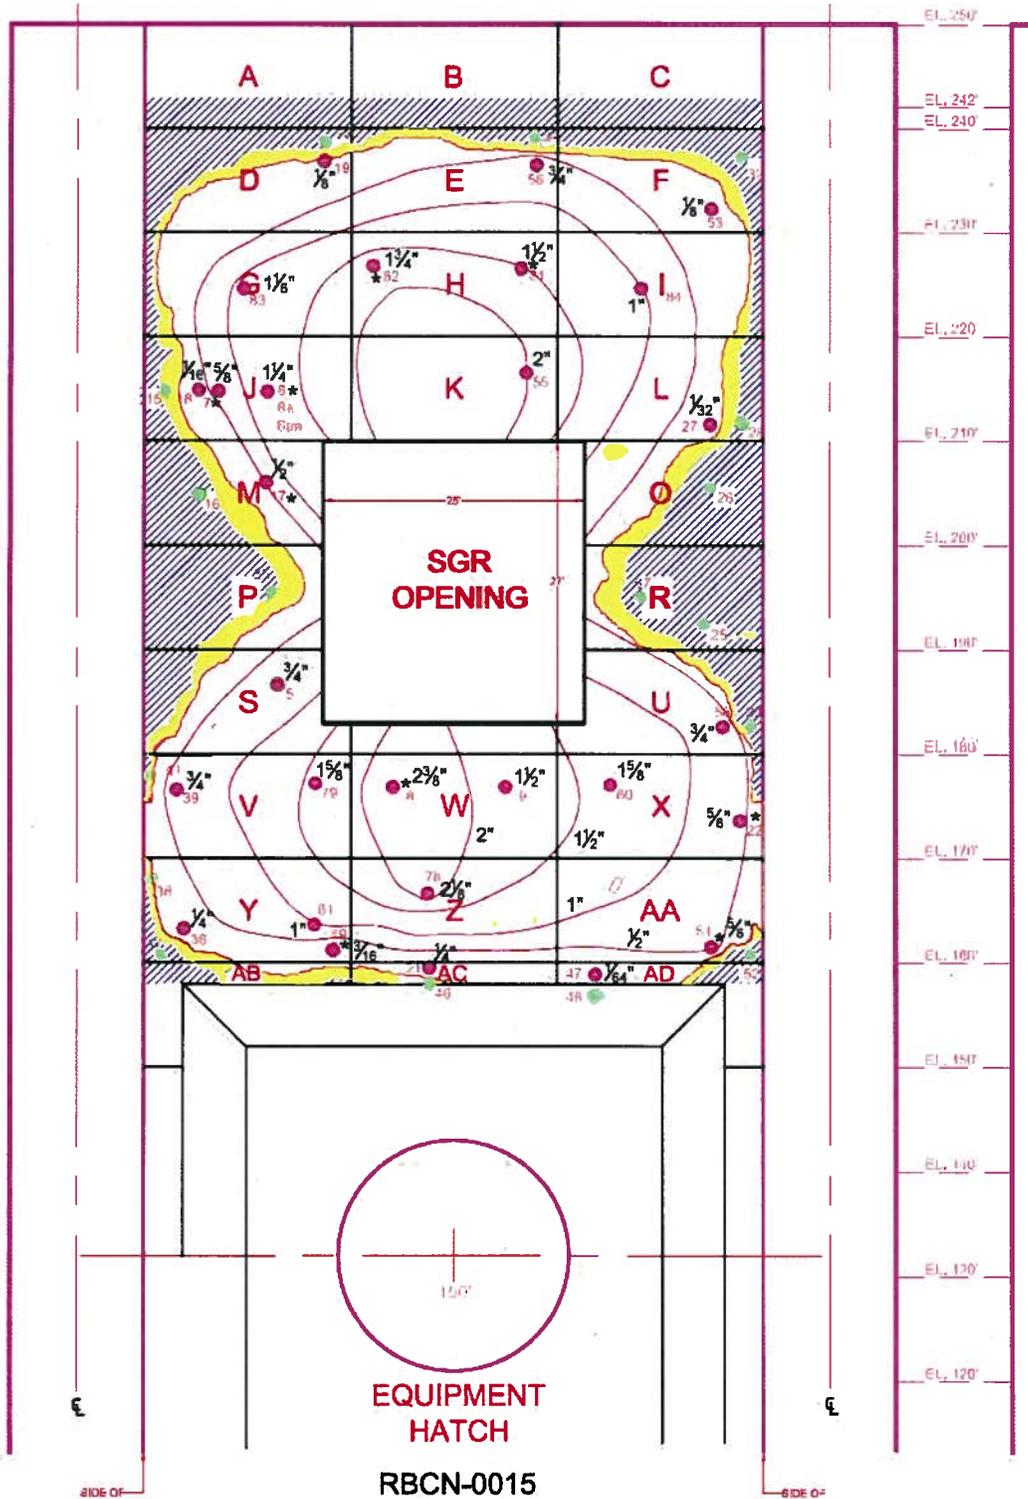
Figure A4.8 Displacement map showing the distribution of delamination depth

Figure A4.8 shows the delaminated area as determined through non-destructive testing (NDT), and confirmed through core drilling and fiberscope follow-up:
