Crystal River Unit #3

Presentation to PNSC Containment Update & Discussion of Repair Options

November 16th 2009 Presented by Garry Miller

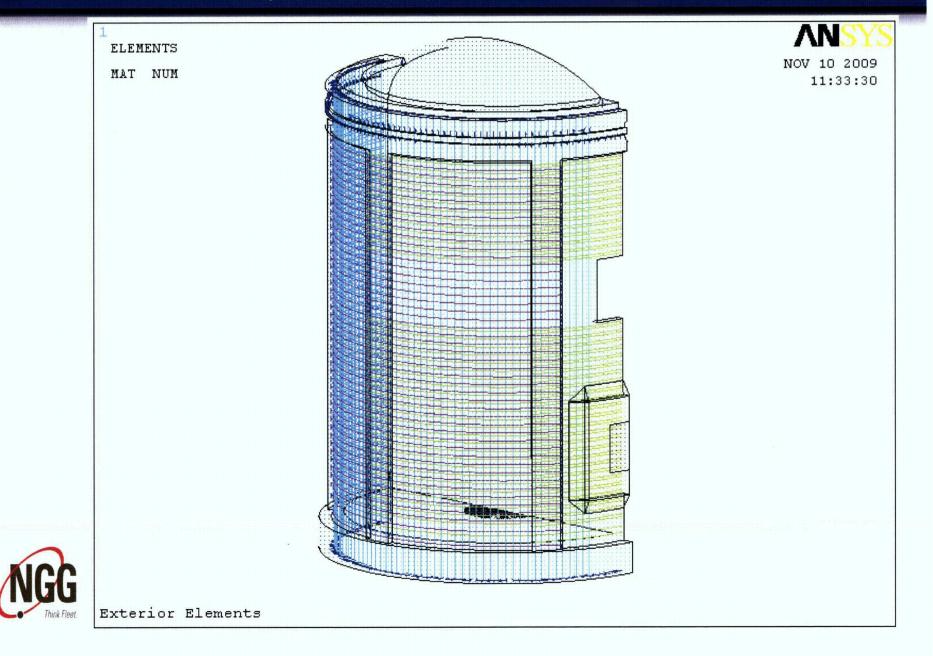
- 180 degree Symmetric model
 - Symmetry plane @ 150 degrees midway Between Buttress 3 & 4 / 1 & 6
 - ½ Opening, ½ Damage & ½ Hatch Modeled Explicitly
