November 11 2009

Subject: **Report of Petrographic Observations  
Crystal River Containment Wall  
Steam Generator Replacement Project  
Crystal River Nuclear Generating Facility, Florida  
MACTEC Project No. 6468-09-2535**

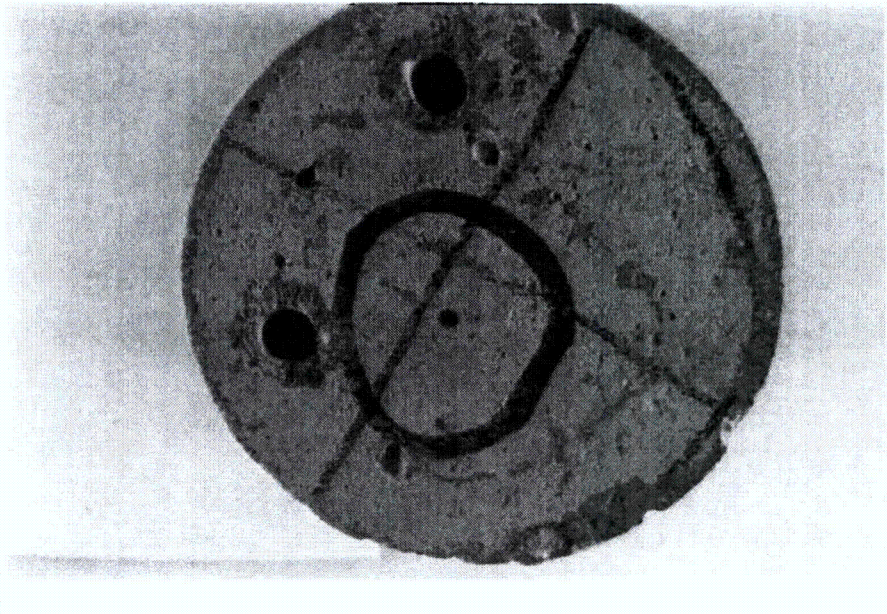
Photograph #5	Remarks

The exterior surface of core 21269.

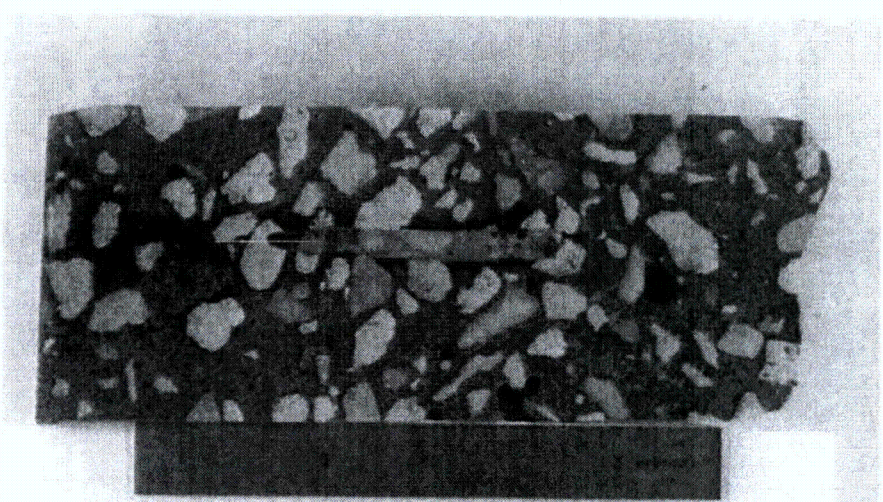
Photograph #8	Remarks

<p data-bbox="526 1725 813 1761">Mactec Lab No. 21269</p>	Polished section 21269A prepared from sample 21269

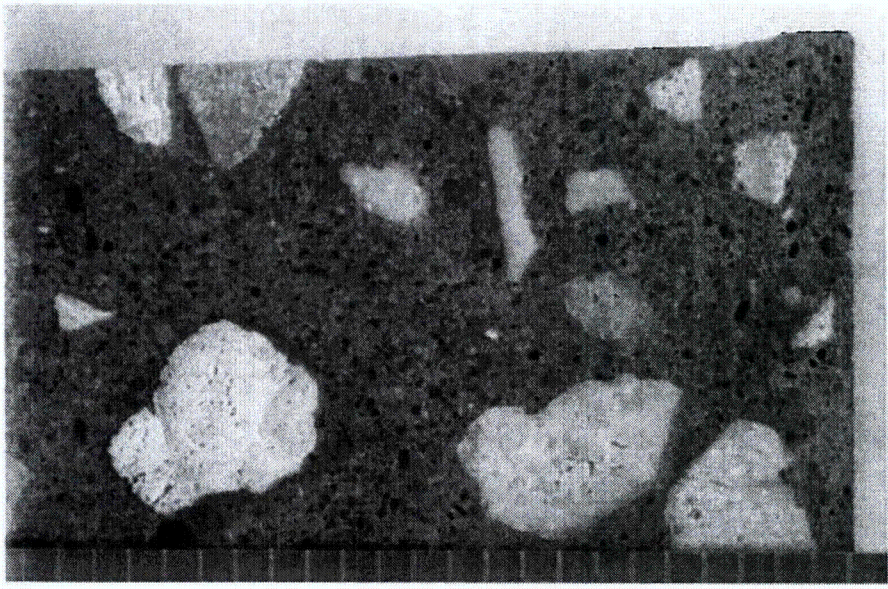
Photograph #9	Remarks

Close-up of the polished section prepared from core 21269A. The exterior end is to the right.

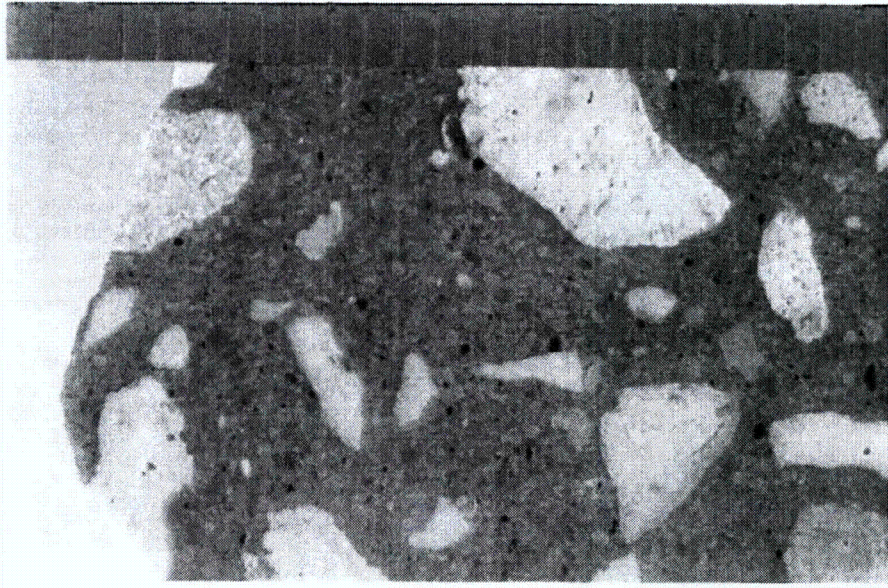
Photograph #10	Remarks

Close-up of the polished section prepared from core 21269A. The fractured surface is to the left.

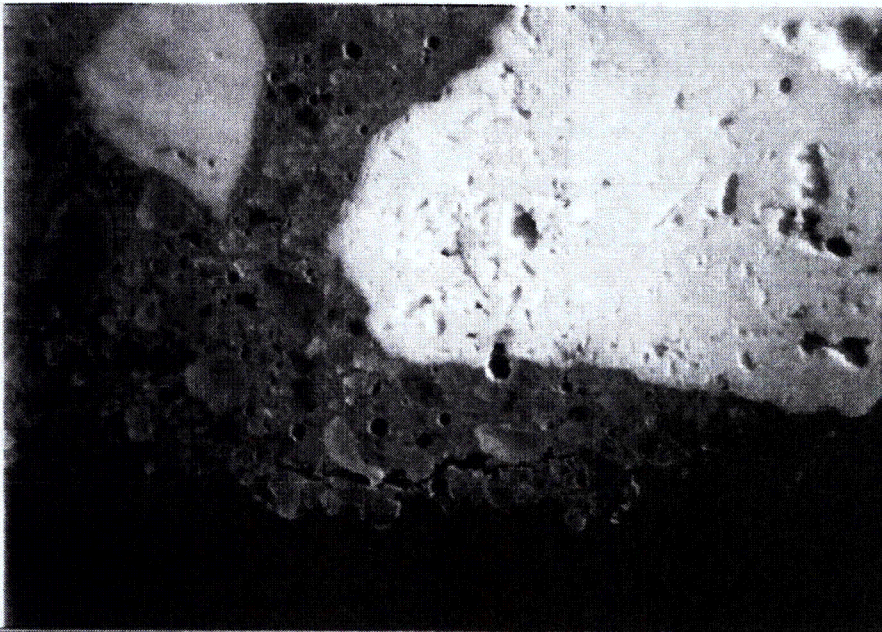
Photograph #13	Remarks

A black and white photomicrograph of a polished concrete section. The image shows a dark, granular matrix with several lighter-colored, irregularly shaped aggregates. A distinct, lighter-colored fracture surface is visible, running horizontally across the middle of the image. The fracture surface appears to be composed of fine, interconnected particles. The overall texture is rough and porous.	<p>Photomicrograph of the polished section. The fracture surface is towards the bottom. Width of view is approximately 0.5 inch.</p>

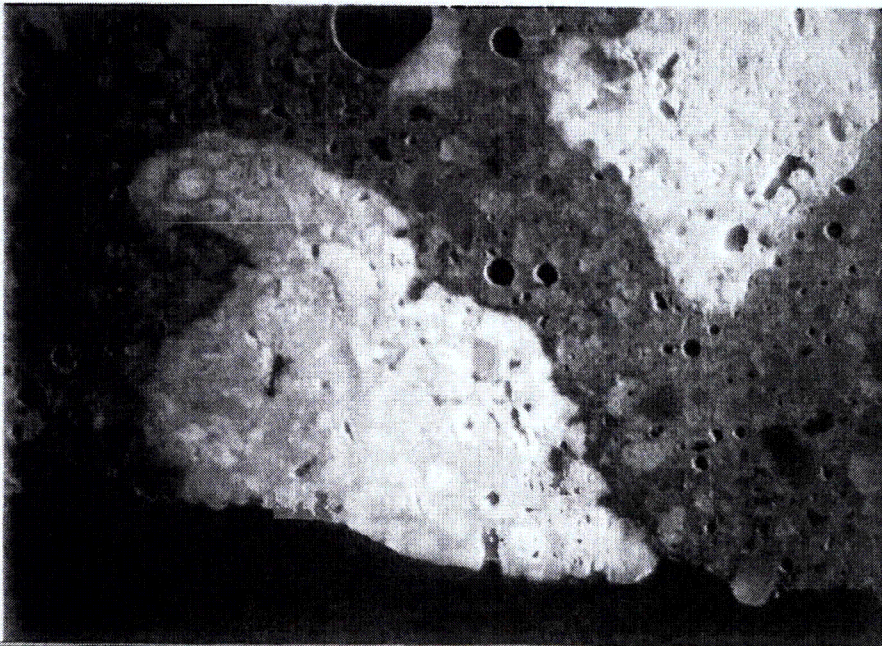
Photograph #14	Remarks

A black and white photomicrograph of a polished concrete section, similar to Photograph #13. It shows a dark matrix with light-colored aggregates. A fracture surface is visible, running horizontally across the middle. The fracture surface is characterized by a rough, porous appearance with many small voids and irregular shapes. The overall texture is highly porous and granular.	<p>Photomicrograph of the polished section. The fracture surface is towards the bottom. Width of view is approximately 0.5 inch.</p>

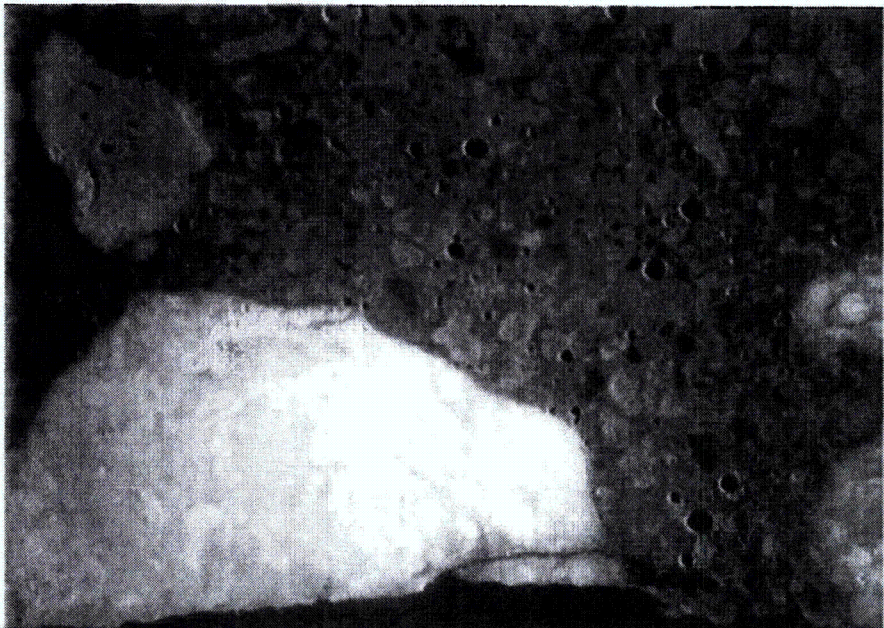
Photograph #15	Remarks

A black and white photomicrograph of a polished concrete section. The image shows a dark, granular matrix with numerous small, dark, circular air voids. A prominent, lighter-colored, irregularly shaped feature is visible in the lower-left quadrant, which appears to be a fracture surface or a large aggregate particle. The overall texture is rough and porous.	<p>Photomicrograph of the polished section. The fracture surface is towards the bottom. Width of view is approximately 0.5 inch.</p>

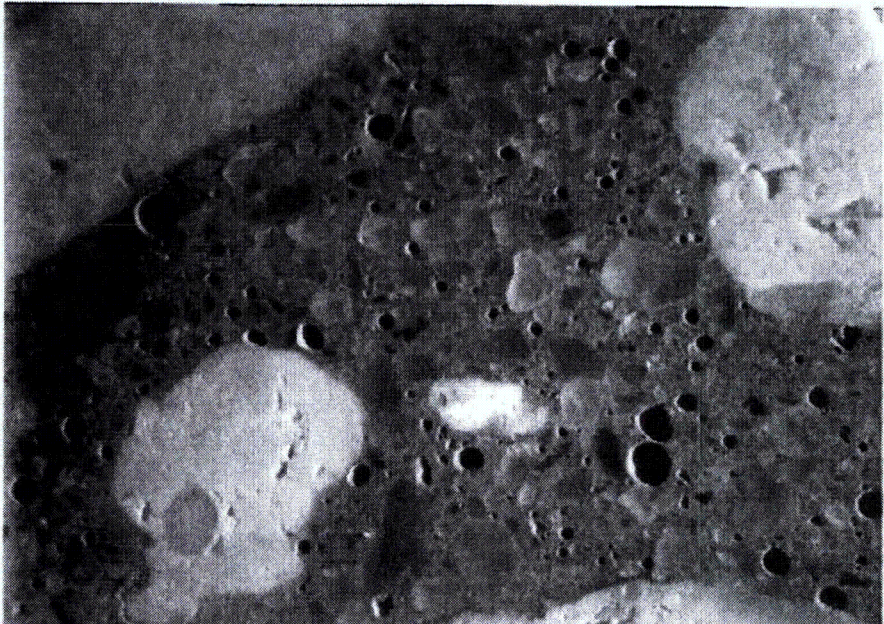
Photograph #16	Remarks

A black and white photomicrograph of a polished concrete section. The image shows a dark matrix with a high density of air voids of various sizes. Some voids are large and circular, while others are smaller and more irregular. The distribution of voids is uneven, with some areas appearing more densely packed than others. The overall appearance is highly porous.	<p>Photomicrograph of the polished section. Note the un-even distribution of air voids. Width of view is approximately 0.5 inch.</p>

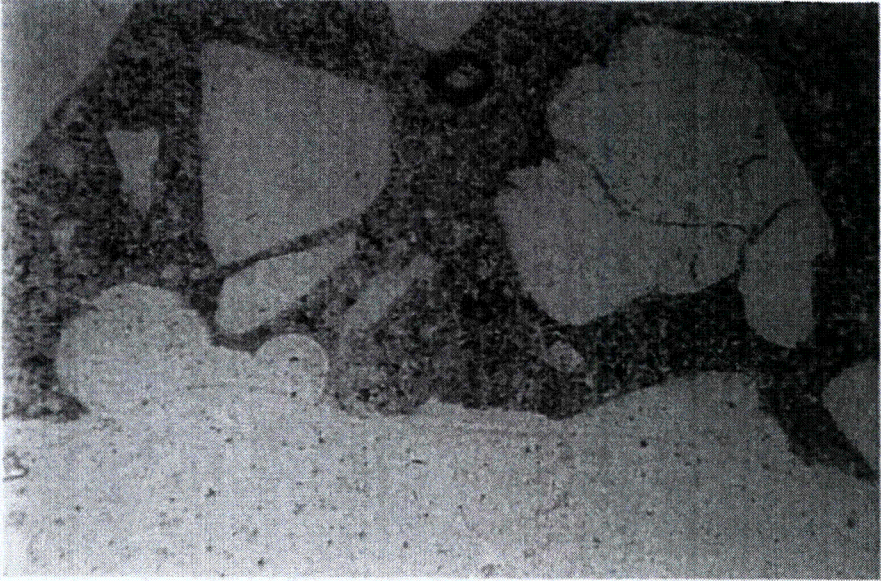
Photograph #21	Remarks

<p>Photomicrograph of a thin section taken with plane polarized light. The fracture surface is towards the bottom. Width of view is approximately 0.5 inch.</p>

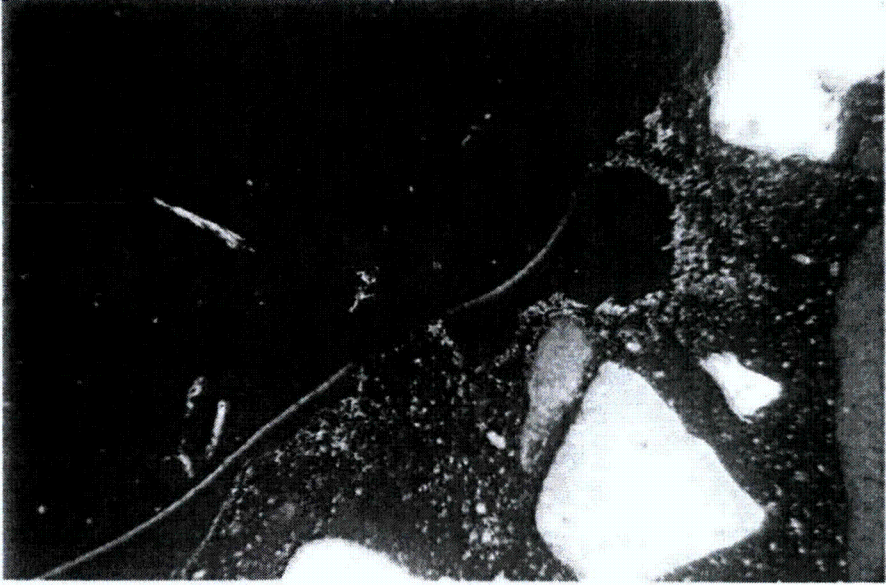
Photograph #23	Remarks

<p>Another view of the area in photograph #22. Width of view is approximately 0.5 inch.</p>

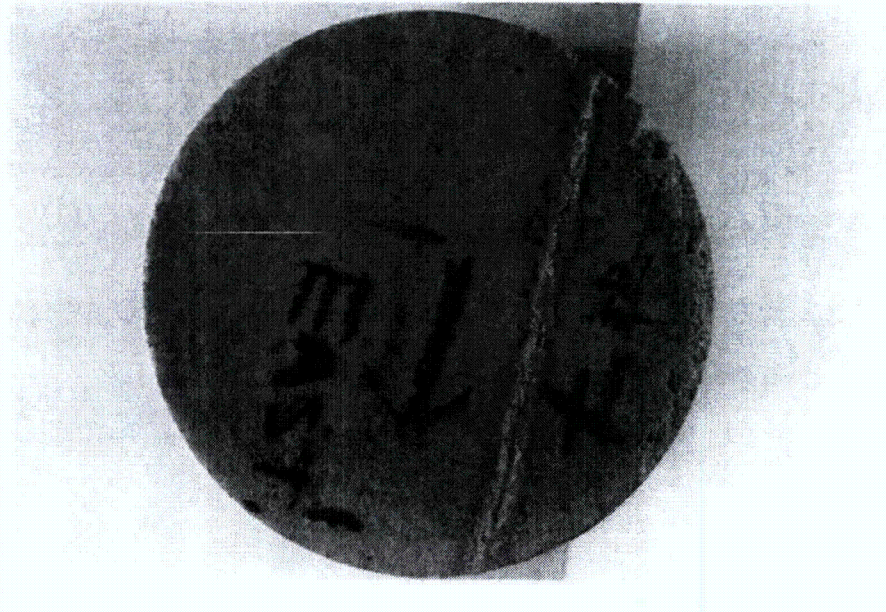
Photograph #4	Remarks

The exterior surface of core 21271.

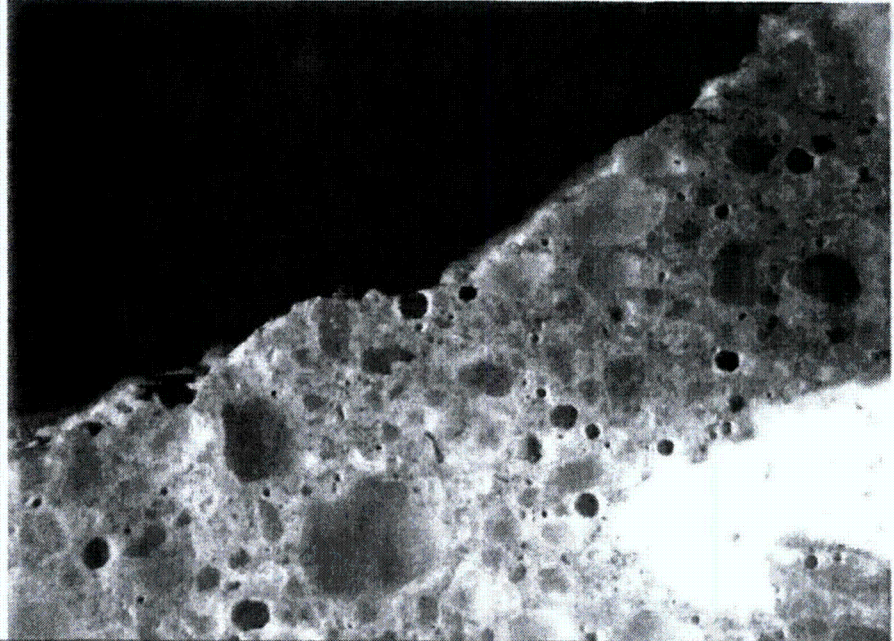
Photograph #16	Remarks

Close up of the polished sections showing the fracture surface (top of photograph). Note uneven distribution of air voids. Width of view is approximately 0.4 inch.

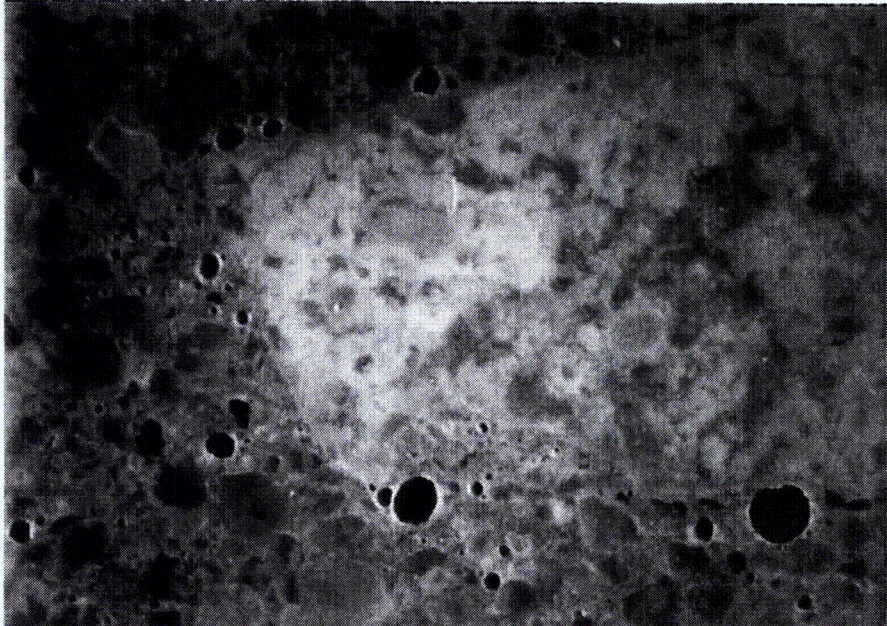
Photograph #17	Remarks

A black and white micrograph showing a central, lighter-colored aggregate particle. Numerous dark, circular air voids are clustered around this particle and scattered in the surrounding matrix. The matrix has a granular, textured appearance.	<p>Close up of the polished sections showing clustering of air voids around an aggregate particle. Width of view is approximately 0.2 inch.</p>

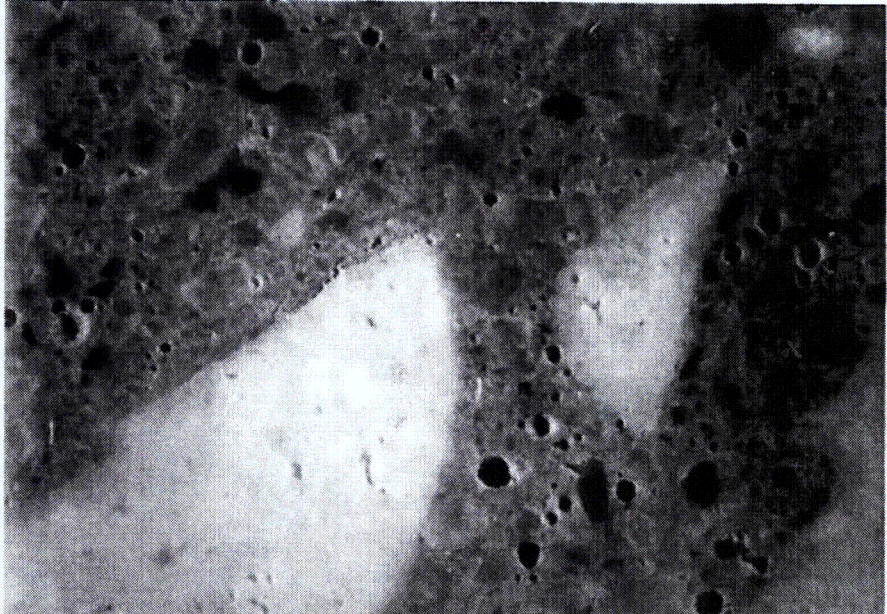
Photograph #18	Remarks

A black and white micrograph showing a large, light-colored aggregate particle on the left side. The surrounding matrix is dark and contains many small, dark, circular air voids. The distribution of these voids is uneven, with some areas appearing more densely populated than others.	<p>Close up of the polished sections showing uneven distribution of air voids. Width of view is approximately 0.2 inch.</p>

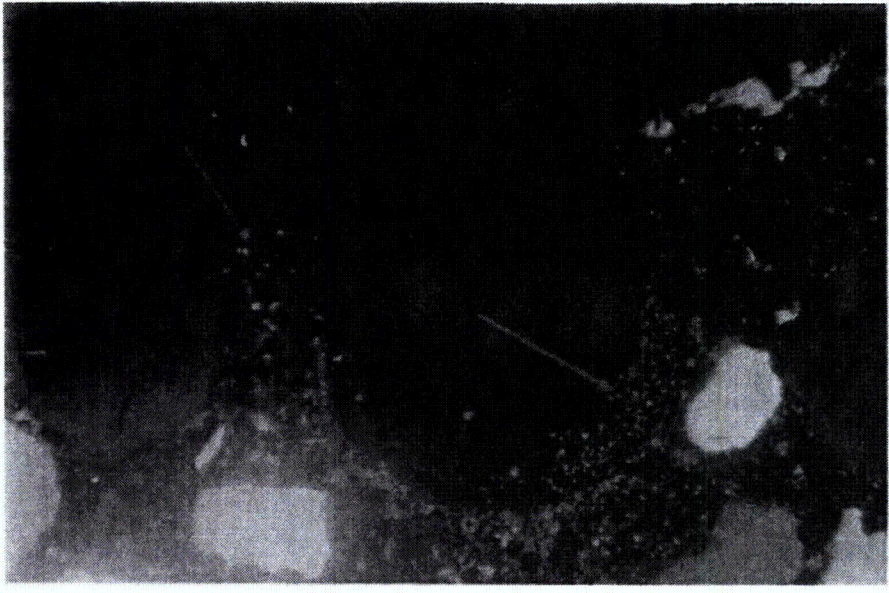
Photograph #23	Remarks

A photomicrograph showing a dark, granular matrix. A prominent, bright, circular feature is visible on the right side, representing mineral growth in an air void. A red arrow points to the edge of this feature, and a blue arrow points to a dark, linear feature on the left, representing a fractured surface. The overall texture is somewhat porous and irregular.	<p>Photomicrograph of thin section in plane polarized light. Note the mineral growth in the air void that was exposed at the fractured surface (red arrow). Note lack of mineral growth on fractured surface (blue arrow). Width of view is approximately 0.3 inch.</p>

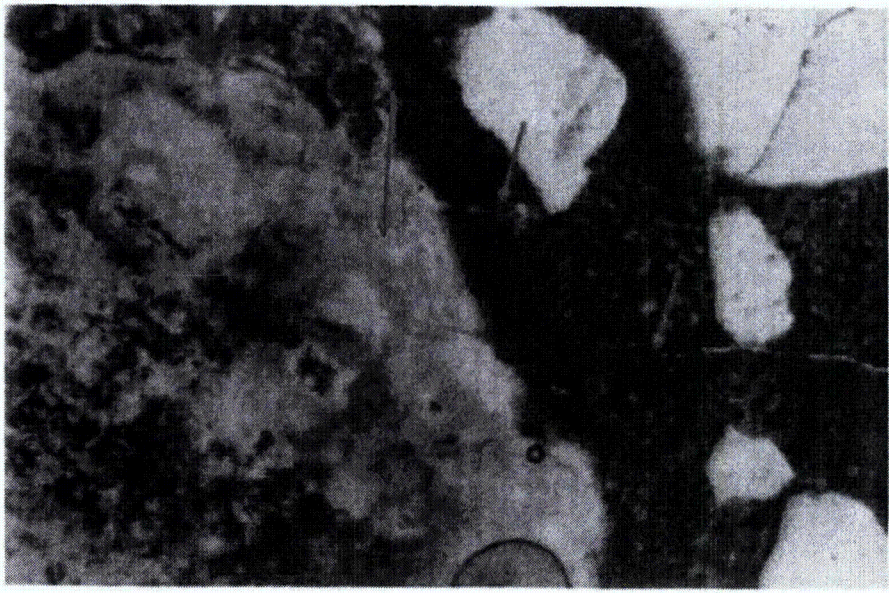
Photograph #24	Remarks

radial silica (essentially chert) with the limestone, several cracks were observed going through the portion which was predominately chert. There appeared to be minor amounts of ASR gel but a positive identification could not be made due to the small amounts present.
Contamination	Not observed.
<b>FINE AGGREGATE:</b>	
Shape	Generally sub-rounded to sub-angular
Grading	#4 and smaller
Distribution	Even
Texture	Fine
Composition	Siliceous
Rock Types	Quartz
Alteration:	Not Observed
- Degree	
- Products	
Coatings	Not Observed
Rims	Not Observed
Internal Cracking	A few internal fractures were observed
Contamination	Not observed.

A photomicrograph showing a complex, textured surface. Several bright, angular, and somewhat rounded features are scattered across the field of view, representing chert deposits. Red arrows point to dark, linear features (fractures) extending from these bright areas. Blue arrows point to other bright, irregular shapes representing limestone particles. The background is dark and granular.	<p>Photomicrograph of thin section using plane polarized light. Note fractures (red arrows) coming out of chert deposit (blue arrows) in a limestone particle. Width of view is approximately 0.5 inch.</p>

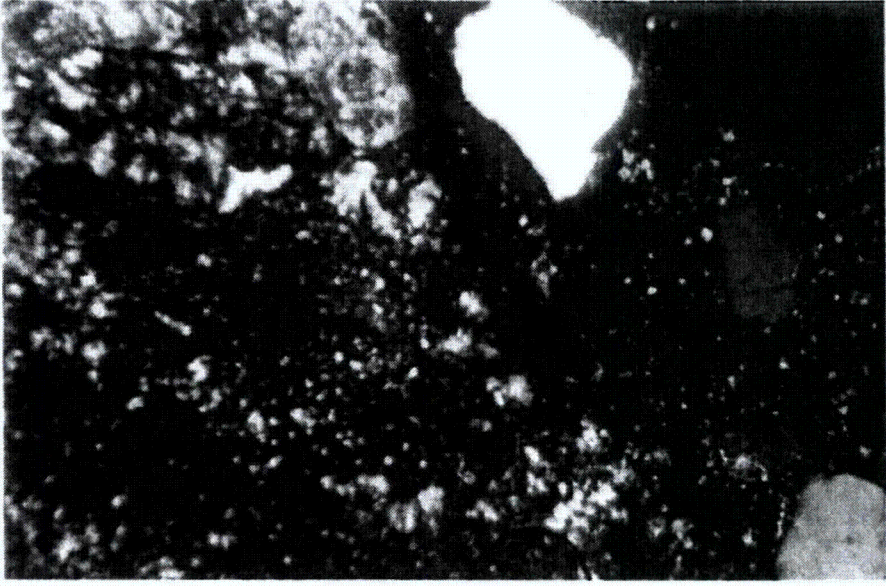
Photograph #25	Remarks

<p>Same view as photograph #24 taken with cross polarized light. Width of view is approximately 0.5 inch.</p>

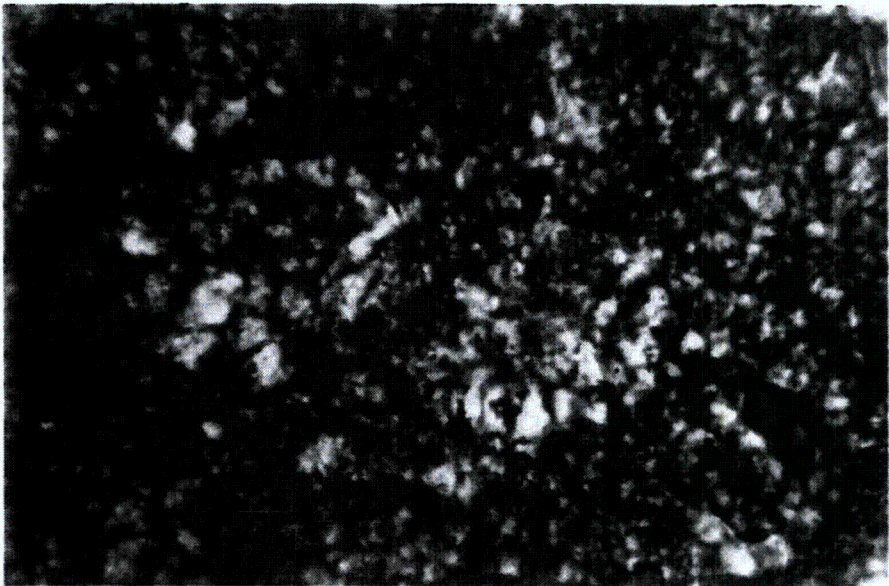
<b>Photograph #27</b>	<b>Remarks</b>

Same view at photograph #26 taken with cross polarized light. Width of view is approximately 0.5 inch.
