Study of the Unit 2 Spent Fuel Pit Permeability

**Entergy Nuclear Northeast
Indian Point Unit 2**

*Report No. 1464385-R-004
Revision: Draft B*

**ABS Consulting
118 Portsmouth Avenue
Stratham, NH 03885**

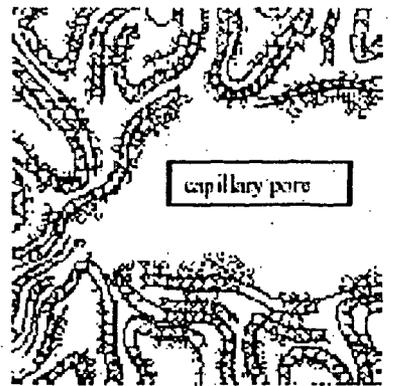
At the smallest scale, water may move into concrete through interconnected capillary porosity. Capillary pores are essentially a residue of the originally water filled spaces in fresh concrete. Capillary pore scale is important with respect to durability of concrete as it is the path by which water and other aggressive ions penetrate into the concrete matrix. A depiction of this is shown in Figure 5 (A).

A – Capillary Pore in Hydrated Cement Paste

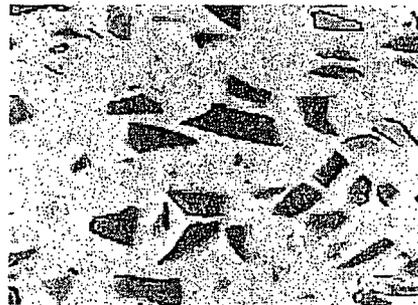
Somewhat larger but of similar magnitude to capillary pores are micro-cracks and transition zones. Micro-cracks may be formed due to internal thermal and shrinkage forces or stress due to external loads. The transition zone is a weak permeable layer that occurs around aggregate particles. This scale is also of importance with respect to movement of water and other aggressive chemicals within the concrete matrix and thus is important from a durability standpoint as well. A depiction of micro-cracks and transition zone is shown in Figure 5 (B) and Figure 5 (C), respectively.

B - Micro Crack around Aggregate Particles

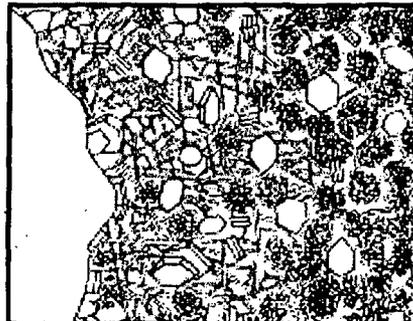
C – Illustration of the Transition Zone
