ROOT CAUSE REPORT

TITLE: INADEQUATE RESPONSE TO UNPLANNED ENVIRONMENTAL TRITIUM RELEASES FROM BRAIDWOOD STATION DUE TO THE LACK OF INTEGRATED PROCEDURAL GUIDANCE.

Unit(s): Braidwood Units 1 and 2

Event Date: 11/30/2005

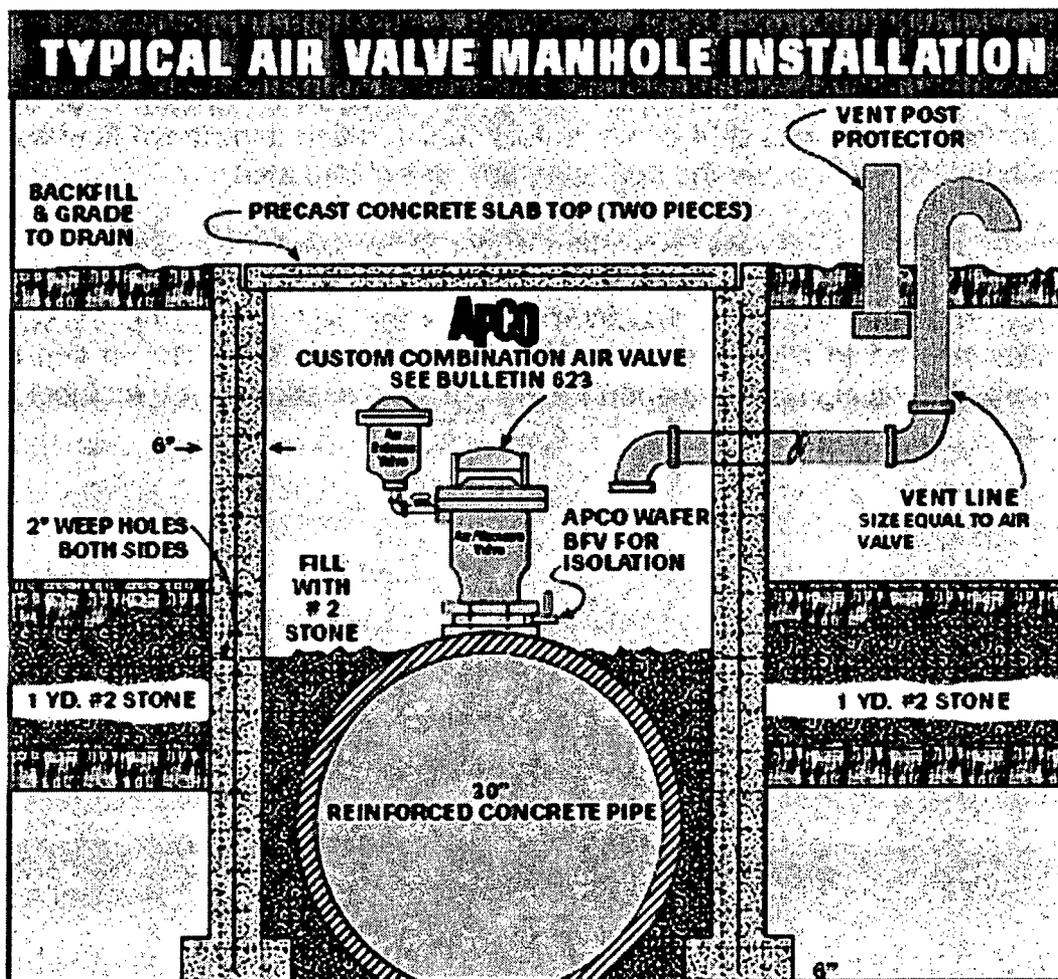
~~The Circ Water Blowdown system was originally designed to be maintained full and pressurized. This was accomplished through manipulation of the Blowdown Spray Valves, 0CW018A/B at the Kankakee River blowdown structure. These valves were susceptible to freezing due to their location and system operation requirements. Based on this, other maintenance issues, and parts obsolescence, these valves were eventually abandoned in the full open position in the late 1980's. To allow air release from the piping on start-up and to allow air,~~

introduction to protect against vacuum damage to the piping, vacuum breakers were installed.

System control was transferred to the upstream motor operator isolation valves (1/2CW018) located in the turbine building. This modification caused the blowdown line to operate in a partially voided condition in various locations, depending on elevation which allowed column separation water hammer events to occur when flow rates were changed significantly, i.e., during system start-up or shut-down. Events were not initially seen because blowdown was essentially in service all the time. As a result of this modification, the blowdown system would no longer be maintained full and pressurized upon shutdown. Minimal technical review was performed on the hydraulic transient effects on the vacuum breakers from this method of operation (i.e., surge check valves were not evaluated for system incorporation).

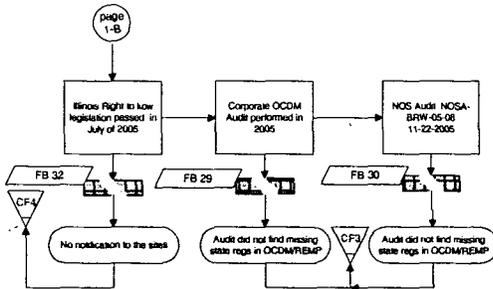
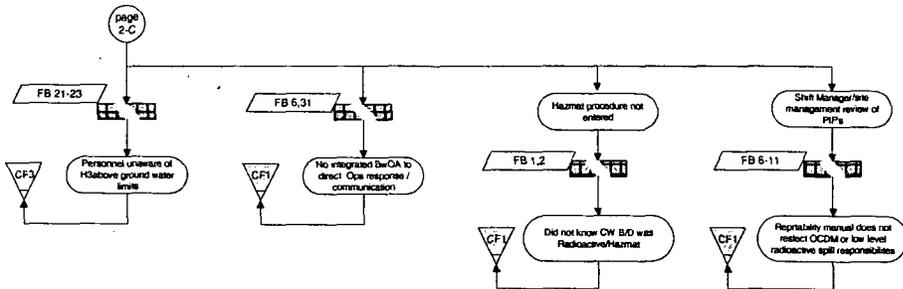
Event and Causal Factor Chart
Tritium Event
Root Cause Report
IR# 00428868

Page 3 for history of blowdown vacuum breakers
