2010 Annual Site Inspection and Monitoring Report for Uranium Mill Tailings Radiation Control Act Title I Disposal Sites

January 2011

LMS/S06929

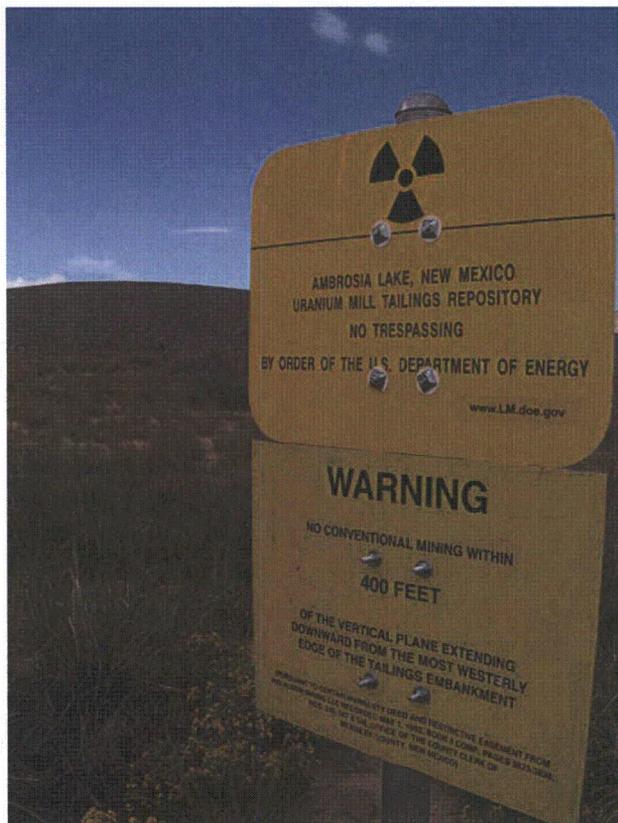
The entrance sign and all perimeter signs were in good condition. Posts for perimeter signs P1 through P15 include mining restriction-area warning signs (PL-1).

AMB 8/2010. PL-1. Perimeter sign P1 and mining restriction area warning sign.

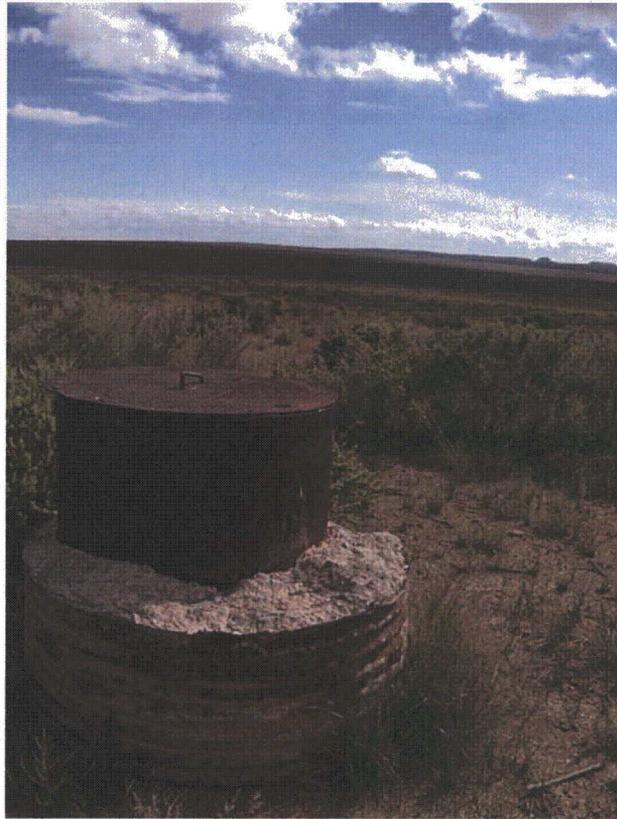
Mine Vents—A mine vent shaft, associated with abandoned underground mine, is within the site boundary in the northern portion of the site. The vent has a casing that rises approximately 3 feet above the ground and a spot-welded cover. The vent was secure at the time of the inspection (PL-3). Inspectors will continue to monitor the condition of the vent to ensure that the closure remains secure.

AMB 8/2010. PL-3. Mine vent shaft.

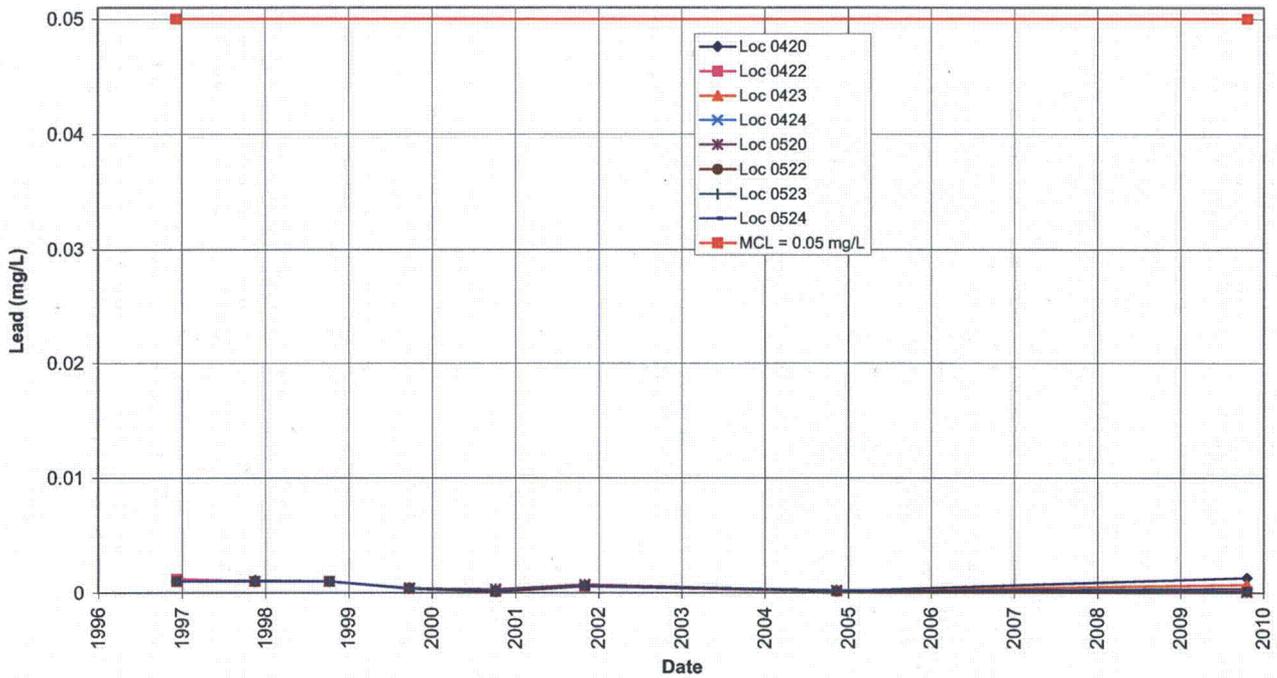
Figure 2-2. Time-Concentration Plot of Lead in Groundwater at the Burrell Disposal Site

Concentrations of lead in groundwater in both the shallow alluvial wells (400-series wells) and the deeper bedrock wells (500-series wells) remained well below the MCL. The 2009 results from all locations were more than an order of magnitude below the MCL (Figure 2-2).

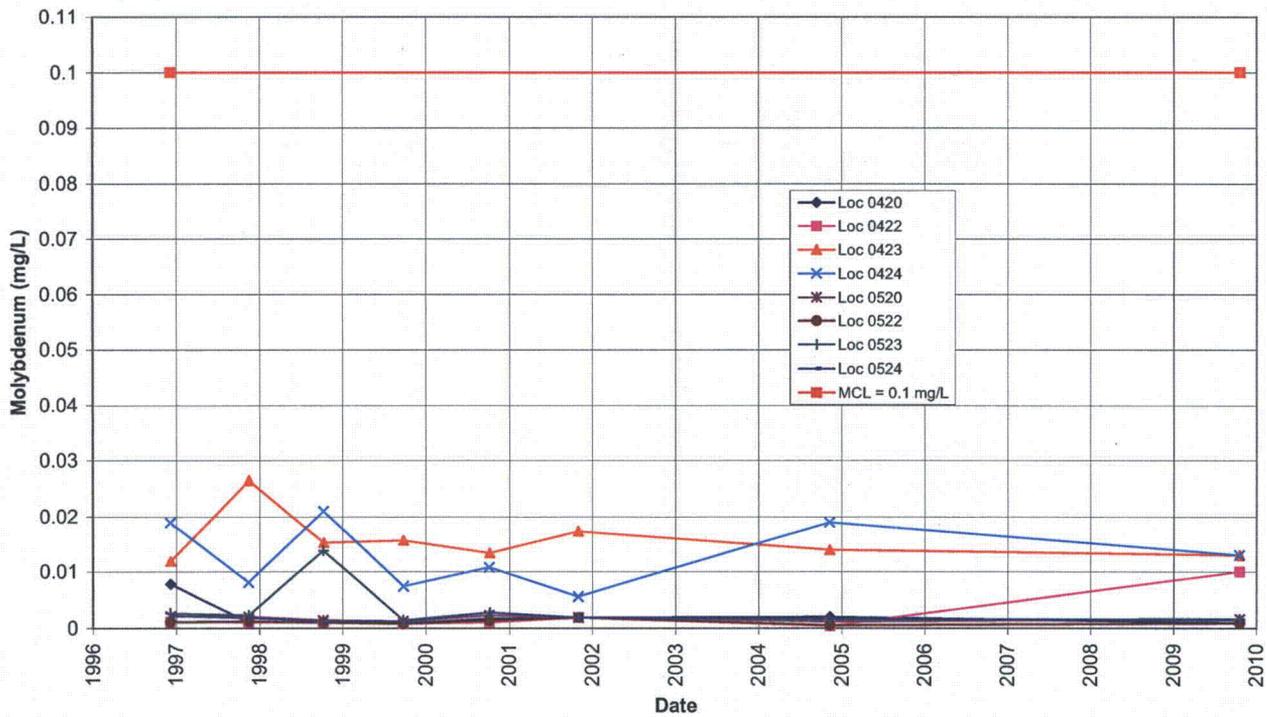
Figure 2-3. Time-Concentration Plot of Molybdenum in Groundwater at the Burrell Disposal Site

Concentrations of molybdenum in groundwater in both the shallow alluvial wells (400-series wells) and the deeper bedrock wells (500-series wells) remained well below the MCL. The 2009 results from all locations (except downgradient wells MW-0422, MW-0423 and MW-0424) were more than an order of magnitude below and at or near the laboratory detection limit. Concentrations in wells MW-0422, MW-0423 and MW-0424 were well below the MCL (Figure 2-3).

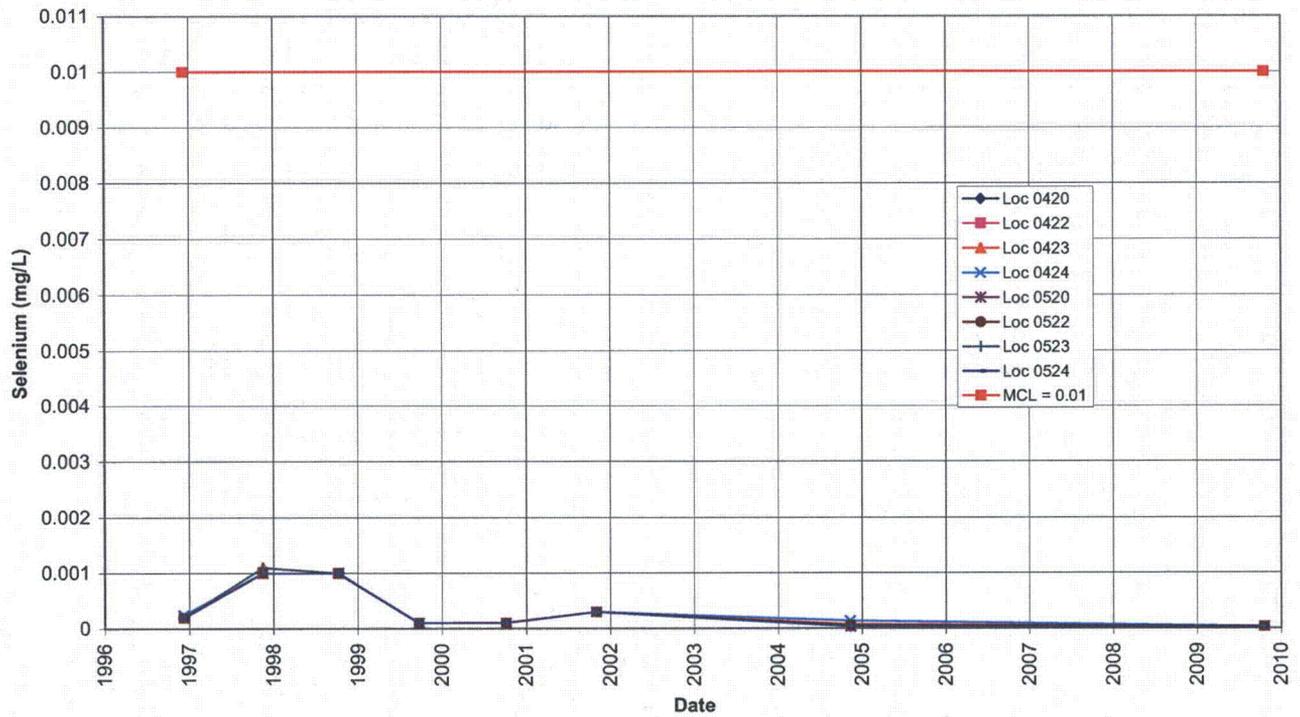
Figure 2-4. Time-Concentration Plot of Selenium in Groundwater at the Burrell Disposal Site

Concentrations of selenium in groundwater in both the shallow alluvial wells (400-series wells) and the deeper bedrock wells (500-series wells) remained well below the MCL. The 2009 results from all locations were more than two orders of magnitude below the MCL and approached the laboratory detection limit (Figure 2-4).

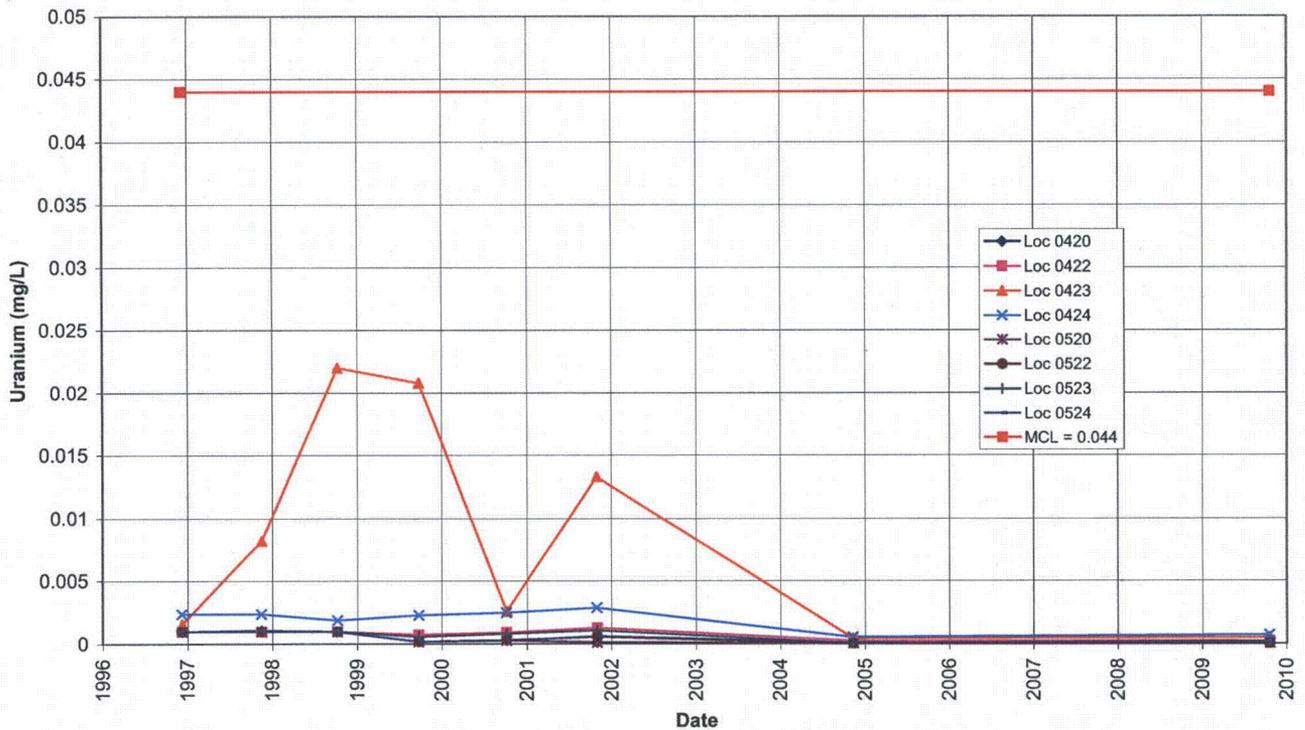
Figure 2-5. Time-Concentration Plot of Uranium in Groundwater at the Burrell Disposal Site

Concentrations of uranium in groundwater in both the shallow alluvial wells (400-series wells) and the deeper bedrock wells (500-series wells) remain well below the MCL. The 2009 results from all locations were two orders of magnitude or more below the MCL and approached the laboratory detection limit (Figure 2-5).

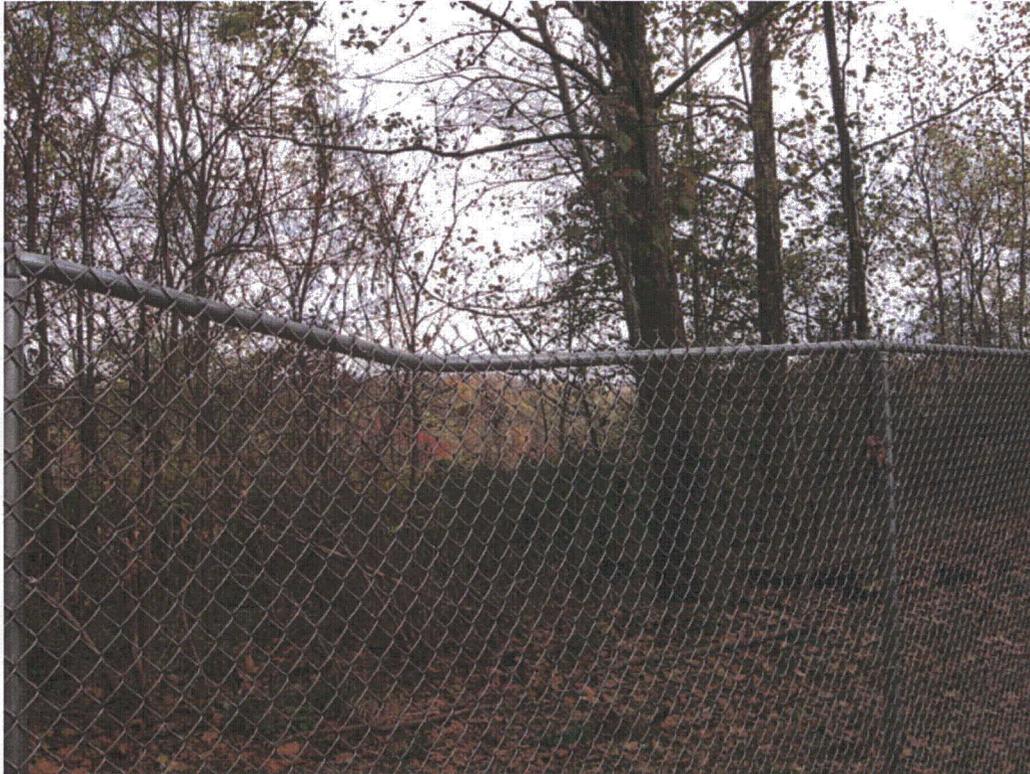
BUR 10/2010. PL-1. Bent rail on top of south perimeter fence.

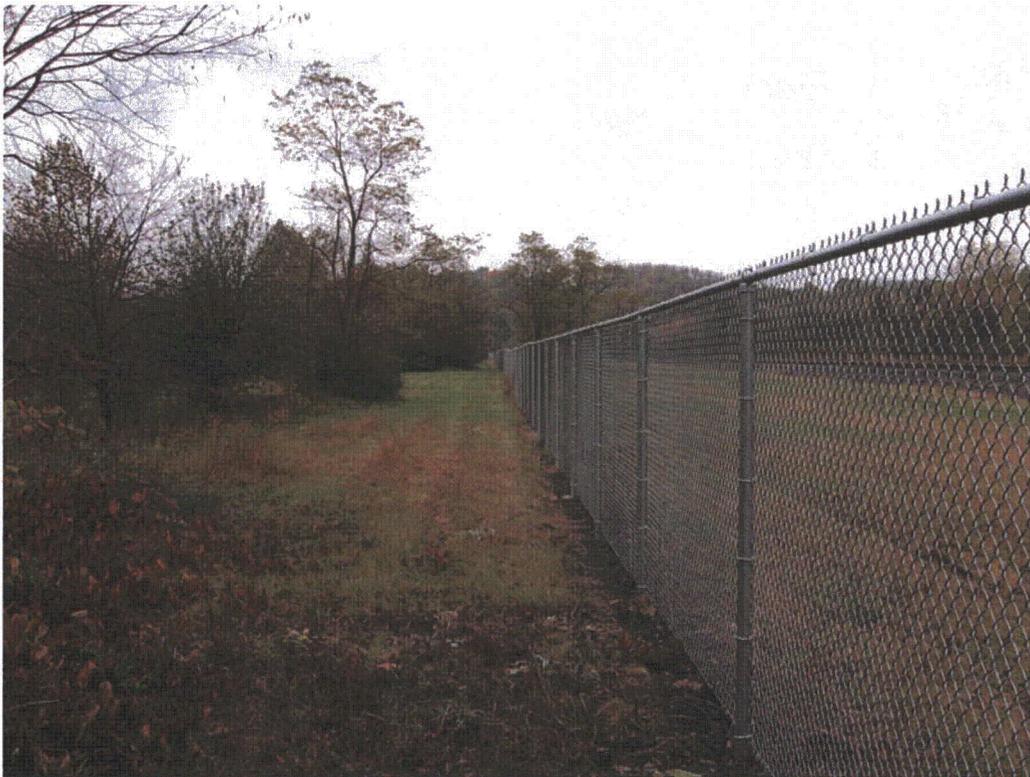
BUR 10/2010. PL-2. View down the inside of the north perimeter fence.

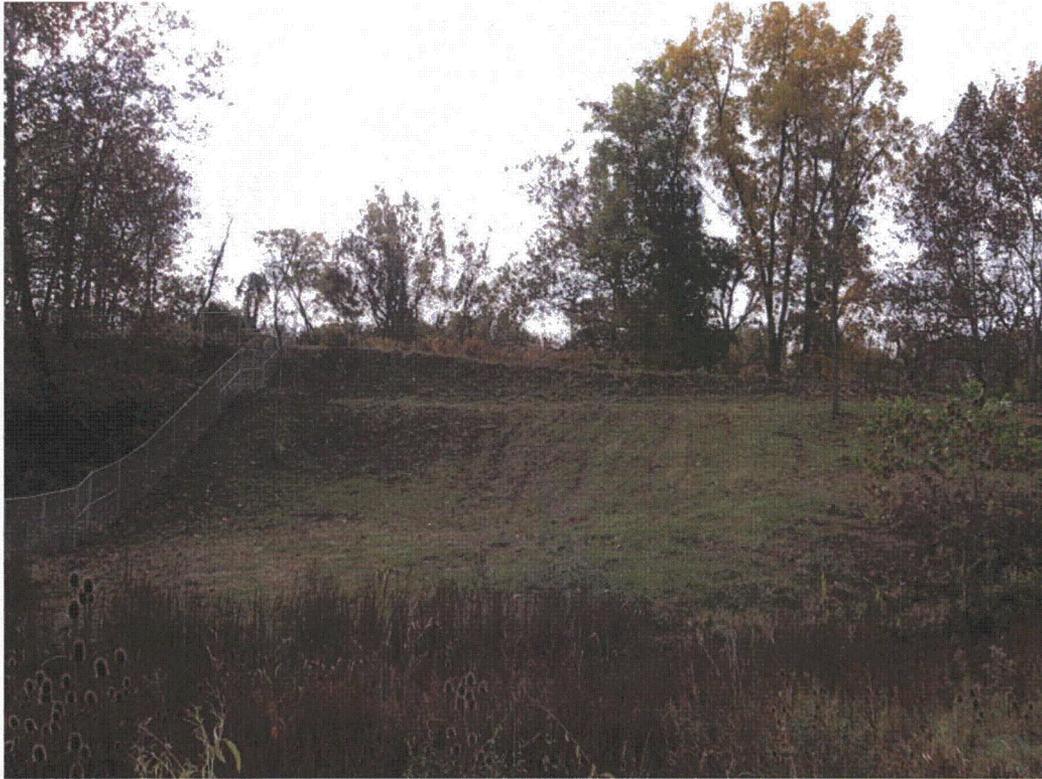
BUR 10/2010. PL-5. Looking south toward seeded slope.

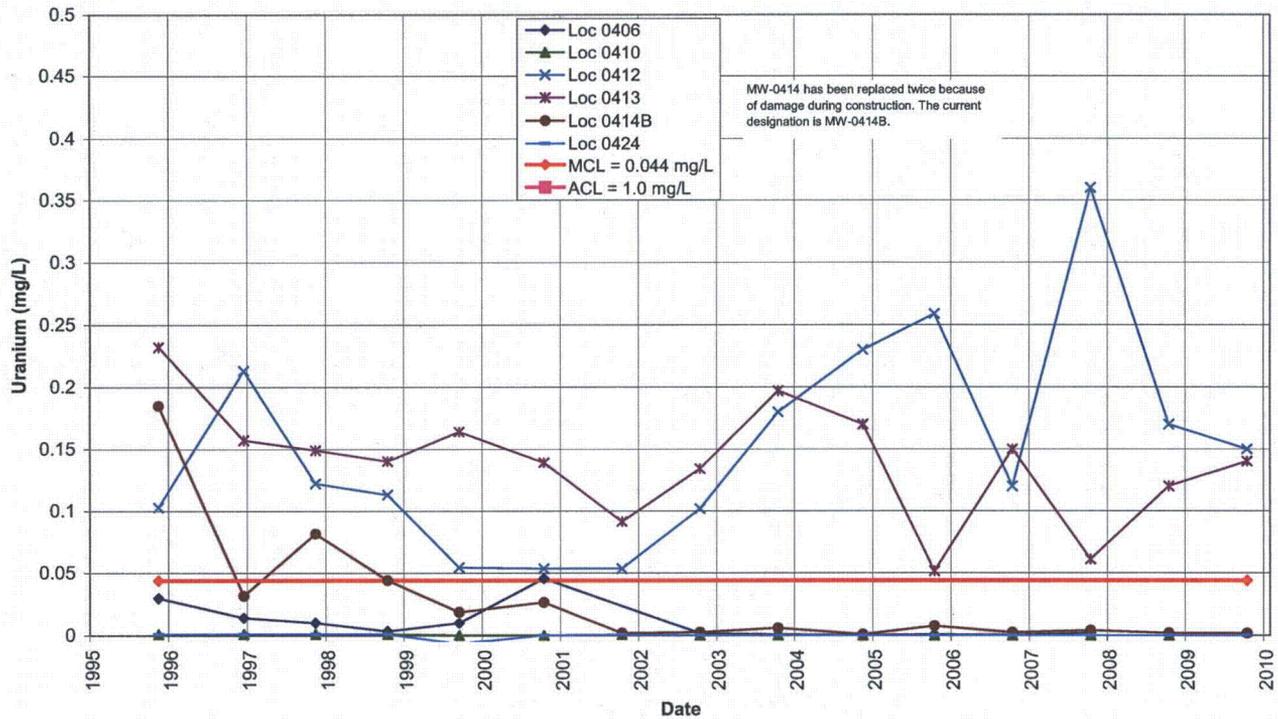
Figure 3–2. Time-Concentration Plot of Uranium in Groundwater at the Canonsburg Disposal Site

Groundwater—Uranium concentrations in 2009 were considerably below the established ACL (Figure 3–2). With the exception of monitoring well MW–0412 and monitoring well MW–0413, uranium concentrations in 2009 were also below the MCL.

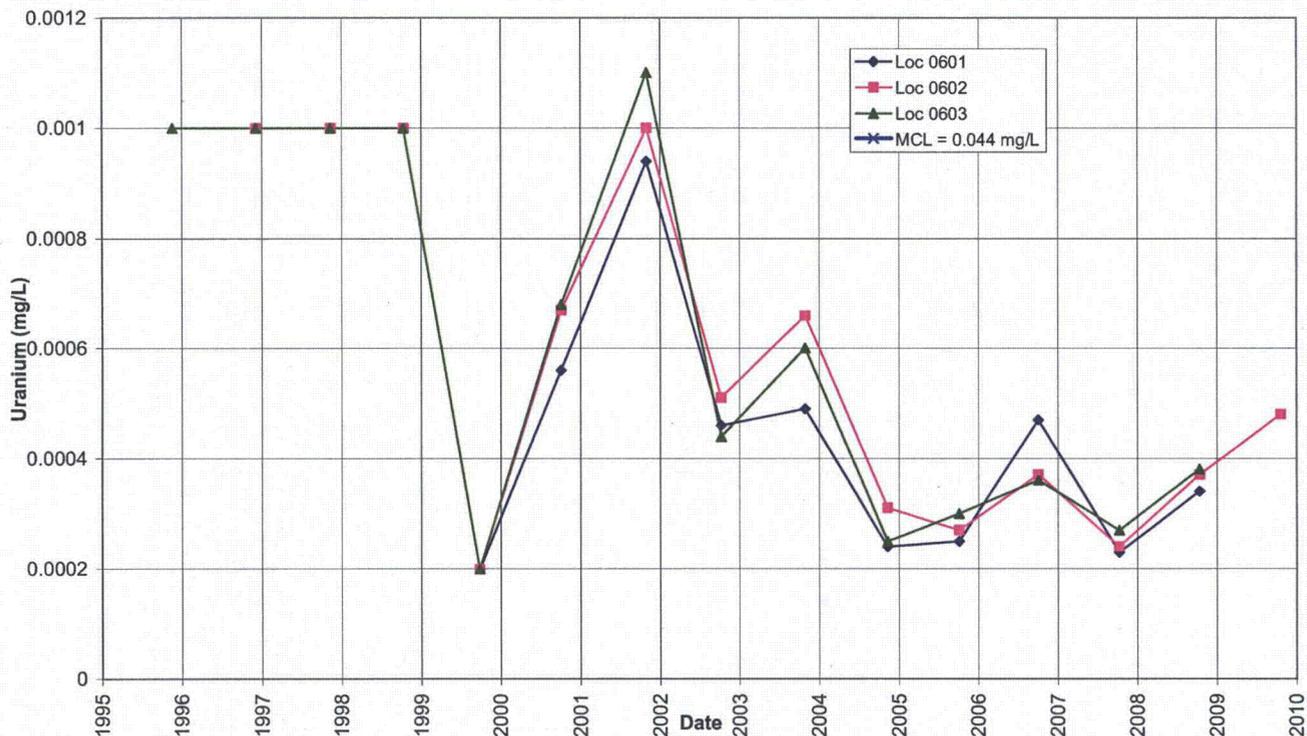
Figure 3-3. Time-Concentration Plot of Uranium in Surface Water at the Canonsburg Disposal Site

Surface Water—Only one surface water location (SW–0602) is sampled under the revised LTSP. The uranium concentration of surface water at location SW–0602 in 2009 remained below the target concentration of 0.01 mg/L (Figure 3–3).

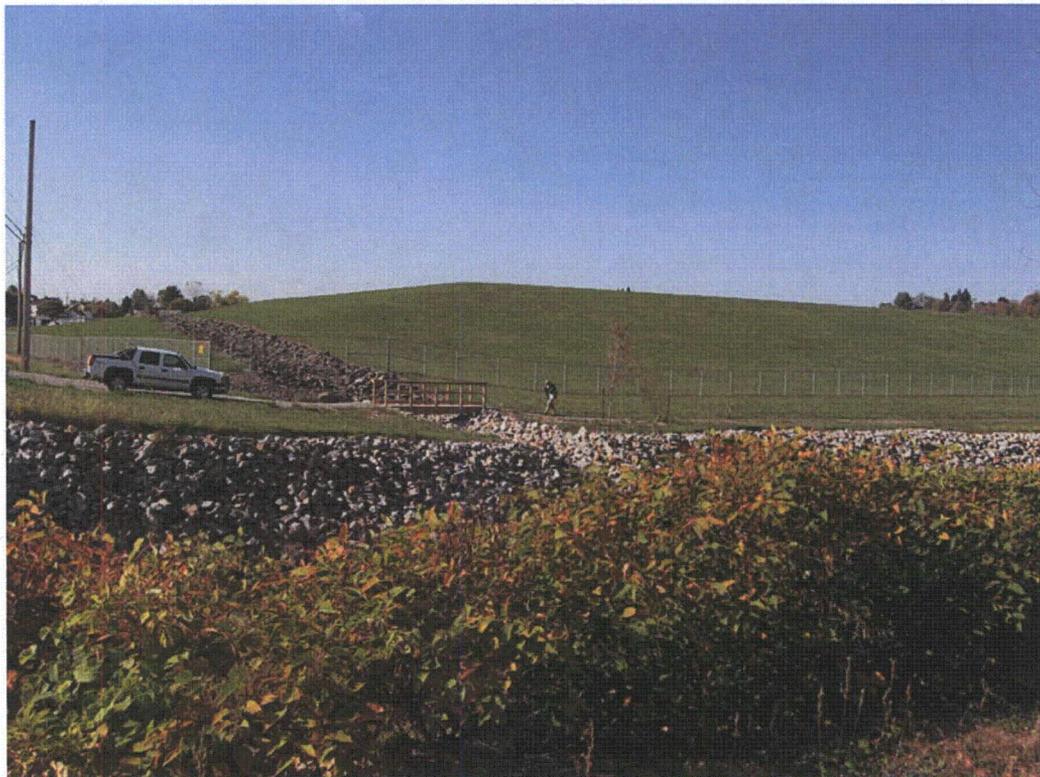
CAN 10/2010. PL-2. Footbridge across a riprap armored diversion ditch.

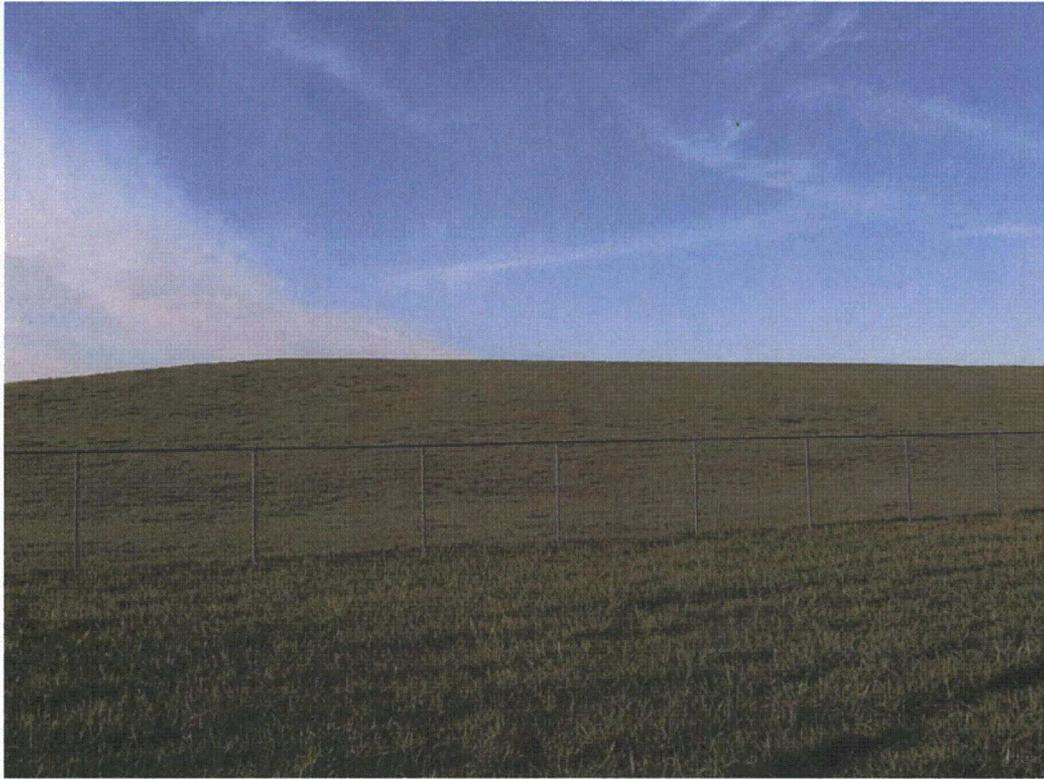
CAN 10/2010. PL-3. North side slope of disposal cell.

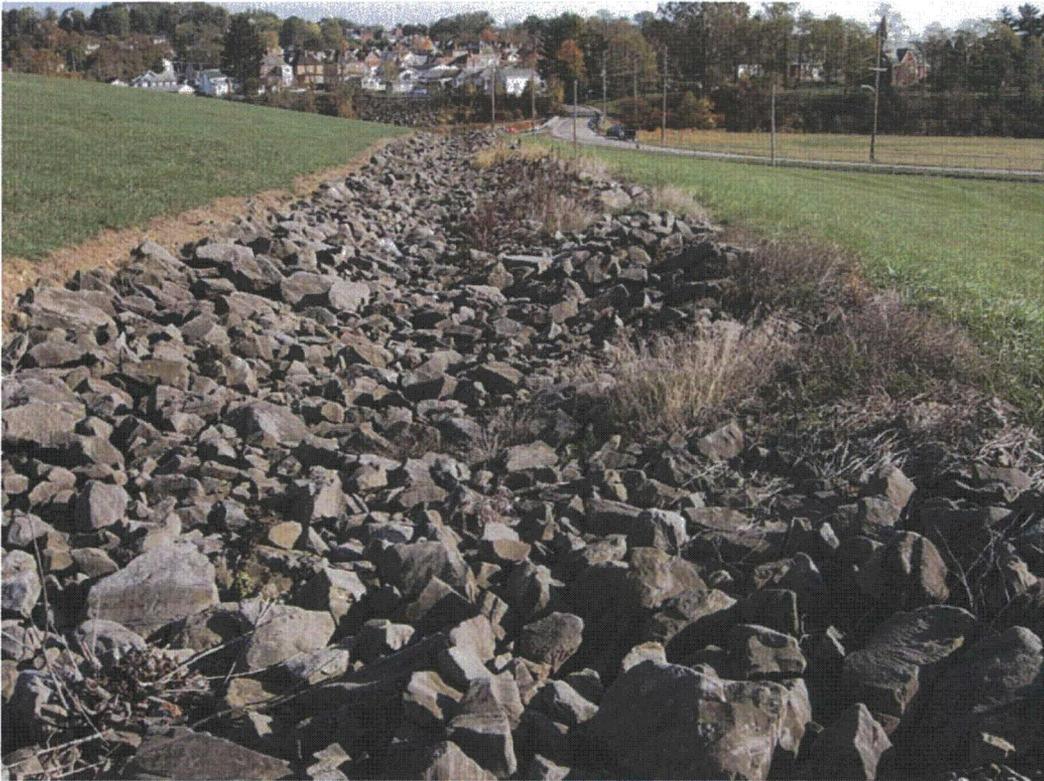
CAN 10/2010. PL-4. Riprap armored diversion ditch.

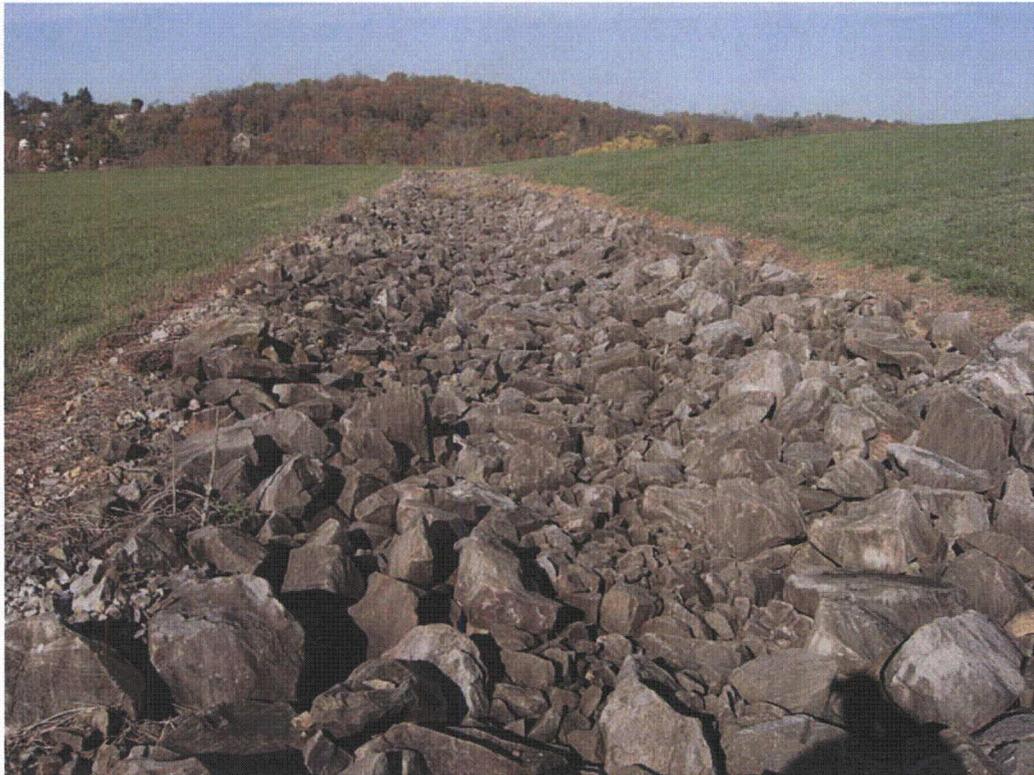
CAN 10/2010. PL-5. Riprap armored diversion ditch.

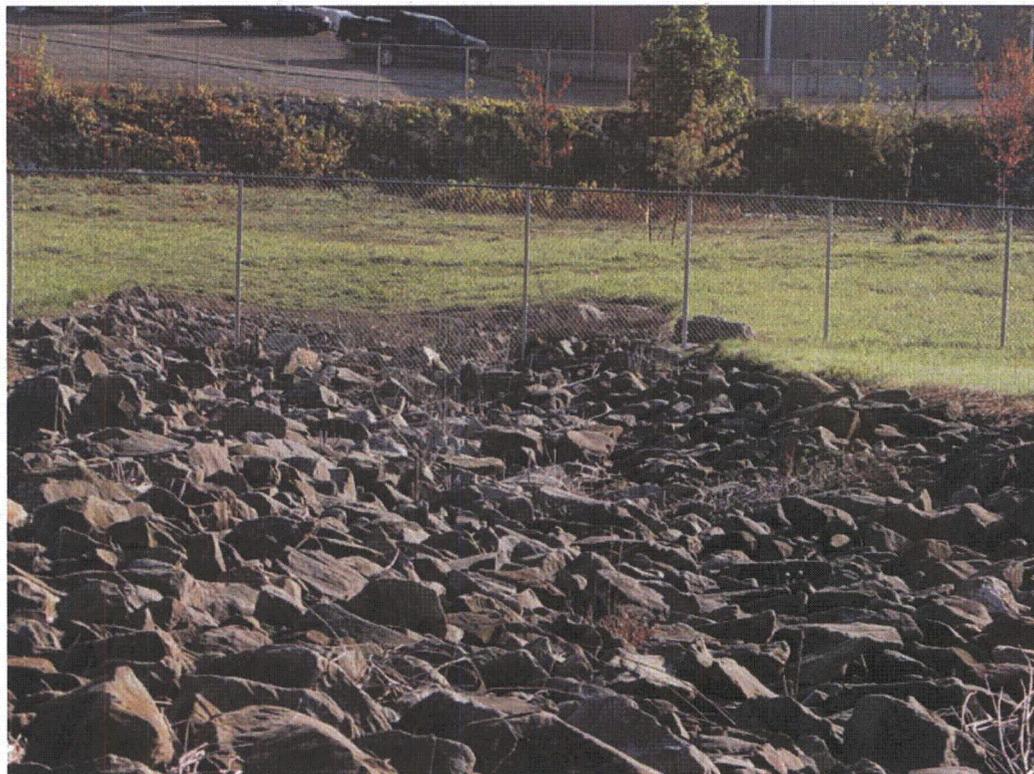
CAN 10/2010. PL-6. Looking down channel of a riprap armored diversion ditch.

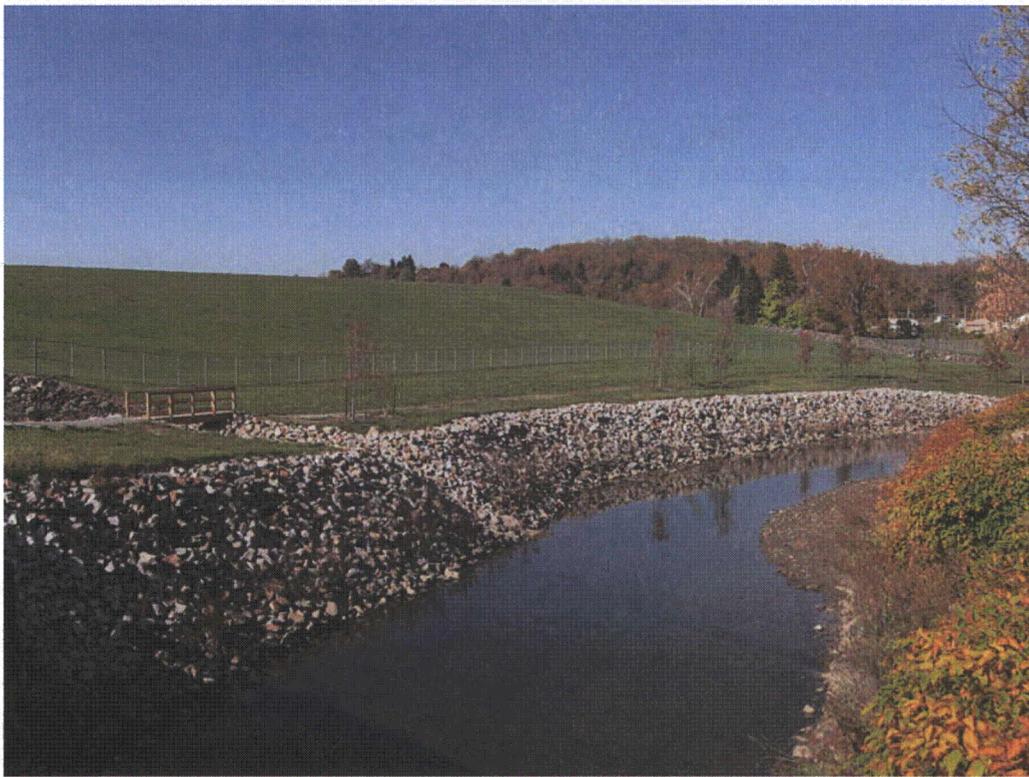
CAN 10/2010. PL-8. Riprap armored stream bank along floodplain area.

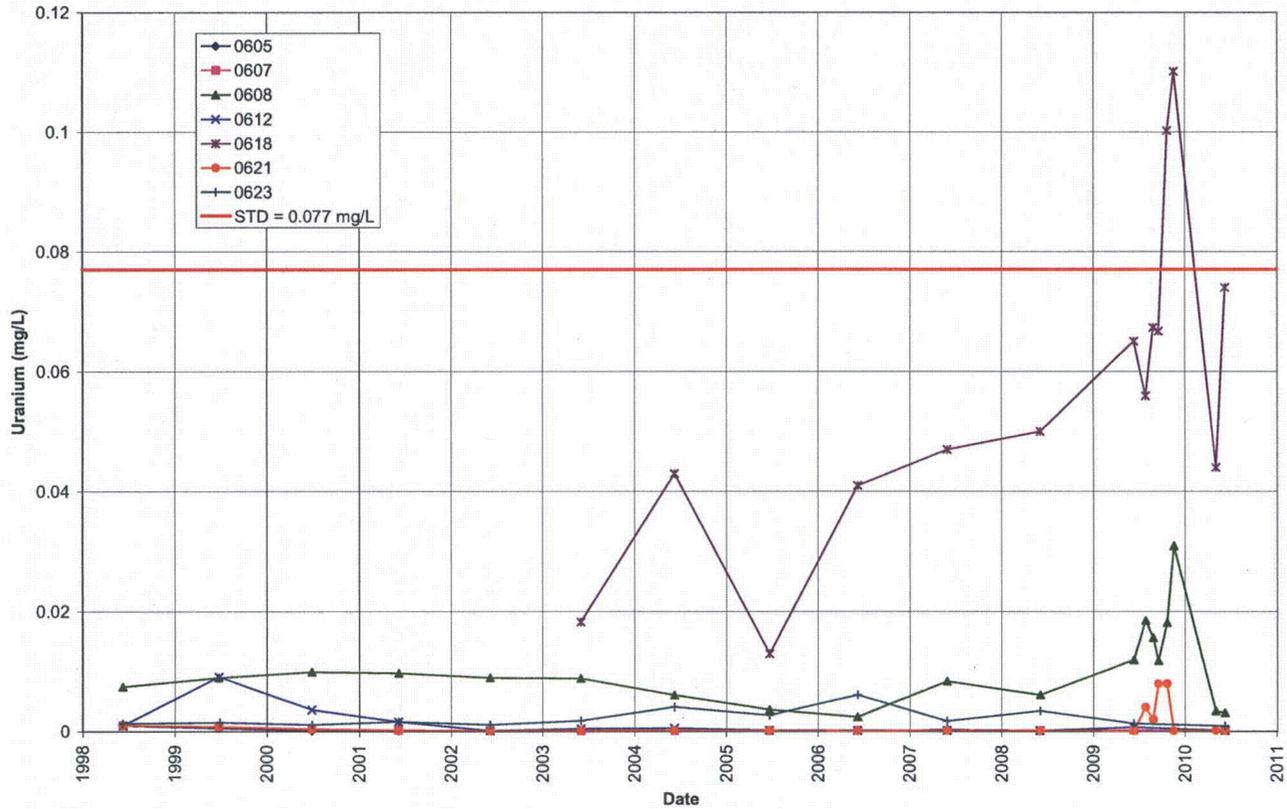
Figure 4-2. Time-Concentration Plot of Uranium in Groundwater at the Durango Disposal Site

Uranium concentrations in monitoring well MW-0618 have decreased since 2009 and are back below the standard though there was an increase observed between the May and June sampling events; concentrations in well MW-0608 decreased and remained consistent between May and June events. Selenium concentrations decreased in both of these wells, and molybdenum remained steady. Analytical results from all other locations are on trend with previous results.

In 2009, the most significant groundwater monitoring result reported was the uranium concentration in well MW-0618. The uranium concentration of 0.11 milligram per liter reported in this well in November 2009 is consistent with the increasing trend that began in 2005, and exceeded site-specific standard of 0.077 mg/L. In fall 2009, well MW-0618 was redeveloped, and the purging method and pump materials were evaluated. The uranium levels have decreased back below the standard in 2010. All other concentrations of uranium, along with all concentrations of both selenium and molybdenum, remain on trend and well below their respective standards.

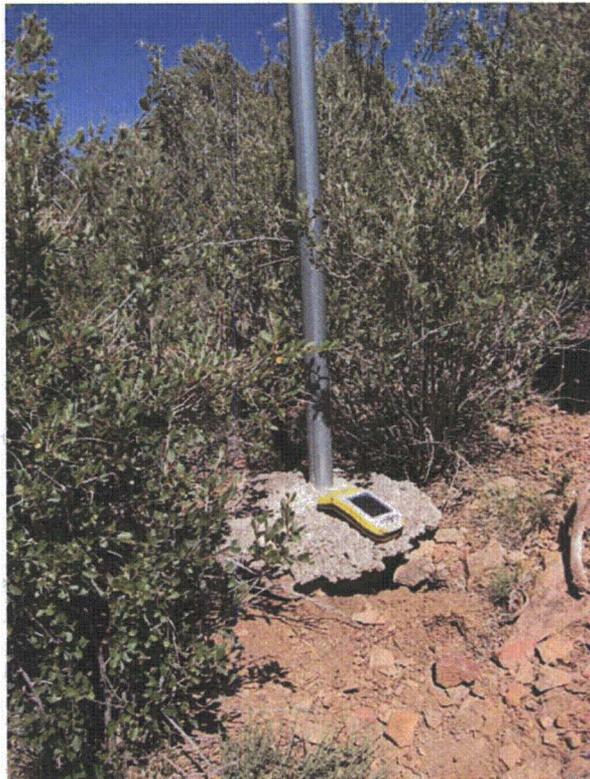
DUR 6/2010. PL-1. Undercutting at perimeter sign P41.

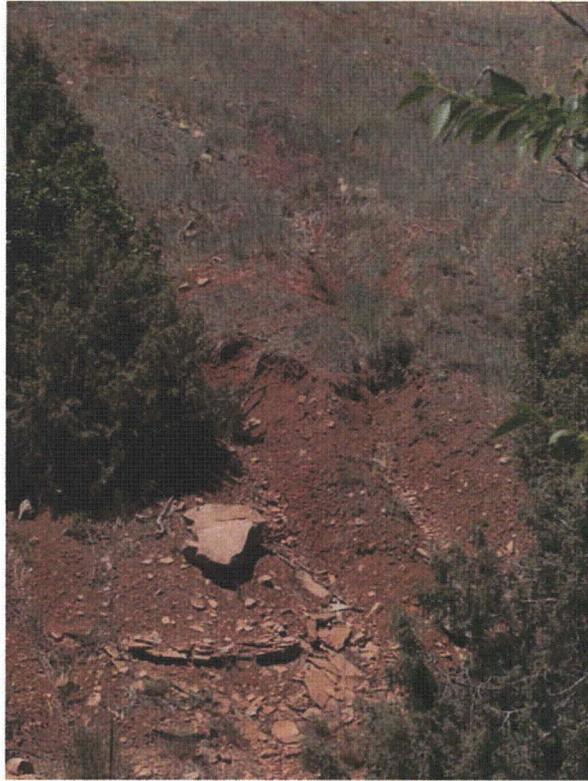
DUR 6/2010. PL-3. Headcuts of gullies below SW corner of disposal cell; no change from 2009

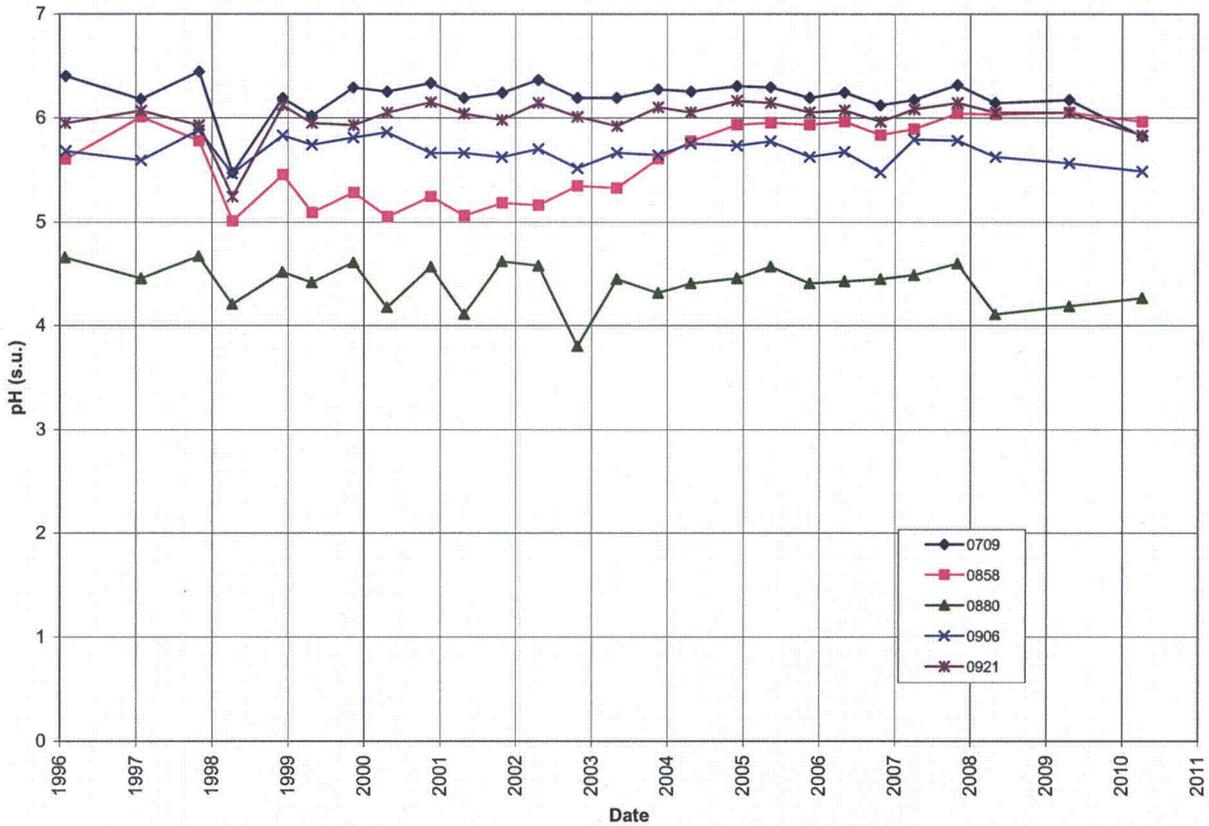
Figure 5-3. pH in Groundwater at Cell Performance Monitoring Locations at the Falls City Disposal Site

At the cell performance monitoring wells, pH levels have historically been higher than the pH in tailings pore fluids, with no significant upward or downward trends. In 2010, the pH levels for the cell performance wells remained within the historical range (Figure 5-3).

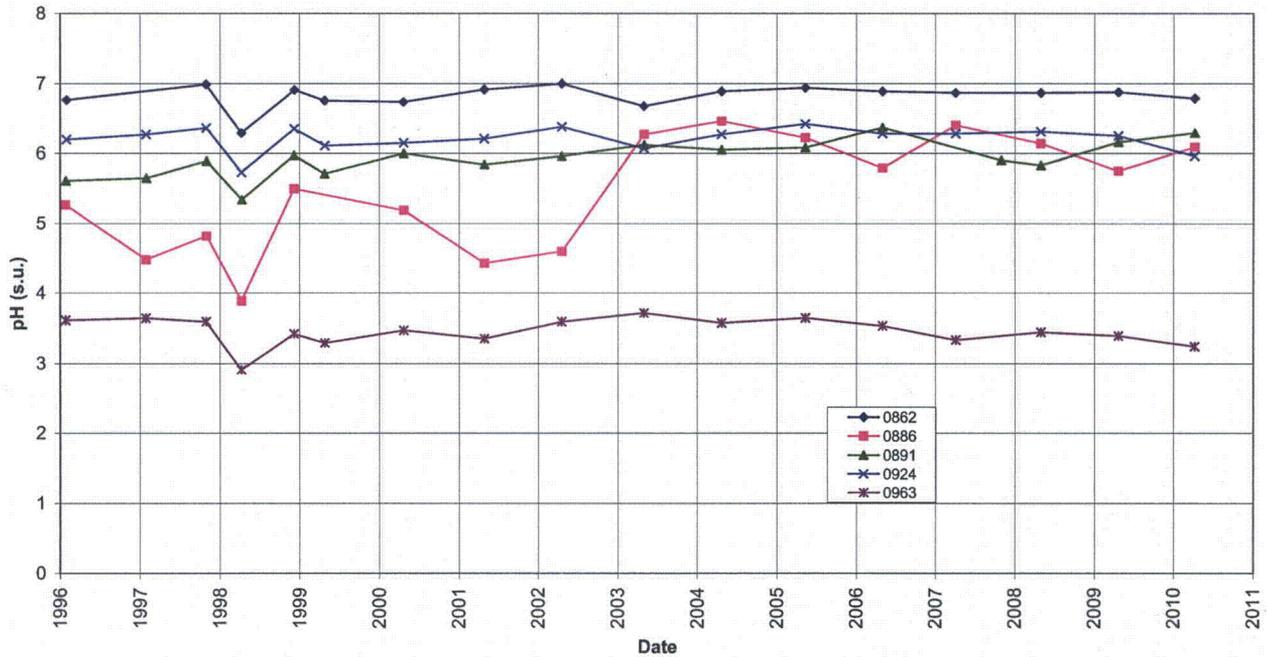
Figure 5-4. pH in Groundwater at Compliance Monitoring Locations at the Falls City Disposal Site

At the groundwater compliance monitoring wells, pH levels have historically been higher than the pH in the plumes of groundwater contaminated by processing activities, with no significant upward or downward trends, except that the pH at MW-0963 has historically been lower than at the other locations. In 2010, the pH levels for the compliance monitoring wells remained within the historical range, with the exception of monitoring well MW-0891. The previous high of 6.12 standard units (s.u.) in 2003 was surpassed in 2006 with a new high of 6.37 s.u. (Figure 5-4).

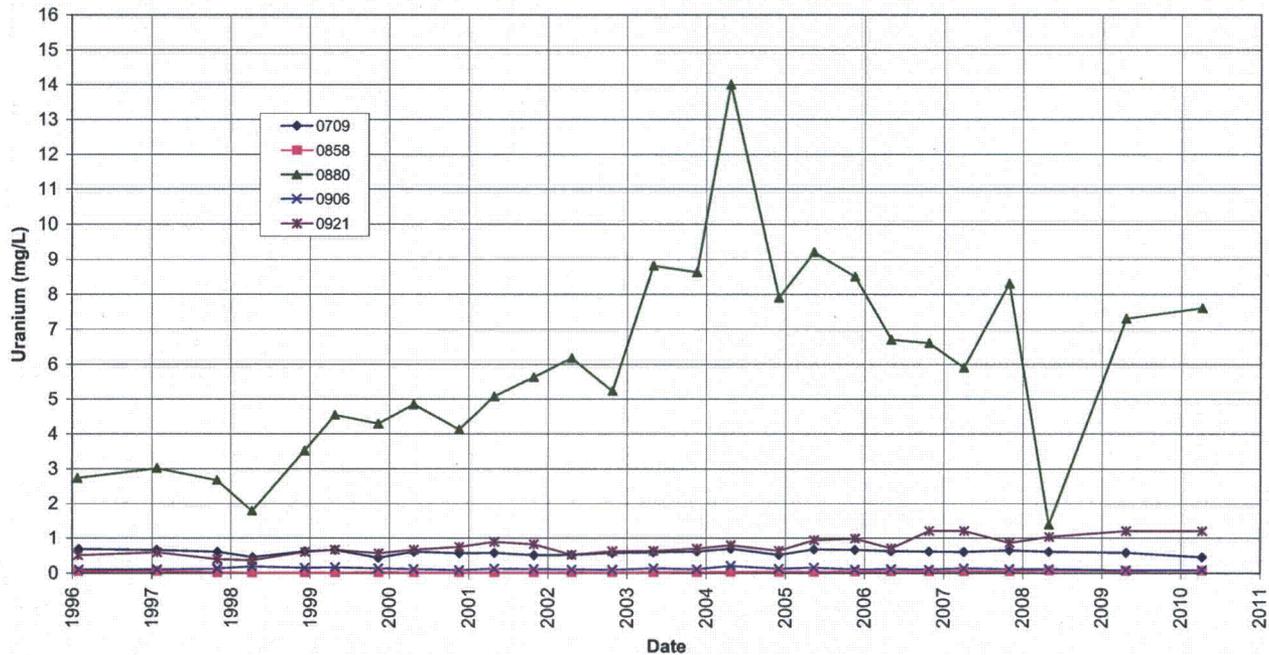
Figure 5-5. Uranium in Groundwater at Cell Performance Monitoring Locations at the Falls City Disposal Site

In 2010, the uranium concentrations in the cell performance network remained relatively stable and within the historical range, approximately 1.2 mg/L or less, with one exception. At well MW-0880, uranium has varied from a low concentration of 1.38 mg/L in 2008 to a high concentration of 14 mg/L in 2004 (Figure 5-5). Over time, the concentration of uranium in this well has been variable and, until 2008, substantially greater than the uranium concentrations at the other cell performance wells. The pH at this location is lower than and has varied more than at other locations in the cell performance monitoring network (Figure 5-3). Water levels are also generally falling at MW-0880 (see the following section, "Groundwater Level Monitoring Results"). These results suggest that the interaction between the disposal cell, the legacy groundwater mound, and processing plumes is still equilibrating. However, monitoring results do not indicate the disposal cell is contributing to degradation of the uppermost aquifer. Because the groundwater in the uppermost aquifer is not used as a potable water source near the Falls City site, the site remains protective.

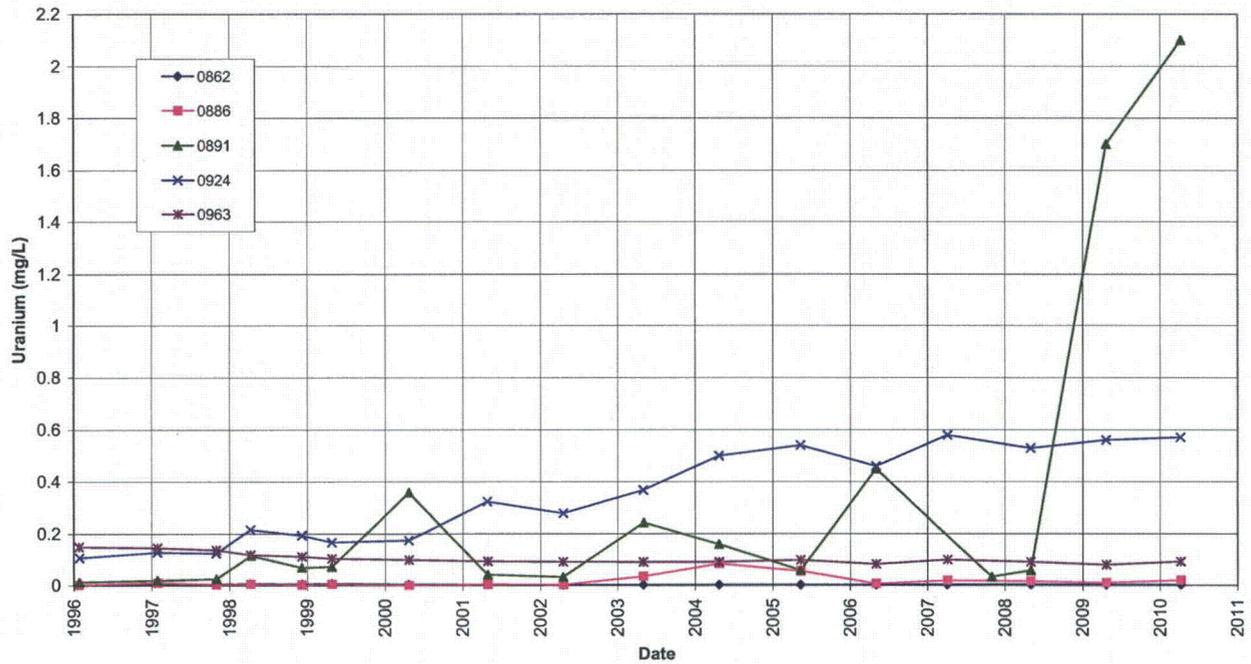
Figure 5-6. Uranium in Groundwater at Compliance Monitoring Locations at the Falls City Disposal Site

The concentration of uranium in groundwater within the compliance monitoring network shows that the uranium concentration trends at monitoring wells MW-0862, MW-0886, and MW-0963 remain stable at low levels (<0.2 mg/L) (Figure 5-6). The increasing uranium concentration trend at well MW-0924 appears to be leveling off between 0.5 mg/L and 0.6 mg/L. The uranium concentration measured at well MW-0891 in 2009 (1.7 mg/L) and 2010 (2.1 mg/L) are anomalously high compared to historical measurements at the well, but not for the aquifer.

The new maximum uranium concentration measured at monitoring well MW-0891 in 2010 (2.1 mg/L) is below the maximum concentration reported for the aquifer, which is also the value used in the risk assessment for the Dilworth groundwater (3.04 mg/L). Since the 2010 measured groundwater concentrations are within historical ranges for the aquifer, there is no evidence that legacy contaminated groundwater contamination is degrading downgradient groundwater.

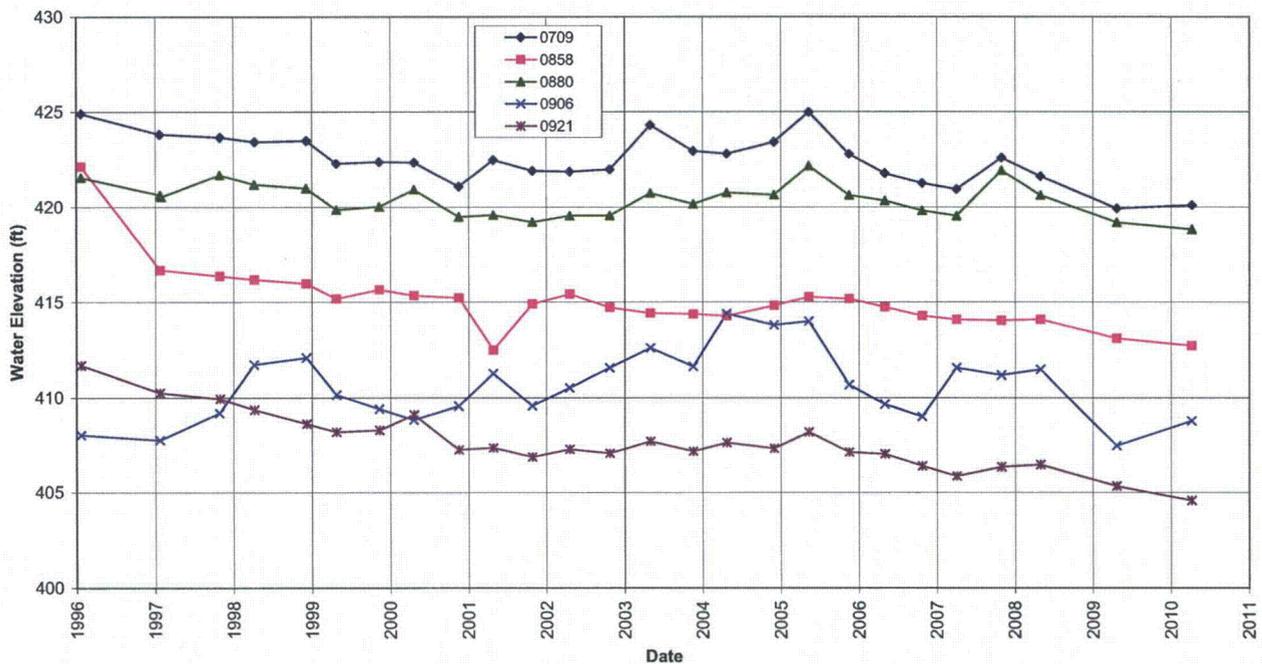
Figure 5-7. Water-Level Measurements at Cell Performance Monitoring Locations at the Falls City Disposal Site

Groundwater-Level Monitoring Results—Water levels measured in 2010 in the disposal cell performance network were consistent with previous measured levels (Figure 5-7). Since 1996, groundwater levels in the disposal cell performance network wells have slightly fallen. The water level in monitoring well MW-0906 has fluctuated more than the other wells over the years. Monitoring well MW-0906 is directly down slope of the disposal cell, and the historical fluctuation may be the result of the infiltration of water shed by and conveyed away from the disposal cell, reflecting variations in annual precipitation. Other contributors that may influence local groundwater levels include (1) the dissipation of the processing-site-related groundwater mound beneath the disposal cell, and (2) the dissipation of transient drainage from the disposal cell.

Two cell performance monitoring wells, MW-0908 and MW-0916, are not shown in Figure 5-7. These wells, designated for groundwater-level monitoring only, are completed in the unsaturated zone of the Conquista Sandstone and have been dry since 1996.
