2010 Annual Site Inspection and Monitoring Report for Uranium Mill Tailings Radiation Control Act Title I Disposal Sites

January 2011

LMS/S06929

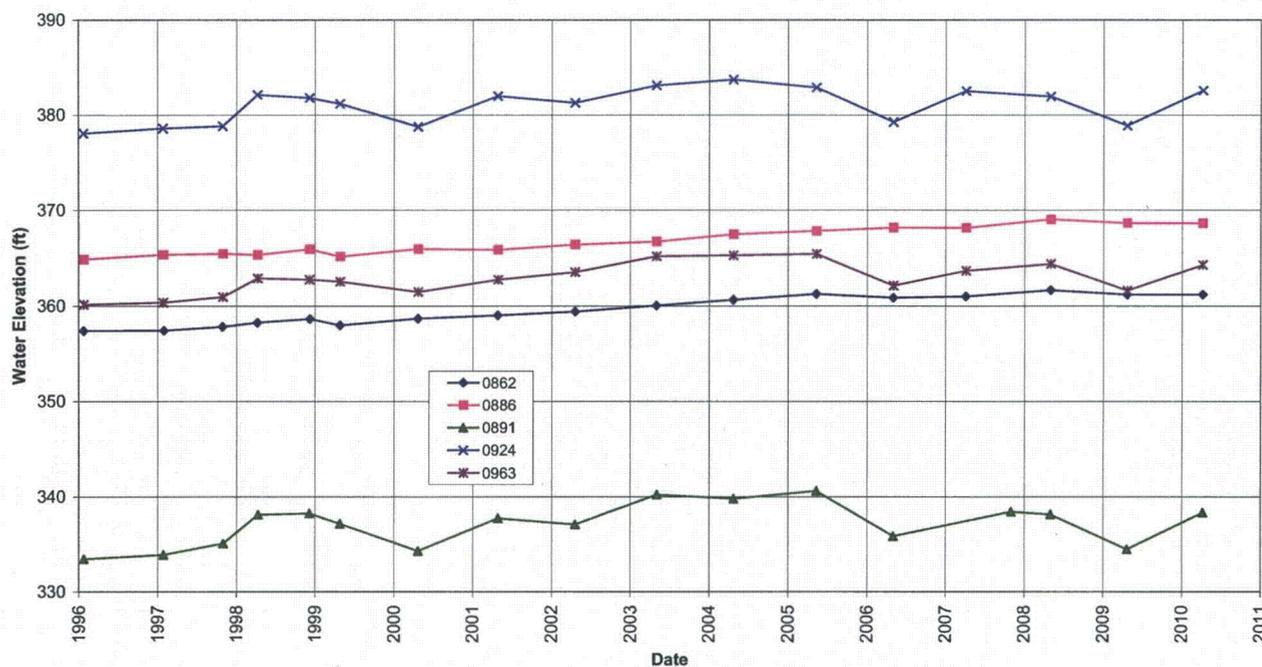
Figure 5–8. Water-Level Measurements at Compliance Monitoring Locations at the Falls City Disposal Site

In contrast, water levels in the groundwater compliance monitoring network wells have all increased slightly between 1996 and 2010 (Figure 5–8).

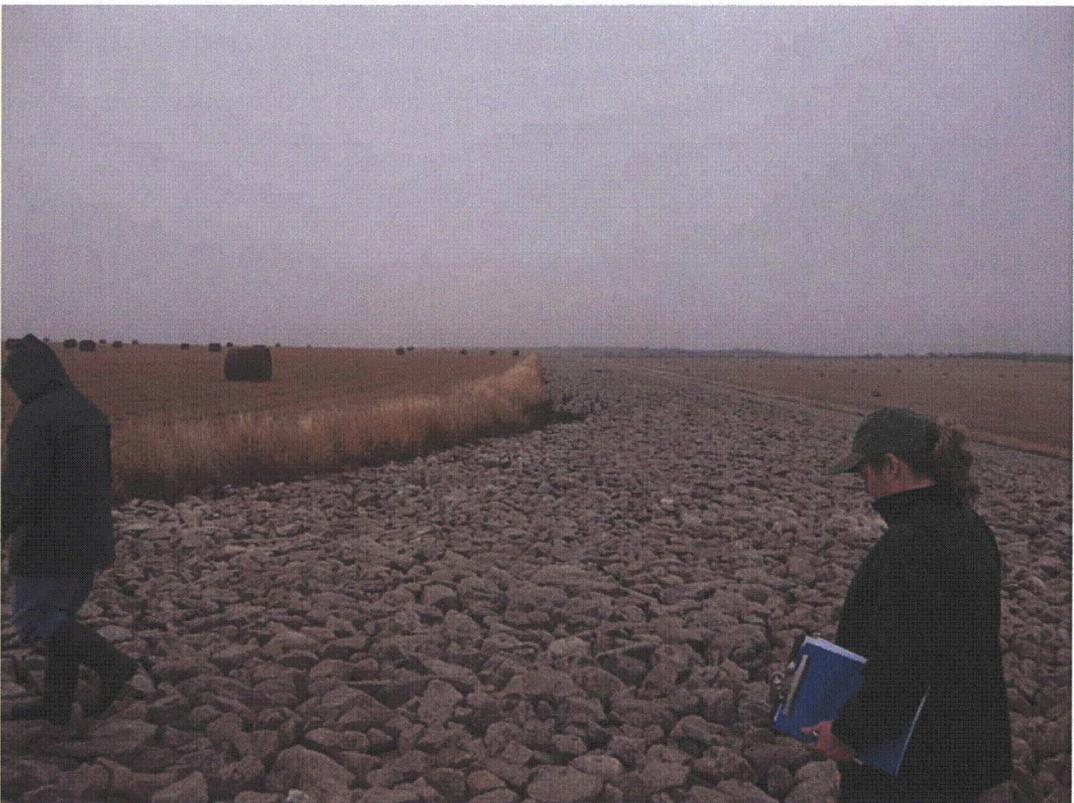
FCT 1/2010. PL-2. Top of north corner of disposal cell.

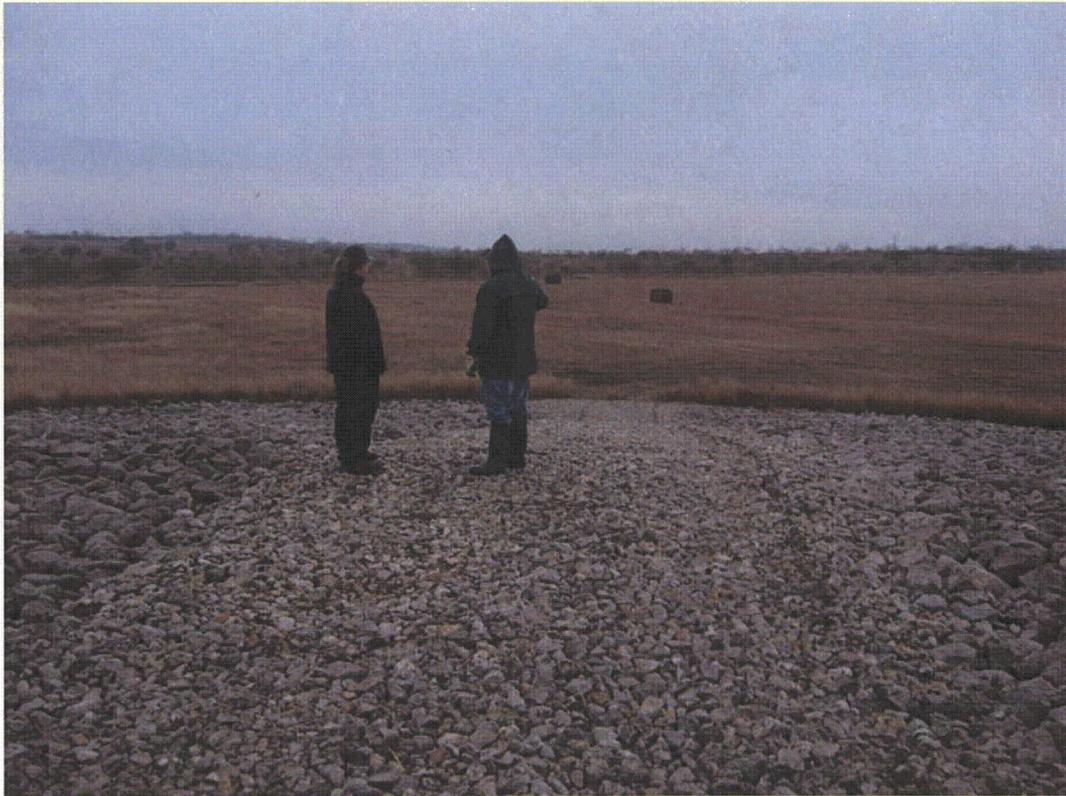
FCT 1/2010. PL-5. Base of aggregate ramp installed in 2006.

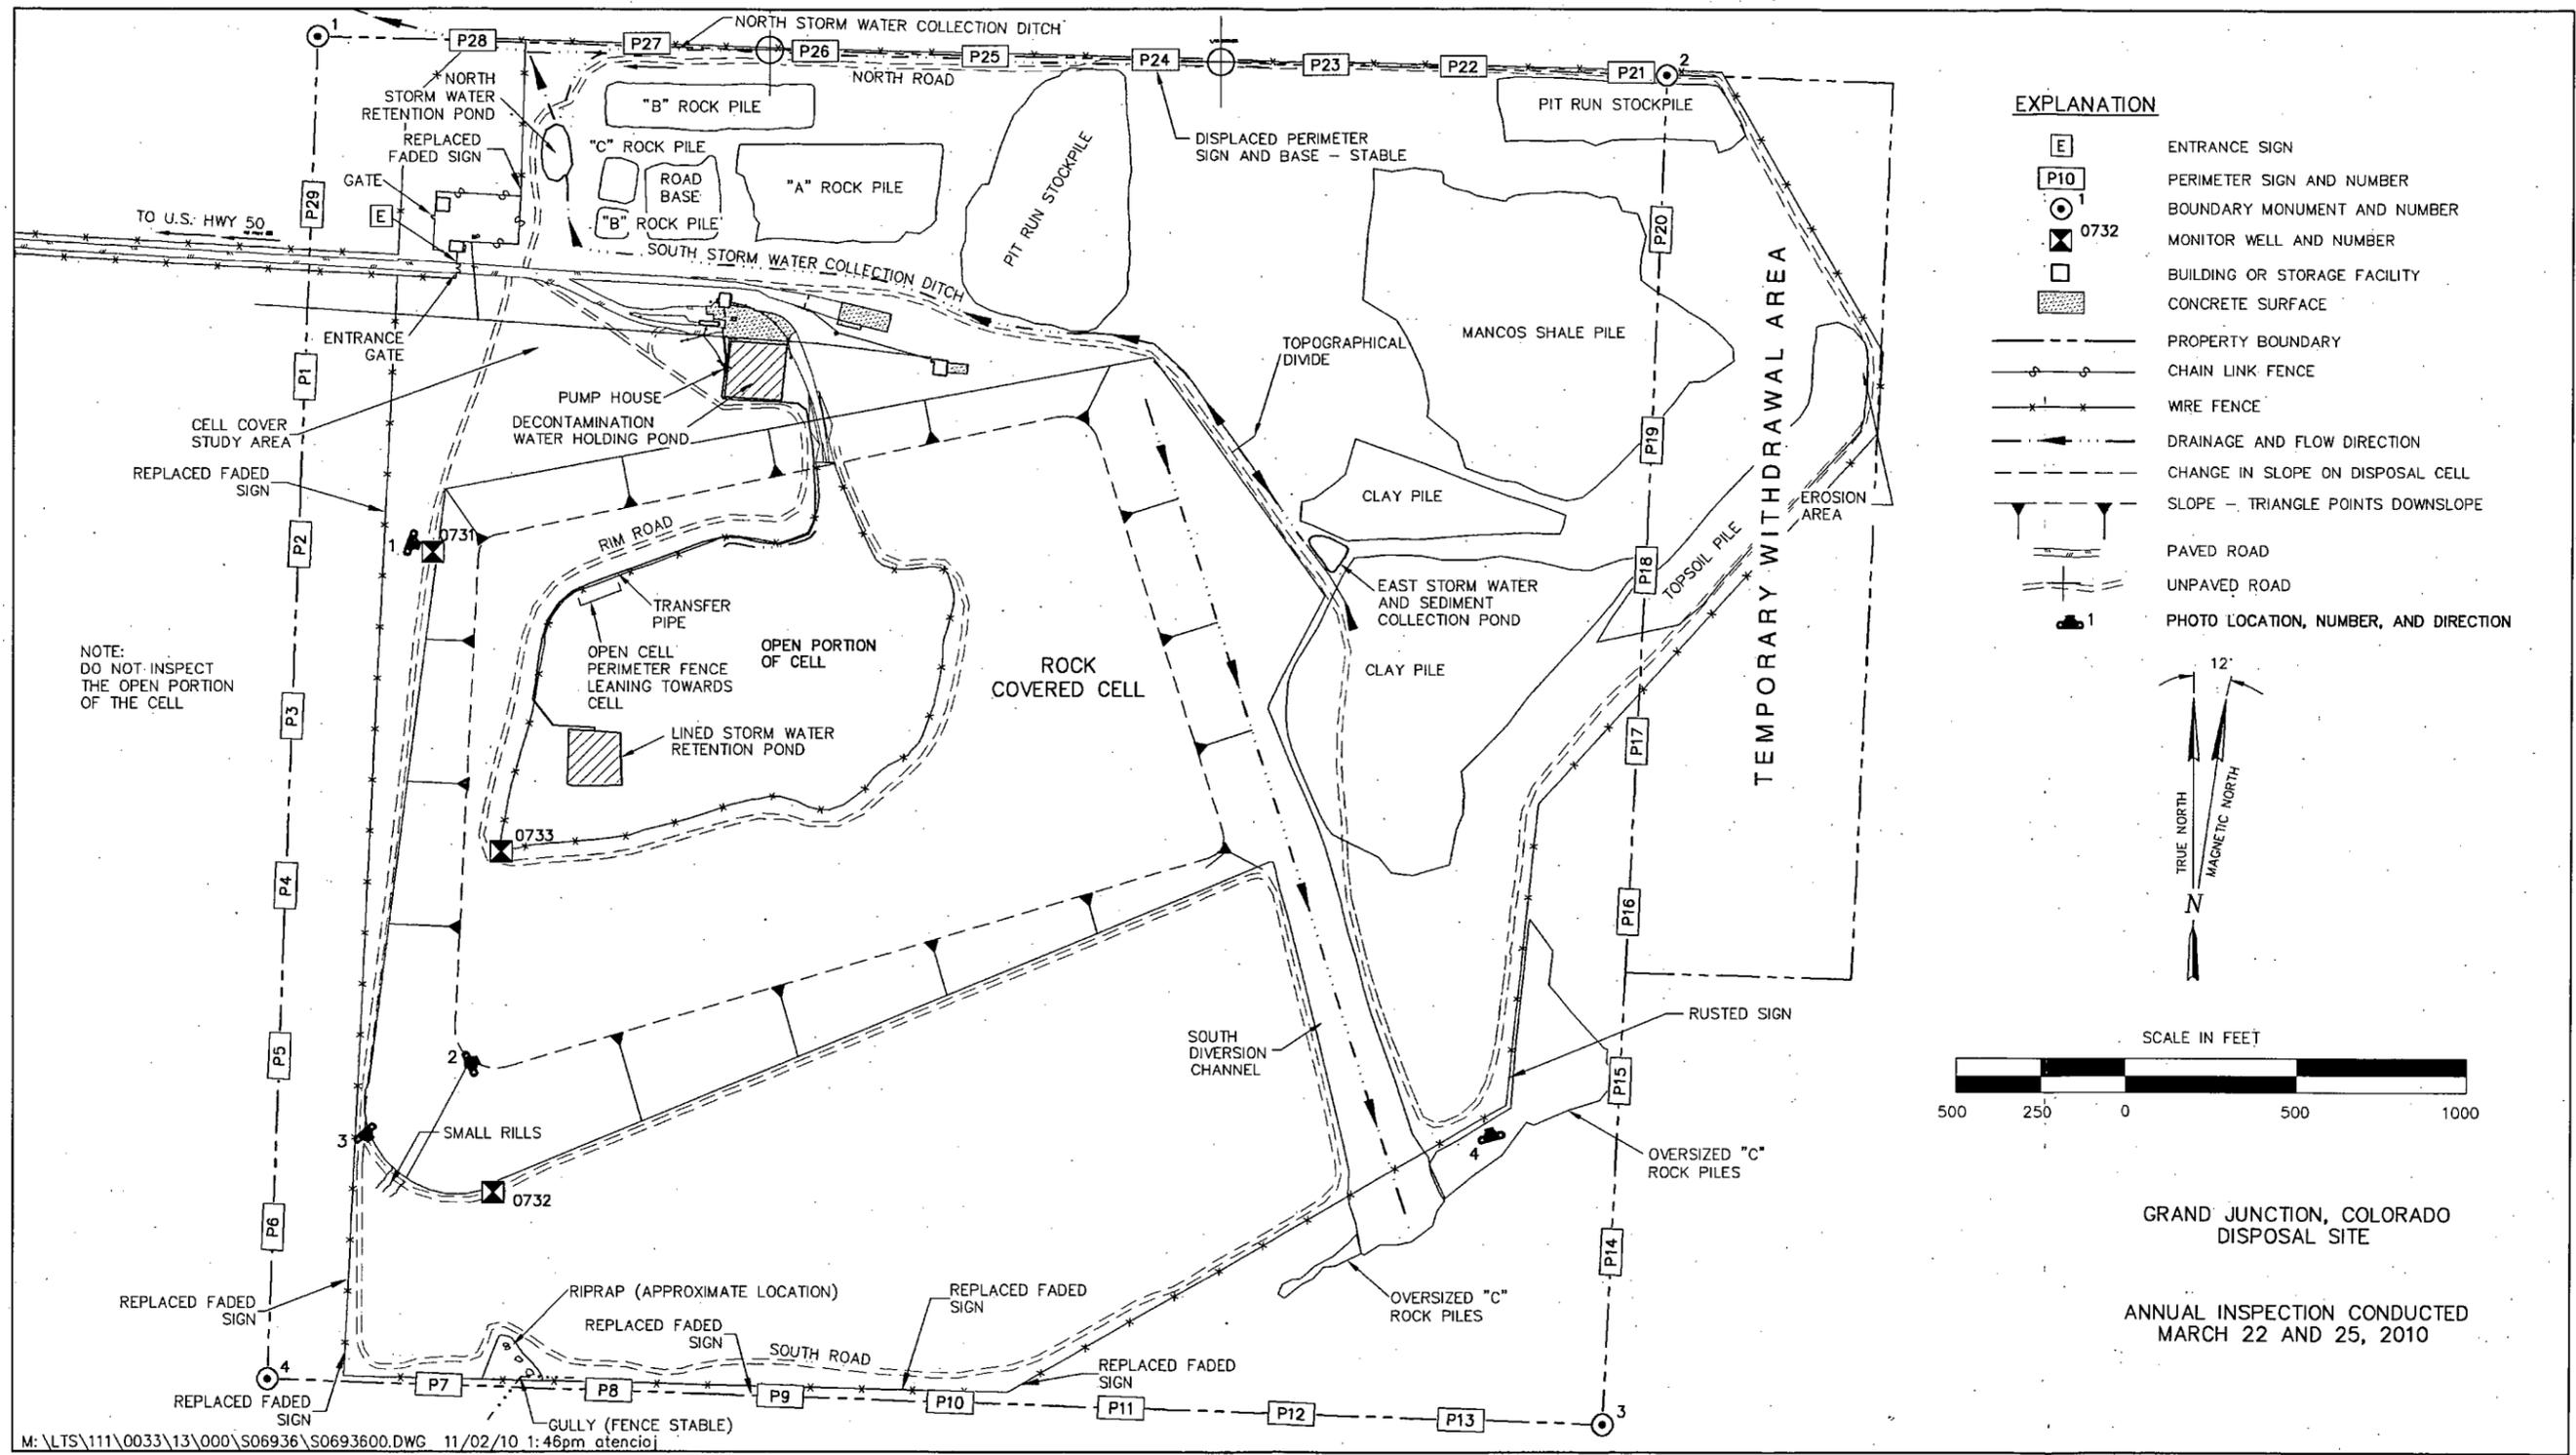
Figure 6-1. 2010 Annual Compliance Drawing for the Grand Junction Disposal Site

Additional warning signs are posted on the wire perimeter fence and are associated with the operation of the open cell. Metal controlled-area signs and yellow plastic no-trespassing signs are secured to the fence in pairs. There are 75 warning signs, each about 200 feet apart along the site boundary. Several “Controlled Area” signs are substantially faded or rusted and were replaced in 2010.

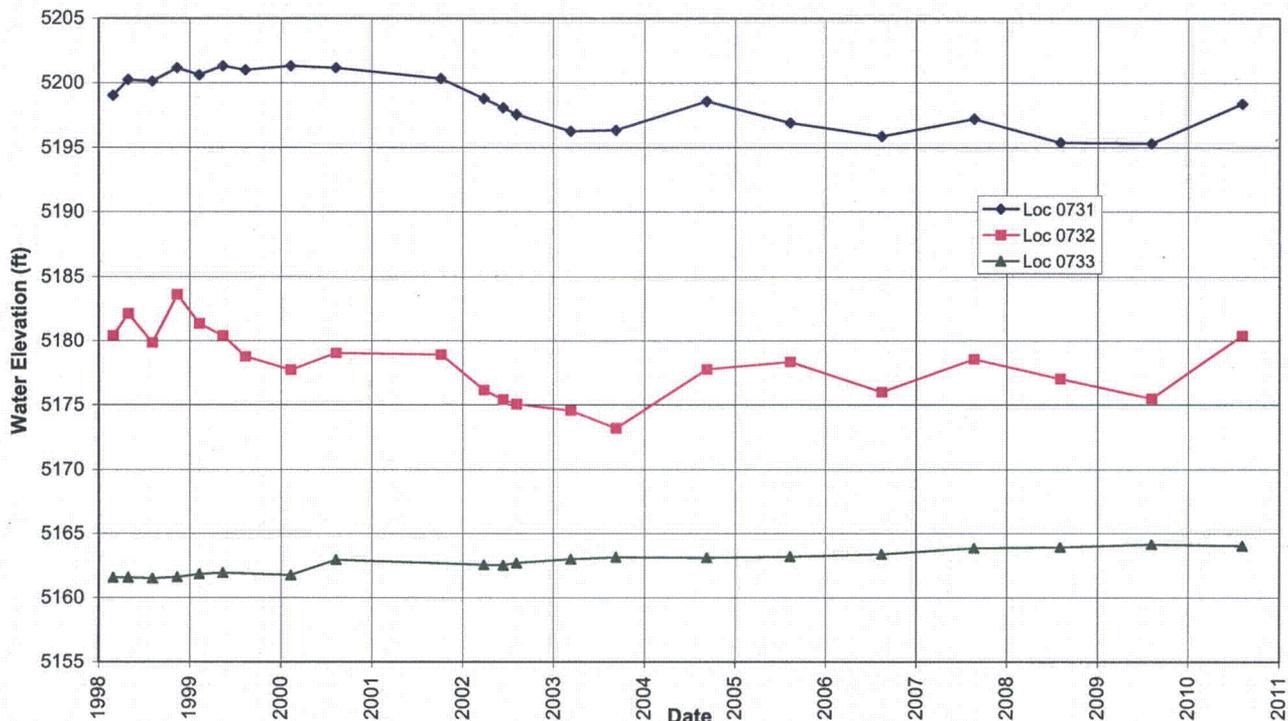
Figure 6-2. Water-Level Measurements at the Grand Junction Disposal Site

Since 1998, the water level in disposal cell well MW-0733 has risen approximately 2.5 feet and has remained significantly lower than the water levels in the two paleochannels wells (MW-0731 and MW-0732) (Figure 6-2). Water levels within the two paleochannels at wells MW-0731 and MW-0732 are approximately equal to 1998 levels. The trends for wells MW-0731 and MW-0732 has been a slightly decreasing trend with level fluctuations that range from 2 ft to 5 ft. Given these elevations, groundwater at the base of the disposal cell at well MW-0733 has no potential to migrate to the paleochannels at wells MW-0731 and MW-0732.

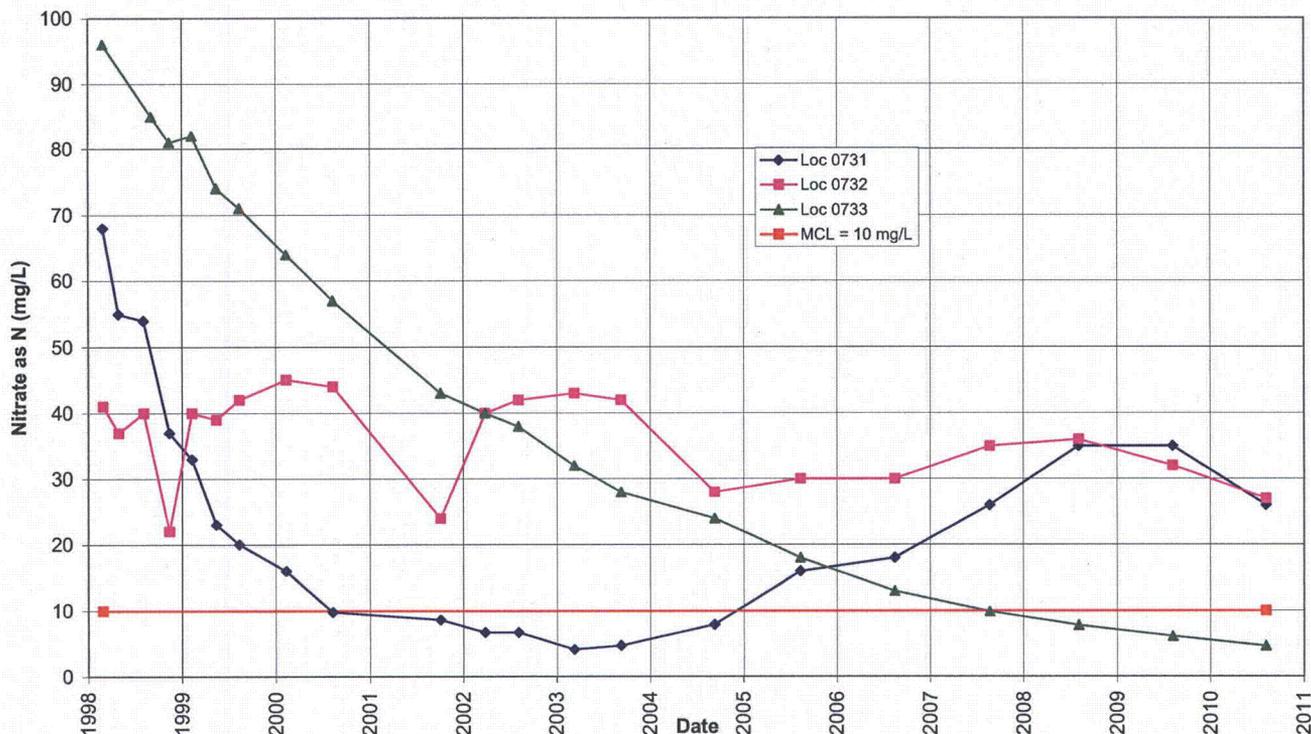
Figure 6-3. Time-Concentration Plots of Nitrate (as Nitrogen) in Groundwater at the Grand Junction Disposal Site

Nitrate (as nitrogen) concentrations in groundwater continued to exceed the MCL of 10 mg/L in the paleochannel monitoring wells (MW-0731 and MW-0732) through 2010 (Figure 6-3). Concentrations in well MW-0731, following an initial steep downward trend, remained below the MCL from 2000 through 2004. In 2005, and continuing through 2010 concentrations steadily increased and remain above the MCL. Concentrations in well MW-0732, though varied, have consistently remained above the MCL since 1998. Concentrations in well MW-0733 continued a

significant downward trend, dropping below the MCL in 2006, and reaching a low of 4.6 mg/L in 2010. Historically, the highest concentration of nitrate (96 mg/L) occurred in 1998 from disposal cell well MW-0733. In 2010, the concentration of nitrate has decreased and is very close in range for both paleochannel monitoring wells with 26 mg/L in MW-0731 and 27 mg/L in MW-0732.

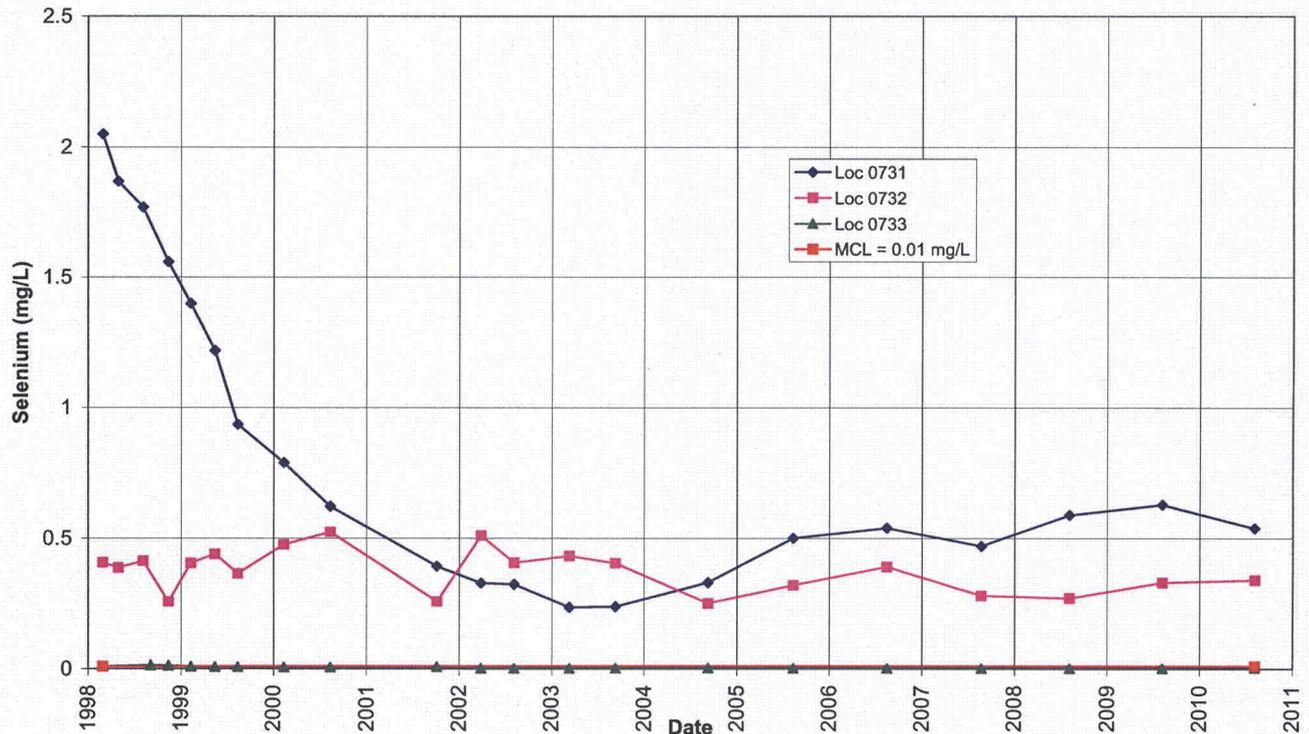
Figure 6-4. Time-Concentration Plots of Selenium in Groundwater at the Grand Junction Disposal Site

Selenium occurs naturally in the Mancos Shale deposits that underlie the disposal cell, and may be the cause of the elevated concentrations reported in both paleochannel monitoring wells (MW-0731 and MW-0732). Selenium concentrations continued to exceed the MCL of 0.01 mg/L in the paleochannel wells (Figure 6-4). Concentrations in well MW-0731 displayed a sharp decreasing trend, and the decreasing trend continued until 2003, when a slight upward trend began. In 2010, selenium concentrations in well MW-0731 have decreased slightly. Concentrations in well MW-0732 continue to display no trend. In well MW-0733, the selenium concentration of 0.0028 mg/L remained well below the standard, with no trend evident. In 2010, the highest concentration of selenium, 0.54 mg/L, occurred in paleochannel well MW-0731.

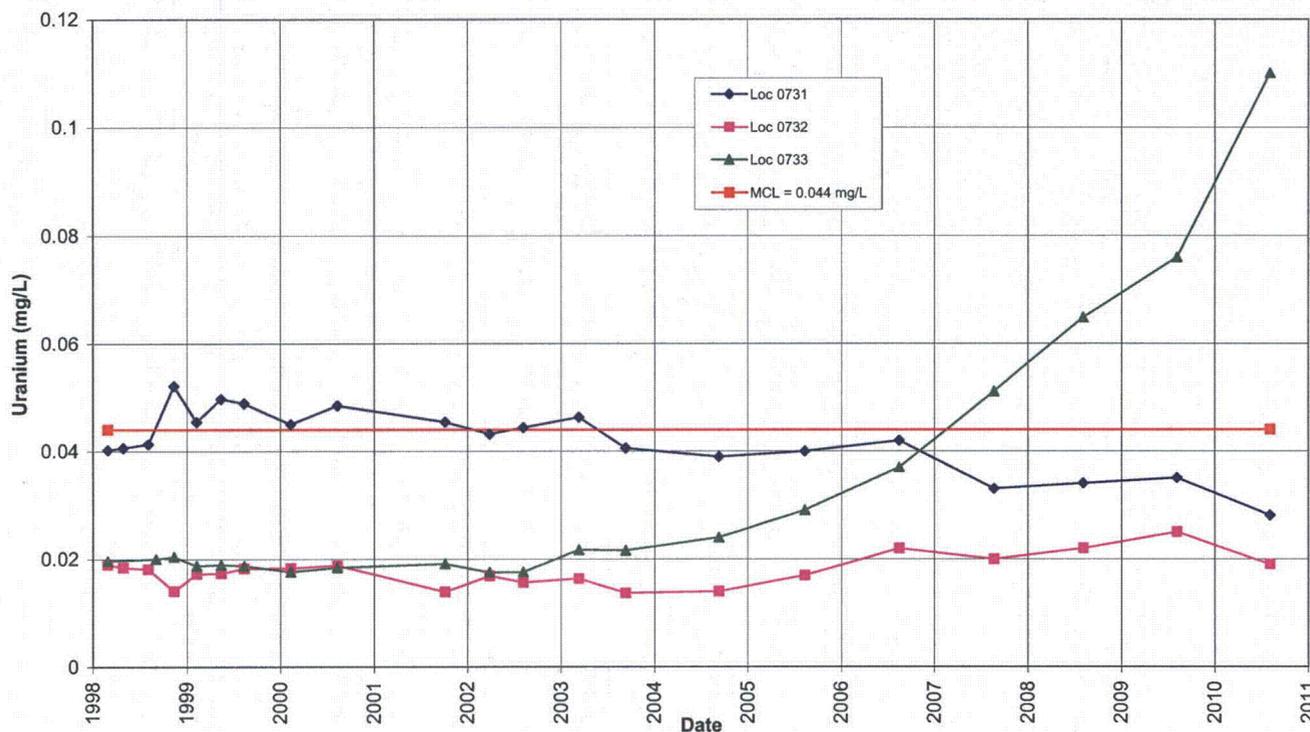
Figure 6-5. Time-Concentration Plots of Uranium in Groundwater at the Grand Junction Disposal Site

Uranium concentrations in groundwater were below the MCL of 0.044 mg/L in samples from paleochannel wells MW-0731 and MW-0732, but were above the MCL in well MW-0733 (0.11 mg/L) for the fourth consecutive time (Figure 6-5). Concentrations in well MW-0731, after an initial increase above the MCL, have displayed a decreasing trend that continued in 2010. Concentrations in wells MW-0732 and MW-0733 remained relatively consistent through 2003, at which time an upward trend began in both wells; the upward trend continues in well MW-0733 and has leveled off in MW-0732.

The elevated uranium in well MW-0733 poses no risk to human health or the environment because the disposal cell is situated on a thick aquiclude overlying “limited use” groundwater that is not for any purpose.

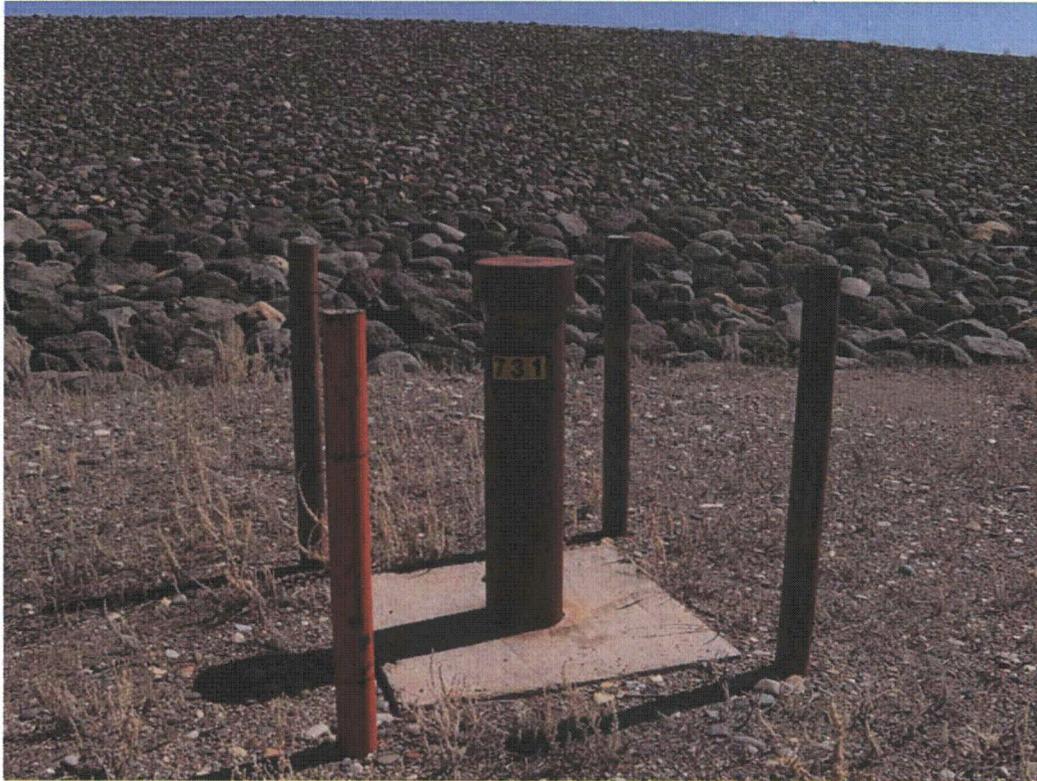
Monitoring wells—The groundwater monitoring network consists of three monitoring wells. All three are inside the site boundary. The wells were secure and in excellent condition (PL-1).

GRJ 3/2010. PL-1. Monitoring well 0731.

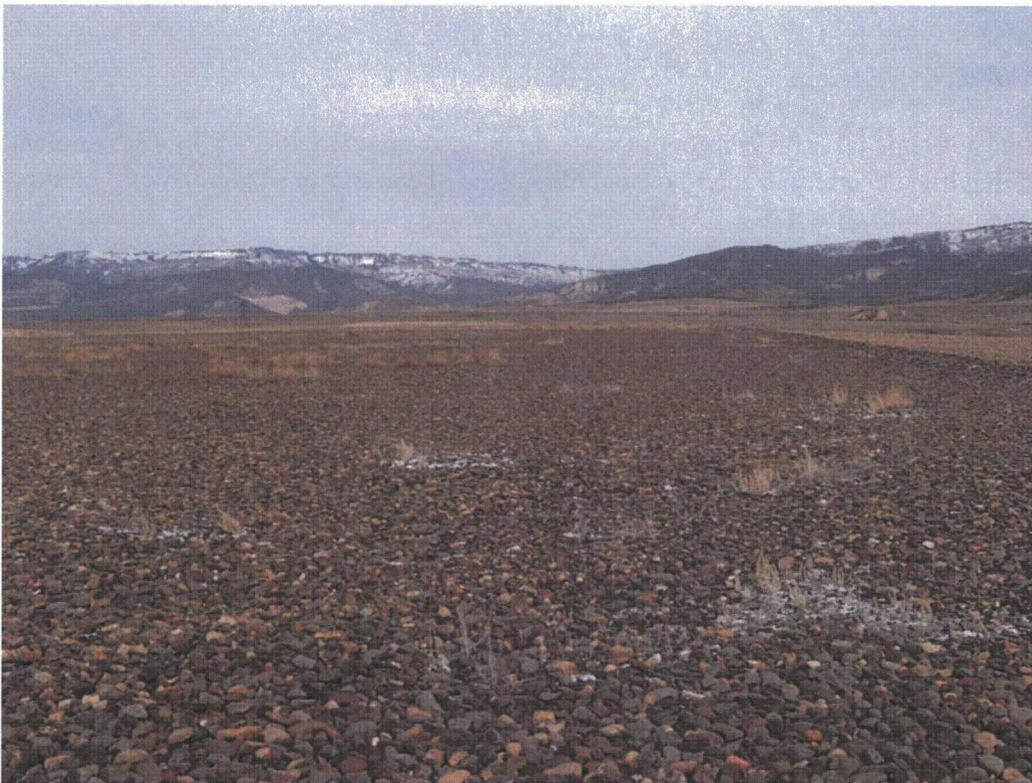
Closed Portion of the Disposal Cell—Basalt riprap covers the top and side slopes of the disposal cell. The rock is durable and in excellent condition. There is no evidence of slope instability, and very little plant encroachment is occurring on the side slopes. The cover was in excellent condition with no evidence of settling or erosion (PL-2).

GRJ 3/2010. PL-2. South side of the disposal cell cover.

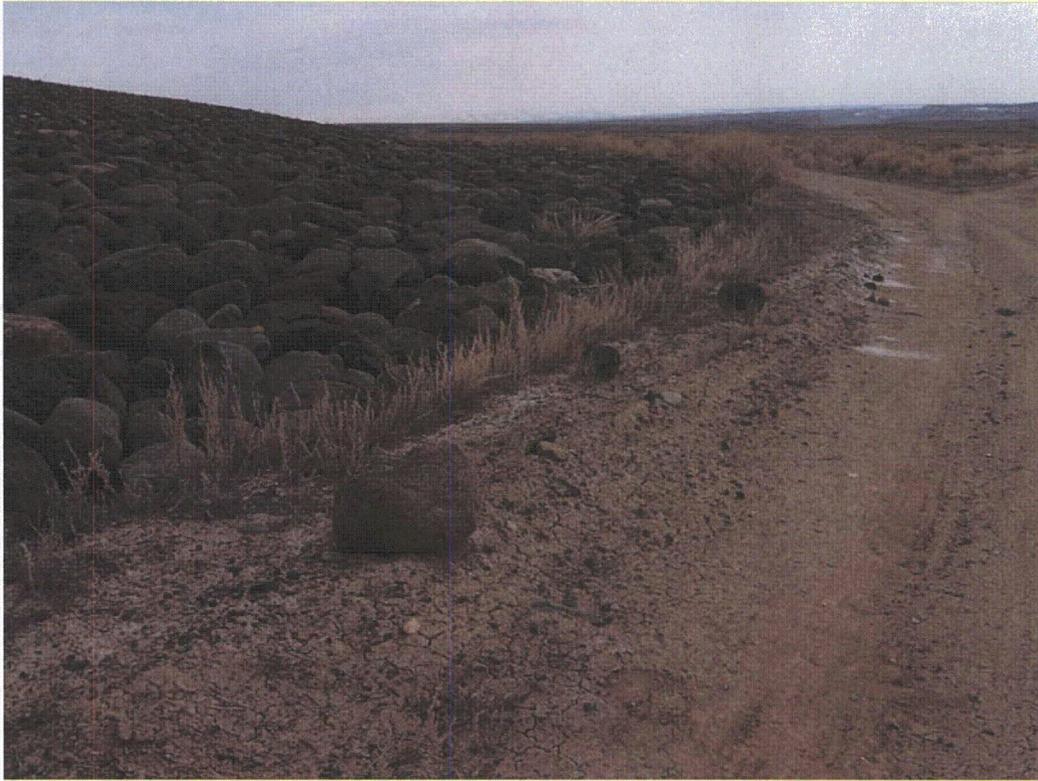
Some large basalt boulders in the apron at the toe of the southwest corner of the disposal cell have shifted, and minor erosion had recently occurred on the site road at that location. It is assumed that these conditions are attributable to freeze-thaw actions and runoff from melting snow and ice. The disposal cell side slope at this location is stable, and there is no concern regarding the integrity or function of the disposal cell.

GRJ 3/2010. PL-3. Apron at the southwest corner of the disposal cell.

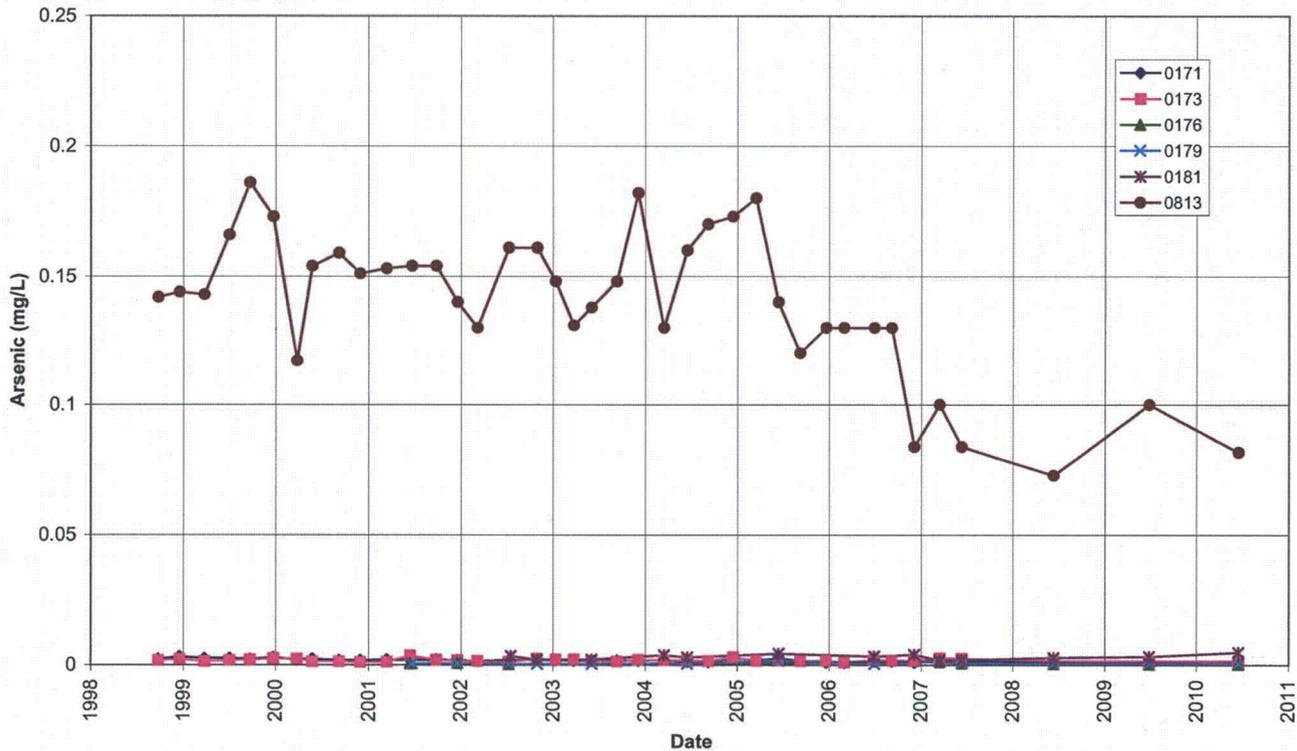
Figure 7-2. Time-Concentration Plots of Arsenic in Groundwater at the Green River Disposal Site

Arsenic concentrations in groundwater remain below the EPA MCL of 0.05 mg/L in all POC wells except well MW-0813, and remain considerably below the proposed ACL of 5.0 mg/L in all POC wells. In well MW-0813, levels continue to exceed the MCL as shown on Figure 7-2, but are substantially below the proposed ACL. The results for this well indicate that arsenic concentrations have trended downward since 2004.

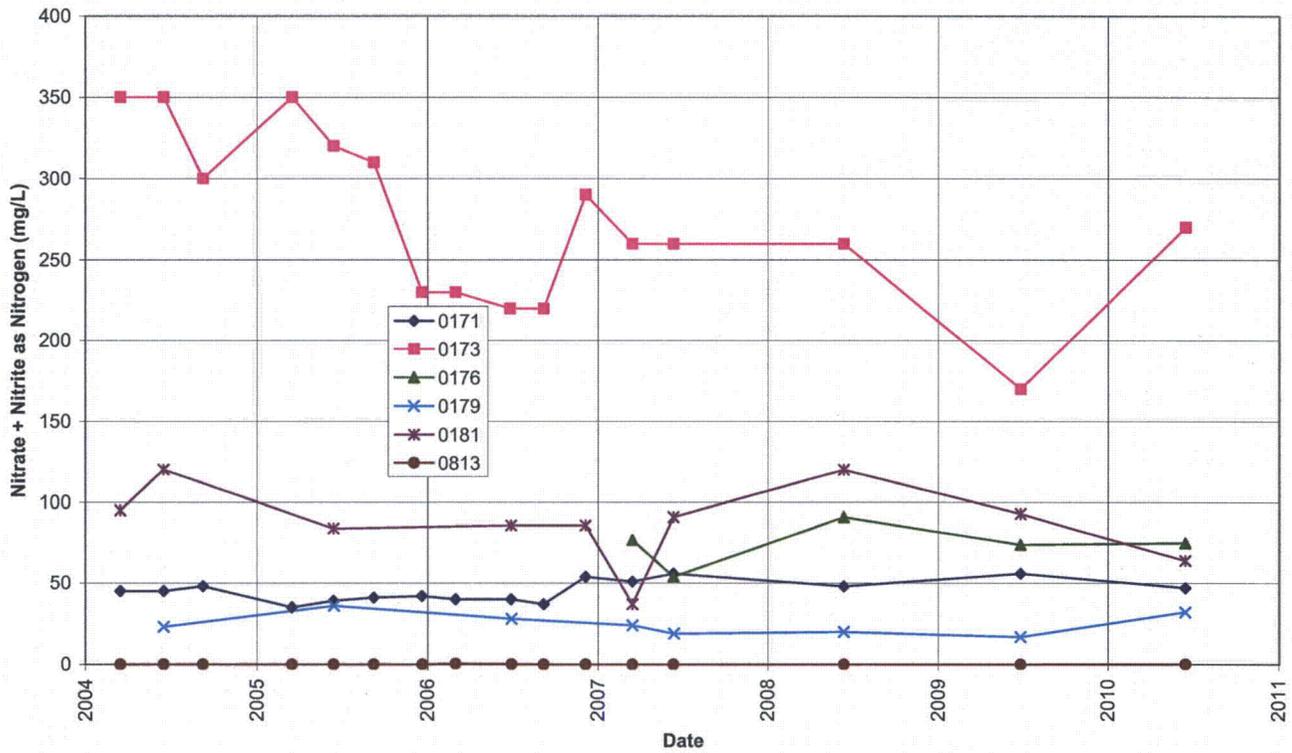
Figure 7-3. Time-Concentration Plots of Nitrate in Groundwater at the Green River Disposal Site

Nitrate concentrations have been measured as nitrate plus nitrite as nitrogen since early 2004 (before then, nitrate was measured as NO_3). Concentrations have continued above the EPA MCL of 10 mg/L in all POC wells except well MW-0813, but they are considerably below the proposed ACL of 1,000 mg/L in all wells (Figure 7-3). Nitrate concentrations in well MW-0813 continue to be below the laboratory detection limit. Nitrate concentrations in the other wells are similar to previous measurements and no trends are apparent.

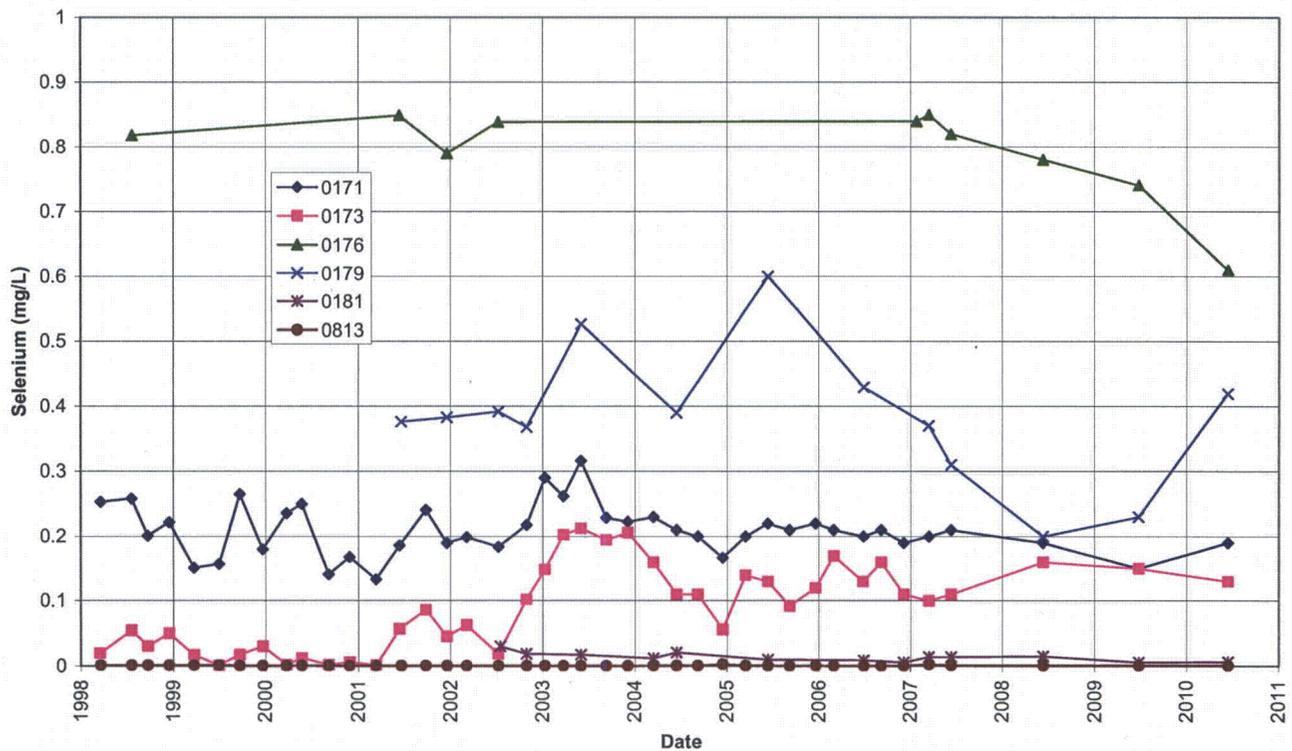
Figure 7-4. Time-Concentration Plot of Selenium in Groundwater at the Green River Disposal Site

Selenium concentrations in wells MW-0181 and MW-0813 remain below the Utah standard of 0.05 mg/L. Concentrations in the other wells continue to be above the Utah standard but are substantially below the proposed ACL of 5.0 mg/L (Figure 7-4). Selenium concentrations appear to be trending downward in well MW-0176; no trends are apparent in the other wells.

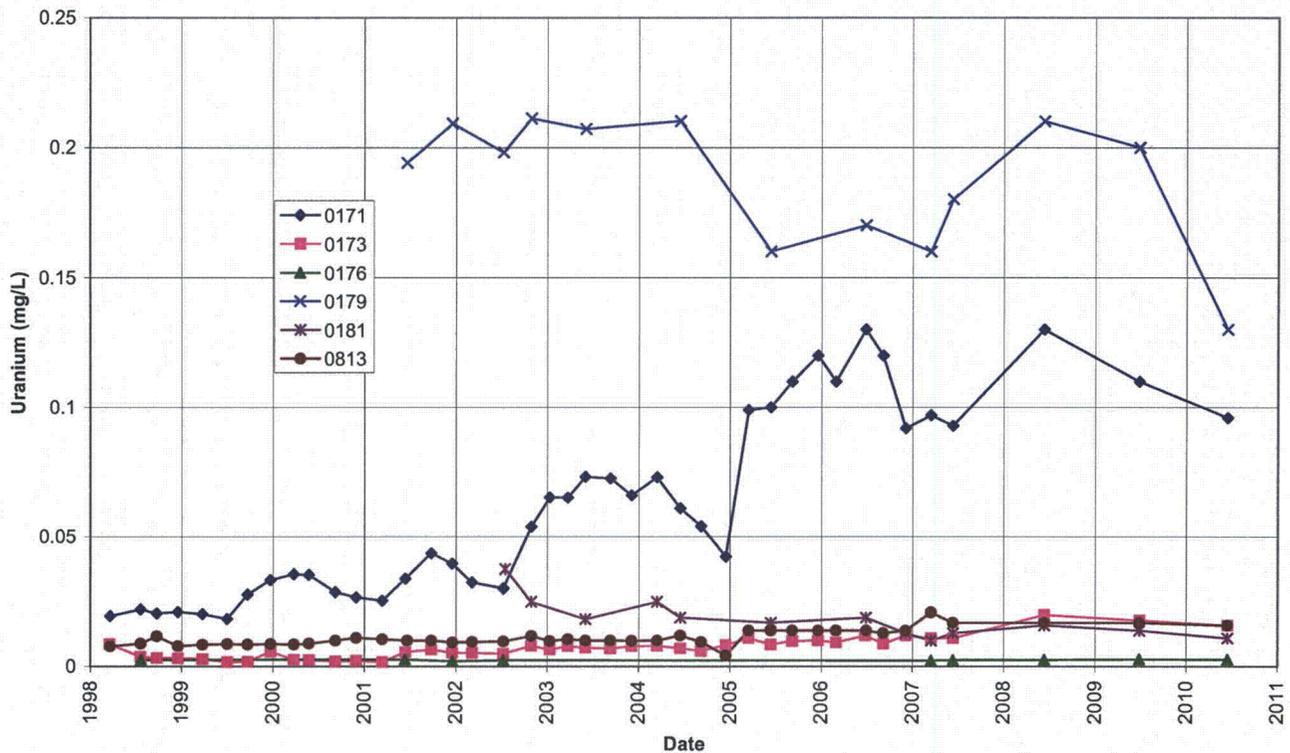
Figure 7-5. Time-Concentration Plot of Uranium in Groundwater at the Green River Disposal Site

Uranium concentrations in groundwater remain below the EPA MCL of 0.044 mg/L in all POC wells except wells MW-0171 and MW-0179, and remain considerably below the proposed ACL of 4.4 mg/L in all POC wells. The highest uranium concentrations continue to occur in well MW-0179 (0.13 mg/L), which is upgradient of the disposal cell. The reason for the elevated concentration of uranium in well MW-0179 has not been determined but may be due to natural causes. At well MW-0171, concentrations exceed the MCL and indicate an upward trend since 1998 (Figure 7-5). Because uranium is the only constituent of concern that has indicated an upward trend in well MW-0171, no conclusions regarding the cause of the trend have been reached.

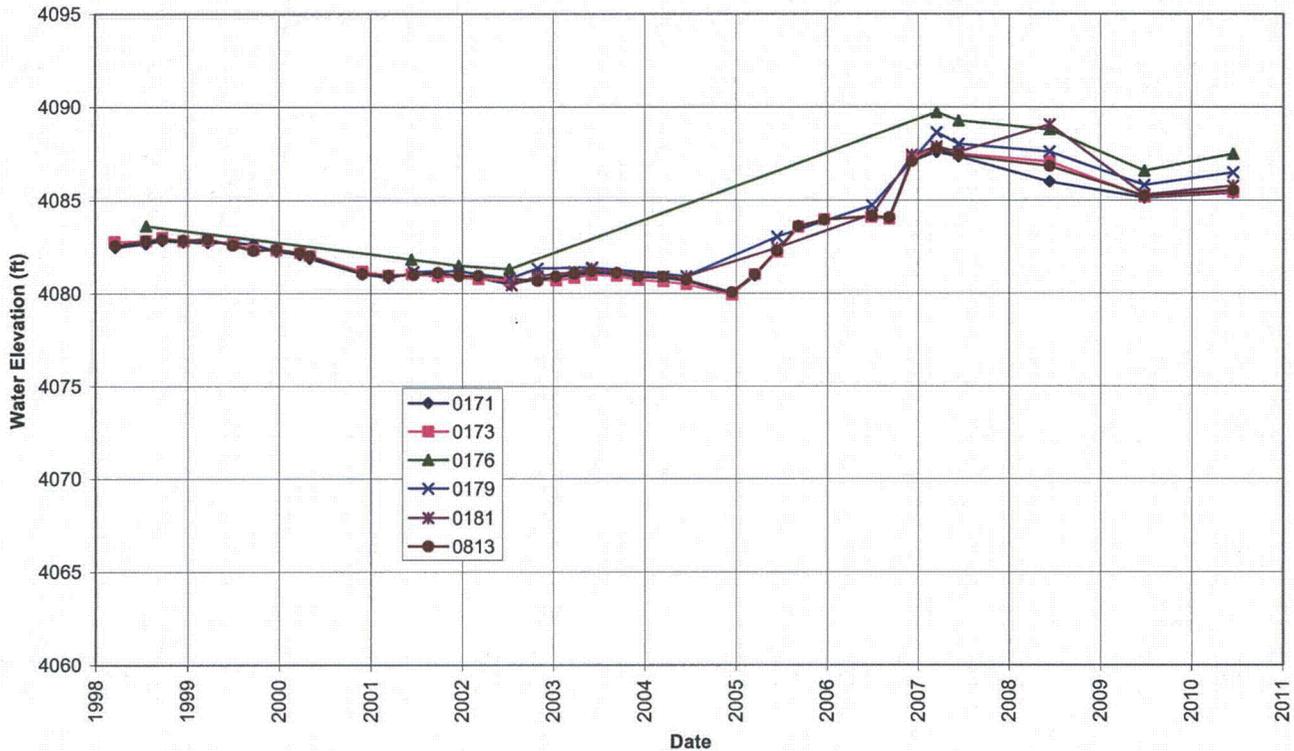
Figure 7-6. Groundwater Elevations at the Green River Disposal Site

Water level hydrographs of the POC wells, completed in the middle sandstone aquifer, indicate that the groundwater elevation decreased approximately 3 feet overall from 1998 through 2004, and then increased approximately 8 feet between 2004 and 2007. Water levels have decreased approximately 2–3 feet since 2007, although slight increases occurred in 2010 (Figure 7-6). Manual measurements were false on several occasions, probably because of equipment problems (continuous measurements indicated essentially no change at those times). Figure 7-6 does not show the false measurements.

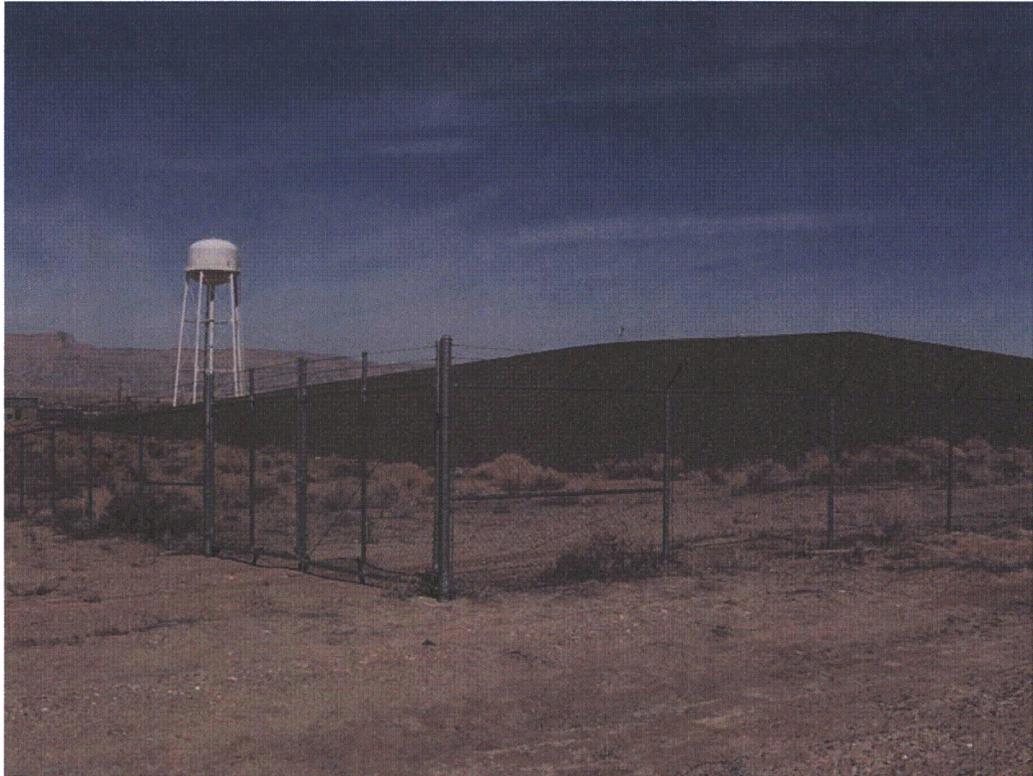
Entrance to the site is through a locked steel gate in the access road right-of-way fence. Past this gate, a short track leads across State land to the disposal cell, which is enclosed within a chain-link security fence. The chain-link fence is set back between 50 and 250 feet from the site boundary. Two vehicle access gates are installed in this fence at the south and east corners of the fence line. A personnel gate is at the north corner of the fence line. The security fence and gates were in excellent condition (PL-1).

Disposal Cell and Adjacent Area Inside the Security Fence—The 6-acre disposal cell was completed in 1989. The slopes of the disposal cell cover are armored with basalt rock. No evidence of any disturbance of the cell surfaces was observed. No vegetation was present on the cell. The quality of the rock is excellent, and the disposal cell cover was in excellent condition (PL-1 and PL-2).

GRN 3/2010. PL-1. Disposal cell and security fence; south vehicle gate is in foreground.

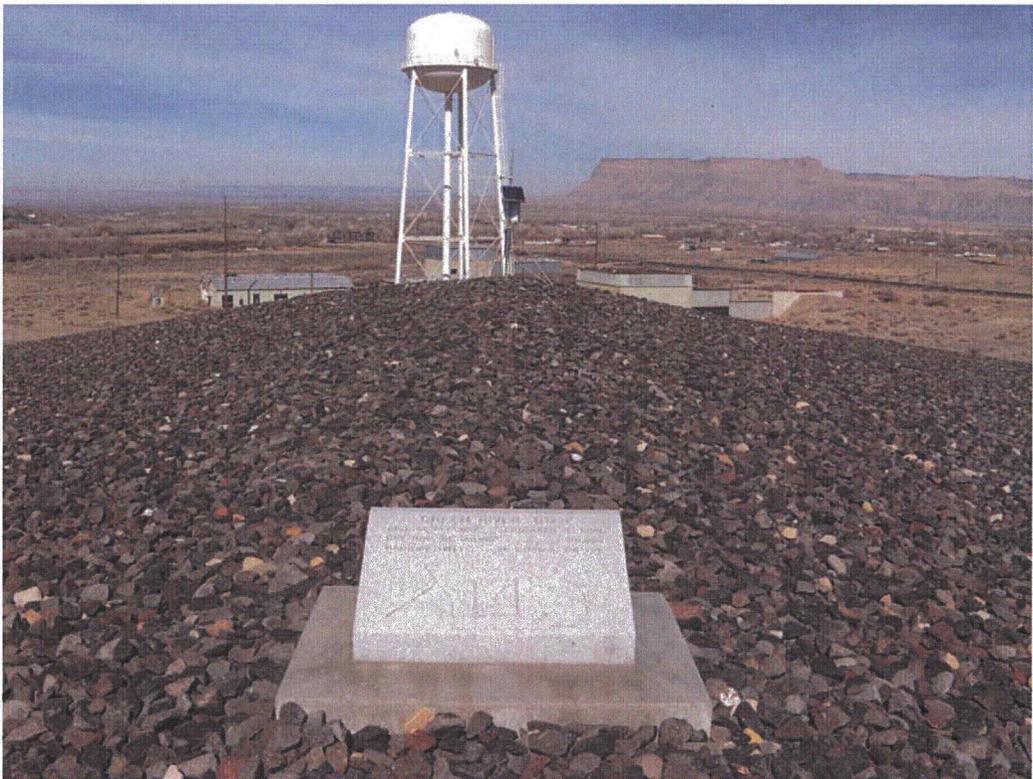
Site Markers and Monuments—Two granite site markers are on site, and both were in good condition (PL-2). The concrete base of site marker SMK-1 has several cracks, but there is no need for repairs at this time. Eleven boundary monuments and three survey monuments are along the site perimeter. All of the monuments were in excellent condition.

GRN 3/2010. PL-2. Site marker SMK-2 on the disposal cell top.

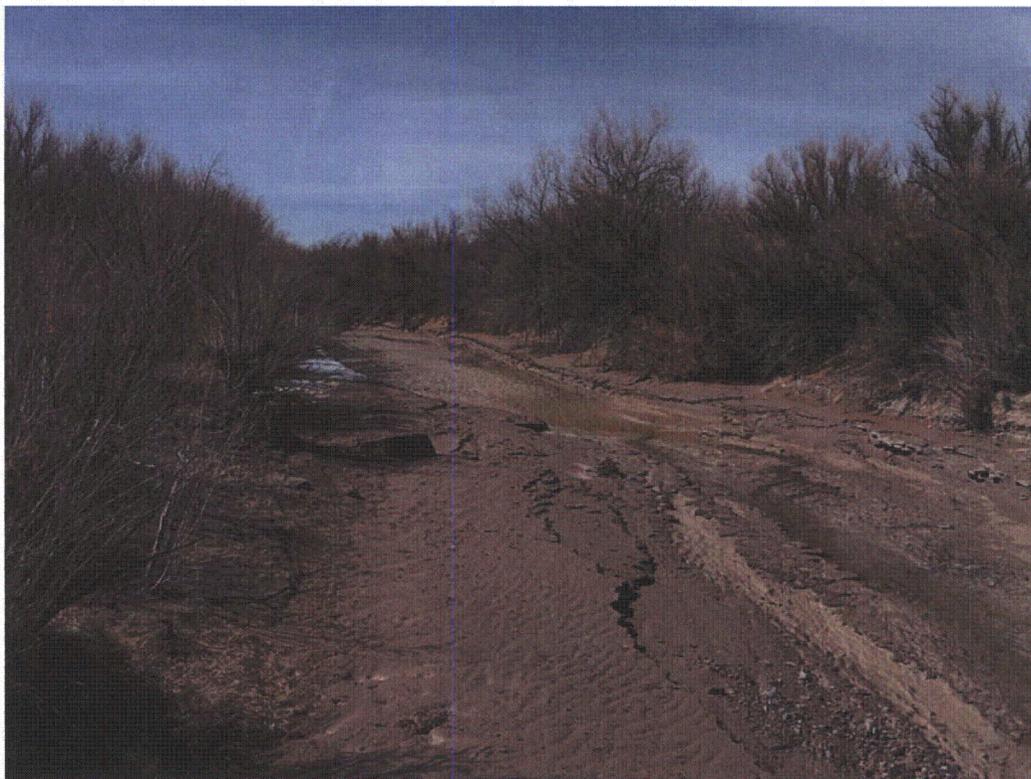
The backwater area near the mouth of Browns Wash was investigated because of its potential as a fish spawning location. The backwater area was nearly filled with sediment, with minimal standing water (PL-4). The conditions of Browns Wash channel and the backwater area change substantially after each runoff event as sediment is either scoured or deposited along the channel bottom.

GRN 3/2010. PL-4. Green River backwater area in Browns Wash.
