2010 Annual Site Inspection and Monitoring Report for Uranium Mill Tailings Radiation Control Act Title I Disposal Sites

January 2011

LMS/S06929

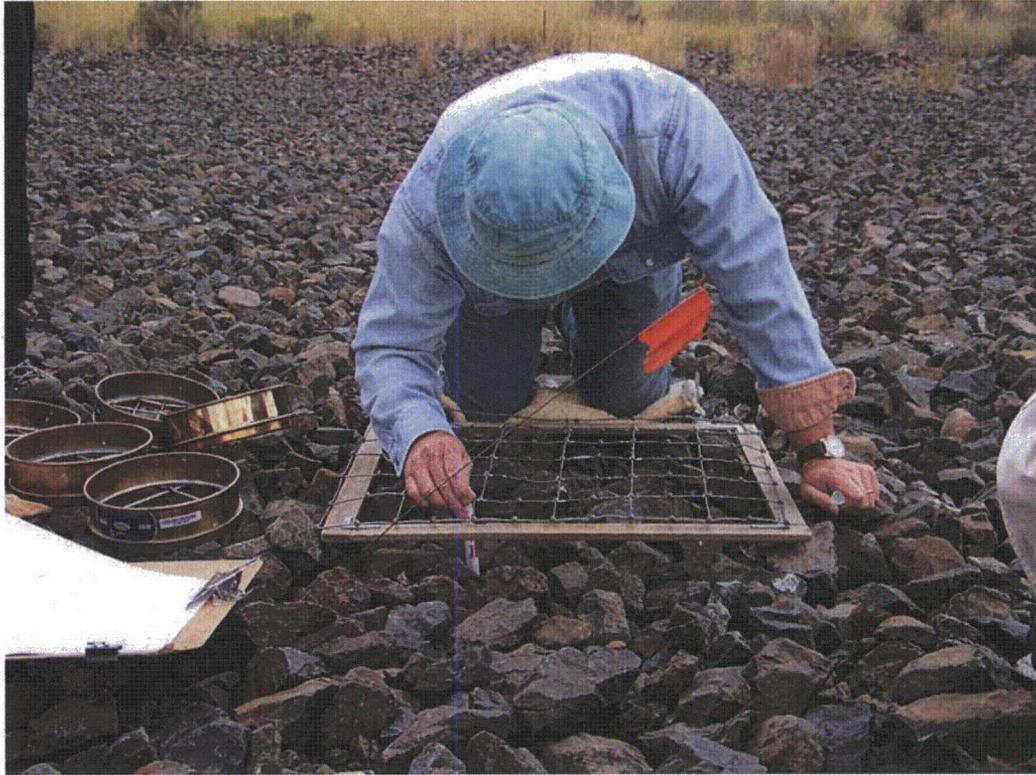
LKV 8/2010. PL-3. Using grid to mark rocks to be used for gradation and durability monitoring on west side slope.

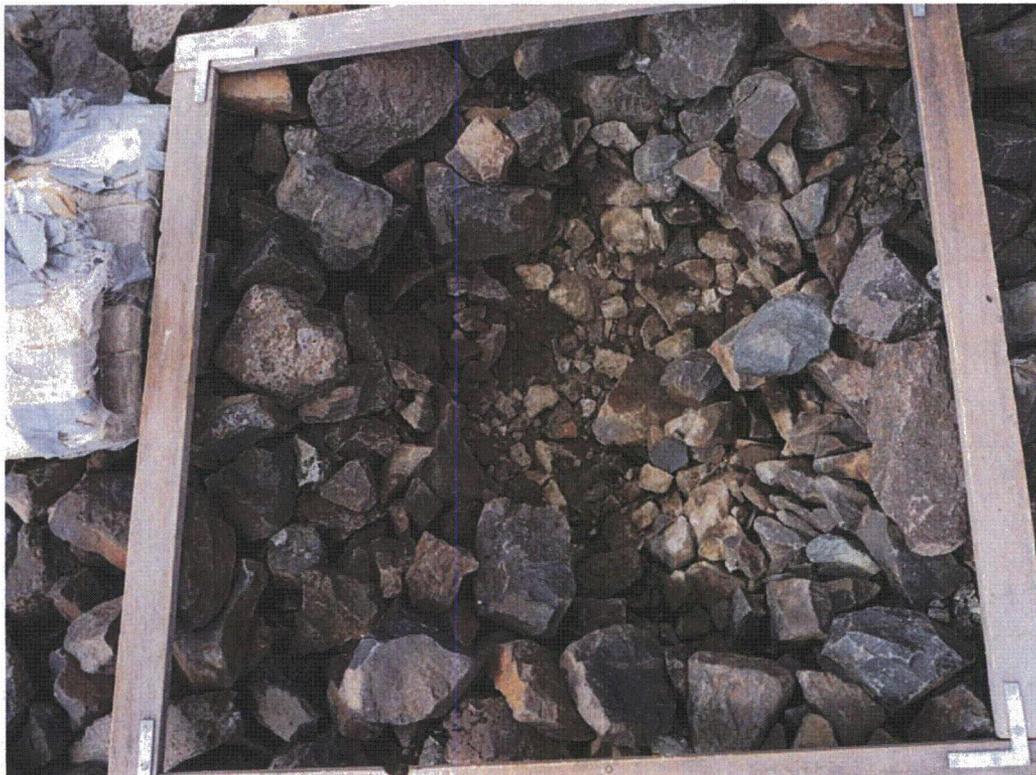
LKV 8/2010. PL-4. Collecting rock samples from beneath the monitored area for laboratory gradation analysis. Rock profile is collected down to bedding layer for each sample. Sampling in progress.

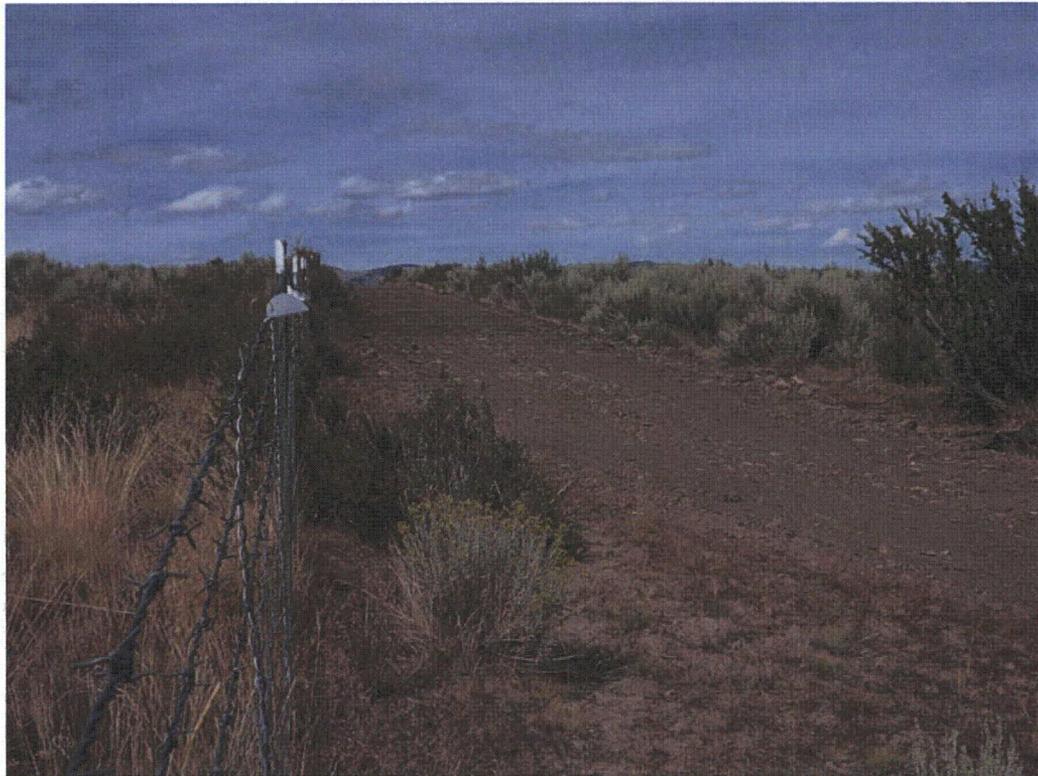
LKV 8/2010. PL-5. New road adjacent to east site fence. Road is not on disposal site. White fence flag shown on fence.

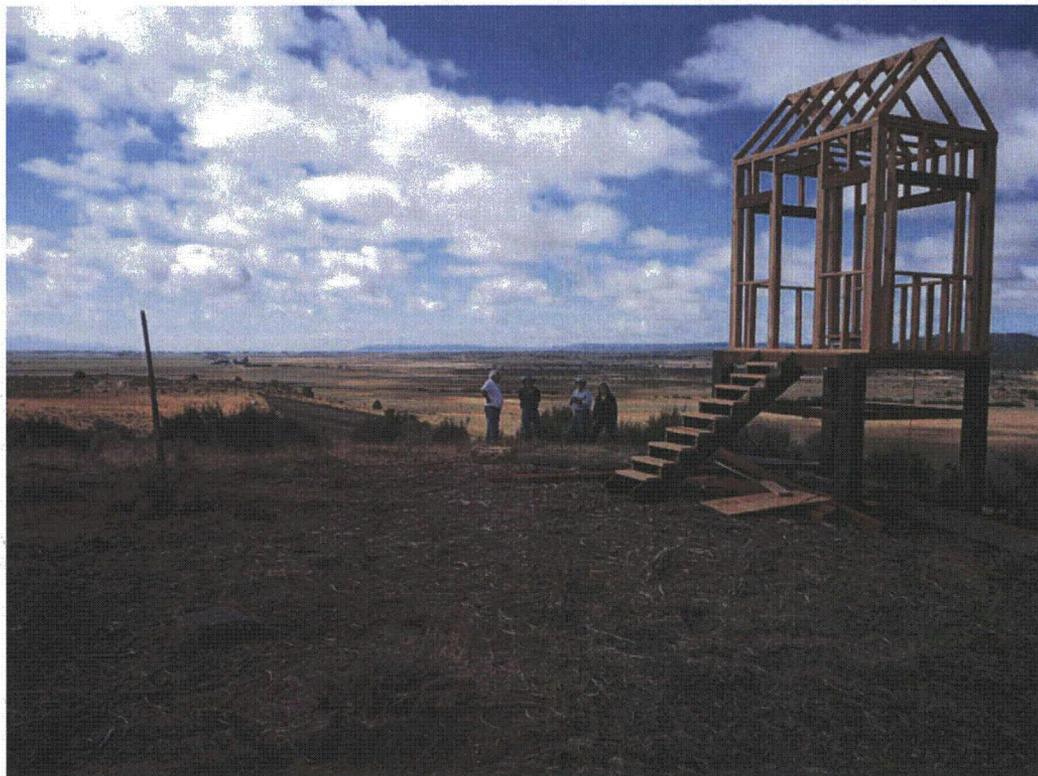
LKV 8/2010. PL-6. View south of new structure being constructed on top of Augur Hill. Shows NRC, Oregon, and S.M. Stoller Corporation representatives.
