## Impacts of a Severe Road Tunnel Fire on Transportation of Spent Nuclear Fuel - 11583

E. Easton,<sup>1</sup> C. Bajwa,<sup>1</sup> T. Mintz,<sup>2</sup> J. Huczek,<sup>3</sup> K. Das,<sup>2</sup> K. Axler<sup>2</sup>

In October 2007 just north of Los Angeles, California, a chain-reaction accident involving numerous tractor trailers in the I-5 "Newhall Pass" truck bypass tunnel occurred. This accident also involved an intense fire that damaged the concrete walls of the tunnel and required the tunnel to be closed for repairs. The objective of the work described in this paper was to determine the maximum exposure temperature in the tunnel and evaluate the conditions likely to be found in this fire. The study included analyses of material recovered from the incinerated vehicles. A simulation of the Newhall Pass tunnel fire, using the Fire Dynamics Simulator code developed by the National Institute of Standards and Technology, is also being completed. A discussion of the results of this study as well as the potential implications of this accident for the transportation of spent nuclear fuel by truck is provided.

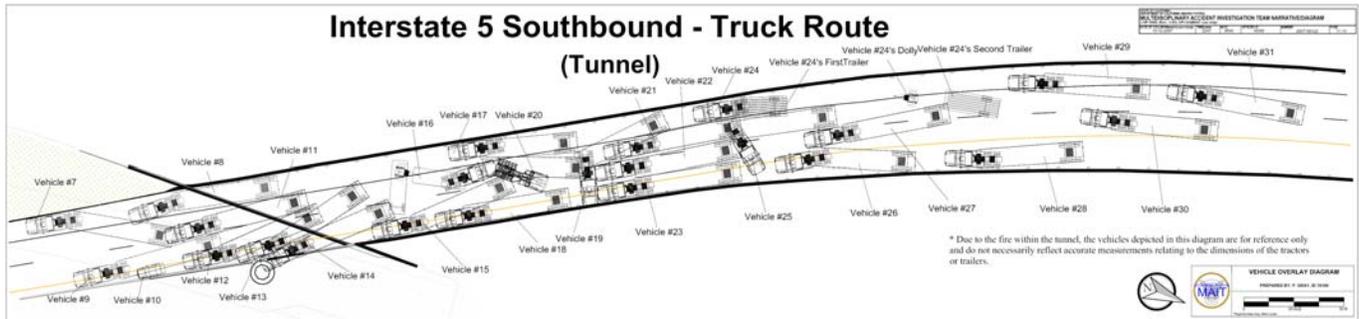
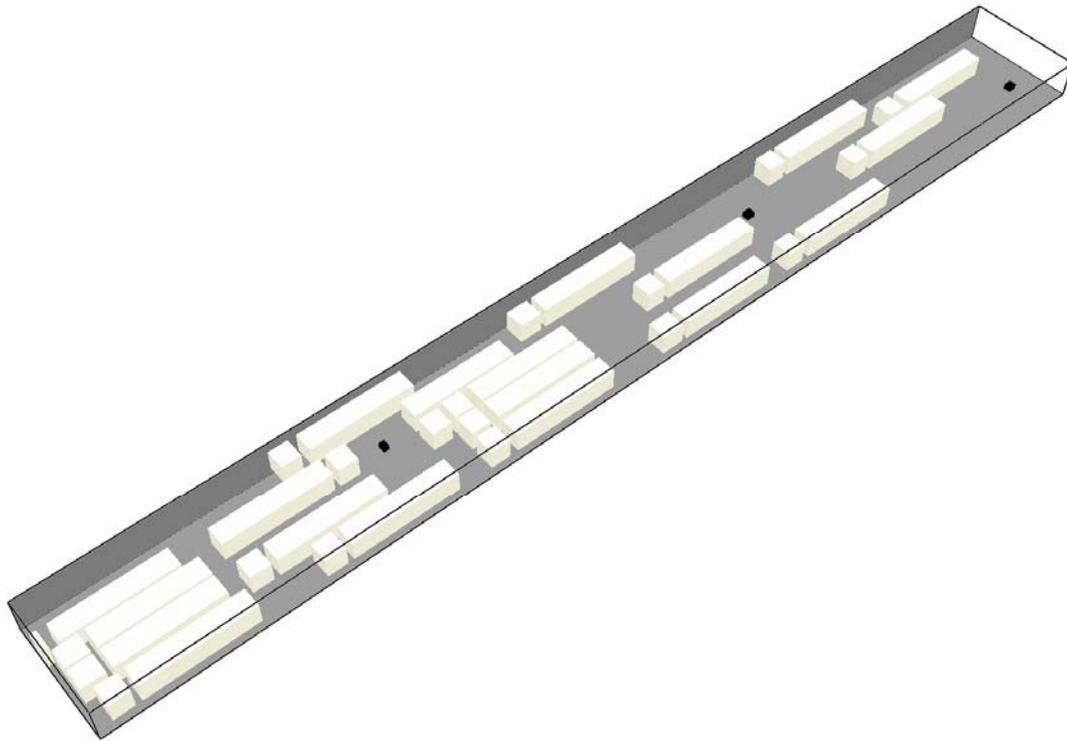
**Fig. 1. Newhall pass tunnel geometry (a) provided by multidisciplinary accident investigation team (courtesy of CHP) and (b) fire dynamics simulator model approximation**
