Subject: INTERIM REPORT  
Flowserve, Limit switch on Limitorque Actuators, Type SMB-00 and Type SMB-2-06

Subject: Final Report for CAR 25500-73903 / Part 21 Evaluation of Geared Limit Switch (NRC Event # 46403)

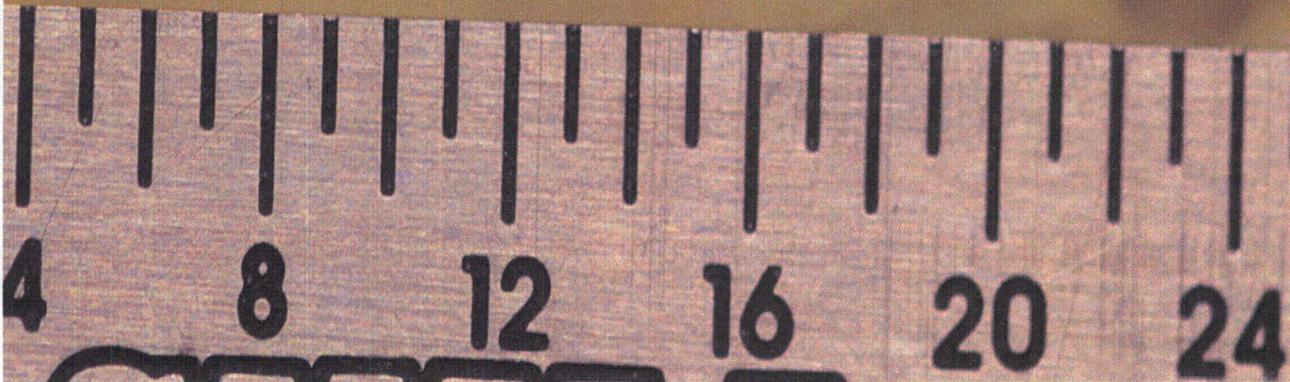
After cycle testing nine (9) switches from Flowserve stock, and seven (7) returned switches from Velan,; it was determined that producing a bend in the contact finger cannot occur during normal cyclic operation of the rotor. A bend in the finger assembly (finger and spring stud) with the use of a flat blade screw driver was duplicated several times. This can happen when turning the intermittent gear shaft during the GLS setting procedure. It was recreated in the 3-D solid models as noted above. This occurs only on the finger assemblies designated as 4L and 8R due to the lever action that can be produced as shown in the models. It is highly likely that this is the cause of the bent finger assemblies reported in the CAR. Evidence of the bent spring stud and scuff marks on the head of the stud are in support of this argument.

The most significant event occurred during testing of the Velan switch from actuator serial # L852269. This switch, as with all of the returned Velan switches, was tested first in the as received condition. The loose finger base was tightened. No adjustments were made to any of the finger assemblies. Notes were taken to document which finger assemblies were "very tight" and which were not. This switch had several "very tight" finger assemblies. Visual inspection did not reveal any obvious bent finger assemblies. All contacts had initial continuity; however, with contacts in the open electrical state, finger contact with the rotor body was not verified. During the testing at 1,057 cycles continuity was lost on contact 4. The switch was allowed to complete the 2,000 cycle test. No additional contacts lost continuity. Visual inspection of contact 4 revealed that finger assembly 4L was no longer touching the rotor button. 4L was not a "very tight" finger assembly. After removal and closer inspection of the finger base from the gear frame it could be seen that there was a slight

bend in finger assembly 4L. The finger assembly was then removed from the finger base. The finger was disassembled and inspected. A bend in the spring stud was clearly evident. It is surmised that prior to initiating the cycle test the finger of contact 4 (switch state open) was not in contact with the rotor body, and in combination with the bent finger, bent spring stud and deformed cotter pin hole; produced dynamic mechanical reactions that eventually resulted in contact 4 losing electrical continuity. High powered macro photos were taken to look for any other damage. The photos revealed a scuff mark on the underside of the spring stud head. This scuff mark supports the argument that the edge of the flat blade screw driver can get caught under the spring stud head. When the screw driver is rotated, it pulls on the head and then pulls the finger and consequently both will bend. The force is great enough to damage the cotter pin hole in the spring stud. It was decided to reassemble the finger assembly, readjust the finger assembly and retest. The readjustment consisted of bending the "L" bracket enough so that the finger is touching the side of the rotor body. The switch was tested again. It was decided to extend the test for the 60 year life of 3,300 cycles. The switch functioned properly with no loss of continuity on any of the contacts. To further substantiate that a bent finger assembly can be readjusted and maintain proper continuity, a similar switch was built from Flowsolve stock and was tested for 3,300 cycles with no loss of continuity.

BENT SPRING STUD WITH DAMAGE TO  
THE COTTER PIN HOLE

DAMAGE TO HEAD OF SPRING STUD
