#### PART 21 REPORT - LIMITORQUE LIMIT SWITCH DEFECT

SUBJECT: FINAL REPORT Flowserve, Limit switch on Limitorque Actuators Type SMB-00 and Type SMB-2-06

Subject: Final Report for CAR 25500-73903 / Part 21 Evaluation of Geared Limit Switch (NRC Event # 46403)

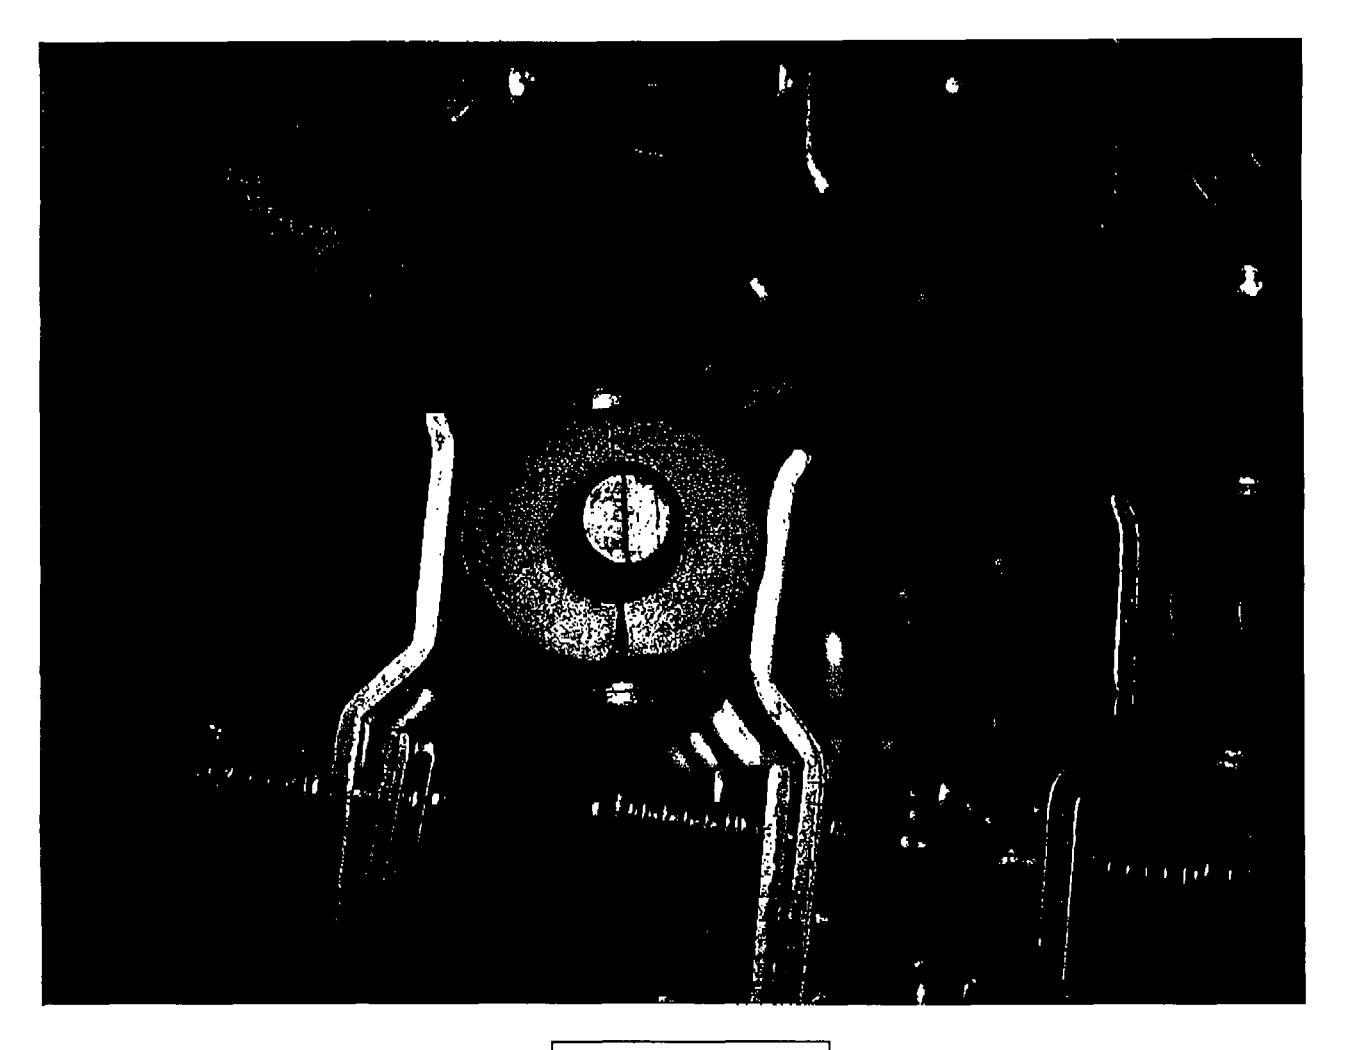
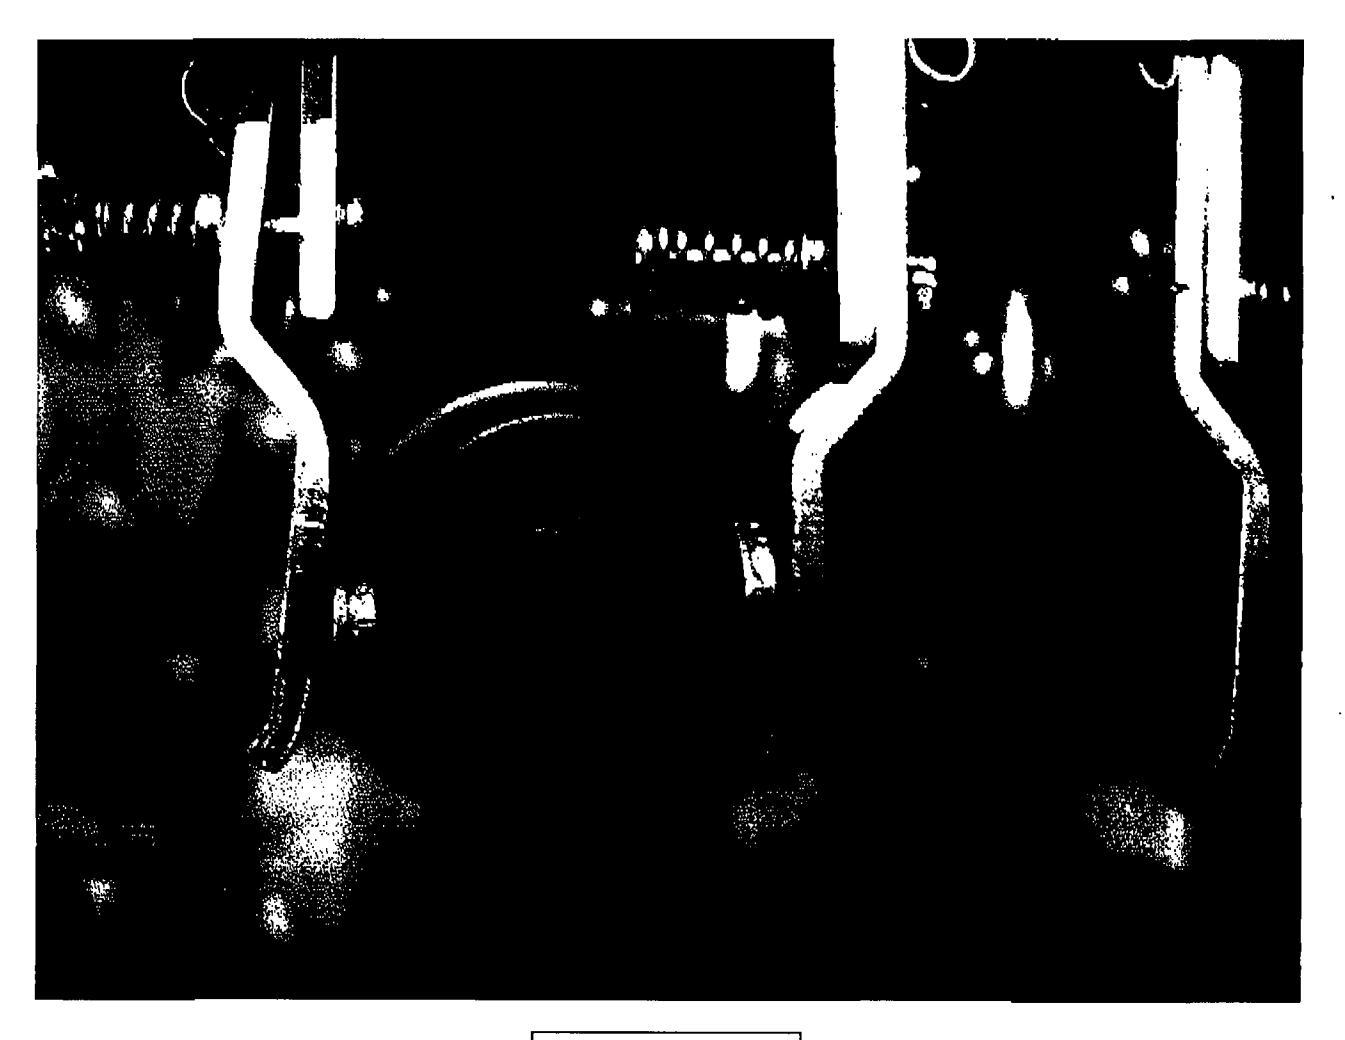
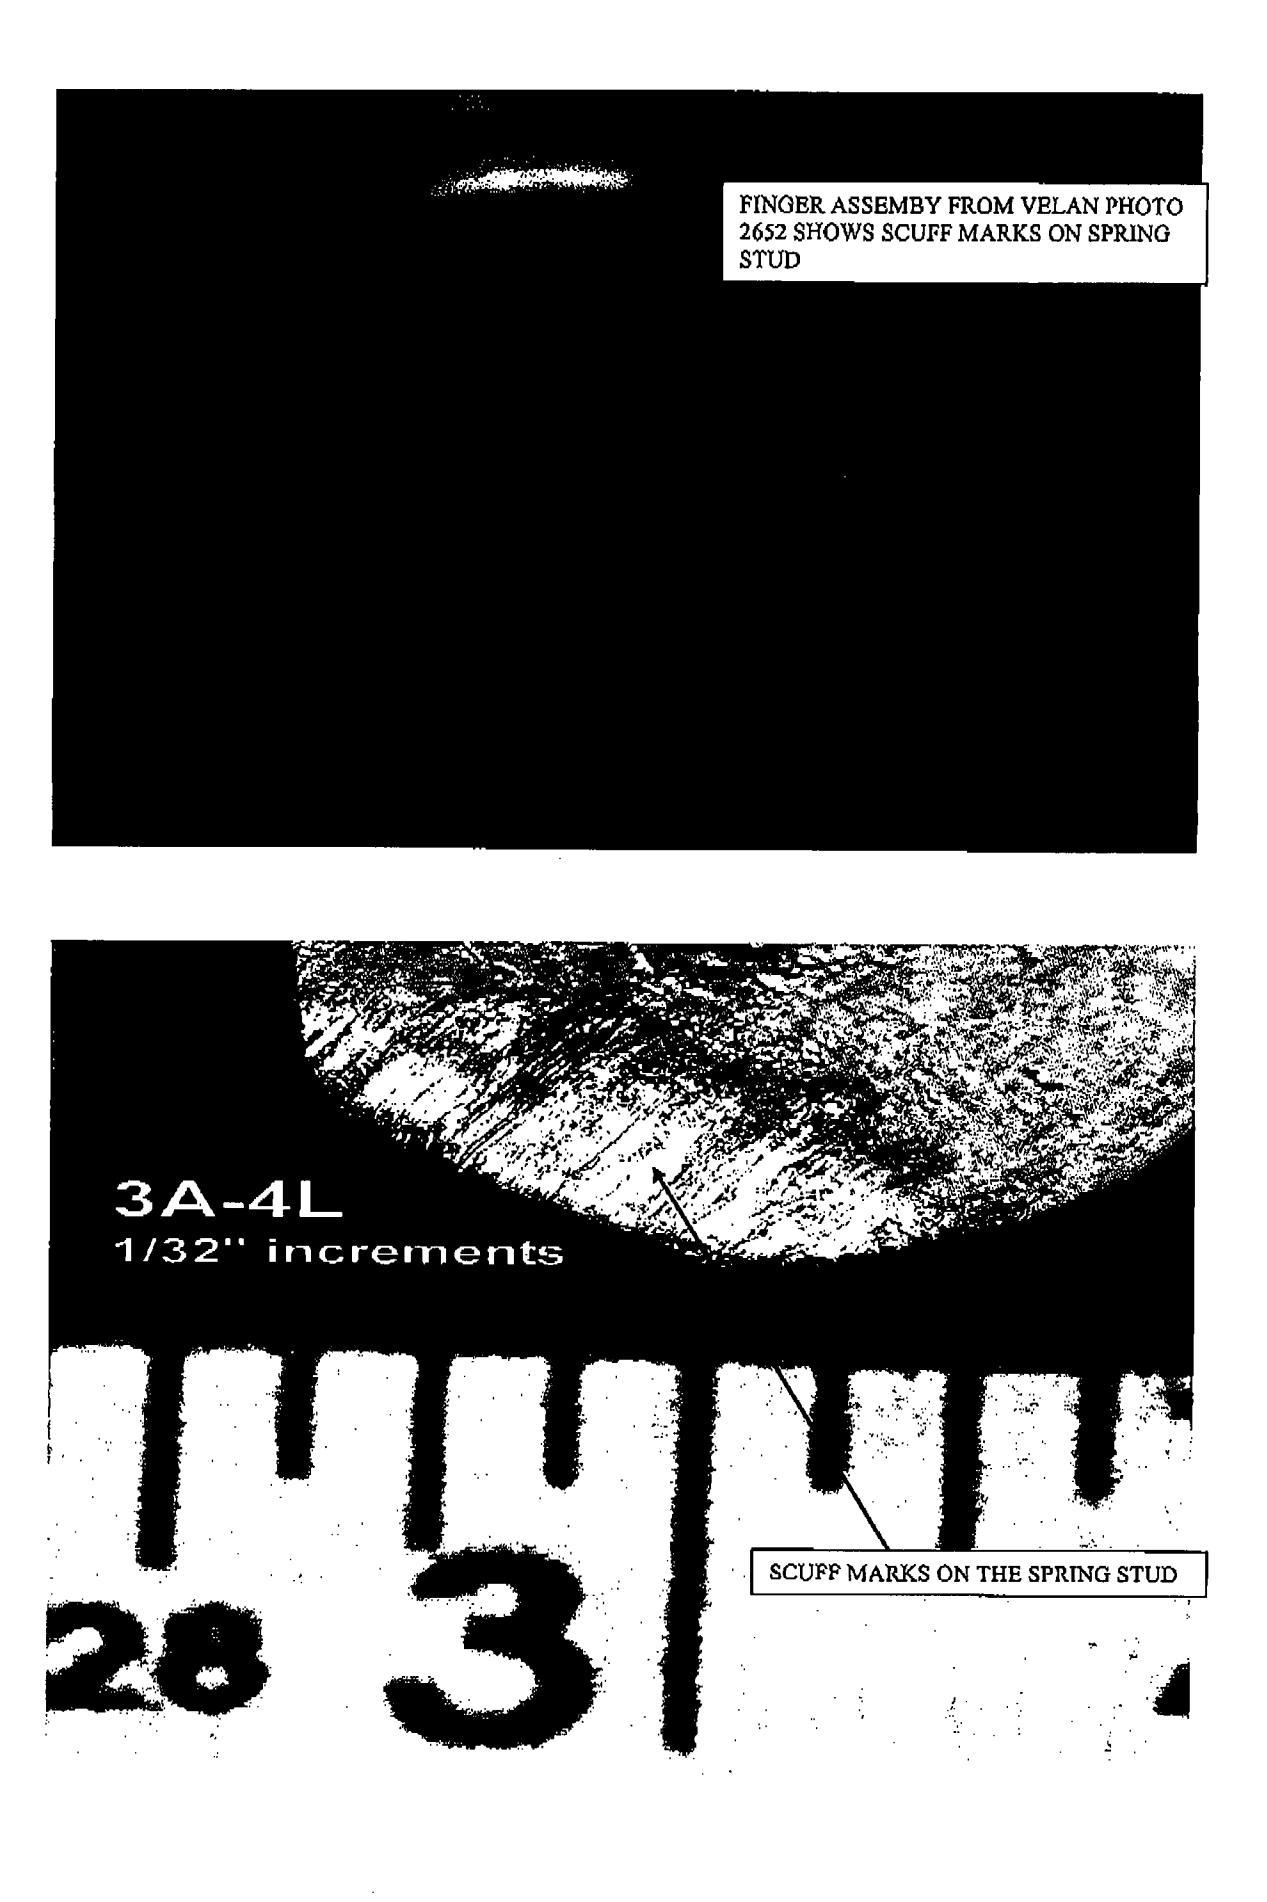
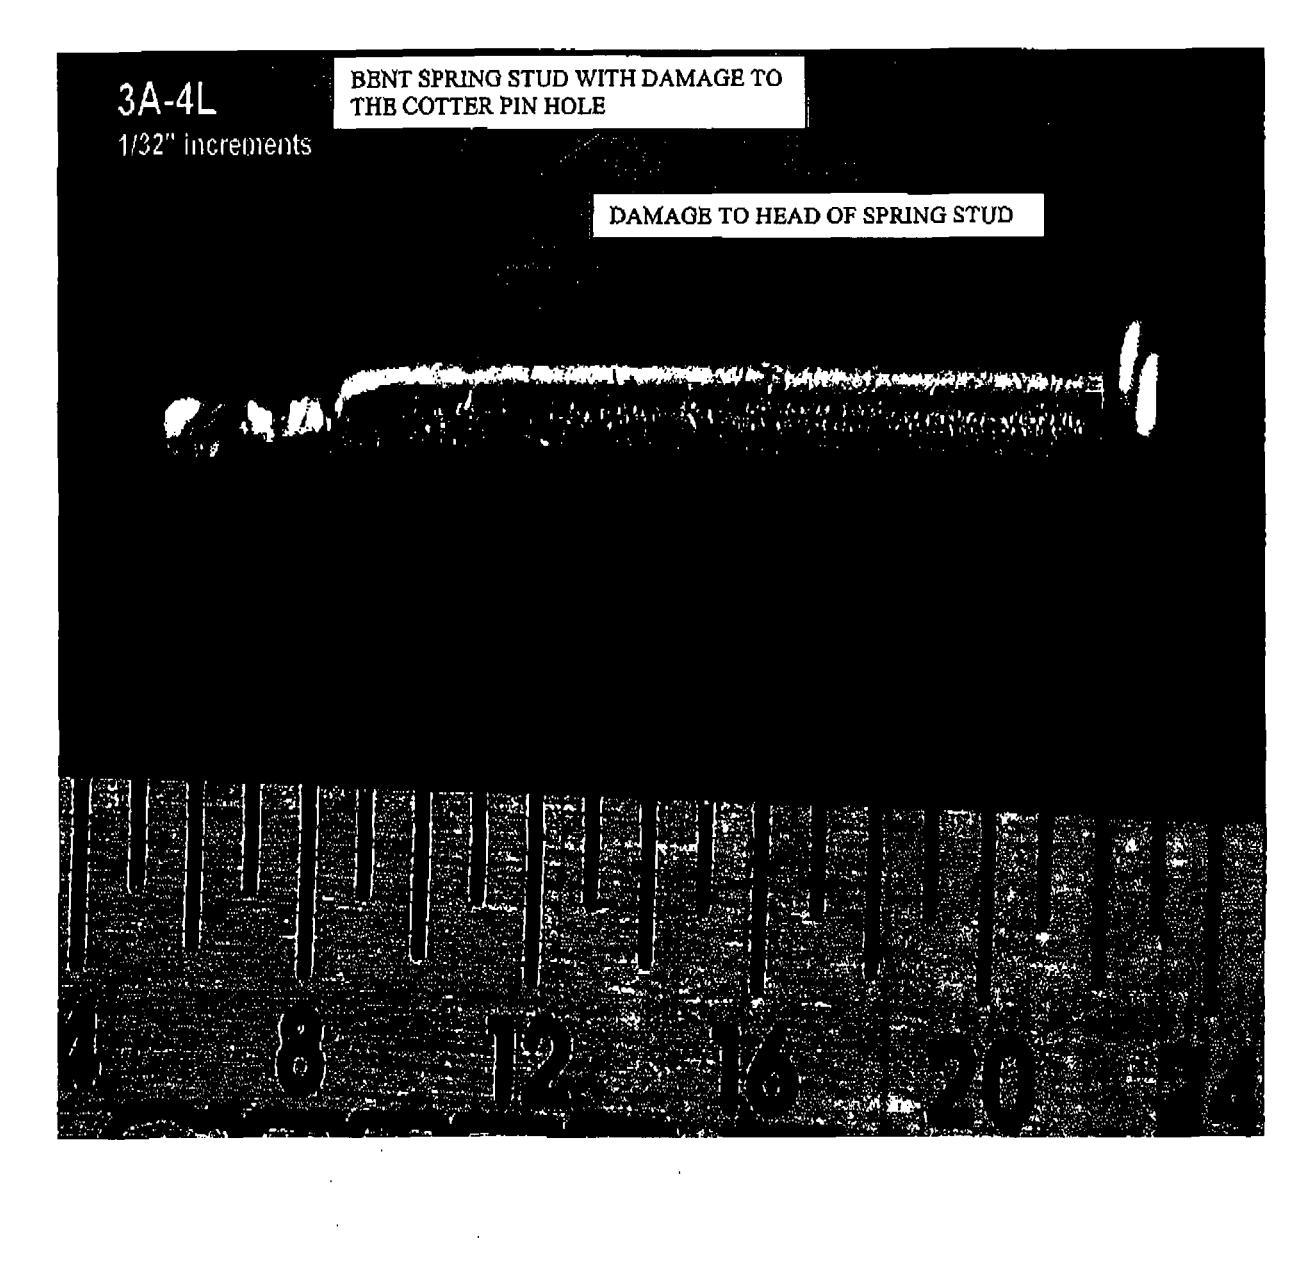
Velan reported they had an actuator become unresponsive after several cycles of open and close. Reference Velan order 219446 (DR 25500). They also reported the same condition on Velan order 217869 (DR73903). Verifying the source of the problem they found several gear limit switch finger assemblies damaged or bent. They also reported that some of the finger assemblies were tight with very little spring action. The following photos were attached to the CAR as evidence of these conditions.

The bent finger condition that was noticed in photos 2525 and 2526 was evaluated and found that the finger was so severely bent that it would not make contact with the rotor button in the closed state. It is Flowserve's opinion that this damage could have been caused by a flat bladed screw driver catching on the rivet head during the switch setting process. While turning the intermittent gear shaft it is possible for the rotating blade of a flat bladed screw driver to contact the spring stud on the contact arm. This creates a bending moment resulting in the contact arm bending at the point where the spring stud passes through the contact arm. Once discovered, this failure mechanism was repeated in multiple trial tests. Subsequent 3-D modeling of the switch assembly reinforced this finding by identifying the contact area of a screwdriver with the spring stud. The photos below show the bent rivet from the above finger assembly and scarring on the head of the rivet.

The tight finger condition that was shown in photo 2527 was found to be caused by the clearance hole in the finger for the rivet to be on the low side of the print tolerance and some of the samples measured showed the hole diameter slightly smaller than tolerance. It was found through the engineering evaluation and 3-D modeling that this tight condition could possibly occur even if the hole diameter was to specification and at the minimal print tolerance. We tested multiple finger assemblies with completely tight to minimal spring action for 3,300 cycles and found no loss of continuity or bending of the contact fingers. Based upon this testing, it was

The switch that had the condition depicted in photos 2641 and 2642 was tested as received and passed over 2,000 cycles with no loss of continuity. This switch finger was found to have very minimal contact with the button in the closed position as a result of the "L" bracket of the finger assembly being bent. This condition allowed for minute contact with the button but the finger assembly would stay stationary when the switch went to the closed position. The finger assembly was not tight and had full spring deflection. Unfortunately we did not notice this condition upon the initial testing which may have been the cause for the intermittent loss of continuity at Velan. This finger assembly was subsequently adjusted properly so the finger was touching the rotor body in the electrically open state and the switch was tested an additional 3,300 cycles with no loss of continuity.

After cycle testing nine (9) switches from Flowserve stock, and seven (7) returned switches from Velan;; it was determined that producing a bend in the contact finger cannot occur during normal cyclic operation of the rotor. A bend in the finger assembly (finger and spring stud) with the use of a flat blade screw driver was duplicated several times. This can happen when turning the intermittent gear shaft during the GLS setting procedure. It was recreated in the 3-D solid models as noted above. This occurs only on the finger assemblies designated as 4L and 8R due to the lever action that can be produced as shown in the models. It is highly likely that this is the cause of the bent finger assemblies reported in the CAR. Evidence of the bent spring stud and scuff marks on the head of the stud are in support of this argument.

The most significant event occurred during testing of the Velan switch from actuator serial # L852269. This switch, as with all of the returned Velan switches, was tested first in the as received condition. The loose finger base was tightened. No adjustments were made to any of the finger assemblies. Notes were taken to document which finger assemblies were "very tight" and which were not. This switch had several "very tight" finger assemblies. Visual inspection did not reveal any obvious bent finger assemblies. All contacts had initial continuity; however, with contacts in the open electrical state, finger contact with the rotor body was not verified. During the testing at 1,057 cycles continuity was lost on contact 4. The switch was allowed to complete the 2,000 cycle test. No additional contacts lost continuity. Visual inspection of contact 4 revealed that finger assembly 4L was no longer touching the rotor button. 4L was not a "very tight" finger assembly. After removal and closer inspection of the finger base from the gear frame it could be seen that there was a slight

bend in finger assembly 4L. The finger assembly was then removed from the finger base. The finger was disassembled and inspected. A bend in the spring stud was clearly evident. It is surmised that prior to initiating the cycle test the finger of contact 4 (switch state open) was not in contact with the rotor body, and in combination with the bent finger, bent spring stud and deformed cotter pin hole; produced dynamic mechanical reactions that eventually resulted in contact 4 losing electrical continuity. High powered macro photos were taken to look for any other damage. The photos revealed a scuff mark on the underside of the spring stud head. This scuff mark supports the argument that the edge of the flat blade screw driver can get caught under the spring stud head. When the screw driver is rotated, it pulls on the head and then pulls the finger and consequently both will bend. The force is great enough to damage the cotter pin hole in the spring stud. It was decided to reassemble the finger assembly, readjust the finger assembly and retest. The readjustment consisted of bending the "L" bracket enough so that the finger is touching the side of the rotor body. The switch was tested again. It was decided to extend the test for the 60 year life of 3,300 cycles. The switch functioned properly with no loss of continuity on any of the contacts. To further substantiate that a bent finger assembly can be readjusted and maintain proper continuity, a similar switch was built from Flowserve stock and was tested for 3,300 cycles with no loss of continuity.

Based on the testing and evaluations of all Velan returned switches and switches from Flowserve stock, a design deficiency has not been identified. Properly set switches will perform their intended functions. Flowserve believes that this issue is not reportable to the nuclear industry under the guidelines of 10CFR50 Part 21 regulations. A maintenance update will be issued by Flowserve to guide the industry on any recommendations during their regularly scheduled maintenance outages.
