## EMD JACKET WATER PUMP WITH INCORRECT IMPELLER ORIENTATION

**Report No. 10CFR21-0100**

**10CFR21 REPORTING OF DEFECTS  
AND NON-COMPLIANCE**

COMPONENT: EMD water pumps

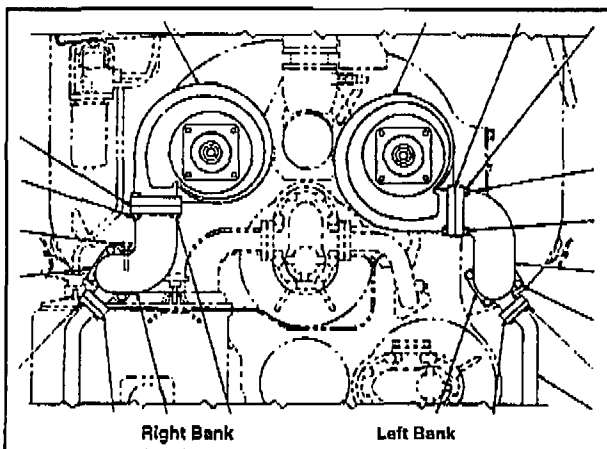
**Figure 1**

EMD diesel engines utilized for emergency diesel generator sets use two engine jacket water centrifugal pumps (one for each bank) to circulate fluid throughout the engine for cooling. Each pump is mounted on the front of the engine and rotates in the opposite direction of the engine crankshaft. For single engine generator set applications (i.e. left hand rotation engine, viewed from the rear of the engine), the pumps used on each bank contain identical components; the only difference is the position of the impeller housing in relation to the pump shaft housing. When viewed from the front of the engine, these water pumps rotate counterclockwise (see Figure 1 below).

**Water Pumps for LH Rotation Engine**

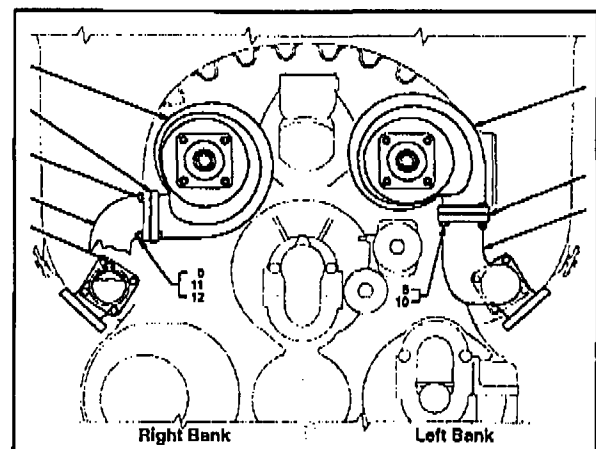
**Figure 2**

For tandem generator set applications, one engine is left hand rotation and the other is right hand rotation. For each engine, the pumps used on each bank contain identical components and the only difference is the position of the impeller housing in relation to the pump shaft housing. However, for a right hand rotation engine the water pumps rotate clockwise when viewed from the front of the engine (see Figure 2 below).

**Water Pumps for RH Rotation Engine**
